# FACILITY CONDITION ASSESSMENT

**Oregon Department of Education**

Springfield High School  
875 N 7th Street  
Springfield, OR 97477

*March 5, 2025*

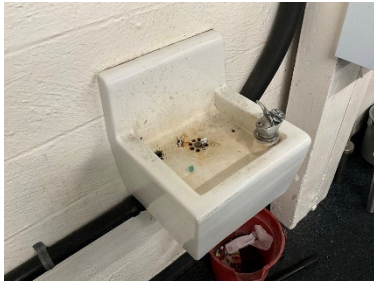
### Drinking Fountain in Failed Condition.

Wall-Mounted, Single-Level  
Grandstand  
Weight Room

Not operational  
- AssetCALC ID: 8959983

Uniformat Code: D2010  
Recommendation: **Replace in 2025**

Cost Estimate: \$1,900

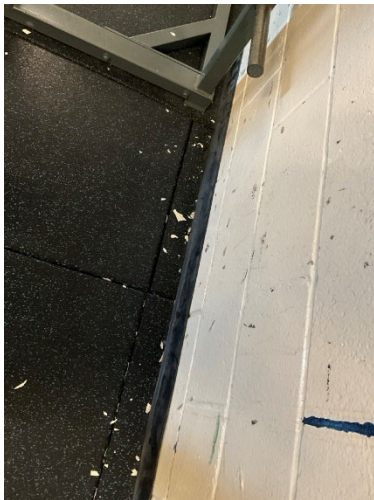
### Wall Finishes in Poor Condition.

Any surface  
Grandstand  
Throughout Building

Uniformat Code: C2010  
Recommendation: **Prep & Paint in 2026**

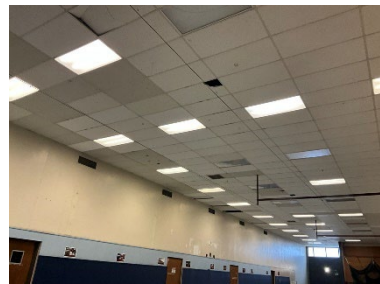
**Fire Suppression System**

Full System Install/Retrofit, Medium  
Density/Complexity  
Gymnasium  
Throughout Building

Adding a fire suppression sprinkler system is recommended for all student occupied areas. - AssetCALC ID: 8963825

Uniformat Code: D4010  
Recommendation: **Renovate in 2030**

Cost Estimate: \$379,800

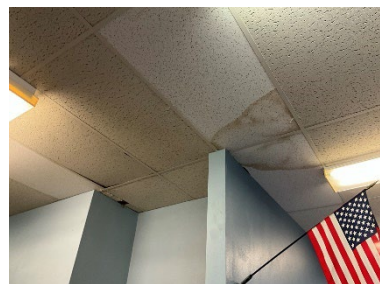
**Suspended Ceilings in Poor Condition.**

Acoustical Tile (ACT)  
Gymnasium  
Throughout Building

Stains and broken drop ceiling - AssetCALC ID: 8963851

Uniformat Code: C1070  
Recommendation: **Replace in 2027**

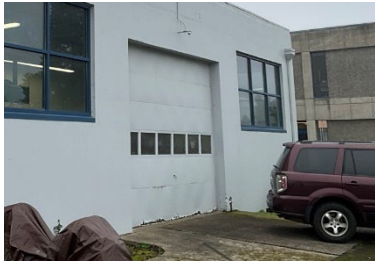
### Overhead/Dock Door in Poor Condition.

Steel, 12'x12' (144 SF)  
Metal Shop  
Building Exterior

Dock doors are broken at the bottom - AssetCALC ID: 8963951

Uniformat Code: B2050  
Recommendation: **Replace in 2027**

Cost Estimate: \$8,100

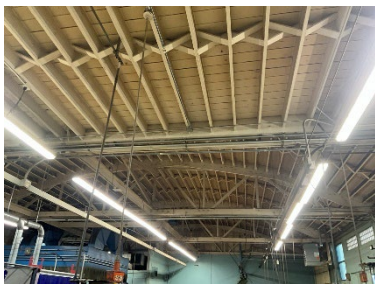
### Fire Suppression System

Full System Install/Retrofit, Medium  
Density/Complexity  
Metal Shop  
Throughout Building

Uniformat Code: D4010  
Recommendation: **Install in 2030**

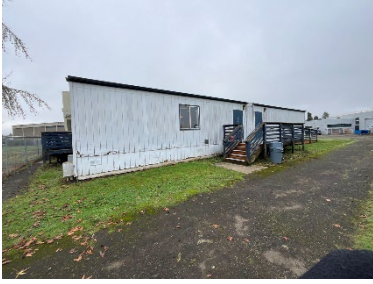
### **Classroom/Office Module in Poor Condition.**

The portable building has damaged side panels and its paint has faded over time. - AssetCALC ID: 9009048

Uniformat Code: F1020  
Recommendation: **Replace in 2026**

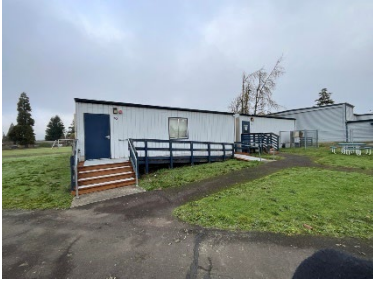
### **Classroom/Office Module in Poor Condition.**

The portable building has damaged side panels and its paint has faded over time. - AssetCALC ID: 8758530

Uniformat Code: F1020  
Recommendation: **Replace in 2025**

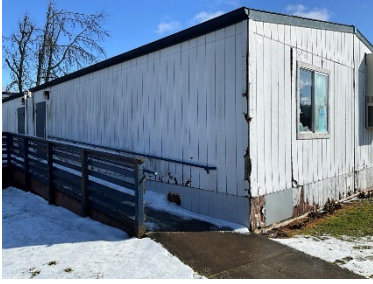
### **Classroom/Office Module in Poor Condition.**

The portable building has damaged side panels and its paint has faded over time. - AssetCALC ID: 9009047

Uniformat Code: F1020  
Recommendation: **Replace in 2025**

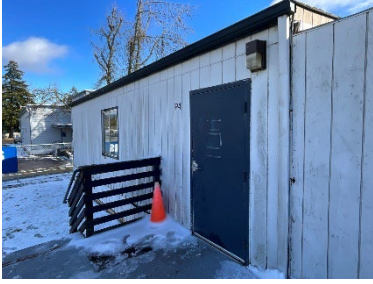
### **Classroom/Office Module in Poor Condition.**

Portable Building  
Portable 4  
Throughout Building

The portable building has damaged side panels and its paint has faded over time. - AssetCALC ID: 9009049

Uniformat Code: F1020  
Recommendation: **Replace in 2025**

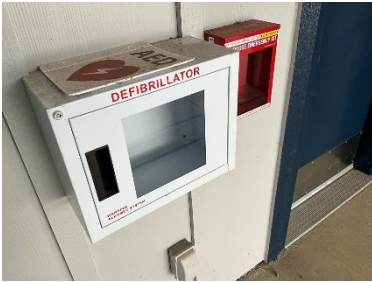
### Healthcare Equipment in Failed Condition.

Defibrillator (AED), Cabinet-Mounted  
Softball Batting Facility  
Building Exterior

Defibrillator unit is missing - AssetCALC ID: 8960022

Uniformat Code: E1040  
Recommendation: **Replace in 2025**

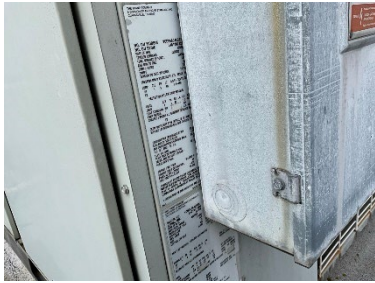
### Packaged Unit in Poor Condition.

RTU, Pad or Roof-Mounted  
Springfield High School - Main  
Roof

Rusted and corroded - AssetCALC ID: 8963677

Uniformat Code: D3050  
Recommendation: **Replace in 2026**

Cost Estimate: \$100,600

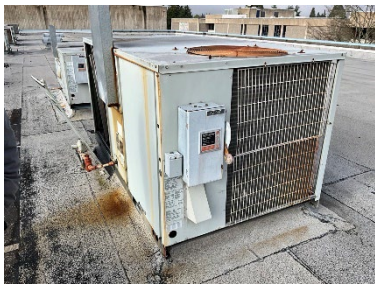
### Packaged Unit in Poor Condition.

RTU, Pad or Roof-Mounted  
Springfield High School - Main  
Roof

Rusted and corroded - AssetCALC ID: 8963614

Uniformat Code: D3050  
Recommendation: **Replace in 2026**

Cost Estimate: \$17,900

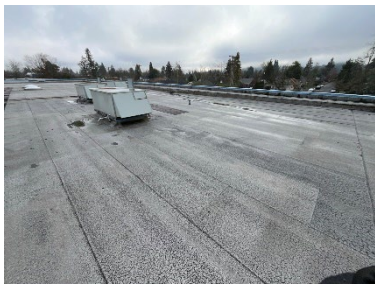
### Roofing in Poor Condition.

Modified Bitumen  
Springfield High School - Main  
Roof

Leaks - AssetCALC ID: 8963625

Uniformat Code: B3010  
Recommendation: **Replace in 2027**

Cost Estimate: \$208,500

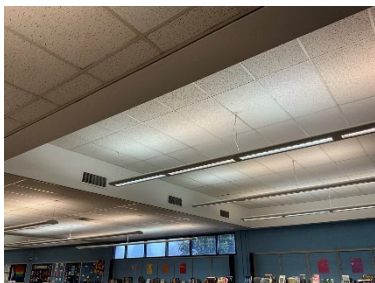
### Fire Suppression System

Full System Install/Retrofit, Medium  
Density/Complexity  
Springfield High School - Main  
Throughout Building

There is no fire suppression system installed - AssetCALC ID: 8965687

Uniformat Code: D4010  
Recommendation: **Install in 2030**

Cost Estimate: \$1,646,900

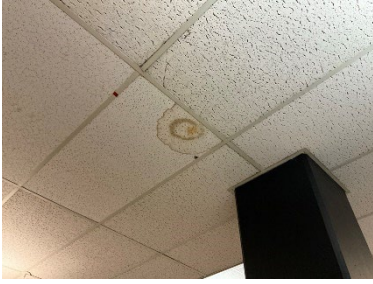
## Suspended Ceilings in Poor Condition.

Acoustical Tile (ACT)  
Springfield High School - Main  
Library

Stains in different spots - AssetCALC ID: 8963681

Uniformat Code: C1070  
Recommendation: **Replace in 2026**
