# FACILITY CONDITION ASSESSMENT

Academy of Arts and Academics  
615 Main Street  
Springfield, OR 97477

*December 13, 2024*

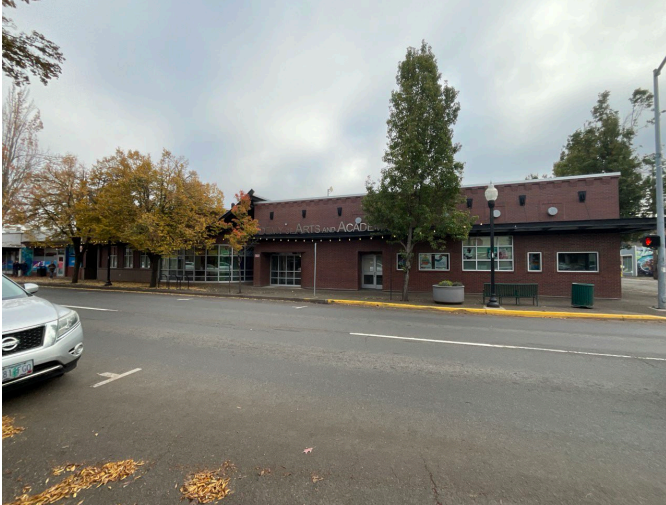
1 - FRONT ELEVATION

The exterior finishes remain in good condition overall. The exposed brick on the main facade is in better-than-fair condition. The west facade murals are well-maintained, while the painted CMU (concrete masonry unit) walls at the rear are in fair condition.

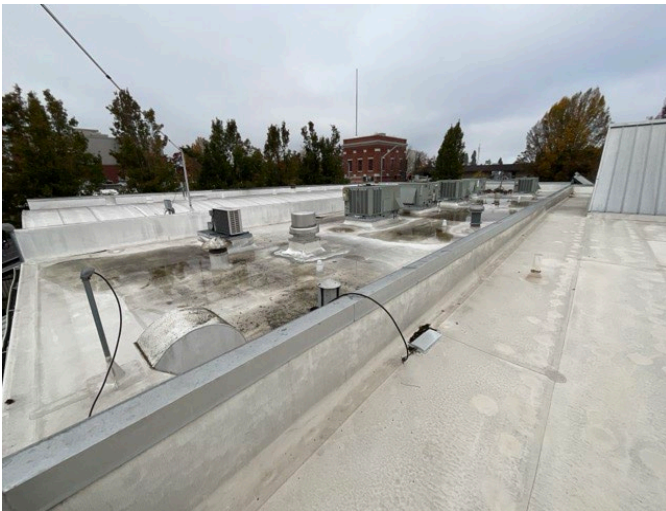
9 - PRIMARY ROOF OVERVIEW

No leaks have been reported, and the assessment did not reveal any anomalies in the roof's condition. It remains within its expected useful life.

| Uniformat Code | Location Description | ID | Cost Description | Lifespan (EUL) | EAge | RUL | Quantity | Unit | Unit Cost | w/ Markup * | Subtotal | 2024 | 2025 | 2026 | 2027 | 2028 | 2029 | 2030 | 2031 | 2032 | 2033 | 2034 | Deficiency Repair Estimate |
|---|---|---|---|---|---|---|---|---|---|---|---|---|---|---|---|---|---|---|---|---|---|---|---|
| B3010 | Roof | 8567376 | Roofing, Single-Ply Membrane, TPO/PVC, Replace | 20 | 15 | 5 | 15210 | SF | \$13.40 | \$17.89 | \$272,092 | | | | | | \$272,092 | | | | | | \$272,092 |

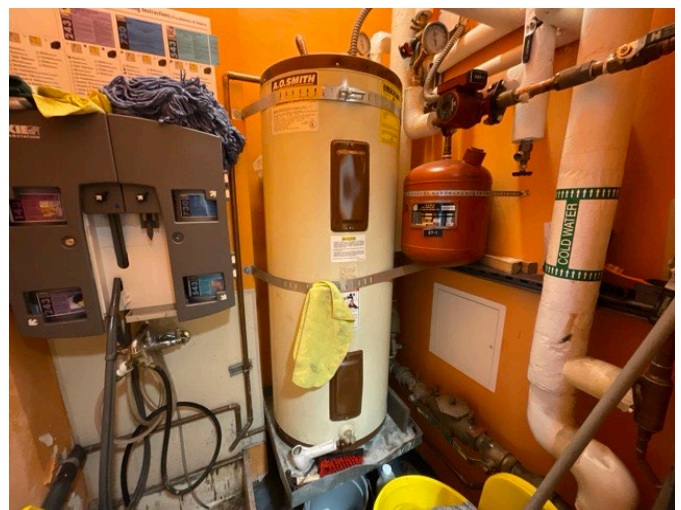
18 - DOMESTIC HOT WATER SUPPLY

Hot water is supplied by an electric water heater installed in 1995. While it remains operational, it is nearing the end of its lifespan and may require replacement soon. Overall, the plumbing system is in fair condition, and no significant issues have been reported.

| Uniformat Code | Location Description | ID | Cost Description | Lifespan (EUL) | EAge | RUL | Quantity | Unit | Unit Cost | w/ Markup * | Subtotal | 2024 | 2025 | 2026 | 2027 | 2028 | 2029 | 2030 | 2031 | 2032 | 2033 | 2034 | Deficiency Repair Estimate |
|---|---|---|---|---|---|---|---|---|---|---|---|---|---|---|---|---|---|---|---|---|---|---|---|
| D2010 | Custodial closet | 8567403 | Water Heater, Electric, Residential, Replace | 15 | 12 | 3 | 1 | EA | \$935.00 | \$1,178.10 | \$1,178 | | | | \$1,178 | | | | | | | | \$1,178 |

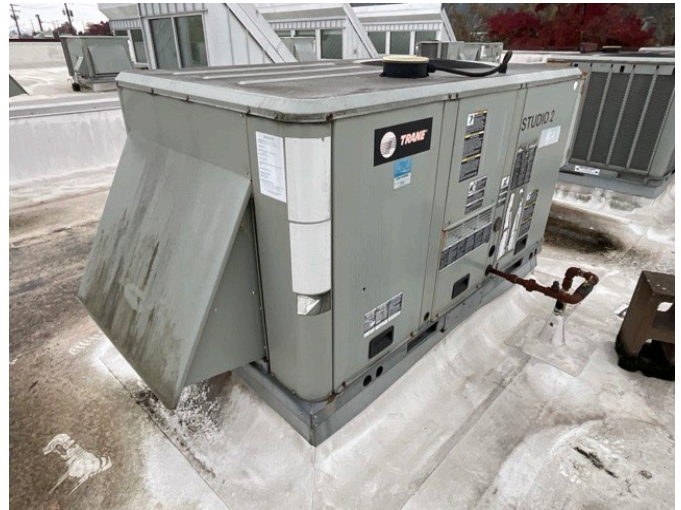
20 - ROOF MOUNTED PACKAGED UNIT

The Academy of Arts and Academics does not have a centralized HVAC system but instead utilizes roof-mounted package units of varying capacities. While the PSQ reported some areas with inadequate ventilation, no temperature anomalies were observed during the assessment. Additionally, none of the package units appeared to be damaged or malfunctioning.
