# FACILITY CONDITION ASSESSMENT

**Oregon Department of Education**  
255 Capitol Street NE  
Salem, OR 97310  
Adam Krein

Thurston Middle School  
6300 Thurston Road  
Springfield, OR 97478

*June 18, 2025*

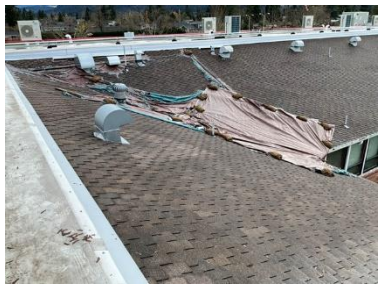
**Roofing in Poor condition.**

any type, Repairs per Man-Day  
Thurston Middle School  
Roof

Roof leak covered by tarp to prevent further damage to the interior of the building. - AssetCALC ID: 8727593

Unifomat Code: B3010  
Recommendation: **Repair in 2024**

Cost Estimate: \$24,200

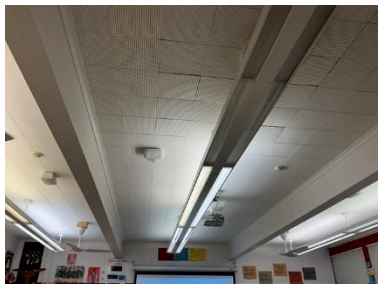
**Fire Suppression System**

Full System Install/Retrofit, Medium  
Density/Complexity  
Thurston Middle School  
Throughout Building

Unifomat Code: D4010  
Recommendation: **Renovate in 2029**

install fire sprinkler system - AssetCALC ID: 8727528
