# FACILITY CONDITION ASSESSMENT

**Oregon Department of Education**  
255 Capitol Street NE  
Salem, OR 97310  
Adam Krein

Briggs Middle School  
2355 Yolanda Street  
Springfield, OR 97477

December 11, 2024

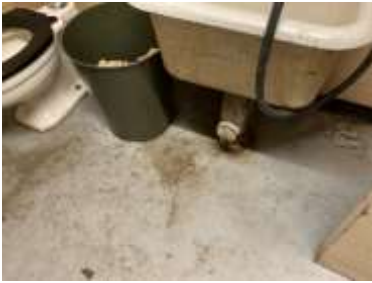
### Flooring in Poor condition.

Concrete  
Briggs Middle School  
Restrooms

The fully finished floor is covered with stains and requires immediate repair - AssetCALC ID: 8575393

Uniformat Code: C2030  
Recommendation: **Repair in 2026**

Cost Estimate: \$2,000

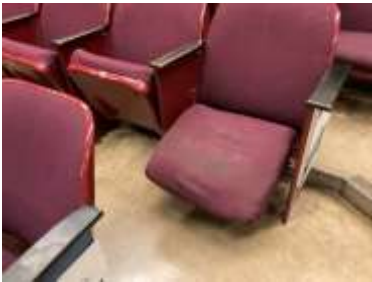
### Fixed Seating in Poor condition.

Auditorium/Theater, Metal Cushioned Standard  
Briggs Middle School  
Auditorium

Old, and very wearing signs, some of them broken - AssetCALC ID: 8575410

Uniformat Code: E2010  
Recommendation: **Replace in 2026**

Cost Estimate: \$100,500

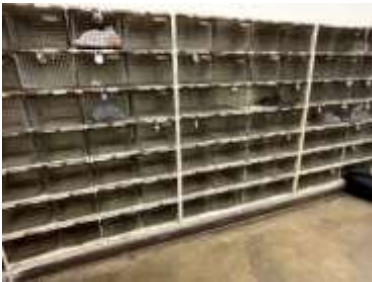
### Lockers in Poor condition.

Steel-Baked Enamel, 12" W x 15" D x 72" H  
Briggs Middle School  
Lockers room

Very old lockers - AssetCALC ID: 8575345

Uniformat Code: C1090  
Recommendation: **Replace in 2026**

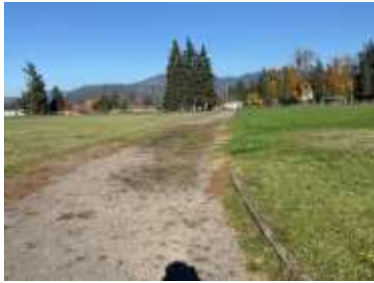
The school's football field is surrounded by a racetrack with a surface that requires renovation and replenishment. The football goalposts are also due to replacement. Notably, the athletic fields lack bleachers and water fountains, which could affect usability for larger events or prolonged activities.

### Running Track in Poor condition.

Aggregate/pebble, Surface Gravel  
Site  
Site

Needs to be replenish there are lots of areas with weed and missing surface material - AssetCALC ID: 8575895

Uniformat Code: G2020  
Recommendation: **Replenish in 2026**

Cost Estimate: \$59,800

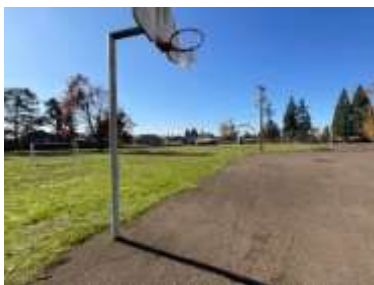
To the south of the building, there is a small, paved area with two basketball hoops that are in need of replacement. Additionally, this area houses two ancillary buildings, which consist of cargo containers.

### Sports Apparatus in Poor condition.

Basketball, Backboard/Rim/Pole  
Site  
Site

Very aged - AssetCALC ID: 8575890

Uniformat Code: G2050  
Recommendation: **Replace in 2026**

Cost Estimate: \$18,800

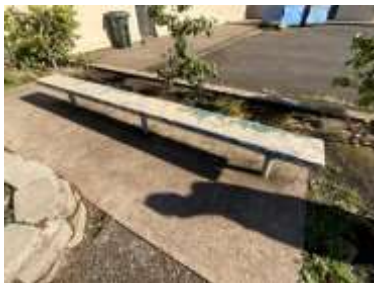
### Park Bench in Poor condition.

Wood/Composite/Fiberglass  
Site  
Site

Very aged - AssetCALC ID: 8575887

Uniformat Code: G2060  
Recommendation: **Replace in 2026**
