# FACILITY CONDITION ASSESSMENT

**Oregon Department of Education**  
255 Capitol Street NE  
Salem, OR 97310  
Adam Krein

Yolanda Elementary School  
2350 Yolanda Street  
Springfield, OR 97477

*December 3, 2024*

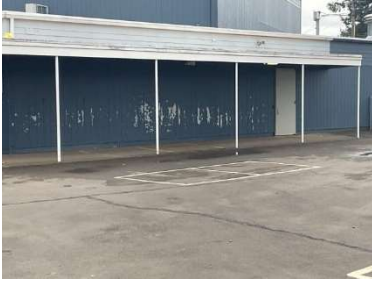
### Exterior Walls in Poor condition.

Stucco Fog Coat, 1-2 Story Building  
Yolanda Elementary School - Main  
Building Exterior

Cafeteria exterior wall is peeling off - AssetCALC ID: 8563832

Uniformat Code: B2010  
Recommendation: **Prep & Fog Coat of Paint in 2025**

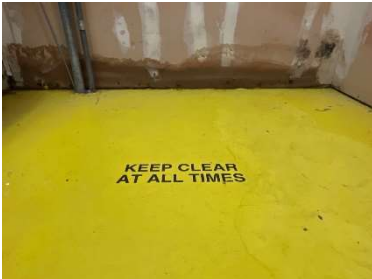
### Interior Remodel in Poor condition.

Down Unit/Space, Minor Repairs  
Yolanda Elementary School - Main  
Electrical Room

The boiler is leaking, and water is getting into the electrical room next to it, immediately repairs needs to be done - AssetCALC ID: 8563854

Uniformat Code: C1010  
Recommendation: **Renovate in 2025**

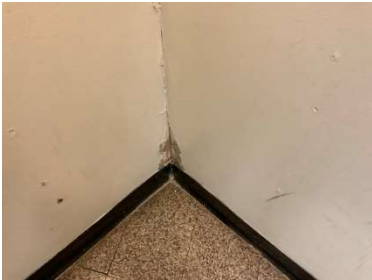
### Interior Remodel in Poor condition.

Down Unit/Space, Moderate Repairs  
Yolanda Elementary School - Main  
Hallways & Common Areas

Throughout the school, several areas were found where the baseboards were damaged and required repair. - AssetCALC ID: 8563837

Uniformat Code: C1010  
Recommendation: **Renovate in 2026**

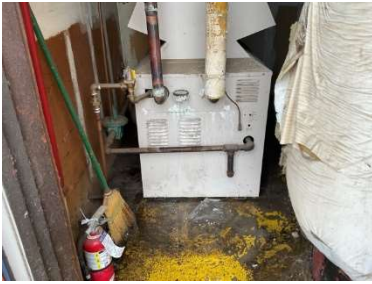
Hot water throughout the building is provided by individual electric water heaters located in each hexagonal building. During the assessment, a boiler dedicated to the cafeteria was found leaking, which requires immediate attention, as it is causing moisture issues in the adjacent room that houses the main electrical panel.

### Boiler in Poor condition.

Gas, Domestic  
Yolanda Elementary School - Main  
Cafeteria boiler room

Boiler during assessment was leaking - AssetCALC ID: 8563850

**Plumbing:** Address the leaking cafeteria boiler immediately to prevent further damage to the electrical room.

Uniformat Code: D2010  
Recommendation: **Replace in 2024**

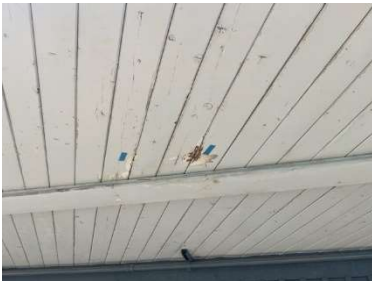
### Soffit/Fascia in Poor condition.

Stucco  
Yolanda Elementary School - Main  
Roof

The fascia has several noticeable damages that need attention. Some repairs are required, which can be estimated to take at least one week of work. Note this is part of the site walkway - AssetCALC ID: 8563820

Uniformat Code: B3080  
Recommendation: **Repair in 2026**

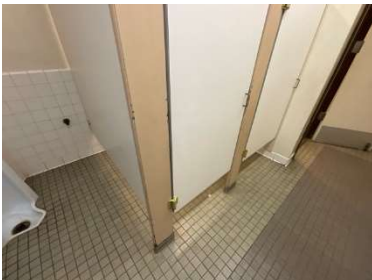
### Toilet Partitions in Poor condition.

Metal  
Yolanda Elementary School - Main  
Restrooms

The bathroom partitions are old and show signs of significant rusting, with various types of doors. It is time to replace them with new partitions - AssetCALC ID: 8563816

Uniformat Code: C1090  
Recommendation: **Replace in 2026**

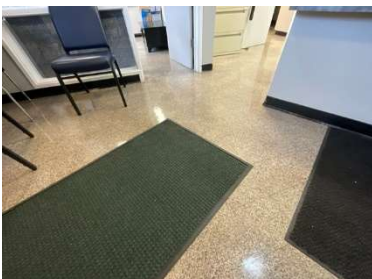
### Flooring in Poor condition.

Vinyl Tile (VCT), w/ Asbestos Abatement  
Yolanda Elementary School - Main  
Office Areas

Asbestos Vct tile - AssetCALC ID: 8563860

Uniformat Code: C2030  
Recommendation: **Replace in 2026**

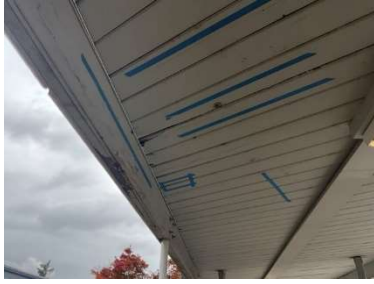
### Structural Flooring/Decking in Poor condition.

Wood  
Site  
Site General

The fascia has several noticeable damages that need attention. Some repairs are required, which can be estimated to take at least one week of work. - AssetCALC ID: 8564068

Uniformat Code: B1010  
Recommendation: **Replace in 2025**

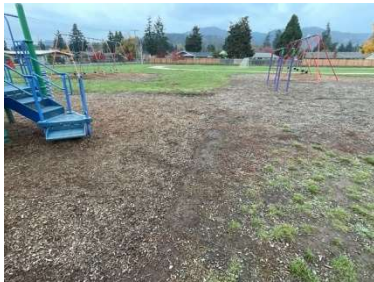
### Playfield Surfaces in Poor condition.

Chips Engineered Wood, 3" Depth  
Site  
Site

It needs to be refilled - AssetCALC ID: 8564056

Uniformat Code: G2050  
Recommendation: **Replace in 2025**

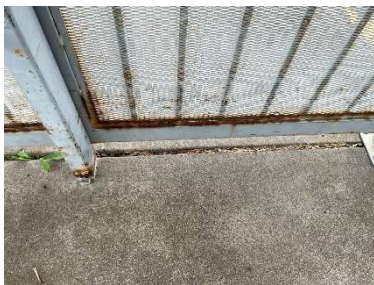
### Fences & Gates in Poor condition.

Pedestrian Gate, Wrought Iron  
Site  
Site General

Gates are oxidized - AssetCALC ID: 8564050

Uniformat Code: G2060  
Recommendation: **Replace in 2025**
