# FACILITY CONDITION ASSESSMENT

Walterville Elementary School  
40589 McKenzie Highway  
Springfield, OR 97478

169411.24R000-143.017

January 9, 2025

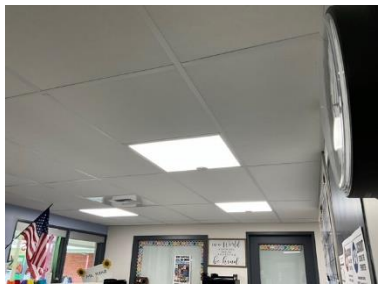
Fire Suppression System

Full System Install/Retrofit, Medium  
Density/Complexity  
Walterville Elementary School  
Throughout Building

Uniformat Code: D4010  
Recommendation: **Renovate in 2029**

install fires sprinkler system - AssetCALC ID: 8764215
