# FACILITY CONDITION ASSESSMENT

Two Rivers Dos Rios Elementary  
1084 G Street  
Springfield, OR 97477

*January 7, 2025*

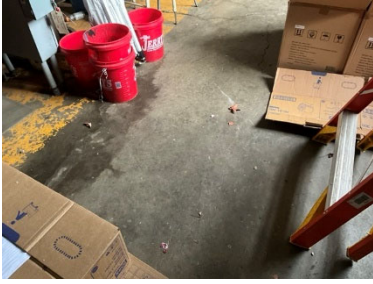
### Flooring in Poor condition.

any surface, w/ Epoxy Coating  
Two Rivers Dos Rios Elementary - Main  
Mechanical Room

Aged and need maintenance - AssetCALC ID: 8668424

Uniformat Code: C2030  
Recommendation: **Prep & Paint in 2025**

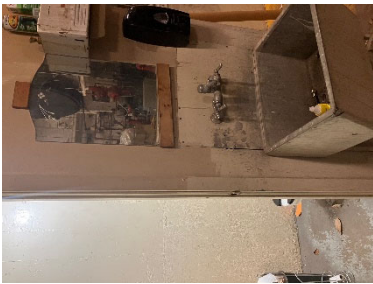
### Sink/Lavatory in Poor condition.

Service Sink, Wall-Hung  
Two Rivers Dos Rios Elementary - Main  
Terminated HVAC

Corroded and rusted - AssetCALC ID: 8668346

Uniformat Code: D2010  
Recommendation: **Replace in 2026**

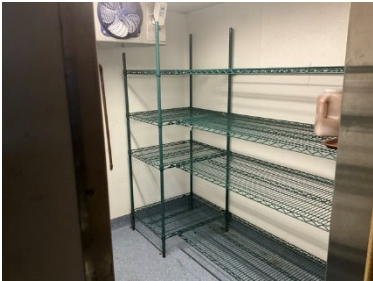
### Foodservice Equipment in Failed condition.

Walk-In, Refrigerator  
Two Rivers Dos Rios Elementary - Main  
Commercial Kitchen

Out of service - AssetCALC ID: 8668370

Uniformat Code: E1030  
Recommendation: **Replace in 2025**

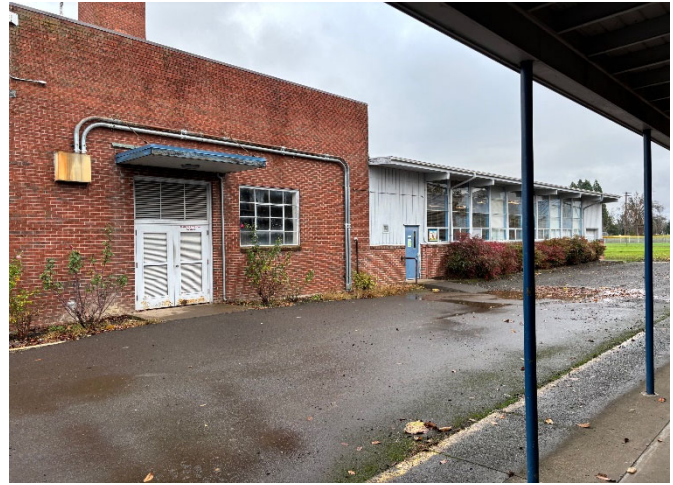
8 – ABANDONED HVAC

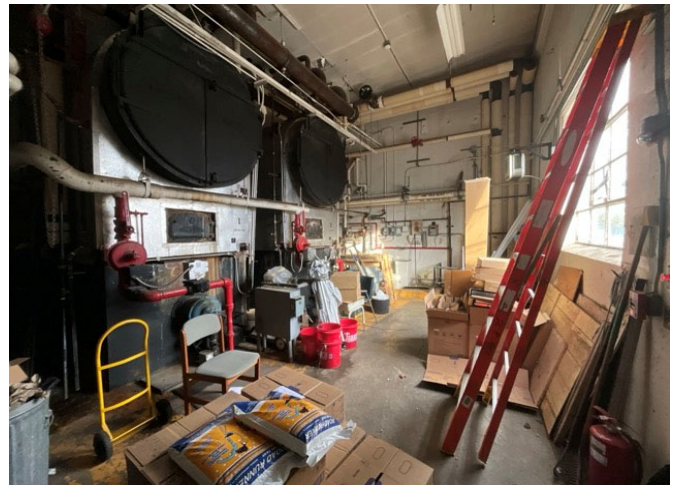
10 – TERMINATED BOILER MECHANICAL

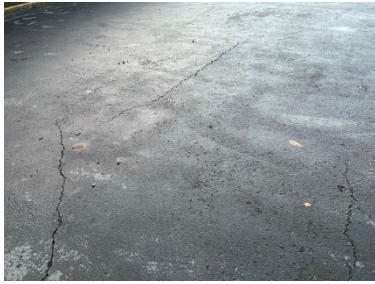
### Parking Lots in Poor condition.

Pavement, Asphalt  
Two Rivers Dos Rios Elementary  
Site

Asphalt, Seal & Stripe - AssetCALC ID: 8668463

Uniformat Code: G2020  
Recommendation: **Seal & Stripe in 2025**

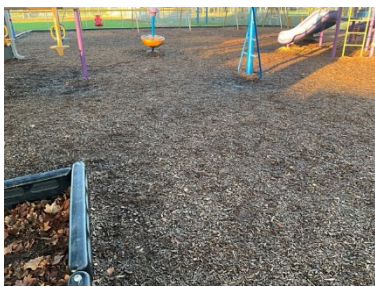
### Playfield Surfaces in Poor condition.

Chips Engineered Wood, 3" Depth  
Two Rivers Dos Rios Elementary  
Site Playground Areas

Wood chips in the playground area is aged and needs to be replaced - AssetCALC ID: 8668449

Uniformat Code: G2050  
Recommendation: **Replace in 2025**
