# FACILITY CONDITION ASSESSMENT

Thurston Elementary School  
7345 Thurston Road  
Springfield, OR 97478

169411.24R000-135.017

January 7, 2025

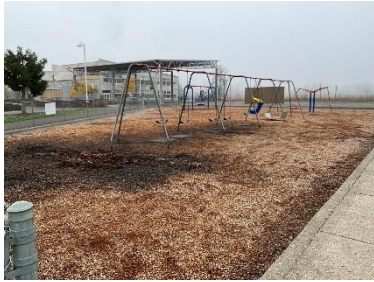
### Playground in Poor condition.

Natural Wood Covering, Chips 3" Depth  
Thurston Elementary School  
Site Playground Areas

Burnt black wood chips - AssetCALC ID: 8709520

Uniformat Code: G2050  
Recommendation: **Replace in 2025**

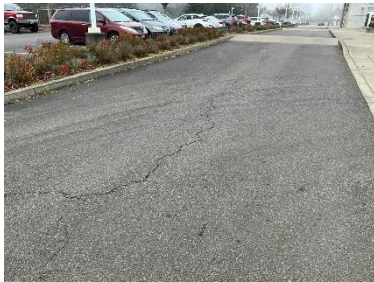
### Parking Lots in Poor condition.

Pavement, Asphalt  
Thurston Elementary School  
Site Parking Areas

Asphalt, Seal & Stripe - AssetCALC ID: 8709515

Uniformat Code: G2020  
Recommendation: **Seal & Stripe in 2025**
