# FACILITY CONDITION ASSESSMENT

160903.24R000-120.017

October 6, 2025

Riverbend Elementary School  
320 51st Street  
Springfield, OR 97478

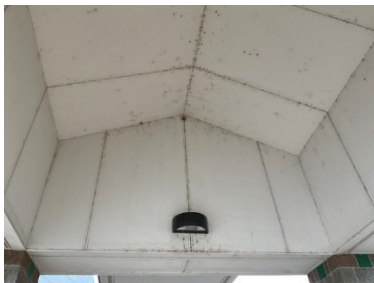
### Exterior Walls in Poor condition.

Brick/Masonry/Stone, Clean & Seal  
Riverbend Elementary School  
Building Exterior

The exterior walls in some areas are stained, and the upper sections of the metal siding also show signs of staining and are covered with numerous cobwebs. A thorough cleaning is required - AssetCALC ID: 8642489

Uniformat Code: B2010  
Recommendation: **Clean & Seal in 2025**

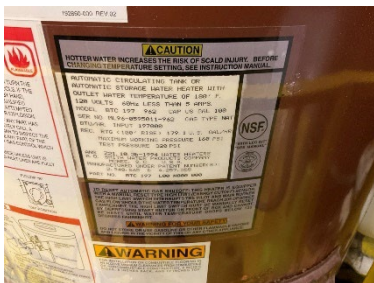
### Water Heater in Poor condition.

Gas, Commercial (200 MBH)  
Riverbend Elementary School  
Mechanical Room

Leaking - AssetCALC ID: 8642505

Uniformat Code: D2010  
Recommendation: **Replace in 2025**

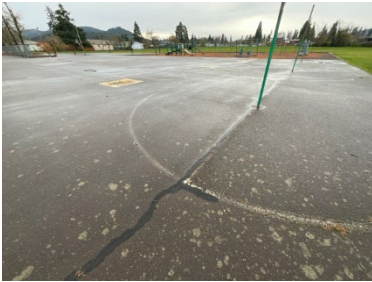
### Athletic Surfaces & Courts in Poor condition.

Basketball/General, Asphalt Pavement  
Site  
Site Playground Areas

The seal and striping on the asphalt Court are faded and require repainting - AssetCALC ID: 8642569

Uniformat Code: G2050  
Recommendation: **Seal & Stripe in 2026**

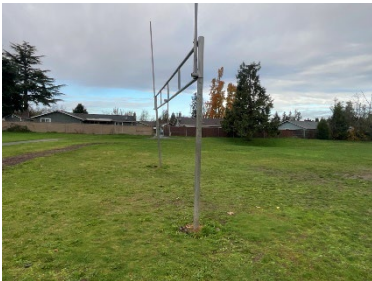
### Sports Apparatus in Poor condition.

Football, Goal Post  
Site  
Site

The football/soccer goalposts show significant signs of aging and are very visible misaligned indicating the Need For Replacement - AssetCALC ID: 8642591

Uniformat Code: G2050  
Recommendation: **Replace in 2026**

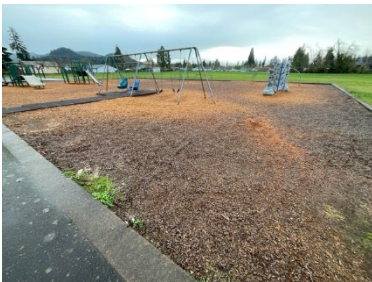
### Playfield Surfaces in Poor condition.

Chips Engineered Wood, 3" Depth  
Site  
Site Playground Areas

engineered wood fiber need to be replaced - AssetCALC ID: 8642597

Uniformat Code: G2050  
Recommendation: **Replace in 2026**

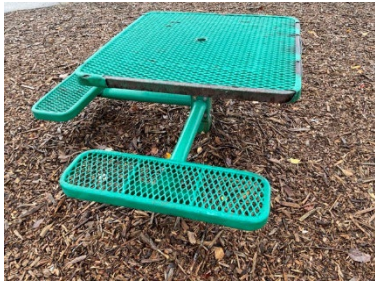
## Picnic Table in Poor condition.

Metal Powder-Coated  
Site  
Site

The picnic tables are rusted and missing parts requiring Attention - AssetCALC ID: 8642572

Unifomat Code: G2060  
Recommendation: **Replace in 2026**
