# FACILITY CONDITION ASSESSMENT

**Oregon Department of Education**  
255 Capitol Street NE  
Salem, OR 97310  
Adam Krein

Ridgeview Elementary School  
526 N. 66th Street  
Springfield, OR 97477

May 20, 2025

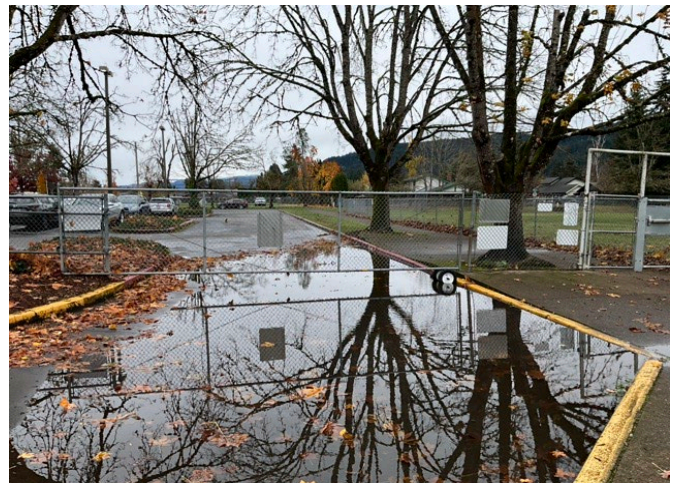
6 – PONDING IN PARKING LOT

| Question | | Response | | | | Comments |
|---|---|---|---|---|---|---|
| 16 | Is site/parking drainage inadequate, with excessive ponding or other problems? | X | | | | Ponding in parking lot |
