# FACILITY CONDITION ASSESSMENT

**Oregon Department of Education**  
255 Capitol Street NE  
Salem, OR 97310  
Adam Krein

*January 10, 2025*

Mt Vernon Elementary School  
935 Filbert Lane  
Springfield, OR 97478

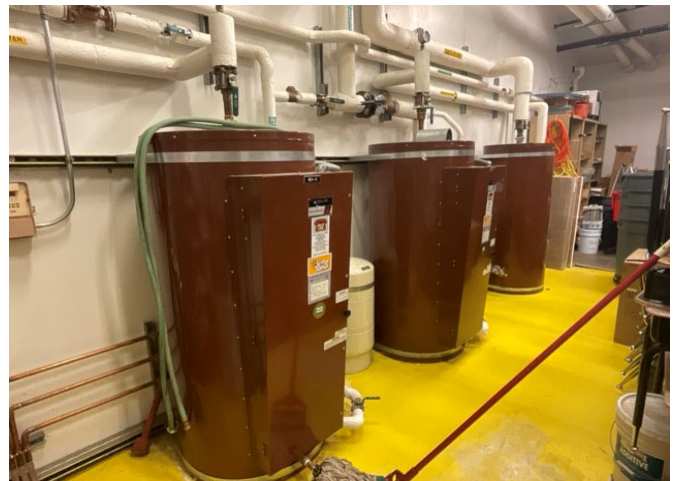
18 – DOMESTIC HOT WATER SUPPLY

Hot water throughout the building is supplied by electric and gas water heaters located in various sections of the facility. These units date back to the original construction of the building. Although they are currently operational, no anomalies were detected during the assessment. However, their expected service life expired seven years ago, and they may fail unexpectedly, necessitating replacement in the near future.

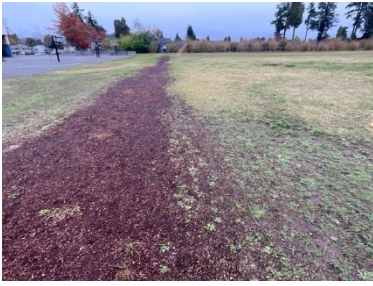
### Playfield Surfaces in Poor condition.

Chips Engineered Wood, 3" Depth  
Site  
Site

Unifomat Code: G2050  
Recommendation: **Replace in 2026**

It should be replenish - AssetCALC ID: 8628075

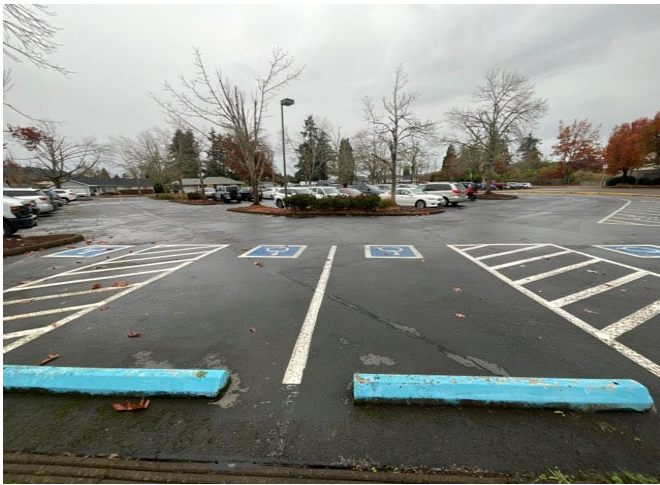
3 – MAIN PARKING LOT

The main parking lot, located on the west side of the school near the main entrance, is in good condition. There are no visible cracks, and the striping is clear and well-maintained.

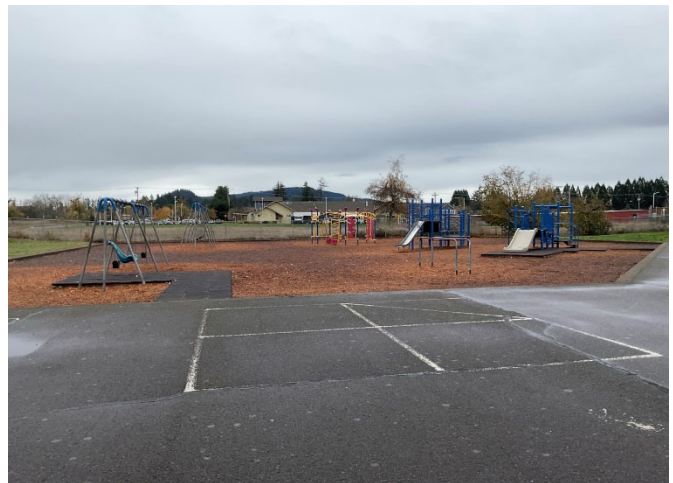
6 – PLAYGROUND

The playground structures are in fair condition. However, the wood chip surfacing requires replenishment to maintain compliance with safety standards. The outdoor fields lack bleachers and water fountains, which limits their functionality for supporting outdoor activities.
