# FACILITY CONDITION ASSESSMENT

Maple Elementary School  
2109 J Street  
Springfield, OR 97477

*December 13, 2024*

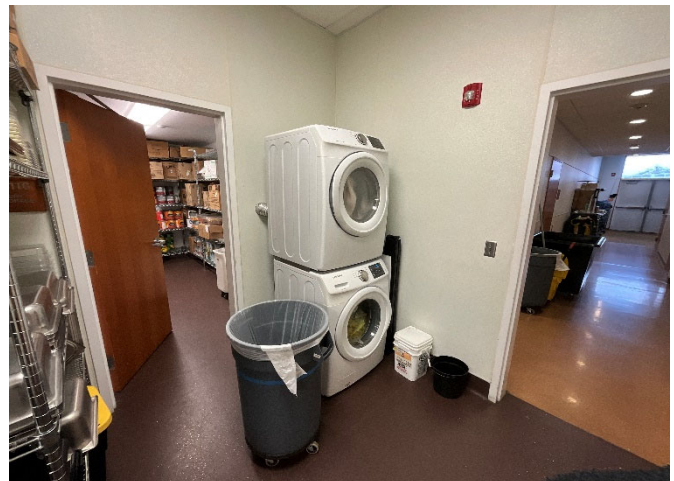
12 – APPLIANCES, WASHER, REPLACE
