# FACILITY CONDITION ASSESSMENT

**Oregon Department of Education**  
255 Capitol Street NE  
Salem, OR 97310  
Adam Krein

Guy Lee Elementary School  
755 Harlow Road  
Springfield, OR 97477

October 6, 2025

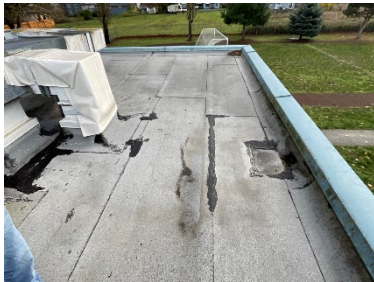
### Roofing in Poor condition.

Modified Bitumen  
Guy Lee Elementary School  
Roof

This portion of roofing has a significant amount of holes that were drilled into it to install/replace equipment and parts of it are "squishy" for the lack of a better term. There were parts of the roof where I was u comfortable walking on due to this. - AssetCALC ID: 8634812

Recommendation: **Replace in 2025**

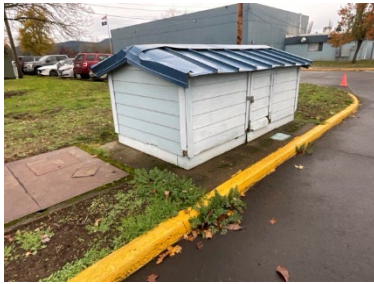
### Backflow Preventer in Poor condition.

Domestic Water  
Site  
Site Parking Areas

The backflow was leaking heavily when on site. The POC says there was nothing to worry about. -  
AssetCALC ID: 8634962

Unifomat Code: D2010  
Recommendation: **Replace in 2025**
