# FACILITY CONDITION ASSESSMENT

Elizabeth Page Elementary School  
1300 Hayden Bridge Road  
Springfield, OR 97477

*October 6, 2025*

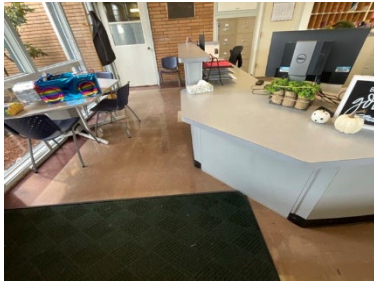
### Casework in Poor condition.

Cabinetry, Economy  
Elizabeth Page Elementary School  
Classrooms General

Uniformat Code: E2010  
Recommendation: **Replace in 2026**

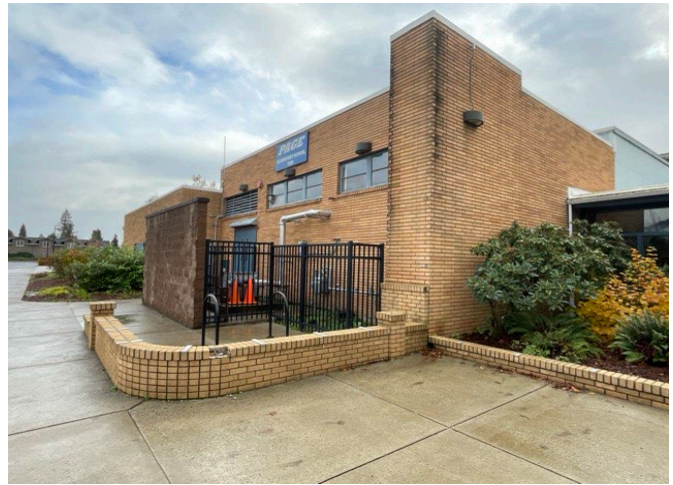
4 – EXTERIOR WALLS

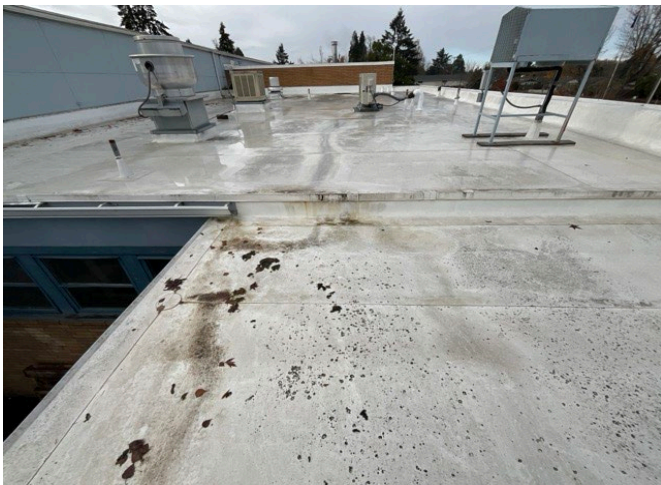
5 – ROOFING

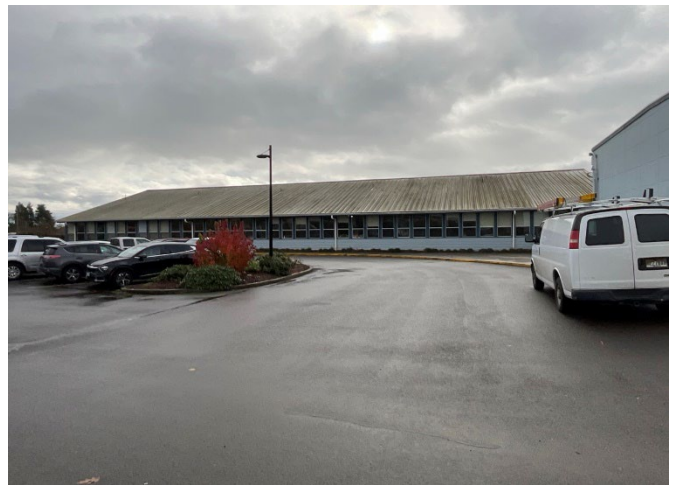
6 – ROOFING
