# FACILITY CONDITION ASSESSMENT

Douglas Gardens Elementary School  
3680 Jasper Road  
Springfield, OR 97478

*Bureau Veritas*  
6021 University Boulevard, Suite 200  
Ellicott City, MD 21043  
800.733.0660  
[www.bvna.com](http://www.bvna.com)

*December 16, 2024*

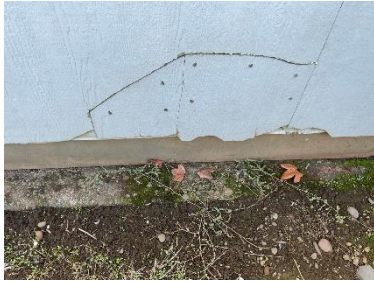
### Exterior Walls in Poor condition.

Wood siding  
Douglas Gardens Elementary School - Main  
Building Exterior

The exterior wood siding is damaged in certain areas and requires repair and repainting. - AssetCALC ID: 8566843

Uniformat Code: B2010  
Recommendation: **Repair in 2026**

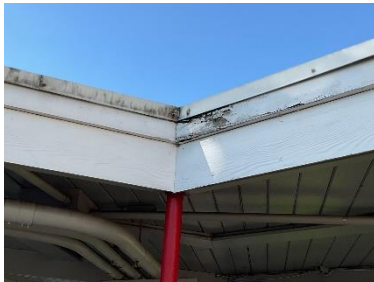
### Roofing in Poor condition.

any type, Repairs per Man-Day  
Douglas Gardens Elementary School - Main  
Roof

Fascia Repair - AssetCALC ID: 8566827

Uniformat Code: B3010  
Recommendation: **Repair in 2024**

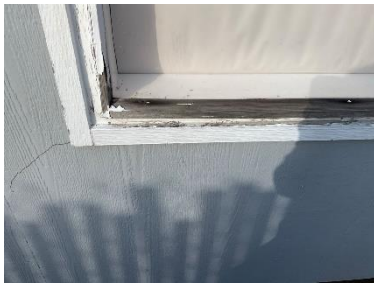
### Window in Poor condition.

Wood, any type  
Douglas Gardens Elementary School - Main  
Building Exterior

The window frame is significantly deteriorated and requires either repair or replacement - AssetCALC ID: 8566791

Uniformat Code: B2020  
Recommendation: **Repair in 2026**

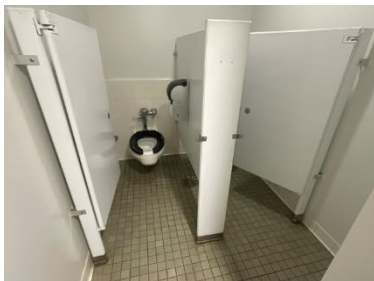
### Toilet Partitions in Poor condition.

Plastic/Laminate  
Douglas Gardens Elementary School - Main  
Restrooms

Toilet Partitions are old and some of them with different materials - AssetCALC ID: 8566860

Uniformat Code: C1090  
Recommendation: **Replace in 2026**

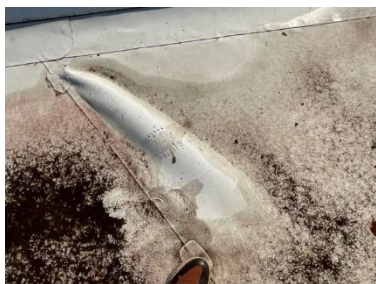
While there were no active leaks reported, the assessment found several areas on the roof where water was pooling, suggesting inadequate drainage toward the gutters. This has resulted in visible stains and debris buildup, which could compromise the roof's lifespan if not addressed. Immediate maintenance and enhanced drainage solutions are recommended to prevent further deterioration.

**Recommended Follow-up Study:  
in Poor condition.**

Building Envelope, Roof  
Douglas Gardens Elementary School - Main  
Roof

Water pooling , not proper drainage - AssetCALC ID: 8566816

Uniformat Code: P2030  
Recommendation: **Evaluate/Report in 2026**

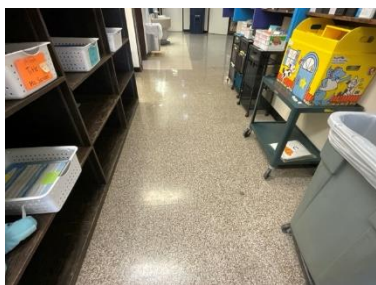
**Flooring in Poor condition.**

Vinyl Tile (VCT), with Asbestos Abatement  
Douglas Gardens Elementary School - Main  
Office Areas

Asbestos Vct tile - AssetCALC ID: 8566872

Uniformat Code: C2030  
Recommendation: **Replace in 2026**
