# FACILITY CONDITION ASSESSMENT

**Oregon Department of Education**  
255 Capitol Street NE  
Salem, OR 97310  
Adam Krein

October 6, 2025

0544 - Centennial Elementary School  
1315 Aspen Street  
Springfield, OR 97477

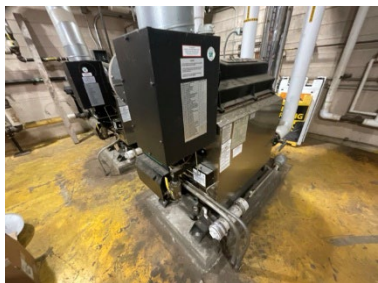
**HVAC System in Poor condition.**

any type, Repairs per Man-Day  
Centennial Elementary School  
Boiler Room

Uniformat Code: D3050  
Recommendation: **Repair in 2025**

The controls for the boilers were moved in Summer 2024 for the install of all the new ductless units and now the boilers don't work properly. - AssetCALC ID: 8653363
