# Walking and Bicycling Audits

San Mateo-Foster City School District

# Bayside S.T.E.M. Academy Walking and Biking Audit

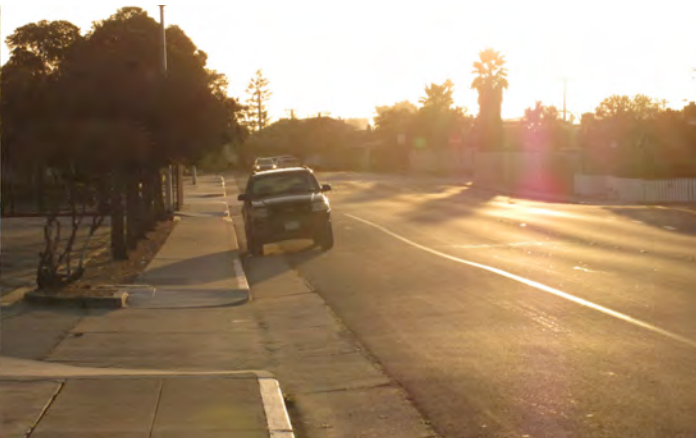
- ➔ Parents reported that visibility facing east on Kehoe Avenue is challenging in the morning due to the rising sun.
- ➔ Driveway traffic at the park was observed conflicting with school driveway traffic at the east school parking lot.

Visibility on Kehoe facing east in the morning can be challenging.

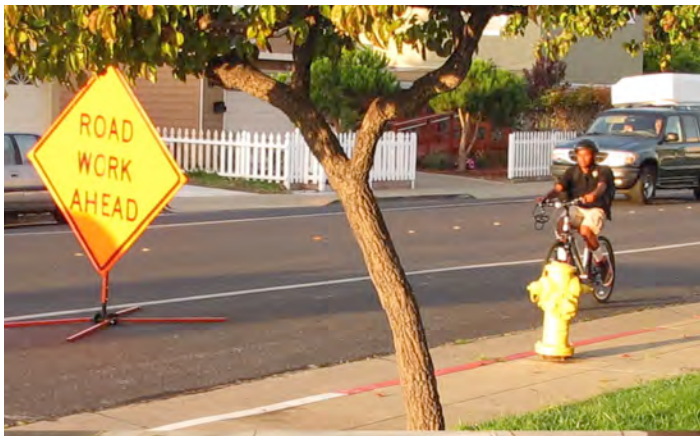
Wrong-way riding in the bike lane next to school.

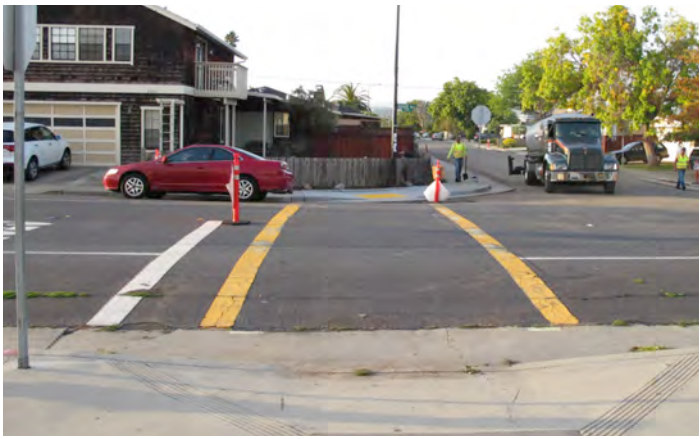
Parked cars sometimes encroach into the crosswalks.

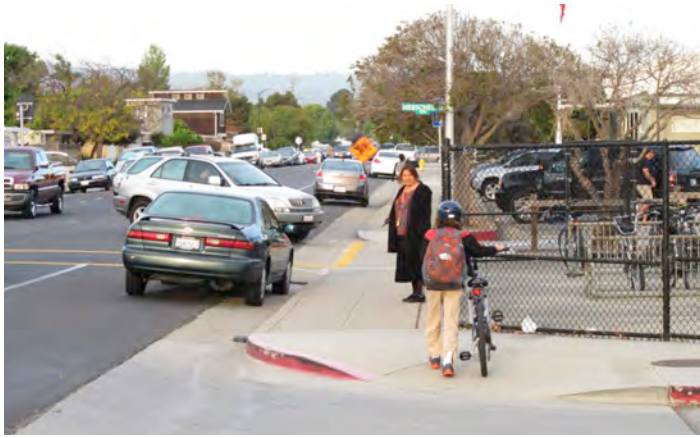
Supervising staff would benefit with appropriate crossing guard equipment and training.

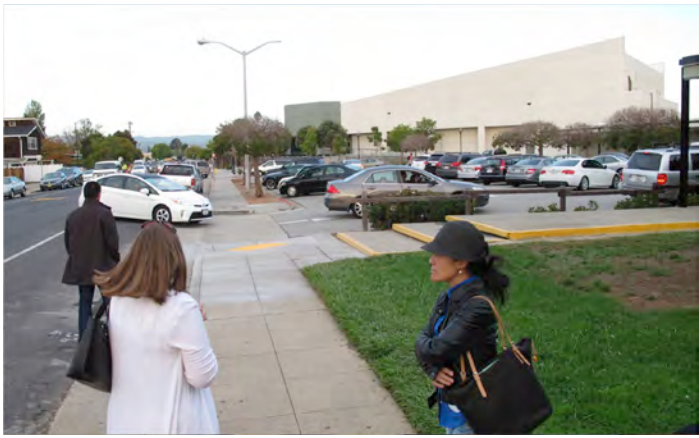
School traffic at the driveways causes congestion before and after school.

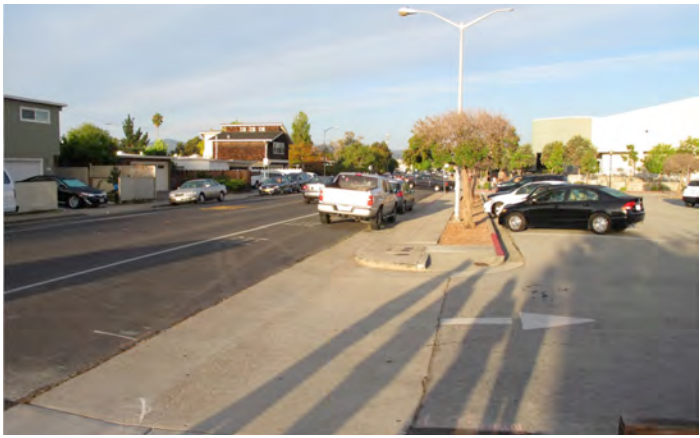
The school driveway lacks striping to designate the path of travel.

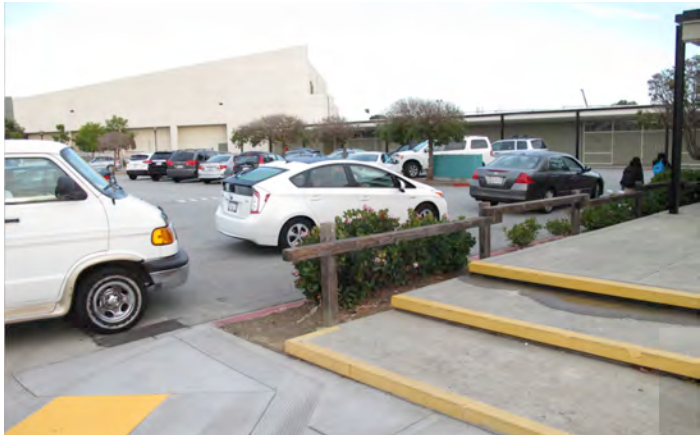
The east side of the lot lacks sidewalks and red curb enforcement.

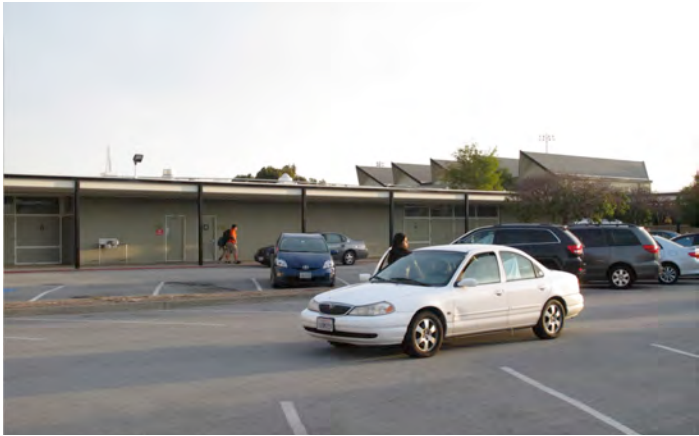
Parents drop-off in both aisles of the school parking lot.

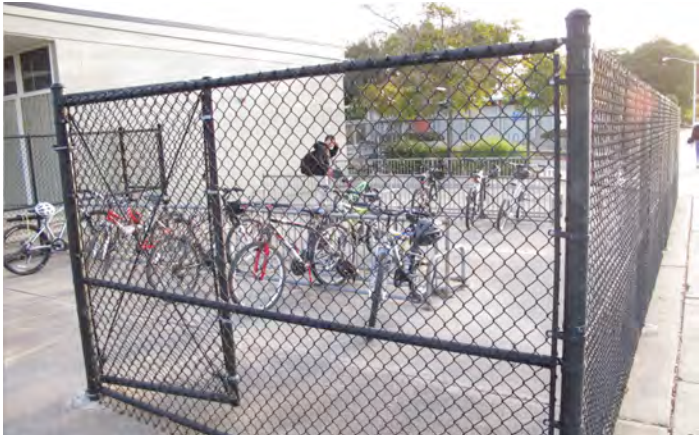
The school bike cage is not secure and not well supervised.

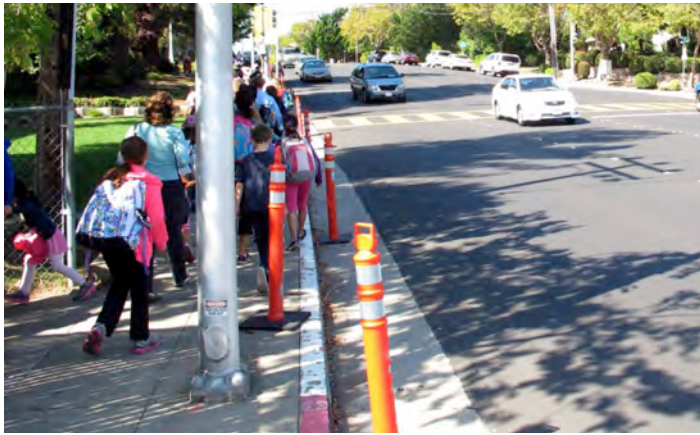
The sidewalk in front of the school is narrow and has obstructions.

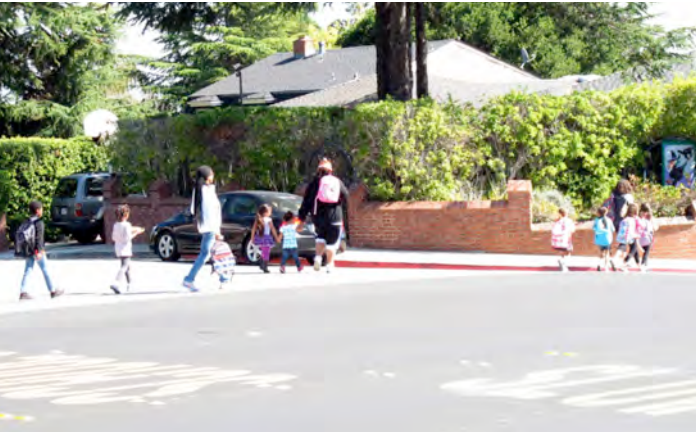
Some crosswalks on the north side of Alameda are missing curb ramps.

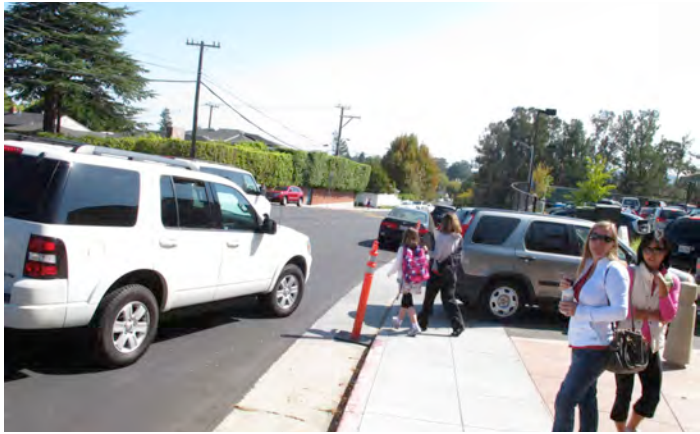
Vehicle queuing into the school drop-off/pick-up zone can block the sidewalk and congest Alameda.

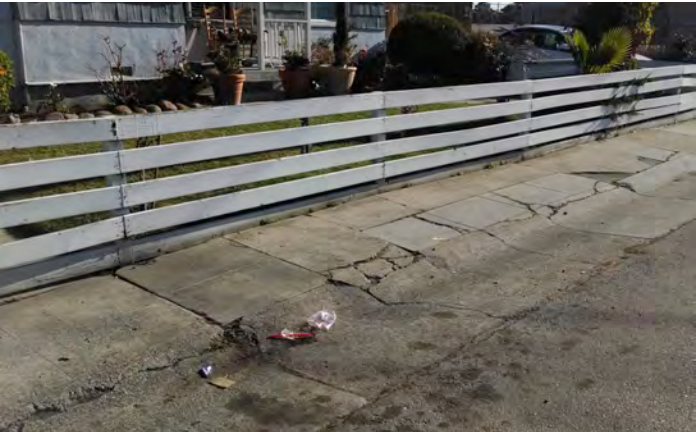
Broken pavement along a segment of Kingston St. presents a tripping hazard.

Repair broken sidewalk on the east side of Kingston north and south of Huron

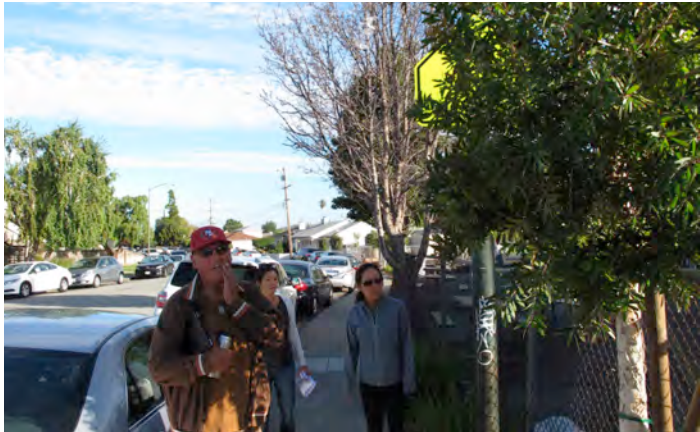
Tree maintenance is needed to preserve sign visibility (Kingston St.).

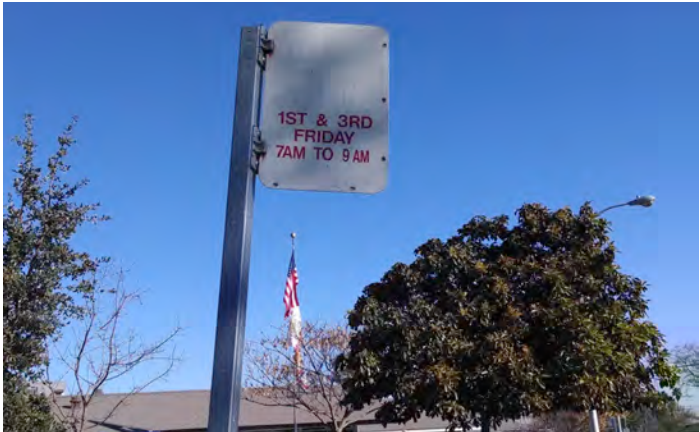
Worn signs and markings should be replaced and updated.

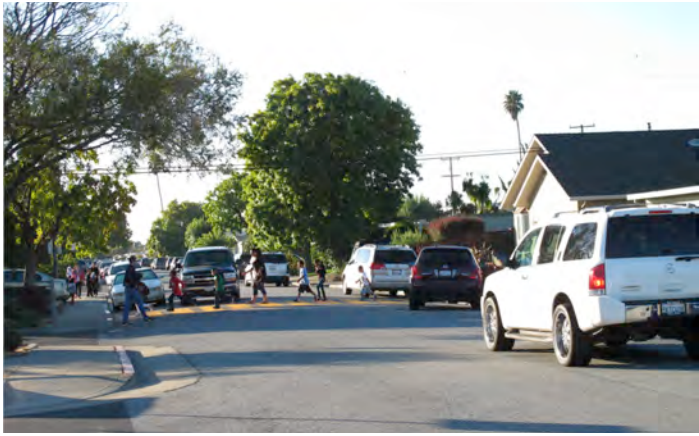
The Eisenhower crossing at the school's south corner is uncontrolled.

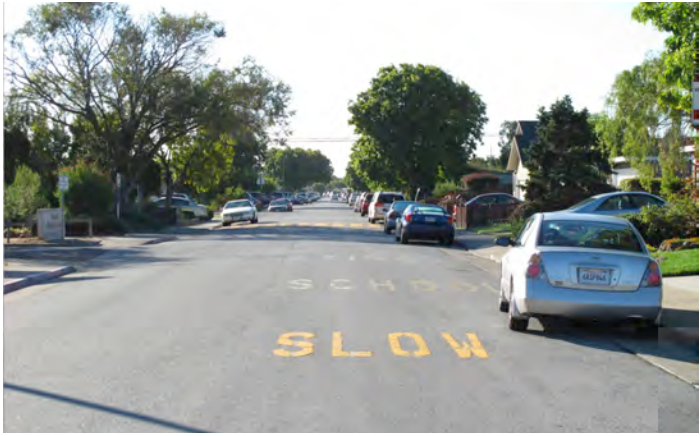
The uncontrolled crosswalk lacks signage and its markings are faded.

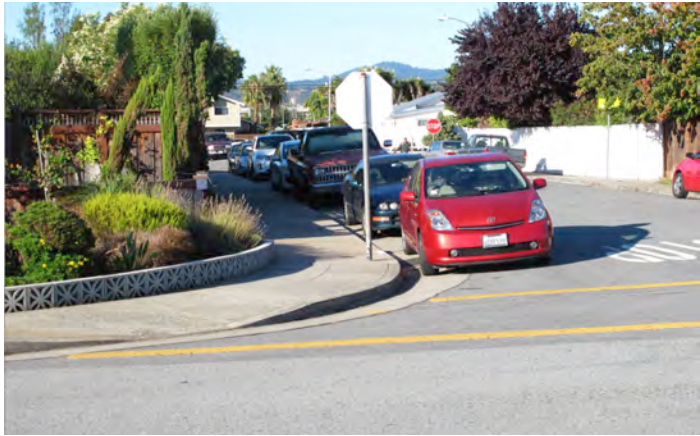
Corners should have painted red curbs to prevent parking.

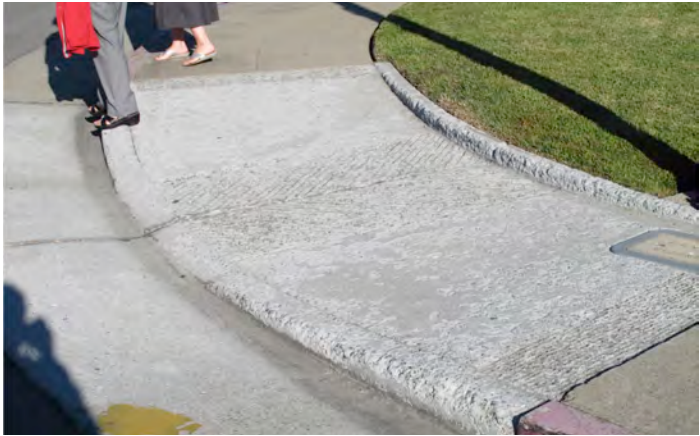
- ➔ All four corner curbs at this intersection are worn and need repair.

All curb ramps are in poor condition at the Norfolk/Halsey intersection.
