# ROAD SAFETY AUDIT

## PROSPECT AVENUE: PARK ROAD TO NEW PARK AVENUE

November 2025

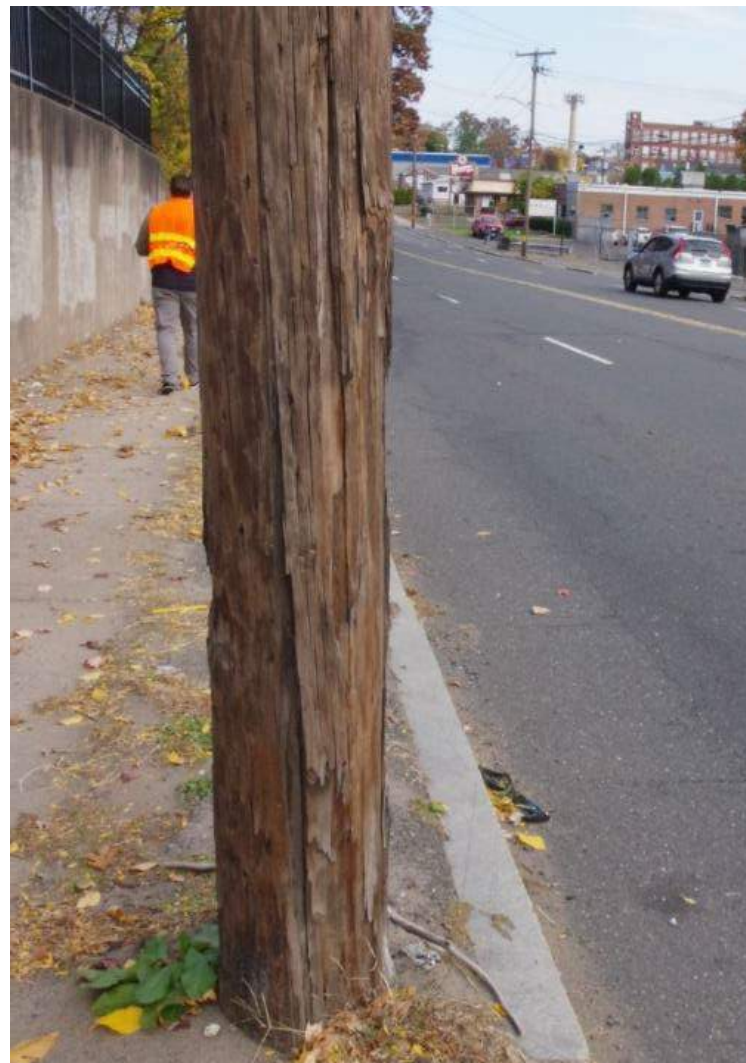
### **Exhibit 4: Utility Pole Near Prospect Ave Plaza**

- The placement of utility poles along Prospect Avenue, as displayed in Exhibit 4, creates obstructions for pedestrian access, particularly for those requiring mobility assistance.

- Reposition utility poles to provide an ADA accessible route across the I-84 bridge.

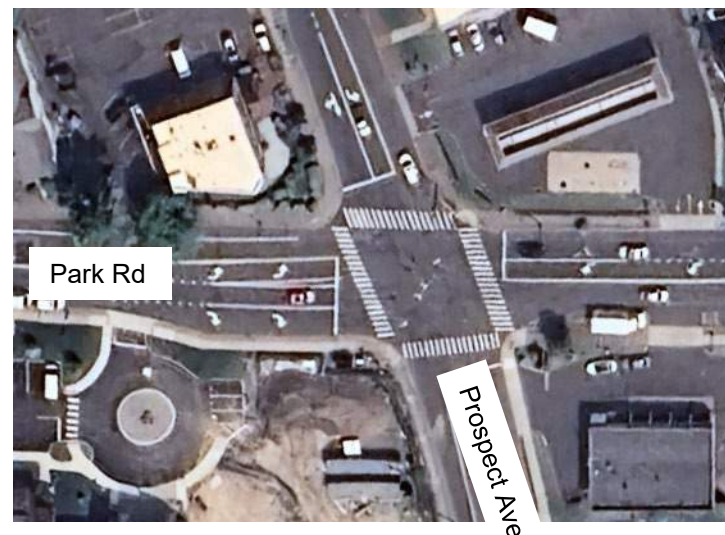
**Exhibit 8: Eastbound Left Turn Stop Bar Location (Source: Google Maps, accessed March 10, 2025)**

- The eastbound left-turn lane is frequently crossed by turning vehicles westbound onto Park Road because of the location of the stop bar, as shown in Exhibit 8.

- Quick Build: Remove eastbound right-turn only lane if traffic counts permit. Evaluate with quick-build trial.
- Relocate stop bar for eastbound left-turn lane to west to reduce encroachment from turning traffic from Prospect Avenue. Revise eastbound stop bar to discourage encroachment of turning vehicles.
- Review clearance timing and ensure all-red phase between end of pedestrian phase and next green interval.

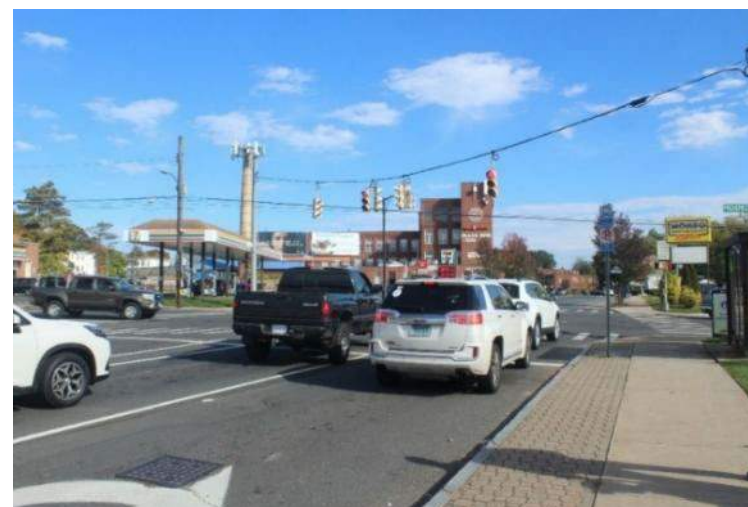
**Exhibit 9: Permissible Right Turn on Red During Pedestrian Phase**

- The eastbound dedicated right-turn, displayed in Exhibit 9, is permissible during the exclusive pedestrian phase, which is a safety concern for pedestrians crossing Park Road.

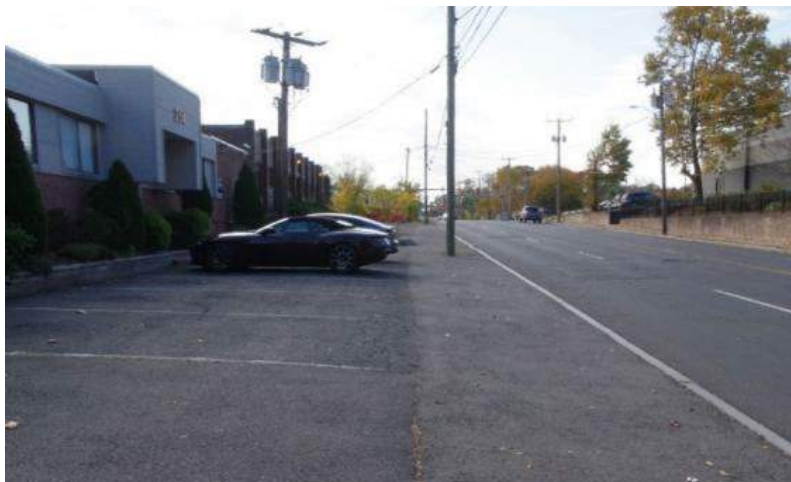
**Exhibit 10: View South of Parking Between 222 – 254  
Prospect Avenue**

- Participants stated that the sidewalk on the east side of the road between 222 and 254 Prospect Avenue is flush with the roadway. There is a lack of dedicated access management that allows vehicles to enter the pedestrian pathway at any point, greatly increasing the risk of pedestrian-vehicle conflicts. This location is displayed in Exhibit 10.

- Coordinate with City of Hartford to pursue access management for adjacent property owners.

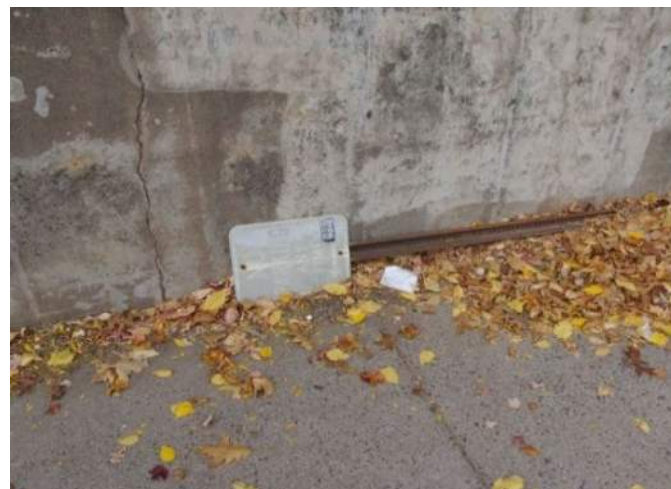
**Exhibit 12: Damaged No Parking Sign**

- Utility placement along the sidewalk reduces pedestrian access.
- No Parking signs are damaged. An example is displayed in Exhibit 12.

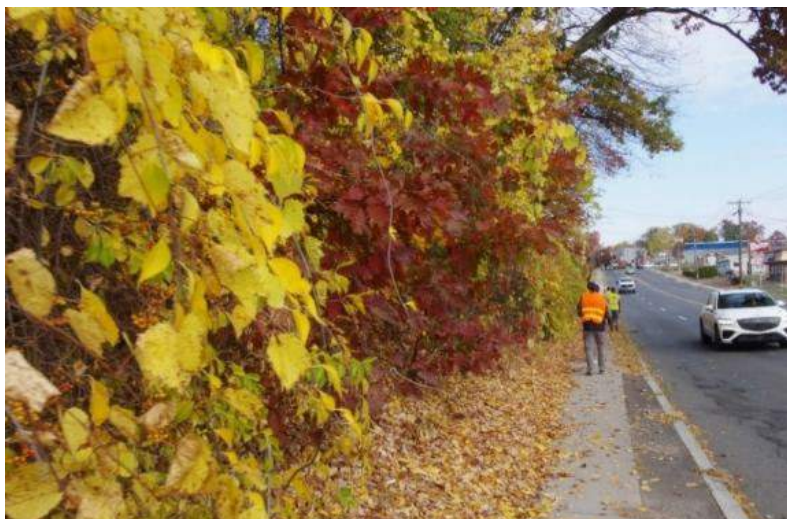
**Exhibit 11: Vegetation on West Side of Prospect Avenue**

- Participants stated an interest in reducing turning movements at the Prospect Avenue Plaza entrance.
- Vegetation on the west side of Prospect Avenue between Park Road and the Prospect Plaza entrance creates unsafe pedestrian conditions. This area is pictured in Exhibit 11.

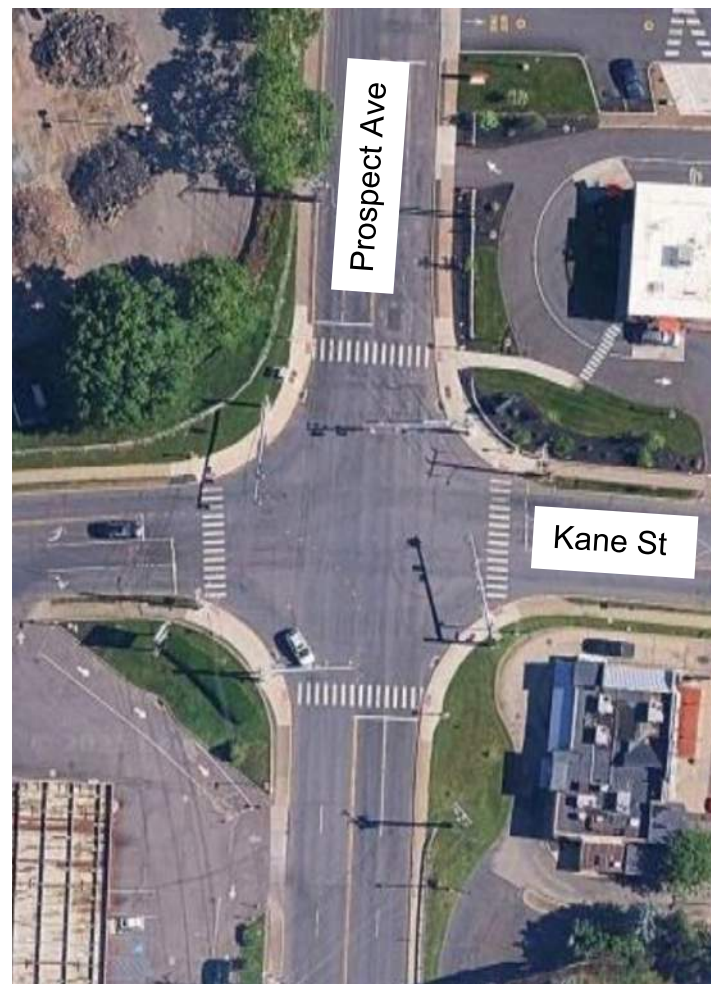
**Exhibit 14: Kane Street Intersection Crosswalks (Source: Google Maps, accessed on Sept 5, 2025)**

- A CT *transit* representative noted that Route 153 buses see high boarding activity at Kane Street, but relatively few passengers depart there. Crosswalks at the Kane Street intersection are approximately 25 feet from the corner, as displayed in Exhibit 14. The desire line to cross is directly at the corner.

- Although visibility at the intersection is generally good, pedestrians in the crosswalk may be difficult for turning vehicles to see.
- Pedestrians require additional time to cross during the exclusive pedestrian phase, as the intersection measures roughly 120 feet diagonally from corner to corner.

- Review pedestrian phase duration at Kane Street to ensure appropriate crossing times.

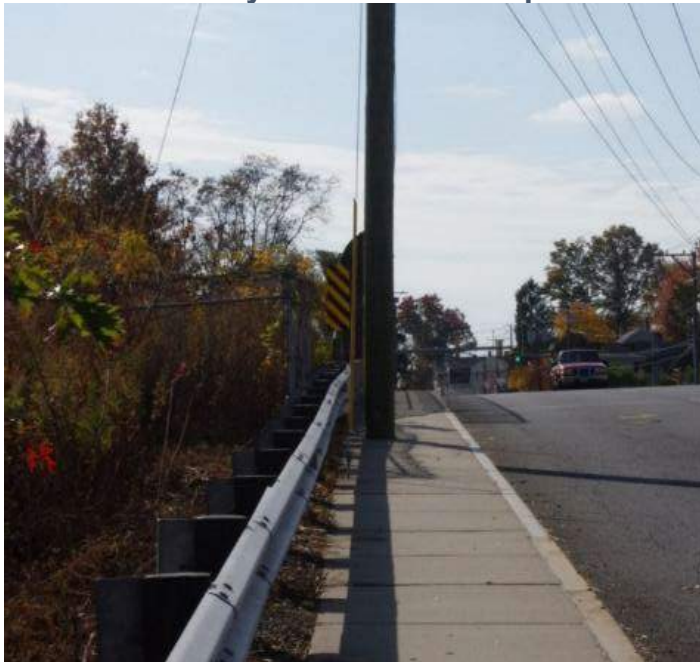
#### **Exhibit 15: Utility Pole at I-84 Overpass**

- Utility poles on the sidewalk across the I-84 overpass create an obstruction for pedestrians, particularly those

that are mobility-impaired. An example is pictured in Exhibit 15.

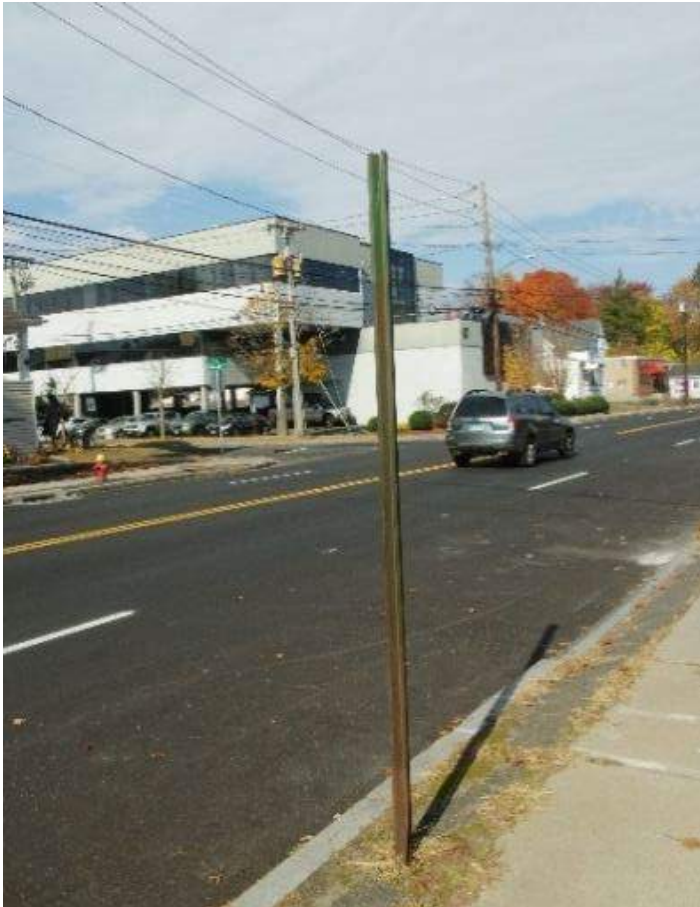
**Exhibit 16: Missing Plates for No Parking Signage**

- The “No Parking” signs on Prospect Avenue south of Caya Avenue are missing from the posts. Cars use the west side of Prospect Avenue as on-street parking from Caya Avenue to New Park Avenue as displayed in Exhibit 16.

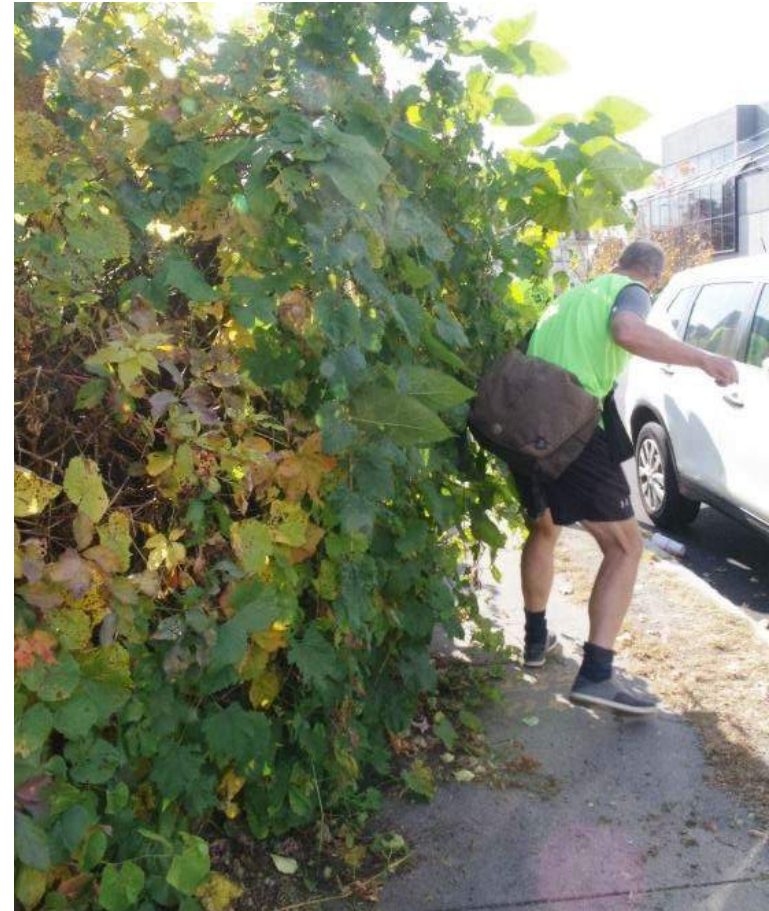
**Exhibit 17: Overgrown Vegetation at 75 Prospect Avenue**

- Overgrown vegetation reduced pedestrian access on the west side of Prospect Avenue, as displayed in Exhibit 17.
- There are missing crosswalk legs on the south and east sides of the intersection at Caya Avenue.

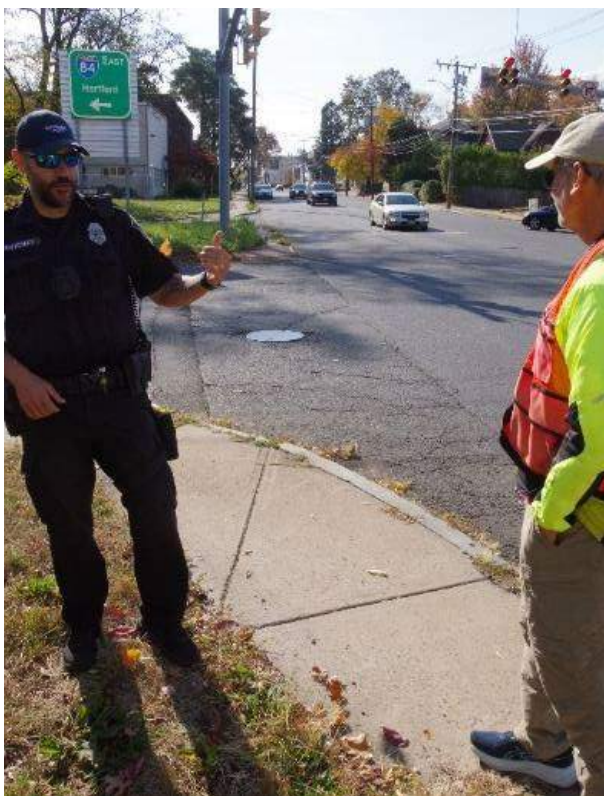
## Exhibit 18: I-84 East Ramp with No Marked Crosswalk

- There is no marked crosswalk at the I-84 east on-ramp, as shown in Exhibit 18.
- Curb ramps are missing at Merrill Street intersection.
- There are incomplete pedestrian accommodations across the east side of the intersection.

- Remove northbound right-arrow indication on signal head at Caya Avenue. Coordinate with CTDOT on installation of yield signage on on-ramp to I-84 eastbound.
- Consider restriping the roadway with the proposed following road diet cross section:

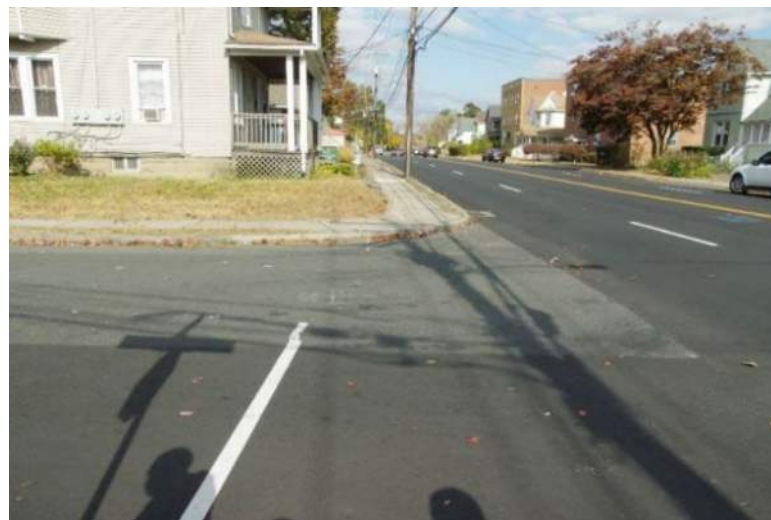
## Exhibit 19: Side Streets Without Marked Crosswalks

- There are no marked crosswalks at stop-controlled side streets that intersect with Prospect Avenue, as shown in Exhibit 19.

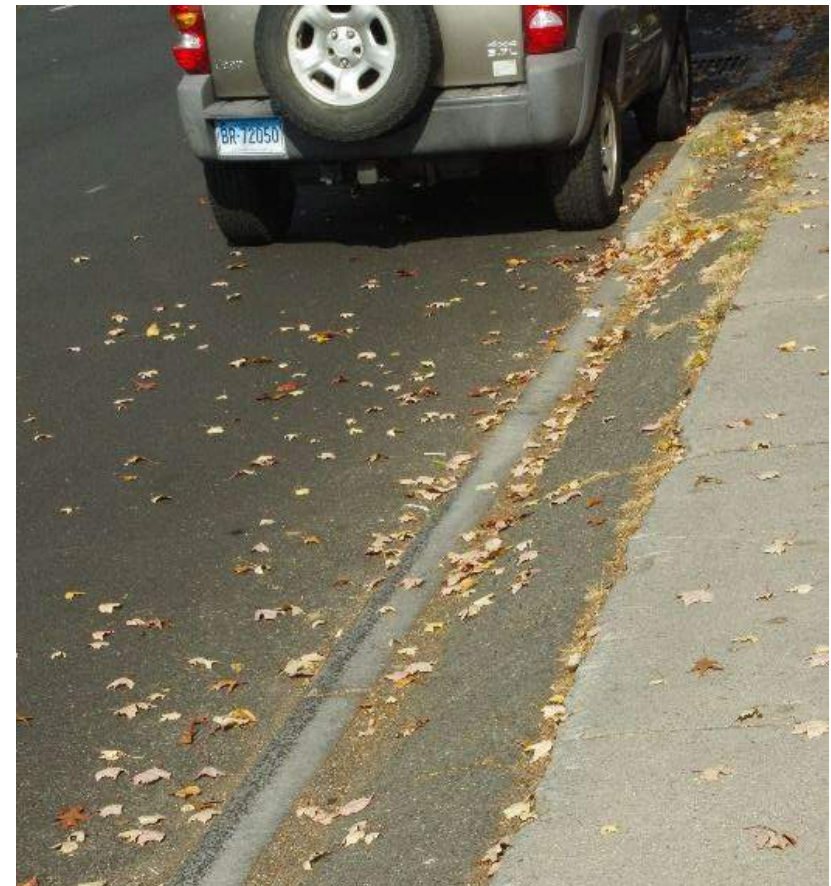
Exhibit 20: Low Curb near New Park Avenue Auto

- There is a low curb at the intersection near the car dealership on the corner, as displayed in Exhibit 20.
- Participants noted that this section of the study area is designated as a Transit-Oriented Development (TOD) Zone.
- There is poor visibility for drivers exiting driveways at 3,7, and 9 Prospect Avenue.
- Crosswalks are missing between the east side of Prospect Avenue to the east side of New Park Avenue.
- Participants stated that the southbound turning movement signage is confusing and causes illegal or unsafe turns to occur.
- There may be room for an pedestrian refuge island at the intersection.
- The sidewalk network ends on the east side of Prospect Avenue near New Park Avenue. Participants noted that vehicles from the auto body shop are often parked on the sidewalk, forcing pedestrians to cross Prospect Avenue mid-block.
