May 1, 2025

### **Comprehensive Radon Survey Report – Multifamily/Commercial Properties**

Sublimity Middle School  
376 E Main St  
Sublimity, OREGON 97385

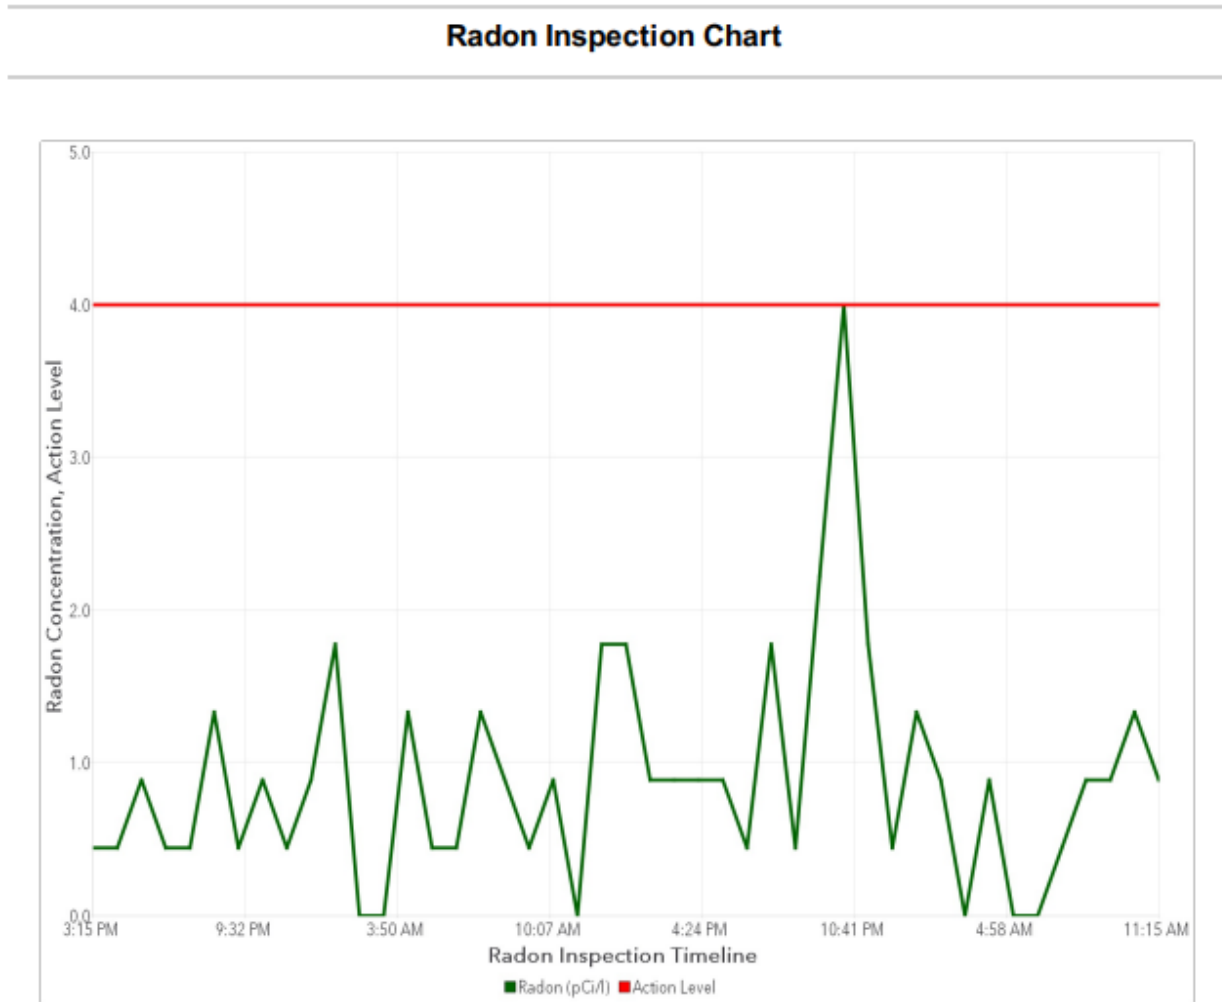
Figure 3A: Radon Inspection Report – CRM Chart (Test Location – Sublimity MS – Office)

| <b>Test Result: Pass</b> | |
| <b>0.9 pCi/l</b> | <b>0.9 pCi/l</b> |

| Radon Concentration: | 0.0 | 4.0 | 0.9 | pCi/l |
