May 1, 2025

### **Comprehensive Radon Survey Report – Multifamily/Commercial Properties**

Sublimity Elementary School  
376 E Main St  
Sublimity, OREGON 97385

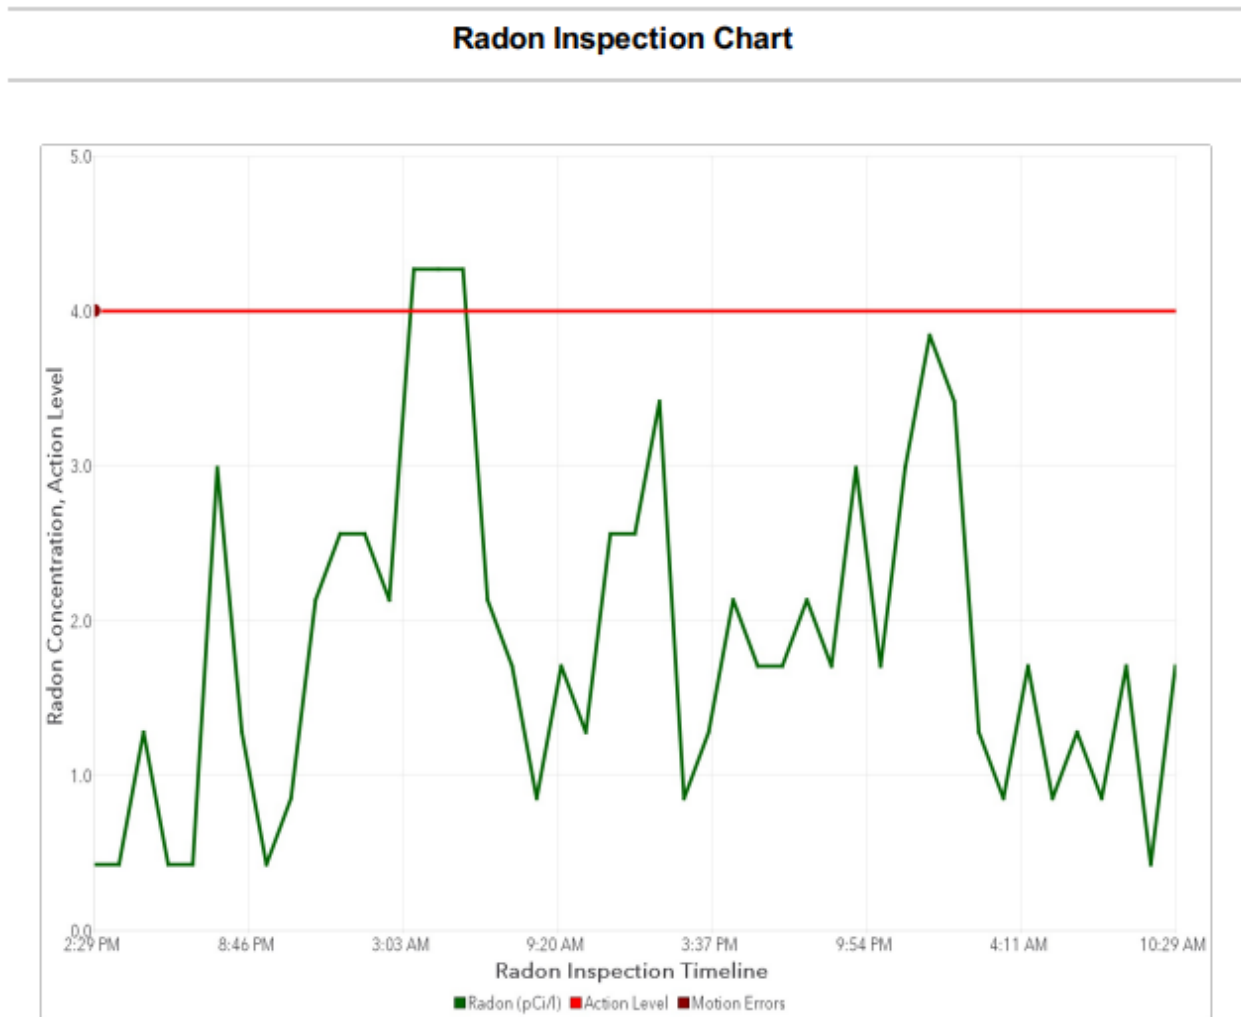
**Figure 3A: Radon Inspection Report – CRM Chart (Test Location – Sublimity ES – Office)**

## Test Result: Pass

| Radon Concentration: | 0.4 | 4.3 | 2.0 | pCi/l |
