# AMIGOS SCHOOL

15 Upton Street  
Cambridge, MA 02139

**Facilities Condition Assessment : October 14, 2022**

Facilities Condition Assessment, Capacity Analysis and Master Plan for CPS

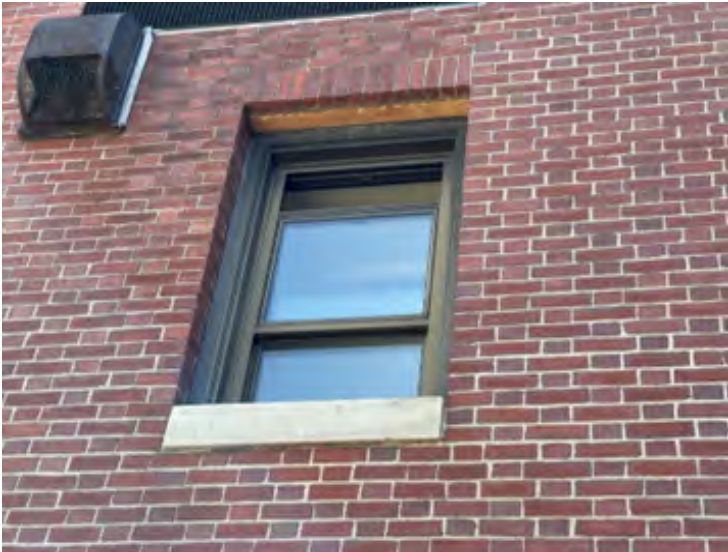
Masonry:  
The masonry façade is largely in good condition overall and there is evidence of previous repointing in some areas. There are isolated locations of cracked and displaced brick and mortar as a result of rust jacking of steel lintels at the head of window openings on the North Elevation. Vertical cracking of brick is present at a few locations as well as spalling mortar below window sills. There is some peeling paint and rusting of the steel lintels. (Ref: Photos AE-6-12)

AE-B: Typical aluminum window within brick masonry façade, with limestone sill and painted steel lintel.

Masonry:  
Isolated replacement of the existing steel lintels could be performed with new galvanized lintels to reduce potential for future rusting and rust jacking damage to the brick and mortar. A short-term repair could include scraping and painting of the existing steel lintels, and introduction of soft joints where the mortar is cracking and becoming displaced due to the rust jacking lintels.

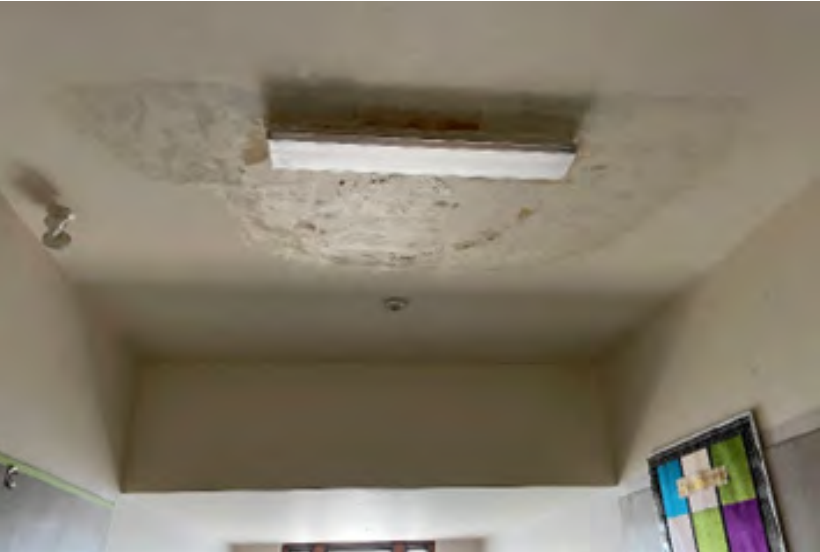
Roofing:  
The roofing assembly is surfaced with a ballasted EPDM installed over a concrete waffle slab deck. Access to the roof is via a roof hatch. The EPDM roof is in fair condition overall and the ballast is not uniformly distributed throughout the roof. It is understood that the ballast was moved around the roof to expose the EPDM to identify and repair sources of roof leakage. (Ref: Photos AE-C-D, AE-30-40)

AE-C: Representative interior ceiling damage due to previous water leakage issues from roof.

Roofing:  
Replacement of all existing roofing systems is recommended. The roof has exceeded its expected service life and should be replaced with a new roofing system with Code compliant insulation and incorporation secondary drainage. Preparation for re-roofing should include investigations into the sources of water leakage observed in various areas of the building to confirm that leakage will be addressed by the proposed roof replacement work and there are no other sources of leakage. New roofing systems should include providing a safe means of access to each roof.

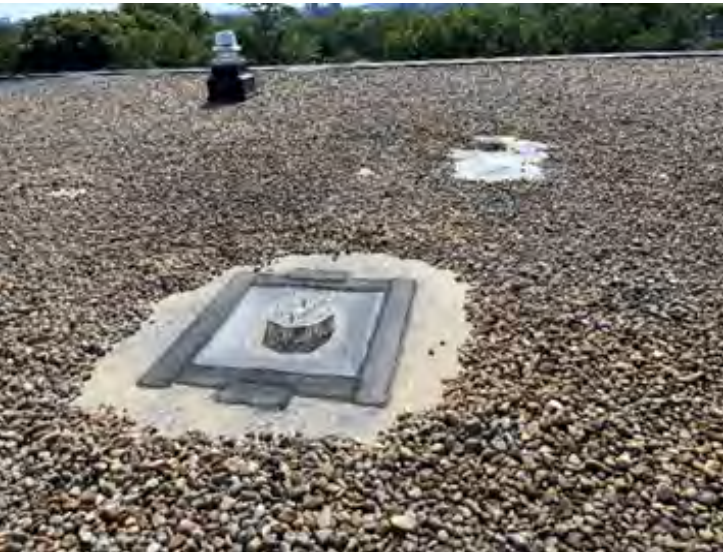
Roof drainage is via through internal roof drains and no secondary means of drainage such as overflow drains or scuppers was observed. The roof drains and strainers appear to have been recently replaced. (Ref: Photo AE-D)

AE-D: Representative ballasted EPDM roof with newer roof drain assembly.

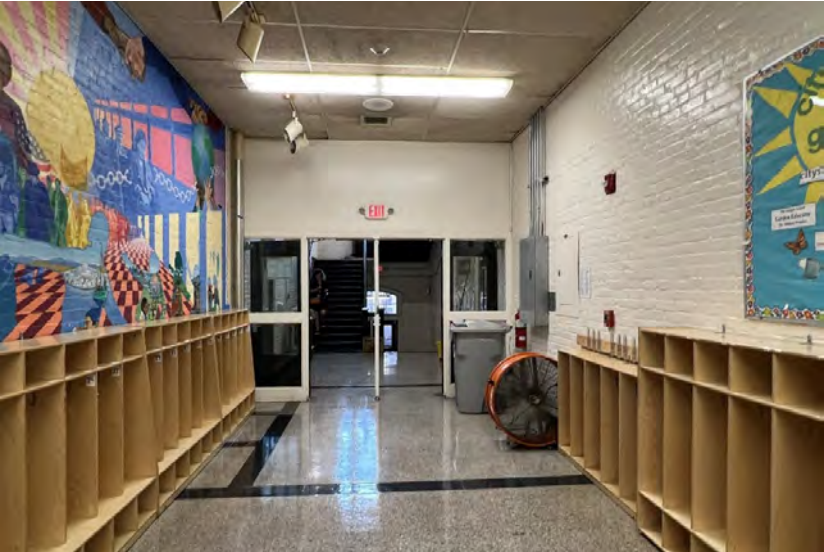
Amigos First Floor Corridor

While corridors are terrazzo, which is typically very durable, this floor is in marginal condition and has a lot of visible damage and cracking that spans significant portions of the floor. The carpet in the library and the wood floor at the stage are both in adequate condition. The gym floor appears to be a rubber or linoleum sheet floor; it is well past its useful life.

Interior finishes are overall well past their useful life. This building is in need of renovations and would best be handled as a full scope project rather than done in isolated scopes.

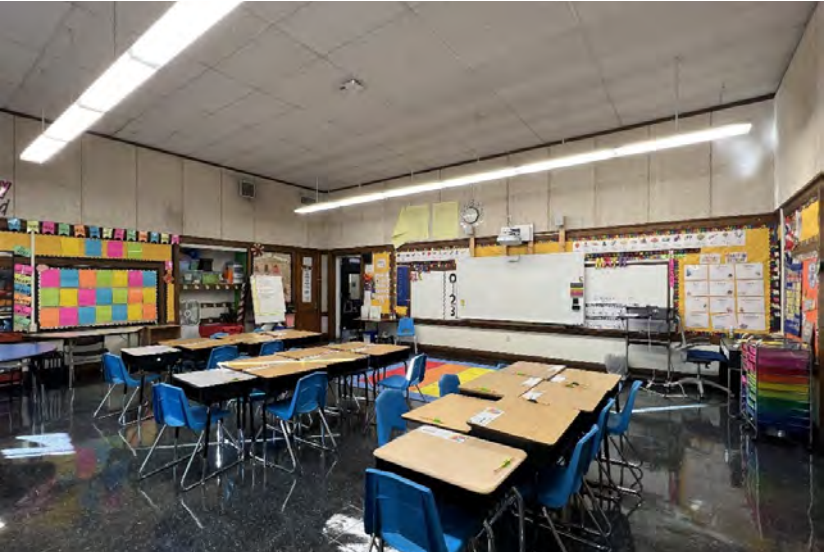
Amigos Typical Second Floor Classroom

Walls:  
Typical classroom walls throughout are gypsum to the door heads and tectum above. The gypsum shows wear and is in need of painting; the tectum above is dirty and stained consistently in all rooms and appears to have only original finish. Some spaces, such as office spaces, appear to have been reconfigured recently and those gypsum walls are in good to adequate condition. The corridors are either brick or tile wainscot (six foot or higher) with gypsum above; they are in functional condition. One stair is brick while the other is tile and gypsum similar to corridor wall. The gym walls have a modular panel with dentil detail; they are in moderate condition.

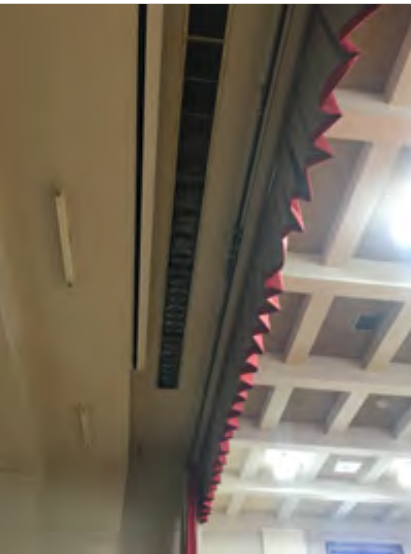
Existing Lighting Fixtures and Valance Curtain

This system should be upgraded. New power and control infrastructure should be installed. Existing fixtures should be replaced by LED fixtures and some additional LED fixtures should be added.

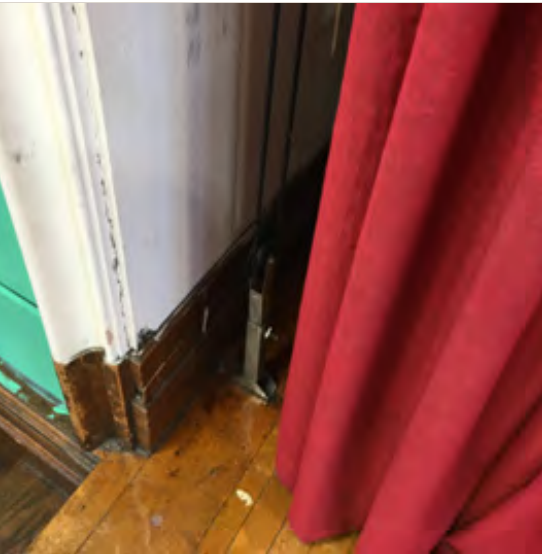
Existing Curtain and Hardware

All drapery tracks and hardware should be inspected and replaced or maintained as needed.

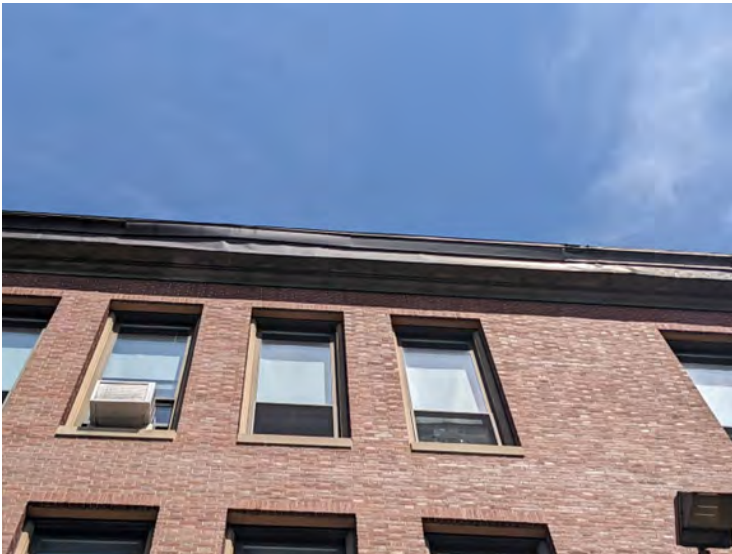
Photo ST-1: Loose Flashing at Roof Edge

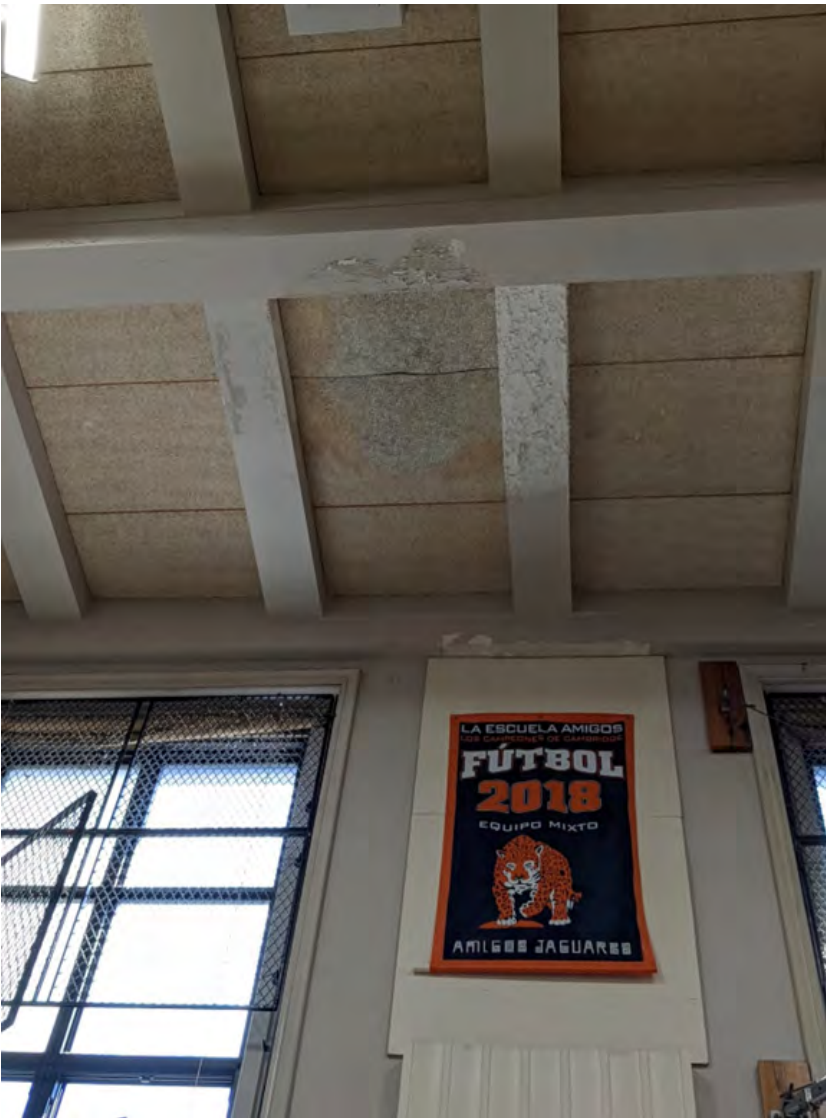
Photo ST-2: Water Infiltration in Gymnasium

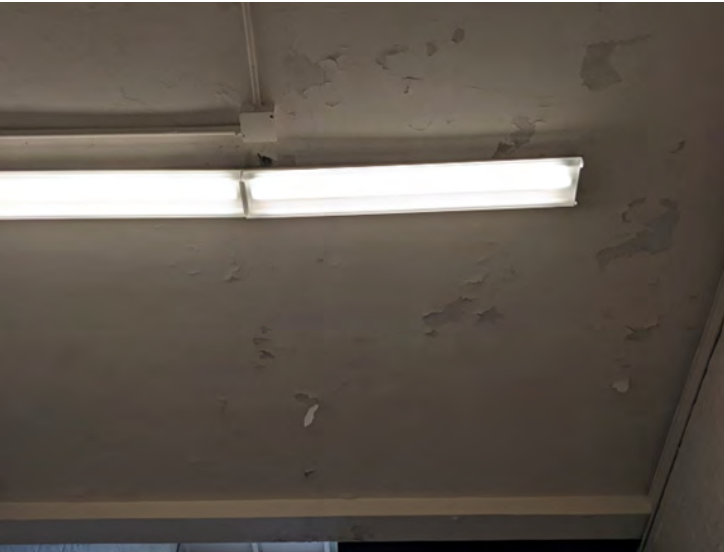
Photo ST-3: Peeling Paint

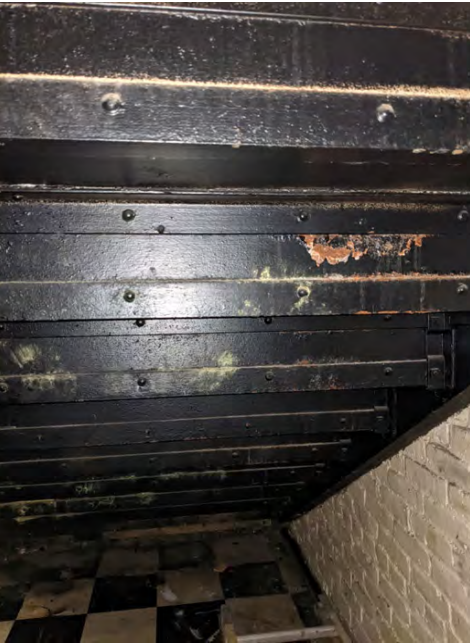
Corrosion and deterioration of the treads and risers of interior stairs were observed in various locations. This type of corrosion typically occurs at ground floor stairs with access to the exterior where exposure to de-icing salts is common. Further evaluation and inspection of all interior stairs is recommended. Refer to Photo ST-4.

Photo ST-4: Rusty/Corroded Stair Treads

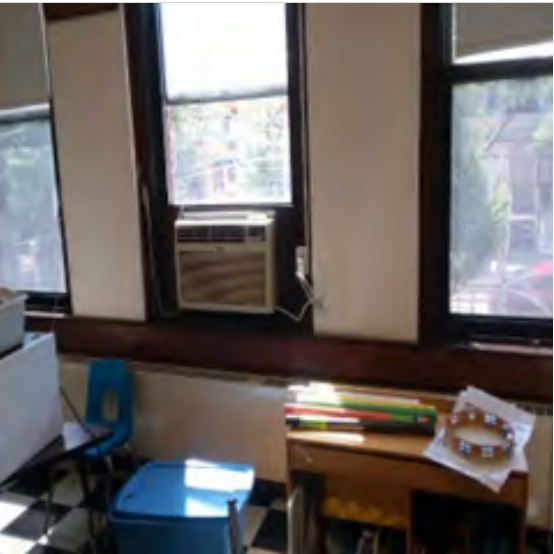
*Existing Condition*  
There is no dedicated or centralized cooling system in the building. Occupied area cooling is accomplished through individual room window mounted air conditioning units.

M-3: Typical Classroom with Window Mounted AC Unit

*Recommendations*  
Concurrent with any air handling system upgrades, replace window mounted air conditioning units with a centralized cooling system.

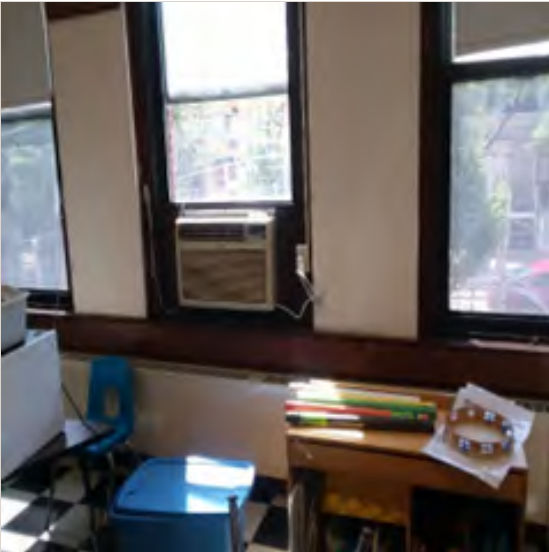
M-4: Classroom Window Mounted AC Unit

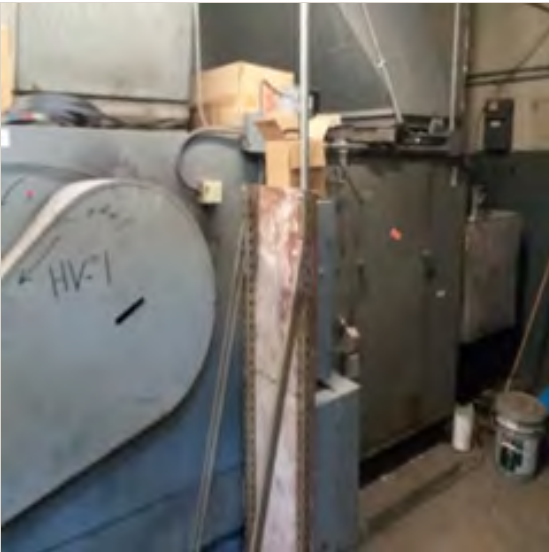
M-5: General Condition of Unit HV-1

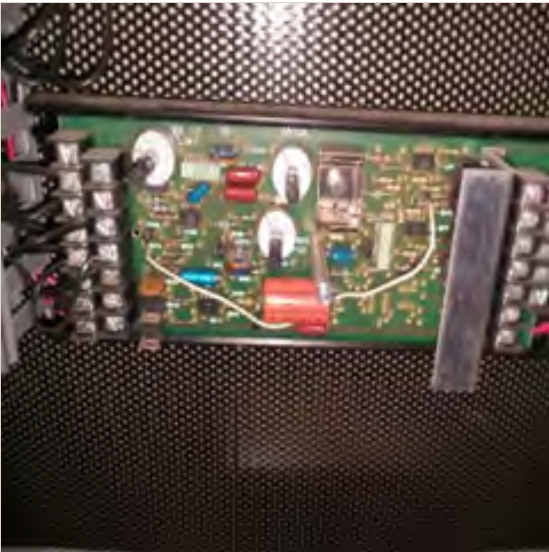
*Existing Condition*  
The existing building automation system is a hybrid of different age and manufacturer control systems which consist of vintage Barber Coleman controllers for the HV air handling units, Reliable/Vykon controllers for the kitchen exhaust system, and a relatively up-to-date JCI Facility Explorer system for the heating hot water plant. As noted above, the controls for the HV units do not appear to be functional. Given the age of this equipment, finding replacement/repair parts is not likely. The kitchen equipment controls are much more modern, though in the middle of anticipated service life (20 years) and appear to be functional with no operational issued noted. The more technologically current JCI Facility Explorer system interfacing with the heating hot water system was installed in 2017 and is fully functional.

M-7: HV-1/2 Unit Controller

*Recommendations*  
The existing HV unit’s DDC systems in their entirety should be replaced. They are well past the expected operational service life (20 years). This replacement should be concurrent with any replacement or upgrades of the air handling units and/or the occupied area heating/cooling equipment. The kitchen equipment DDC devices are in no need of replacement. However, if the HV system controls are to be replaced then it is recommended that the kitchen equipment controls be upgraded with equivalent controls at that time in order to provide a seamless building automation system. The heating hot water/boiler system DDC controls are technologically current and are still fully operational and interface with the current Cambridge School system BAS network. No recommendations are made for replacement/upgrades of this system. Any upgrades to the building’s BAS network should be fully compatible with the current Tridium Niagara platform. Any control system upgrades should include a complete system of DDC controllers, sensors, actuators, and head-end graphics with full integration to the campus-wide network.

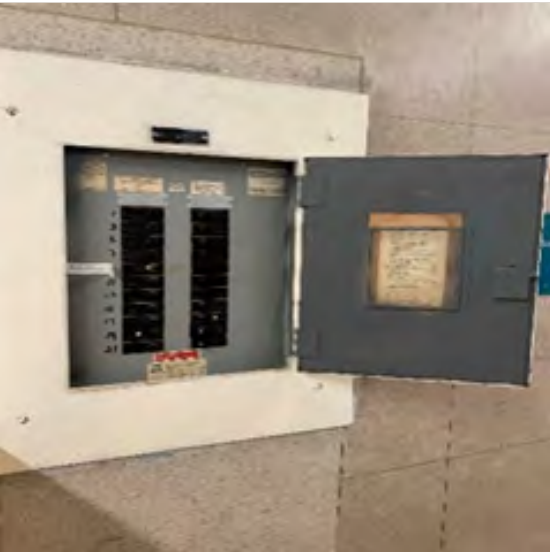
Most of the feeders in the electrical distribution system were not upgraded in the 1982 renovation and are original to 1938. This equipment is past its useful life.

E-2: Circuit Panel ~1982 Renovation

*Recommendations*  
It is generally accepted that the life of an electrical system is thirty (30) years. Beyond that point, it becomes increasingly difficult to cost effectively maintain the system. Wire insulation and equipment failure becomes more common as the system ages, with an increase in outage longevity due to the design of the system and the availability of replacement parts. Often new systems need to be installed to bypass the old system without the benefit of a comprehensive plan designed for the needs of the building. With the aged electrical devices, the devices may not operate under faulty conditions.

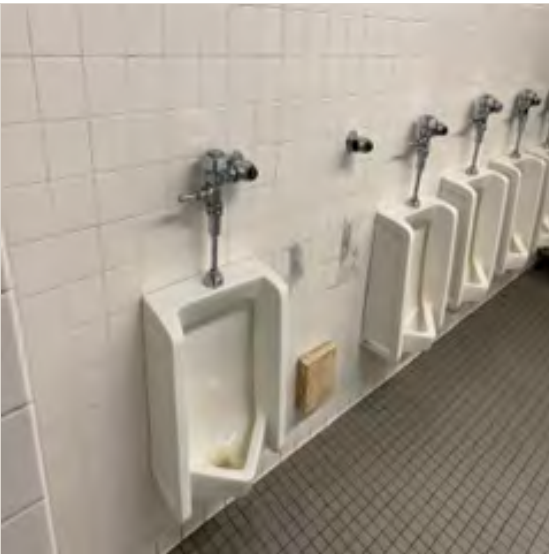
PL-3: Privacy Shields Should Be Provided

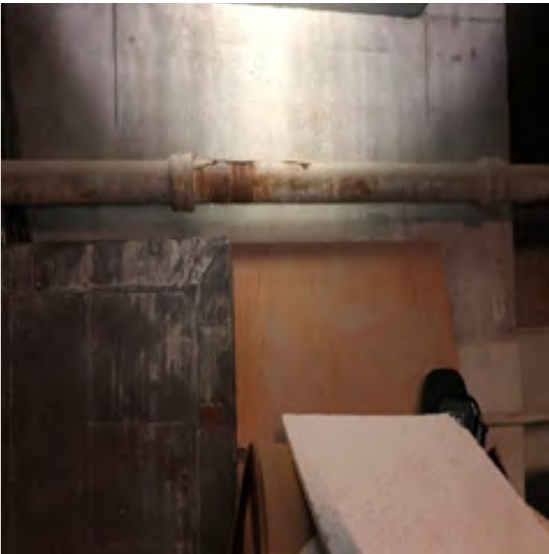
| BUILDING SYSTEMS | CONDITION | PRIORITY |
|---|---|---|
| ° Waste and vent piping has failed in many sections and should be replaced. Storm water leaks exist and roof drains leak – replace. Replace electrical service and distribution – 40+ years old | E | 1-2 |

PL-4: Failed Cast Iron Pipe

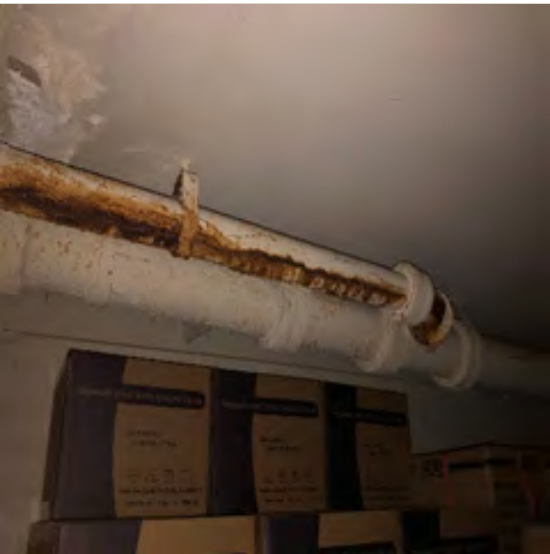
PL-5: Failed Cast Iron Pipe

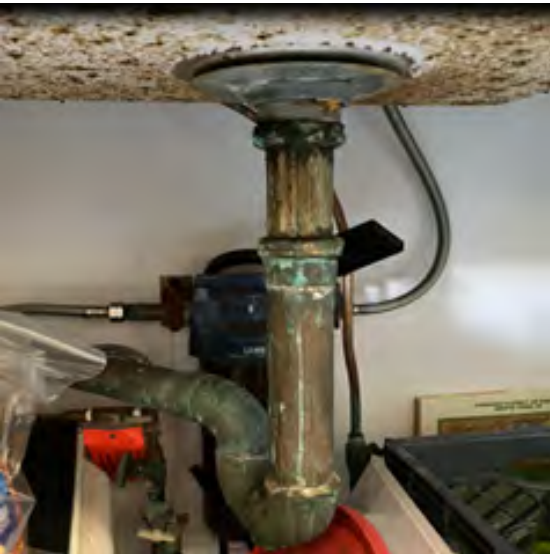
PL-6: Corroded classroom sink drainage

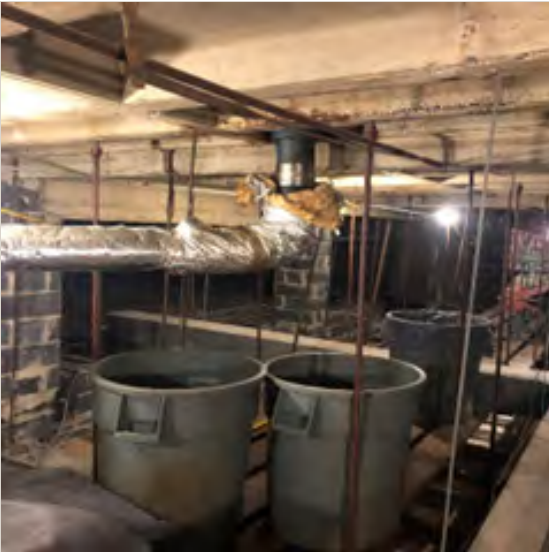
PL-7: Leaking Roof/ Drains at Attic

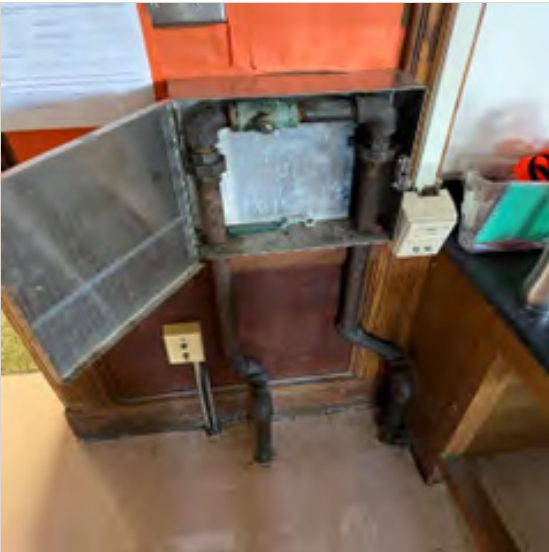
PL-8: Existing Gas Valve Cabinet

If it is determined the natural gas piping to the science classrooms has been disconnected or is no longer required, then the piping and associated gas turrets shall be removed in its entirety.

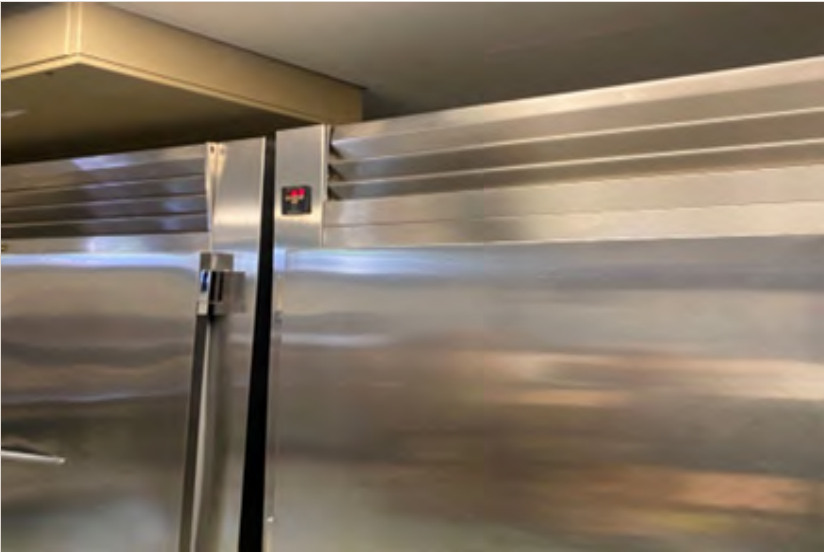
FS-1: Reach-ins cabinets on site were observed outside of food safe temperatures. The reach-in refrigerator was operating at 65° F and the freezer was operating at 20° F. Freezer shall maintain a temperature of -10° F and a refrigerator should be 33°-38° F for proper food holding temperatures. These units require repair or replacement.

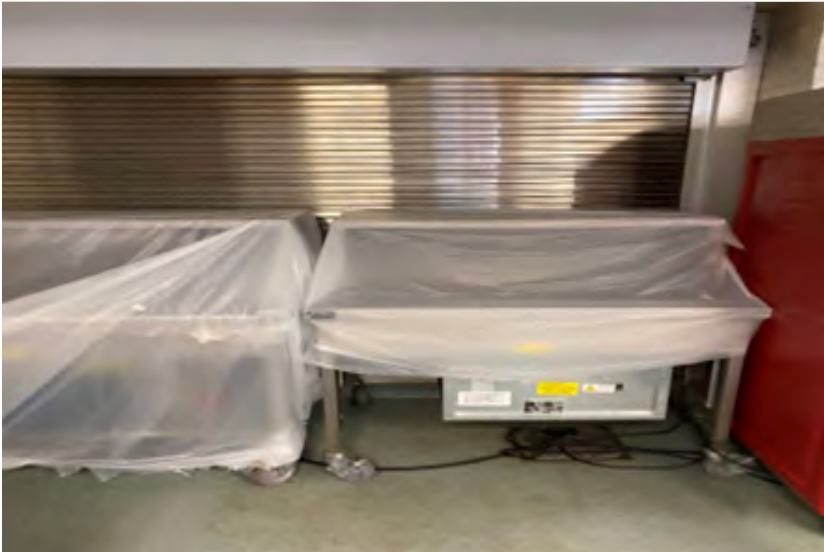
FS-2: The serving counters are limited to only (1) each of mobile hot and cold mobile units. For this population of students, the operations team would greatly benefit from additional temperature-controlled food at the serving line. The sneeze guards are full length and make passage of food to be challenging.
