# BALDWIN SCHOOL

## Facilities Condition Assessment : October 19, 2022

Facilities Condition Assessment, Capacity Analysis and Master Plan for CPS

## 7.2 | BALDWIN SCHOOL BUILDING APPENDIX

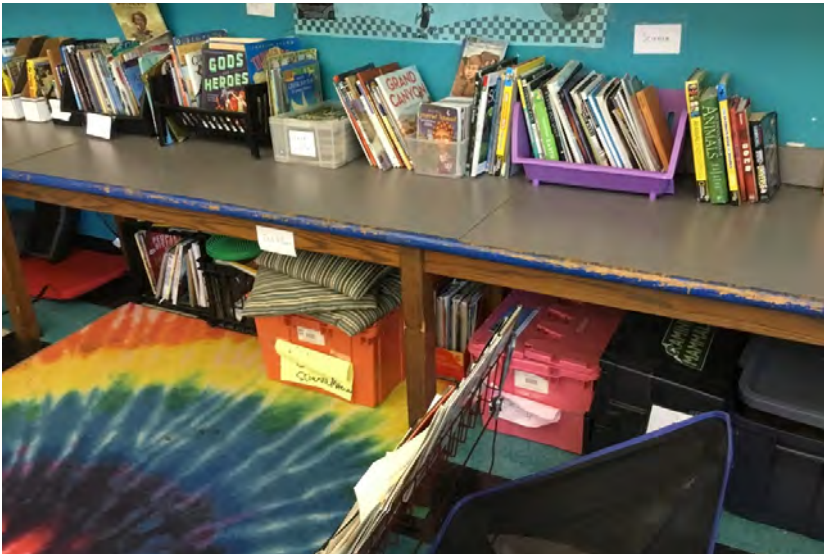
Millwork Damage

Limited repairs such as grout point up and wall prep/ painting would extend the life of the gypsum wall surfaces and wainscot tile. VCT replacement to address gapped joints would require flooring replacement and could be undertaken as systems replacement (possibly summer) project. Millwork repairs could likely be done in-place with new laminates and upgraded edge-banding or wood edging. It may require replacement of all doors and hardware however, back boxes could generally remain. Again, this could be done as an isolated scope. None of these repairs are critical so they are listed as a Priority 4, which would happen later n the overall maintenance program.

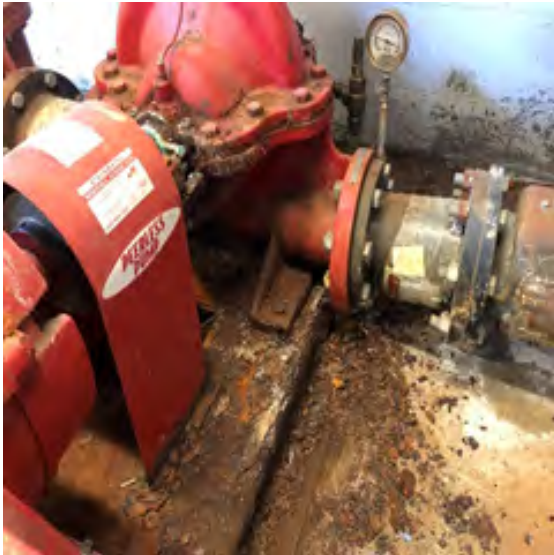
FP-1: Excessive Corrosion at Fire Pump

| ARCHITECTURAL - EXTERIOR | CONDITION | PRIORITY |
|---|---|---|
| <ul style="list-style-type: none"><li>Replace fire pump</li></ul> | E | 1-2 |

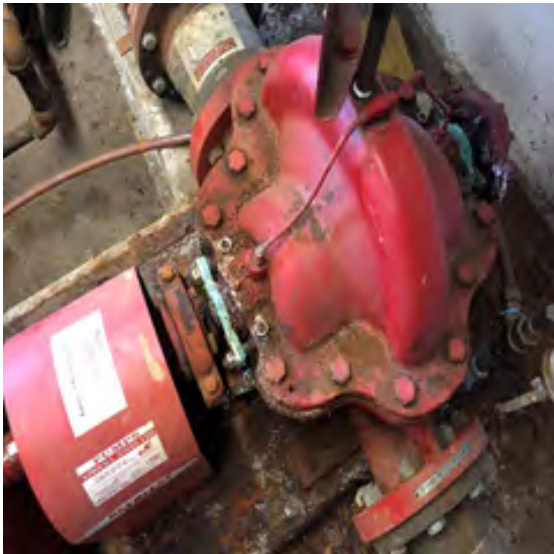
FP-2: Excessive Corrosion at Fire Pump

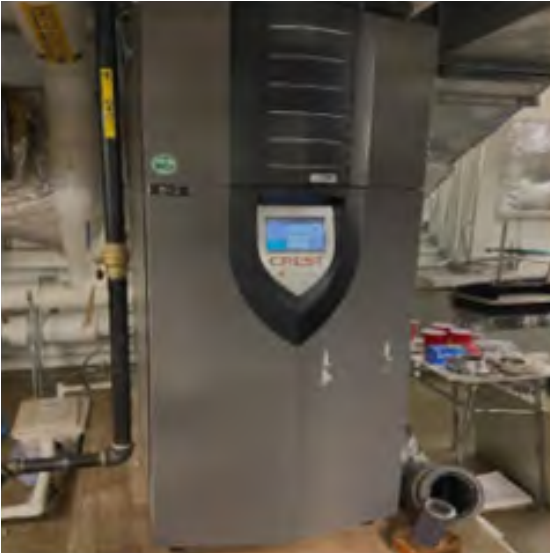
The median service life is for high efficiency, gas fired, condensing boilers and base mounted pumps of this type is anticipated to be 20-25 years.

M-1: (2) Of Existing Lochinvar Boilers

*Recommendations*  
Although service life for this type of equipment is ultimately related to run time duty, environmental conditions, quality and periodicity of routine maintenance, etc. it is recommended that replacement of the heating hot water system should be considered in the next 15-20 years. Areas where piping conditions and circulator pumps are visibly degrading are recommended to be replaced and repaired immediately.

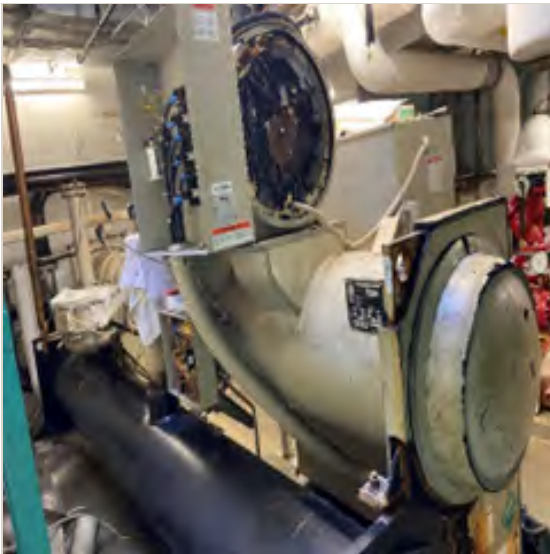
Piping systems are supported by corroded hangers in areas and have ripped and water damaged insulation in need of repair.

M-3: Original Chiller

*Recommendations*  
The head-end of the chilled water system is well beyond its service life and is recommended to be replaced in its entirety with new equipment, piping and insulation.

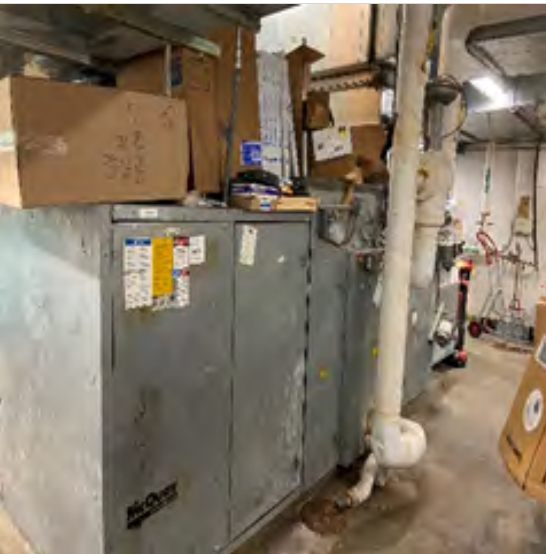
M-7: Original AHU in Mech Room

*Recommendations*  
The air handling units and associated distribution systems are functioning beyond their expected service life and should be replaced with new units, insulated duct work, and piping.

It is further recommended that in conjunction with air handling unit replacement all occupied space terminal units such as the induction units, fan coil units, exhaust fans, etc. also be replaced as all this equipment is beyond the excepted service life and are original to the building.

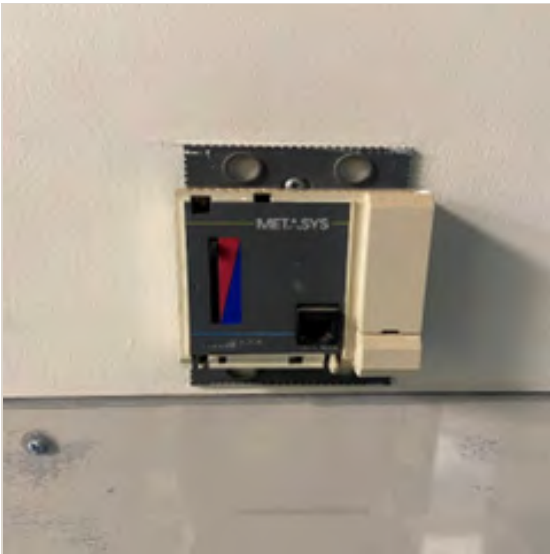
Some controllers have replaced over time as needed. Manufacturers that have been installed include but are not limited to JCI, Schneider, and Distech. Original ports for JCI Metasys can be seen as well.

M-7: JCI Metasys Temperature Sensor

*Recommendations*  
The existing pneumatic system in its entirety should be replaced. It is well past its expected operational service life. This replacement should be concurrent with any replacement or upgrades of the air handling units and/or the occupied area terminal units. Included in this would be the minimal control currently provided to the existing air handling units. The heating hot water/boiler system DDC controls are more technologically current and are still serviceable. However, the majority of the Cambridge School system BAS network resides on a more modern Tridium Niagara platform and ultimately a plan should be developed to transition to this newer platform as the older Metasys system is no longer supported and reaching the end of its expected median service life of 20-years. Control system upgrades should including a complete system of DDC controllers, sensors, actuators, and head-end graphics.

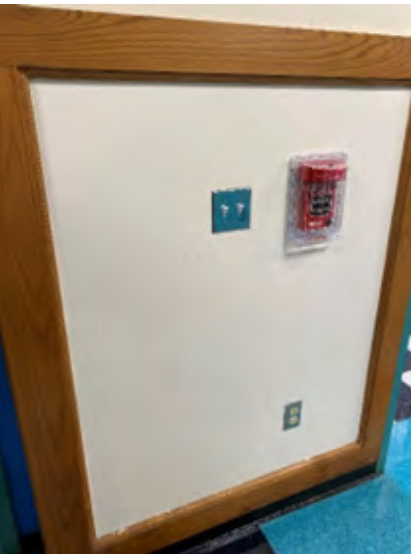
A spot check of wiring devices indicated varying conditions. Light switches and receptacles were generally in poor to fair condition, while many were older and showing wear. Lack of a sufficient quantity of receptacles was noted. Tamper resistance receptacles are also required in Preschools and elementary education facilities

E-3: Switch and outlet condition

It is recommended that all devices be replaced with the next major renovation, as ceilings will need to be removed for MEP work.

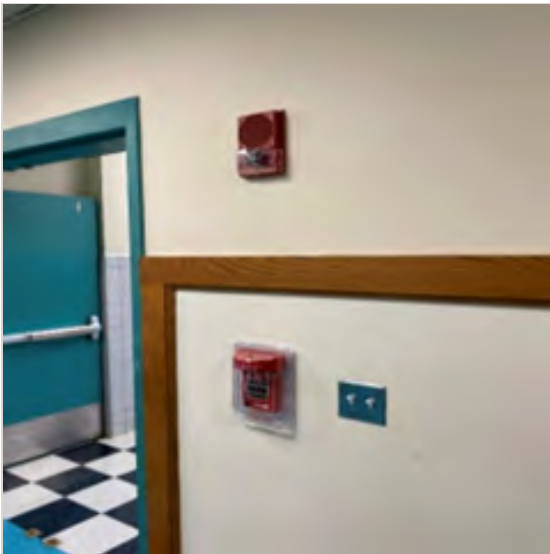
E-5: Existing Fire Alarm Device

*Recommendations*  
Provide all required testing and detailed review for a code compliant installation.

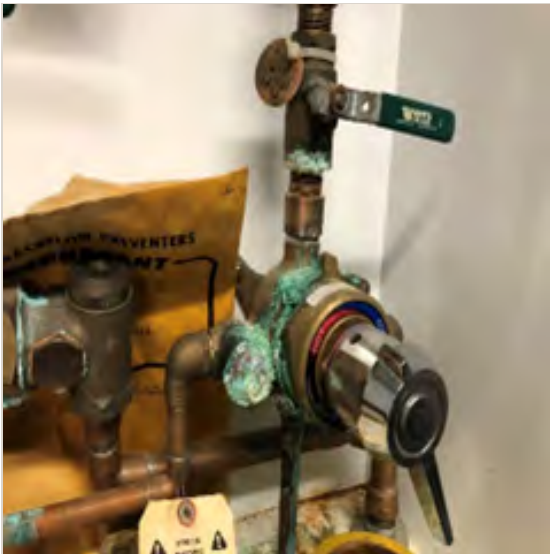
PL-1: Corroded Mixing Valve

Replace plumbing fixtures and floor drains which are heavily corroded and exceeded their useful service life.

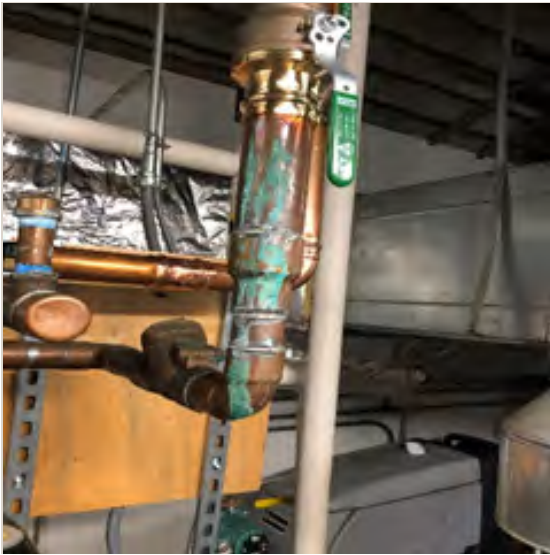
PL-2: Corroded Length of Pipe

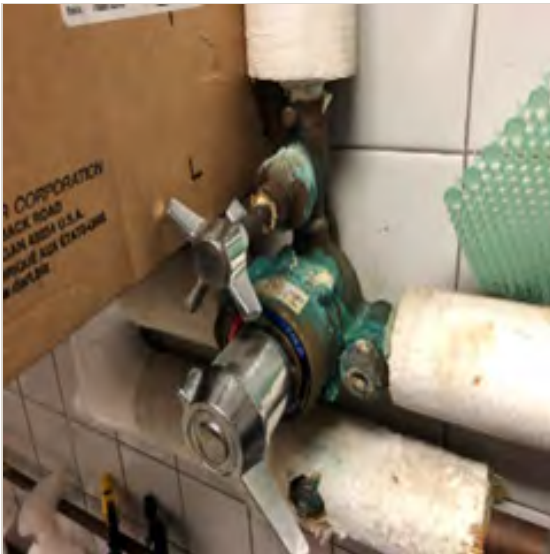
PL-3: Corroded Mixing Valve

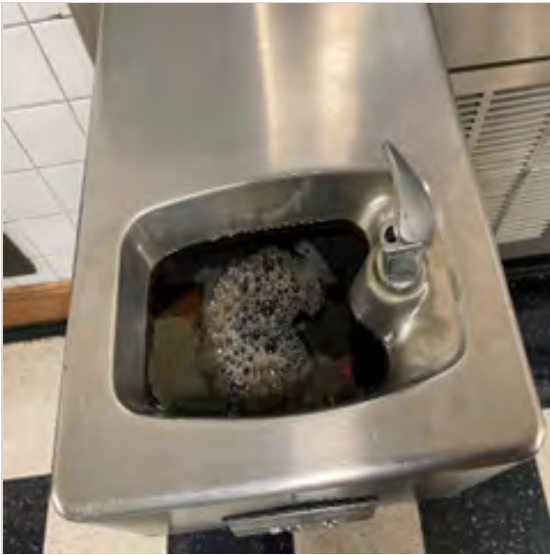
PL-4: Clogged Drinking Fountain

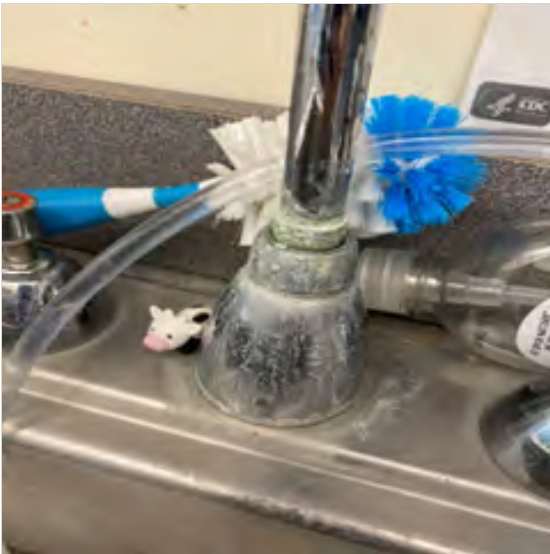
PL-5: Corroded Classroom Faucet

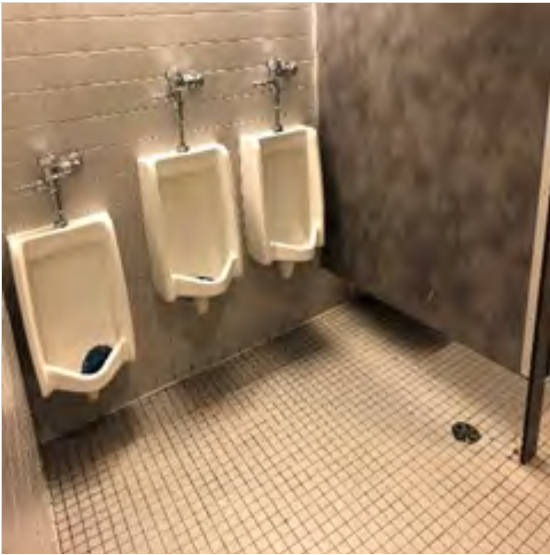
PL-6: Privacy Shields Should Be Provided

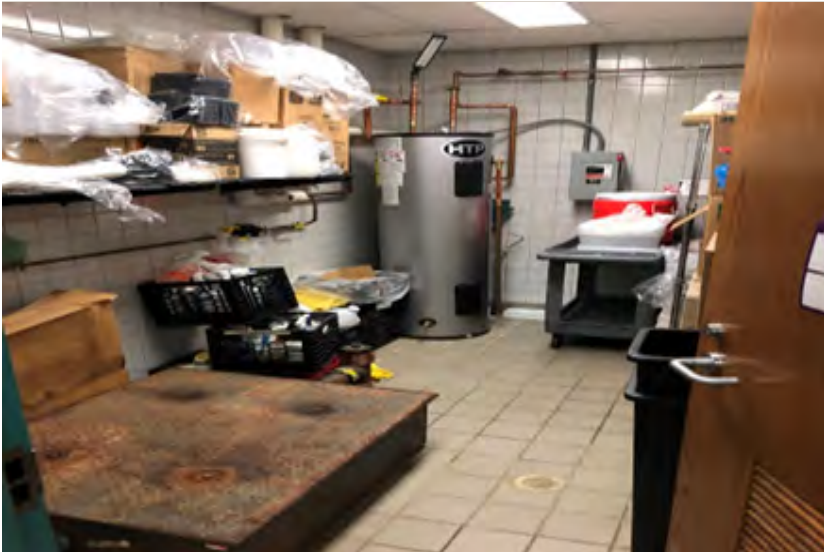
FS-1: The dry storage room is combined with mechanical equipment. Therefore, there’s not enough dedicated dry storage for this facility. The grease trap being located in the dry storage room is not an ideal situation for the operations team.

| ARCHITECTURAL - EXTERIOR | CONDITION | PRIORITY |
|---|---|---|
| <ul style="list-style-type: none"><li>Provide additional refrigerated storage</li><li>Provide additional prep table with sink</li><li>Replace fire suppression system</li></ul> | C | 4 |

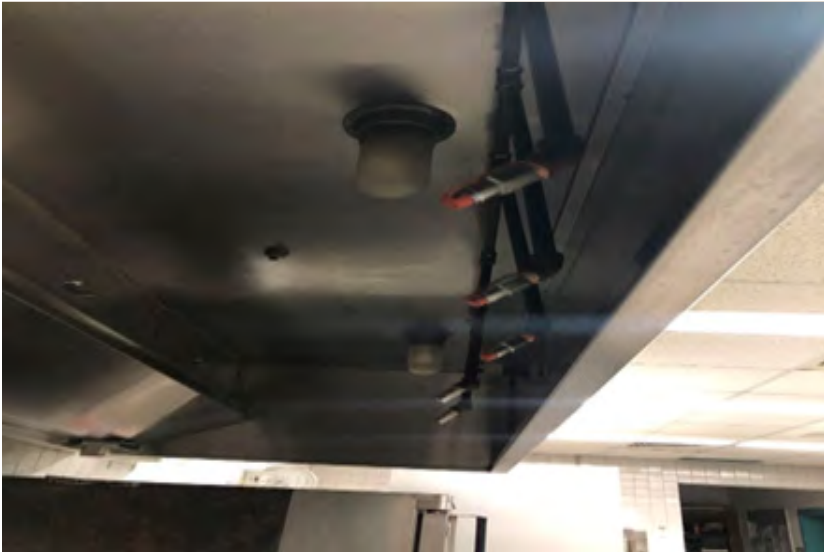
FS-2: The grease filters at the exhaust hood are dated technology and not as efficient as what’s available today. They are also more difficult to clean. The fire suppression piping runs horizontal within the cavity which results in excessive grease build up. Efficient design limits fire suppression to vertical drops only. Iron piping was used for the Ansul system, modern day piping is stainless or chrome for improved cleanability.

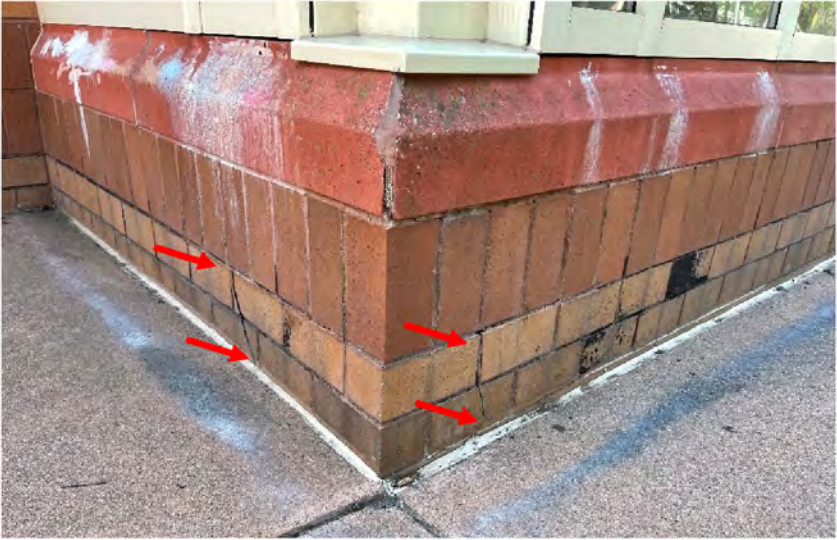
The masonry façade comprises brick veneer with decorative glazed block and is in good condition overall. Isolated cracked brick and efflorescence is present at the lightwell facades on the North Elevation. (Ref: Photos AE-8-9) There is isolated mortar cracking at the base of the engaged pilasters along the West Elevation. (Ref: Photos AE-10-11)

AE-8: Representative brick masonry façade along North Elevation. Typical efflorescence, cracked brick and mortar

A scope of masonry cleaning and repointing should be undertaken at the North Elevation lightwells and retaining wall. This work shall include replacement of cracked or spalled brick.

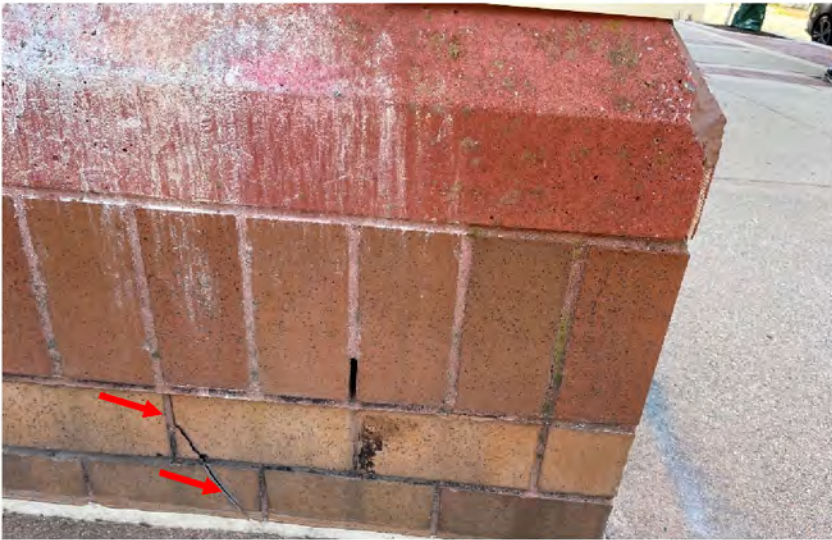
AE-9: Representative brick masonry façade along North Elevation. Typical efflorescence, cracked brick and mortar

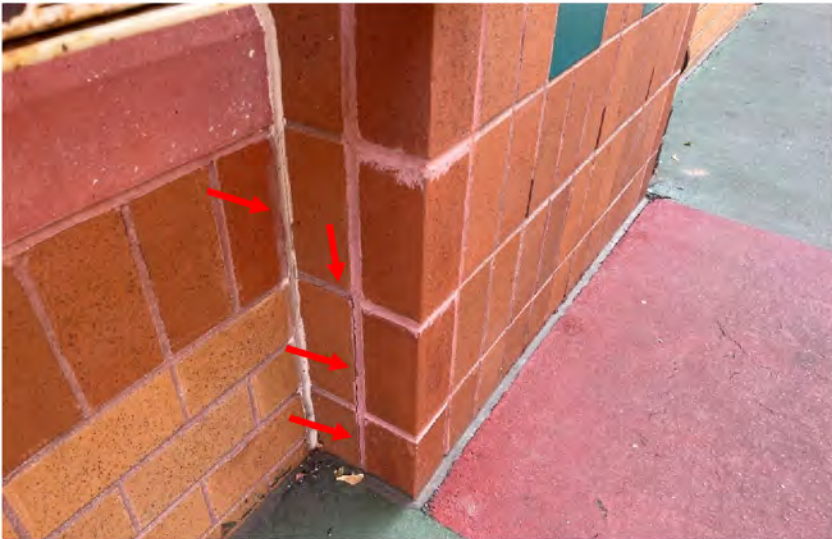
AE-11: Representative cracked mortar at pilasters along base of West Elevation

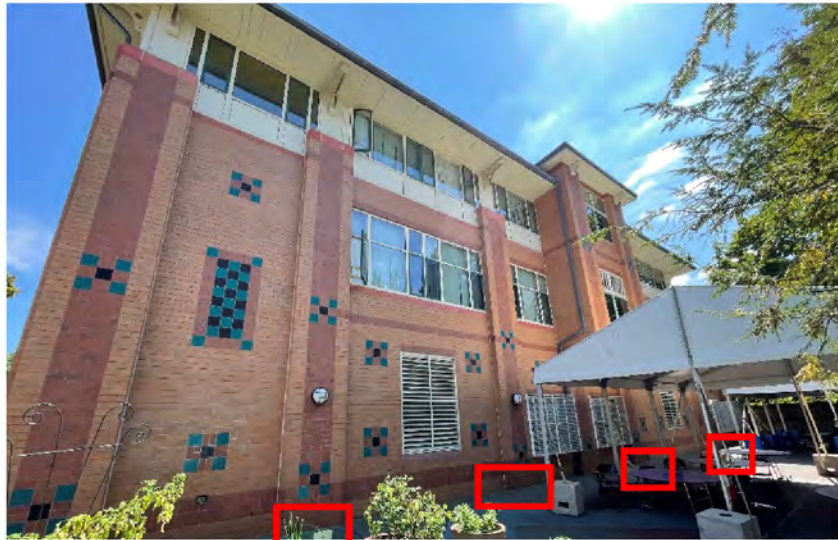
AE-10: Representative cracked mortar brick masonry façade along West Elevation at base of engaged pilasters

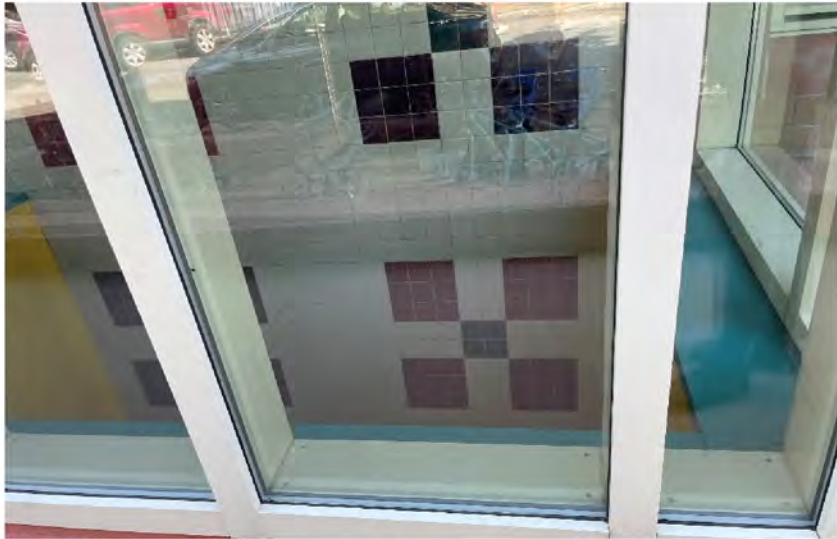
The fenestrations are thermally broken aluminum framed assemblies with insulated glazing, including fixed, spandrel and casement units. The exterior window perimeter sealants observed are in good condition. There is an isolated cracked pane of glass at a lightwell on the North Elevation. There is no interior perimeter sealant between the operable window frame and curtain wall framing. (Ref: Photo AE-14) The operators on the interior of the casement windows hit the internal insect screens, which reduces potential for the operator to be fully closed. Limiting chains have been installed between the window frame and casement sash on the interior to limit the distance these units can be opened. The chains were broken or missing in some locations. (Ref: Photos AE-14-17) Damaged weatherstripping is common at several exterior doors (Ref: Photos AE-18-20)

AE-13: Cracked pane of glass at North Elevation

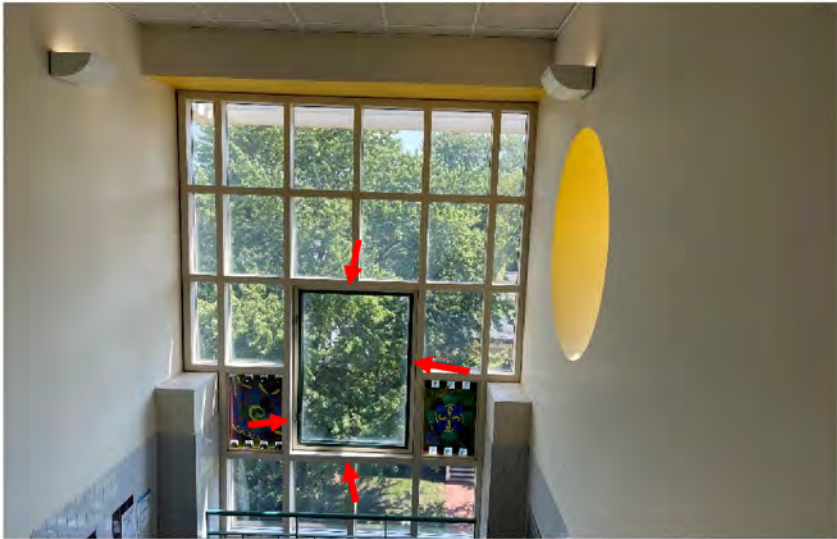
AE-14: Interior of representative curtain wall with operable window. Note lack of sealant around operable window frame

Installation of interior perimeter sealant between operable window frames and curtain wall framing will reduce potential for air infiltration and water penetration. A typical location of this condition is within the stairwells.

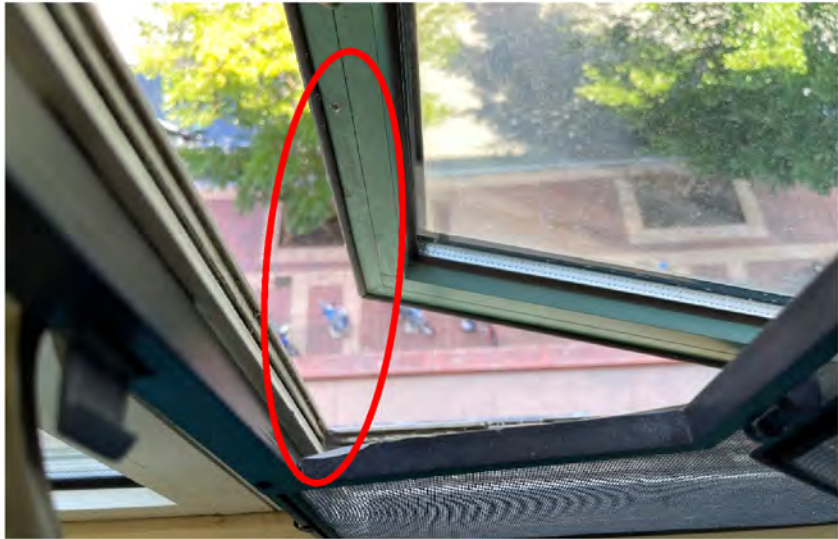
AE-17: Typical broken chain limiter on operable window

Existing damaged chain limiters should be replaced with new limiters appropriate for these windows that can be attached to the hinge. Adjustment of the interior screens is recommended to ensure the window operators can be fully engaged in the closed position, to reduce potential for air infiltration and water penetration. Replacement of existing weatherstripping at exterior doors is recommended.

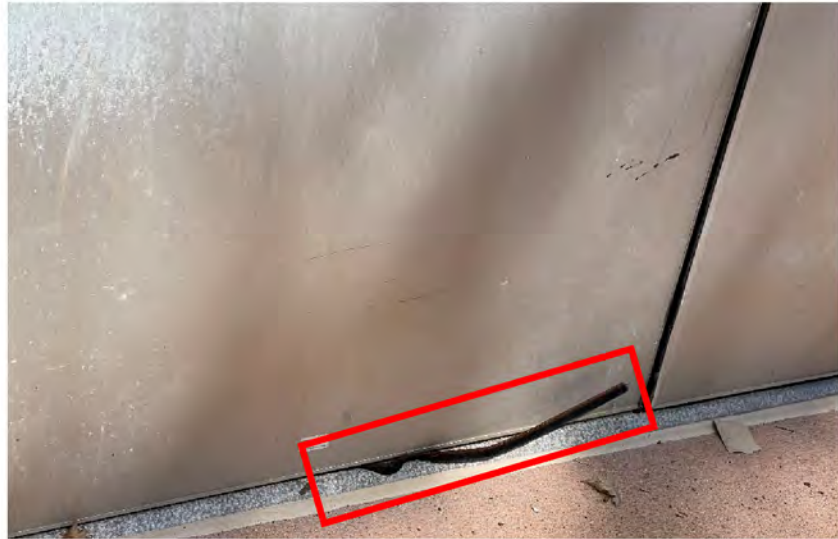
AE-18: Damaged weatherstripping at typical hollow metal door on South Elevation

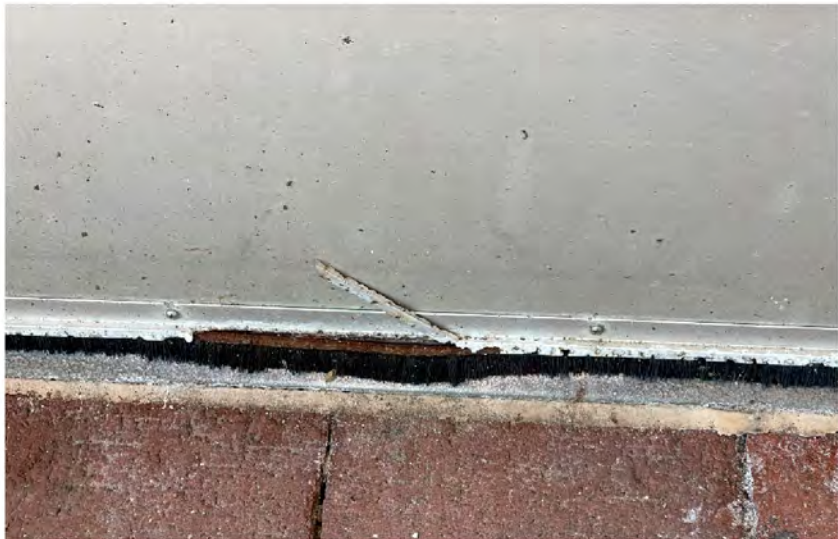
AE-19: Damaged weatherstripping at typical entrance door on East Elevation

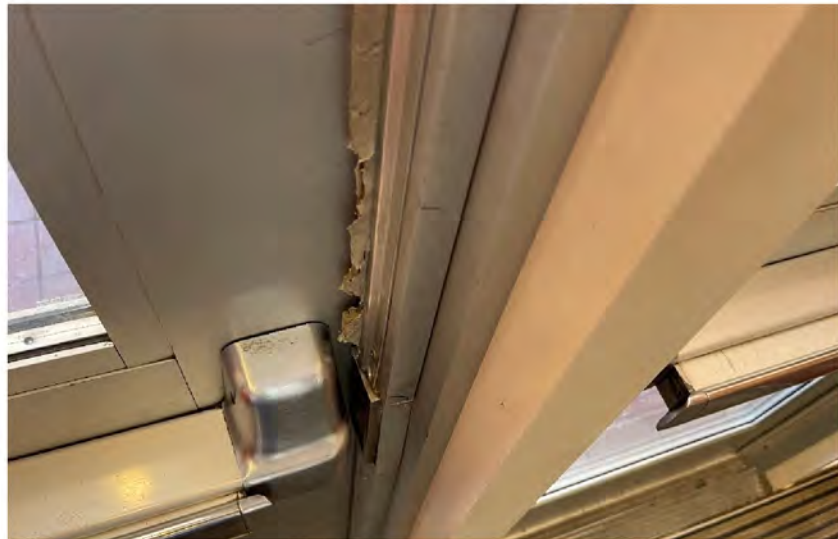
AE-20: Damaged weatherstripping at typical entrance door on East Elevation, viewed from interior

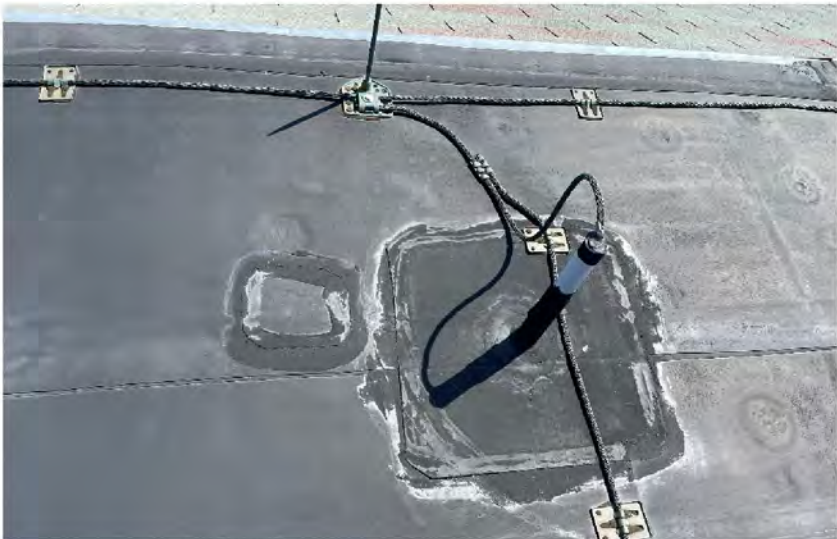
The roofs are in good condition overall, with some failing lap sealants around EPDM patches which is expected for a roof of this age. A few shingles were missing in isolated locations. (Ref: Photos AE-27-28) Roof drainage is via internal roof drains at the EPDM roof of the mechanical well and the ballasted roof. The remaining EPDM roof areas drain onto the surrounding shingled roofs, which drain via gutters and downspouts. Some drip staining on the South Elevation exists below the soffit adjacent to a downspout, potentially indicative of a clogged downspout. Roof access to the main roof is through a roof hatch. There is no access to the ballasted roof. A lightning protection system is installed.

AE-24: Representative patches in EPDM. Failed lap sealant and unadhered EPDM patch

Repair of the existing roofing assemblies is recommended, including but not limited to replacement of missing asphalt shingles and replacement of EPDM flashings and associated lap sealants.

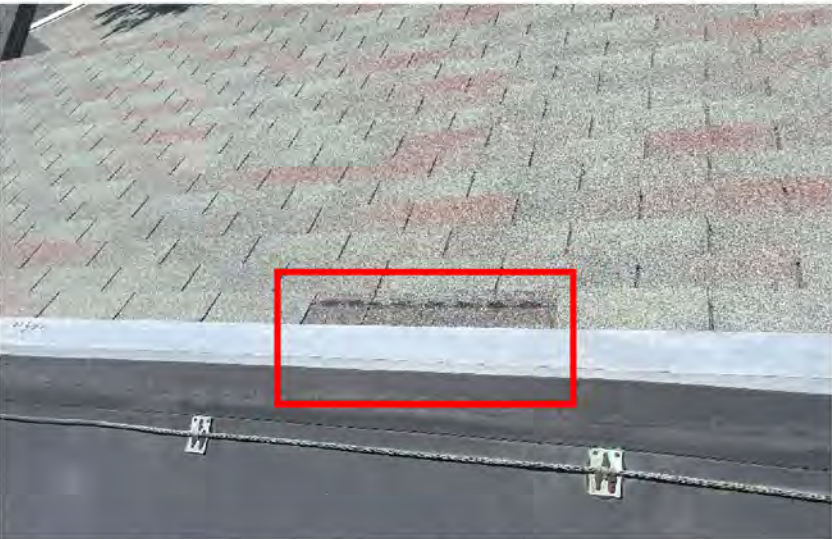
AE-27: Missing shingle near transition with EPDM

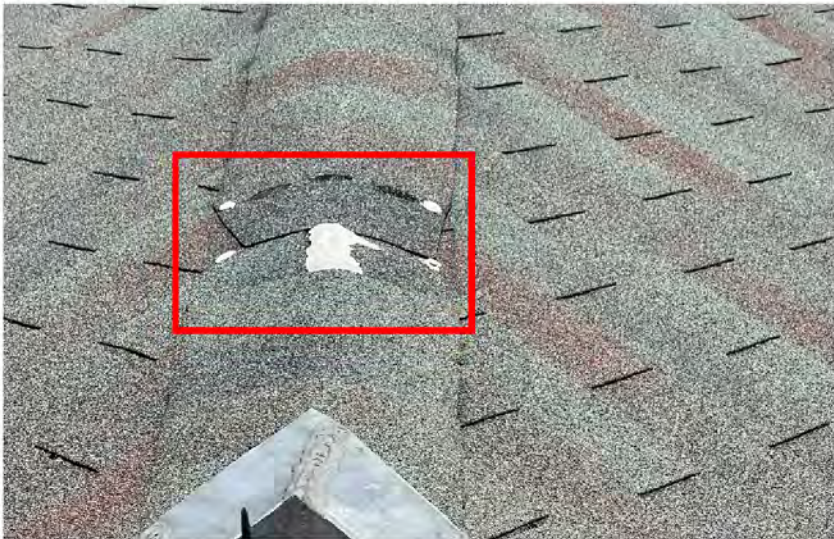
AE-28: Missing ridge shingle

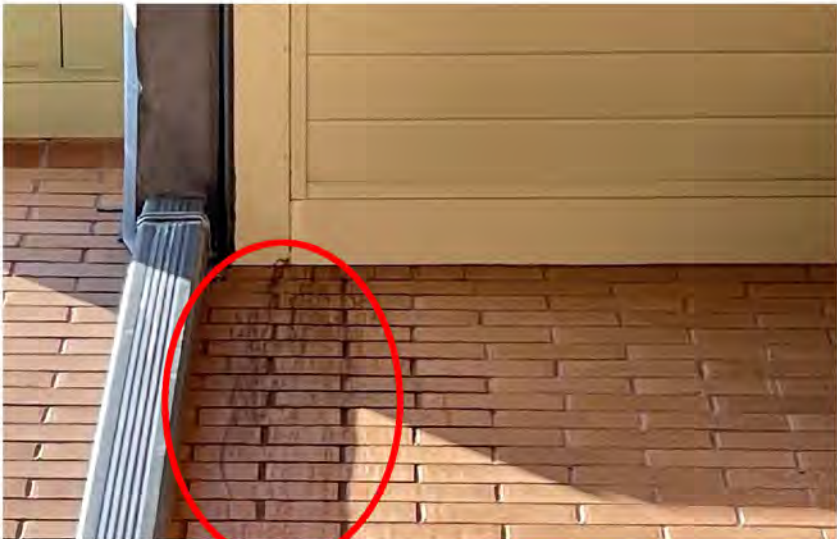
AE-32: Drip staining from soffit adjacent to gutter and downspout at base of shingled roof on South Elevation

A visual review of the gutters should be performed along with removal of any debris such as leaves which can clog the gutters and restrict drainage. Based on the age of the roofing systems, replacement should be scheduled within next five (5) years.

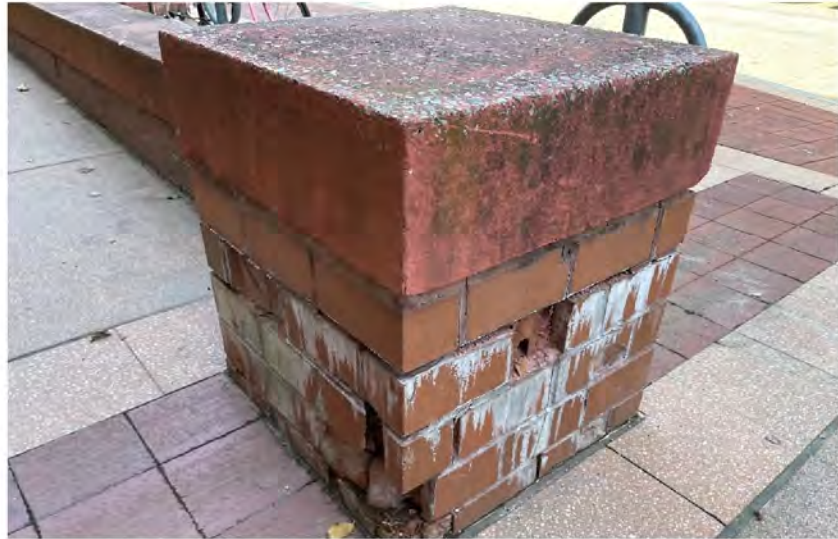
Efflorescence, deteriorated mortar and spalled brick are present at the retaining wall of the ramp near the North Elevation building entrance. There are deteriorated mortar between the granite stair treads along with some cracked granite at railing penetrations. (Ref: Photos AE-33-36)

AE-34: Representative masonry walls along ramp at North Elevation. Note spalled brick, efflorescence

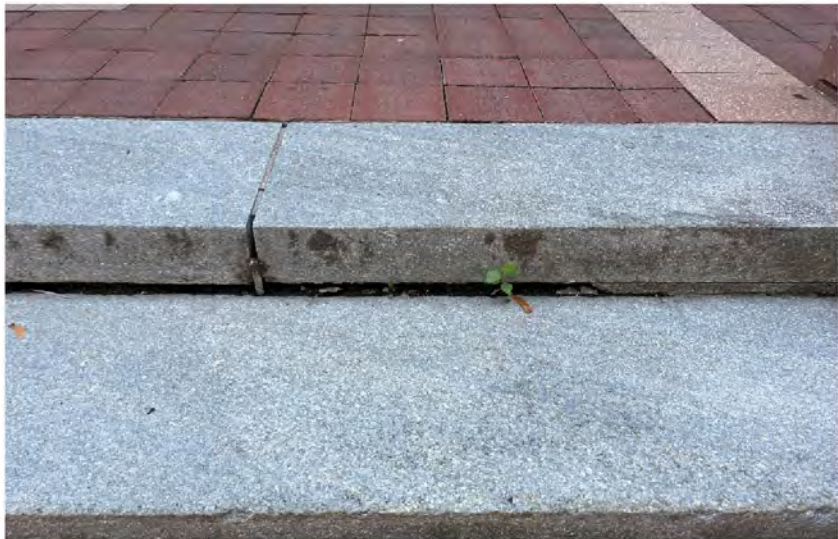
AE-35: Representative Stairs at North Elevation. Typical deteriorated mortar at granite stair treads

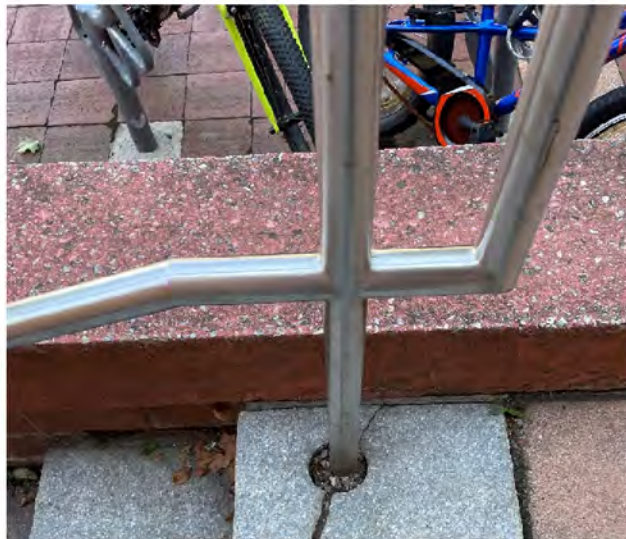
AE-36: Representative Stairs at North Elevation. Typical cracked granite stair tread, deteriorated mortar

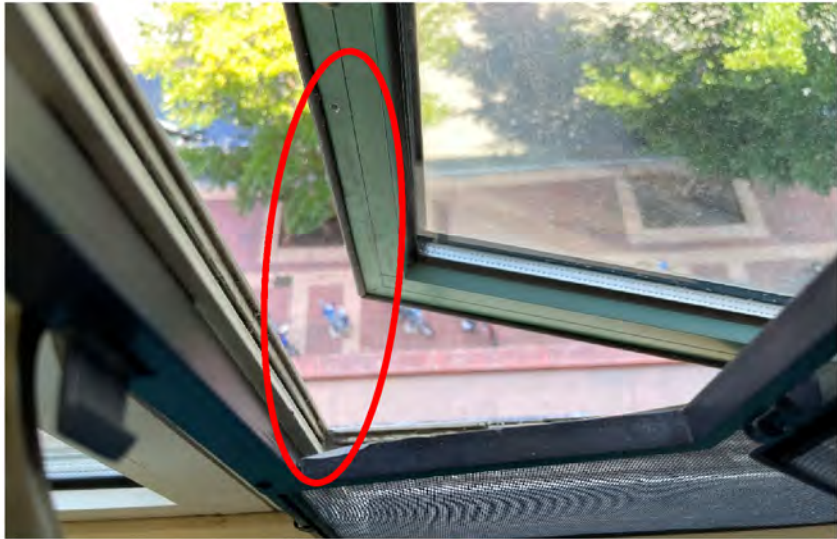
AE-37: Typical broken chain limiter on operable window

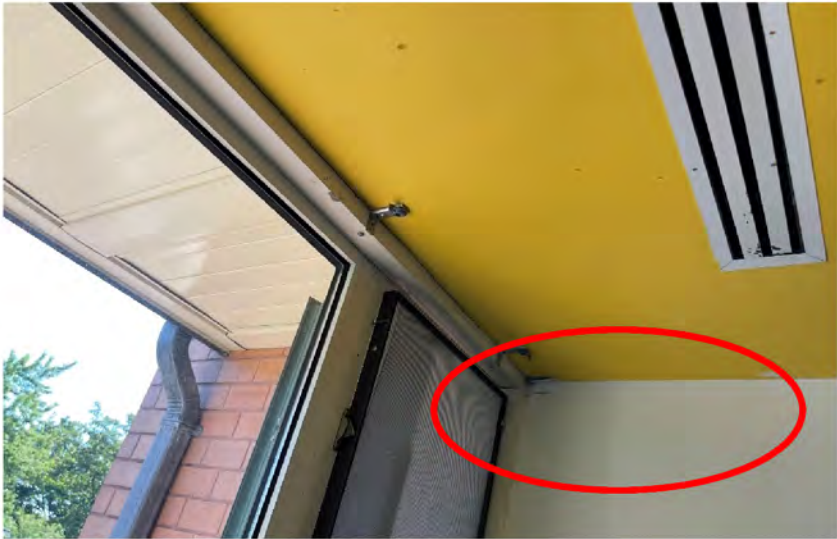
AE-38: Interior of 302 where water leakage was observed below step flashing at shingled roof above. Some drywall damage observed.

A scope of diagnostic water leakage field testing is recommended to be performed at each of the leakage locations, coupled with potential exploratory demolition work to identify the source(s) of water penetration. A scope of remedial work should be executed to address the leakage issues based on the results of the leak evaluation work.

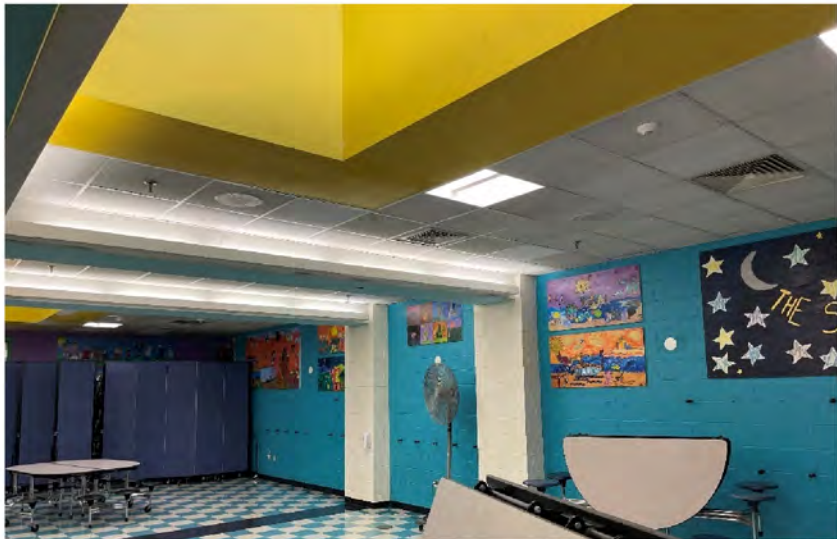
While on site, Discussions were held with facilities personnel to identify any building exterior-related issues that may exist. There are interior locations of periodic water leakage at Room 302 where leakage has occurred below the intersection of shingled roofing and an adjacent rising wall. (Ref: Photo AE-37) Previous repairs have been performed over Room 316 at a similar intersection of step flashing, masonry and shingles. (Ref: Photo AE-38) Recurrent water leakage is occurring within the Cafeteria below a lightwell on the North Elevation, resulting in stained ceiling tiles. (Ref: Photos AE-39-40)

AE-39: Interior of Cafeteria below typical lightwell where water leakage was identified, see next photo

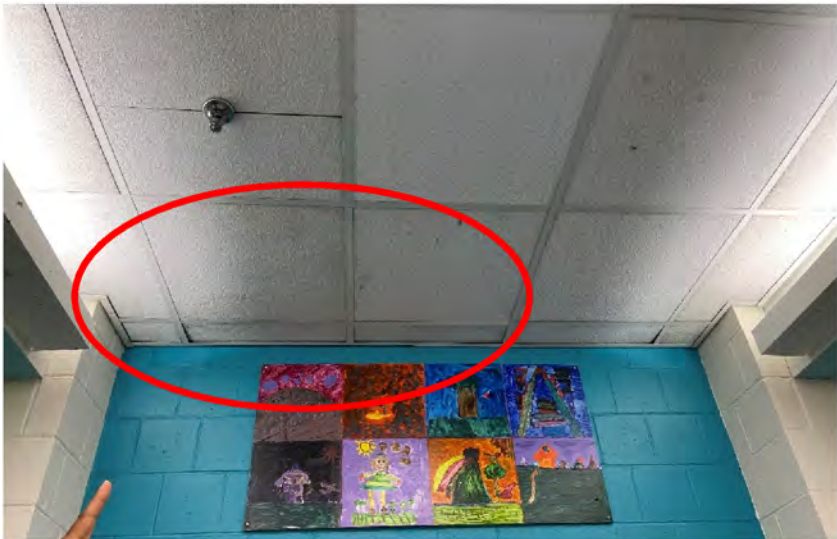
AE-40: Water damage on ceiling tiles due to leakage within Cafeteria
