# CAMBRIDGEPORT SCHOOL

## Facilities Condition Assessment : October 19, 2022

Facilities Condition Assessment, Capacity Analysis and Master Plan for CPS

# 7.3 | CAMBRIDGEPORT SCHOOL BUILDING APPENDIX

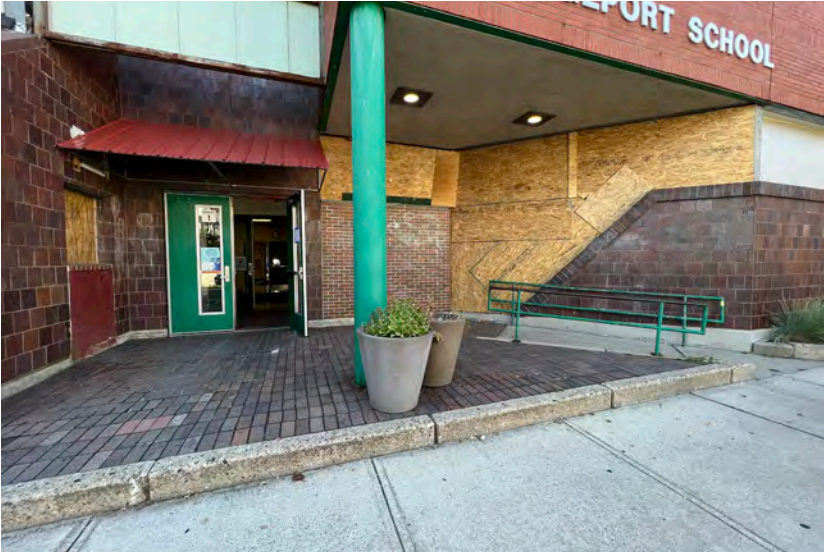
Front Entrance

Cambridgeport School is in a quiet residential area. The front of the school is located on the east side of the site, one step up from grade, bordering Elm Street. The main entry is recessed from the sidewalk and covered, a ramp for accessible entry is located here as well. The floor of the covered exterior space is lined with brick pavers and the ramp is concrete, all in fair condition.

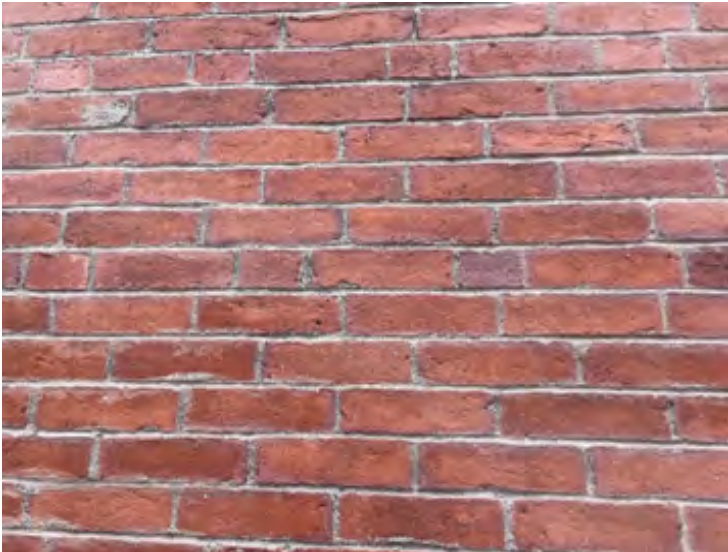
AE-A: Representative multiwythe brick masonry at South wing / original building

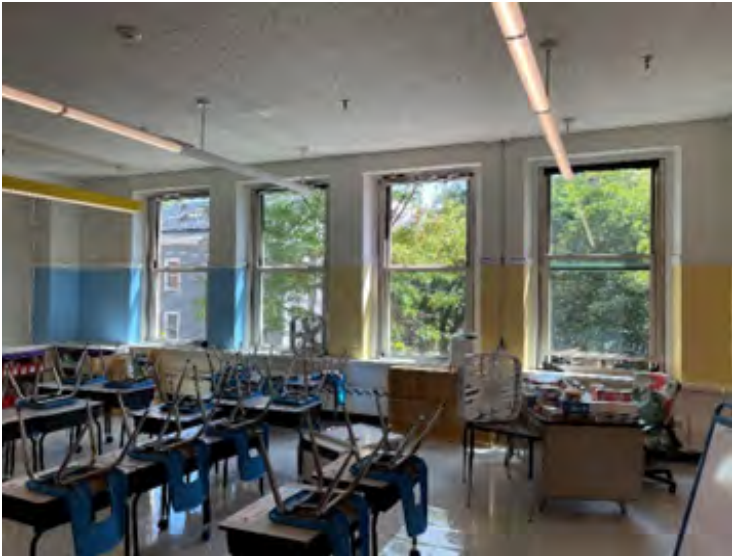
AE-C: Interior of representative classroom with new windows.

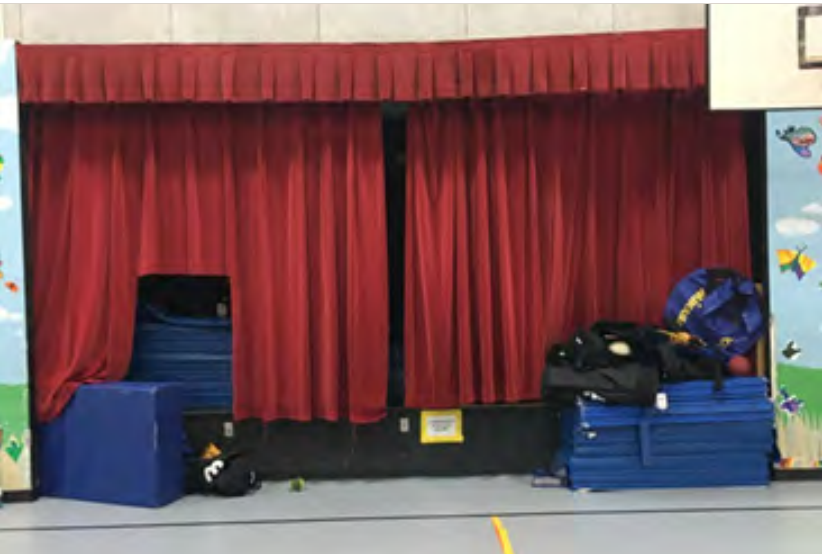
Main Curtain with Damage

All drapery tracks and hardware should be inspected and replaced or maintained as needed.

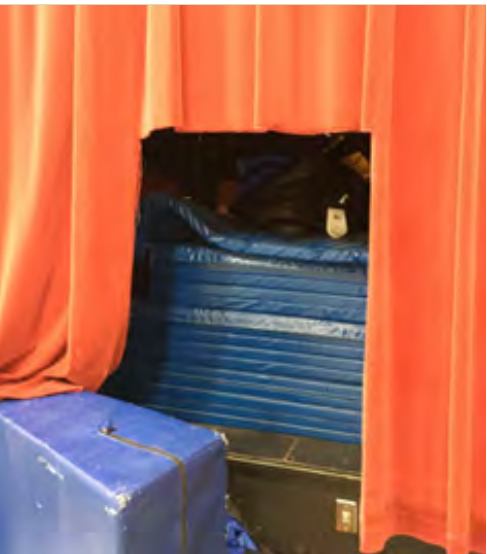
Detail of Curtain Damage

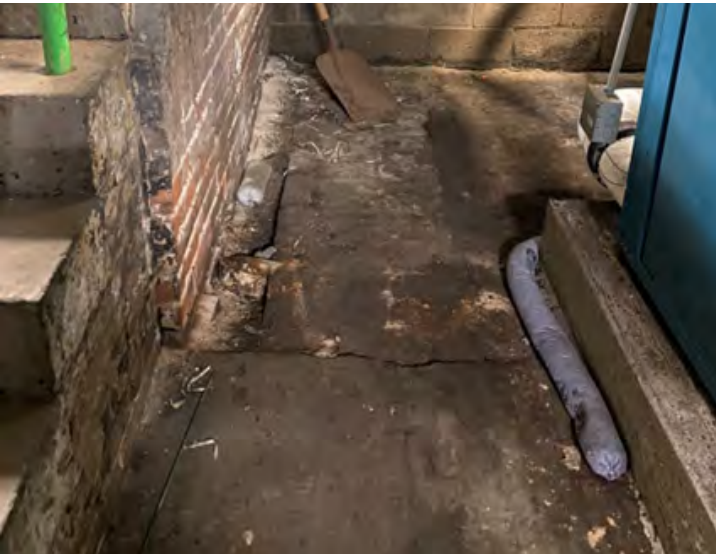
Photo ST-1: Cracks and Moisture in the Slab on Grade at the Mechanical Basement

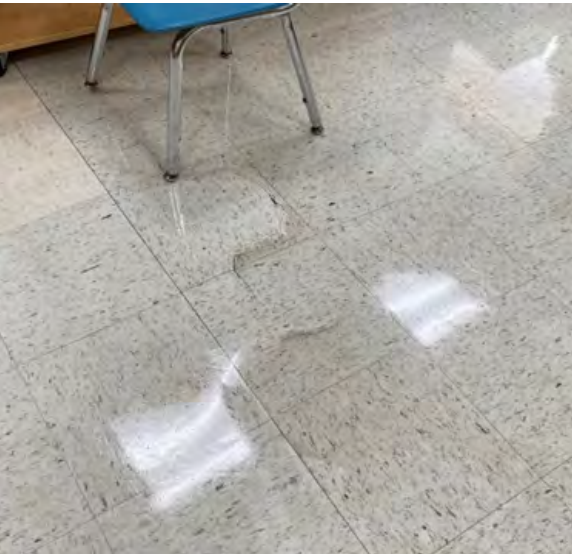
Photo ST-2: Uneven Floor at OT/PT Room

| ARCHITECTURAL - EXTERIOR | CONDITION | PRIORITY |
|---|---|---|
| <ul style="list-style-type: none"><li>Investigate and repair cracks and uneven flooring at OT/PT room slab on grade.</li></ul> | D | 2 |

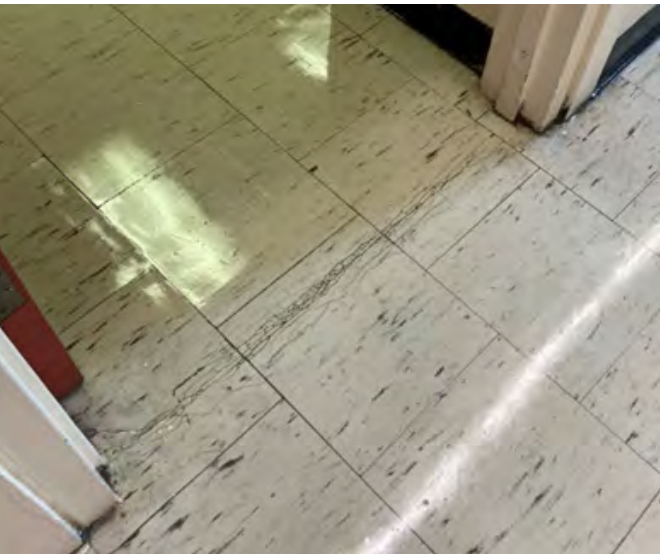
There are several cracks in the floor tiles at the upper floors, mainly occurring at door thresholds. These are likely due to shrinkage of the floor slab/framing and are not a structural concern. However, these conditions should be remediated for potential tripping hazards. Refer to Photo ST-3.

Photo ST-3: Cracks in Floor Tiles at Upper Floor

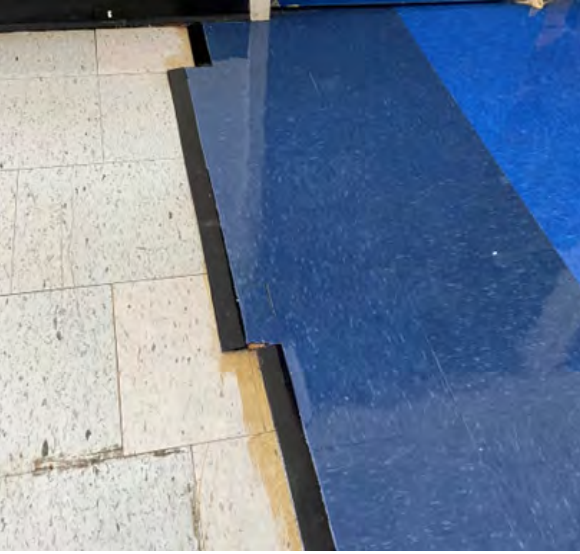
Photo ST-4: Added Floor Tiles at Differential Floor Elevations in Classroom

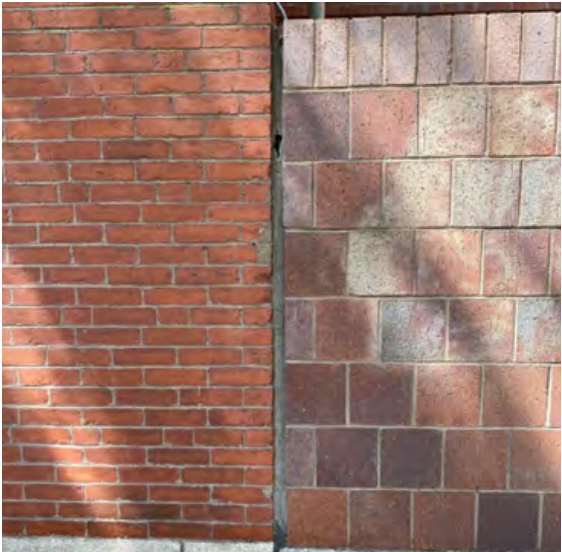
Photo ST-5: Deteriorated Caulking at Exterior

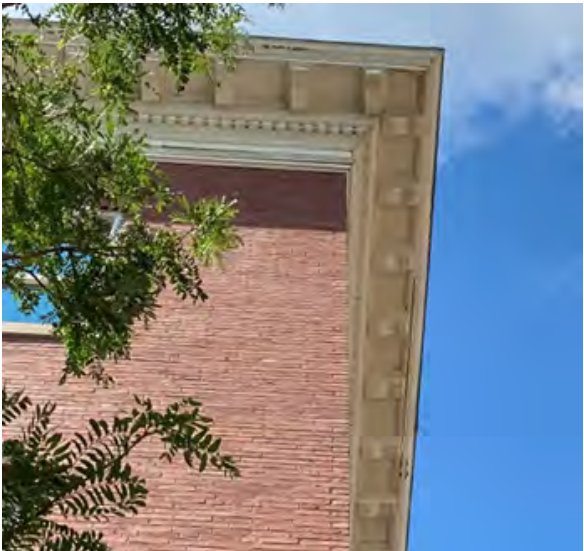
Photo ST-6: Deteriorated Roof Edge Fascia

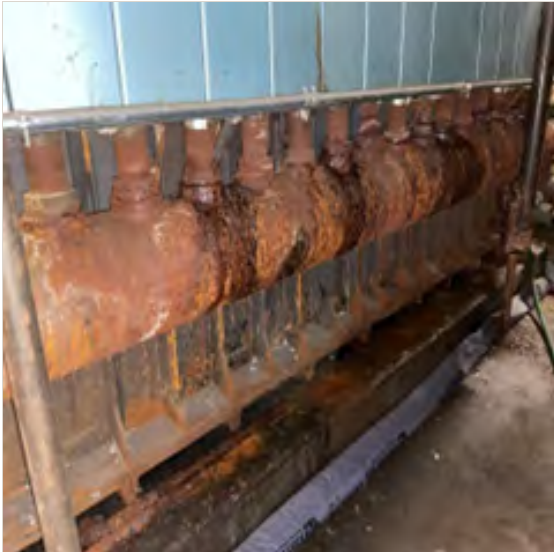
M-1: Vintage Boiler

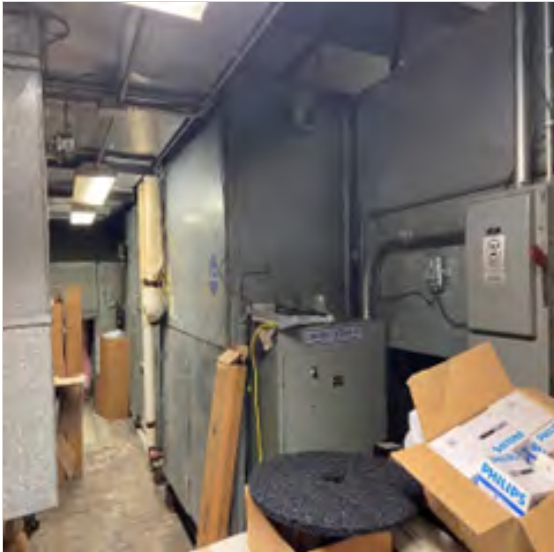
M-3: Vintage H&V Unit

Ductwork systems are also well beyond expected service life and should be considered for replacement along with equipment upgrades. Hot water piping system should also be considered for replacement along with equipment upgrades. A change-out of system type using heat pumps will require upgrade of the ductwork and piping systems.

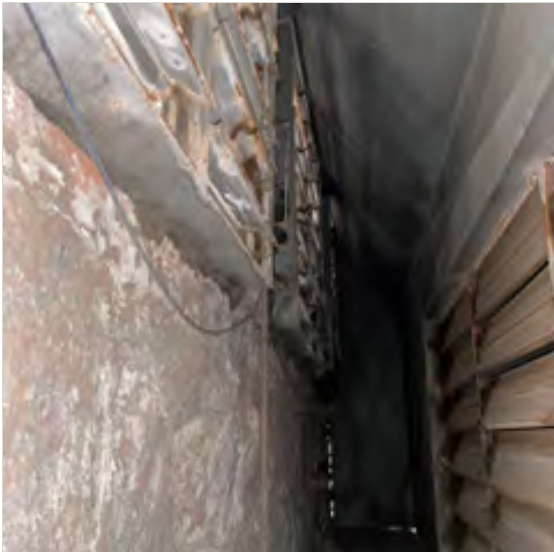
M-4: Corroded H&V Dampers

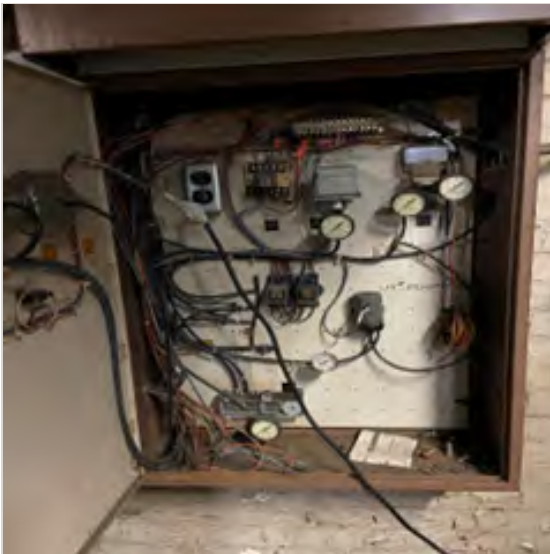
M-5: Pneumatic Control Panel

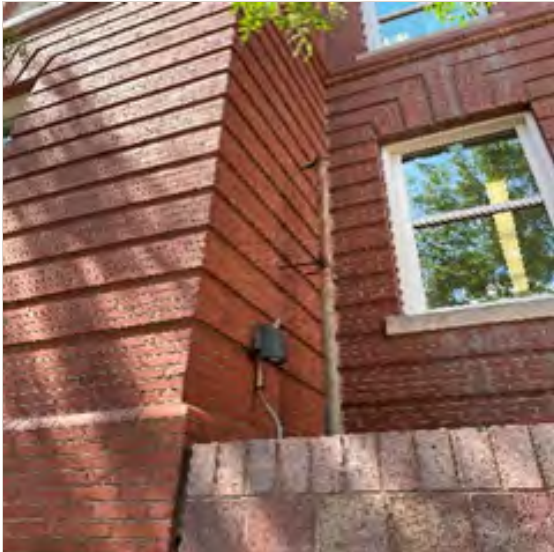
E-2: Generator Exhaust

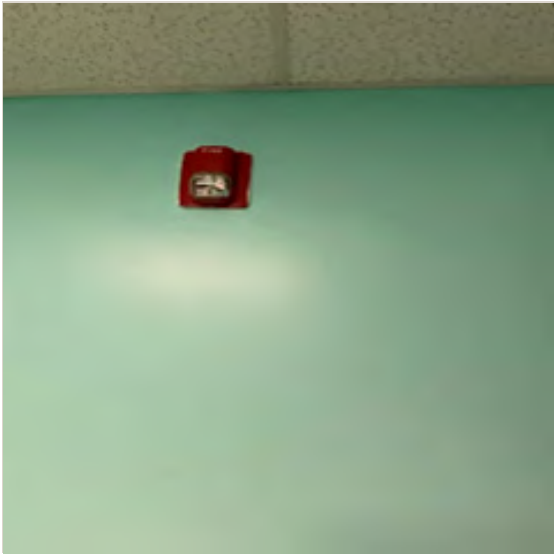
E-5: Existing Fire Alarm Device

Install carbon monoxide devices in alarms devices in every classroom where carbon emitting devices are located. Verify all devices are provided as required by 527 CMR, NFPA 72, 780 CMR, and the Mass Fire Alarm code (Missing pull stations, smoke detection not code compliant etc.)

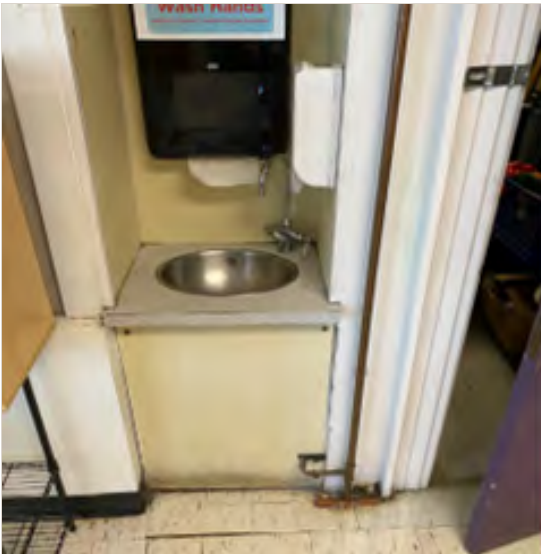
PL-1: Exposed uninsulated cold water at classroom sinks

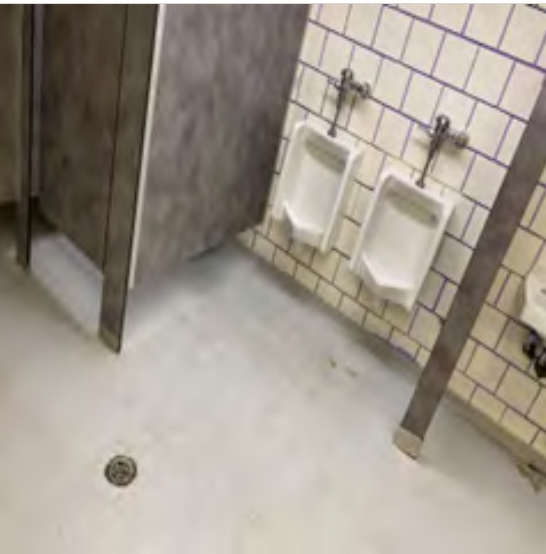
PL-2: Privacy shields should be provided

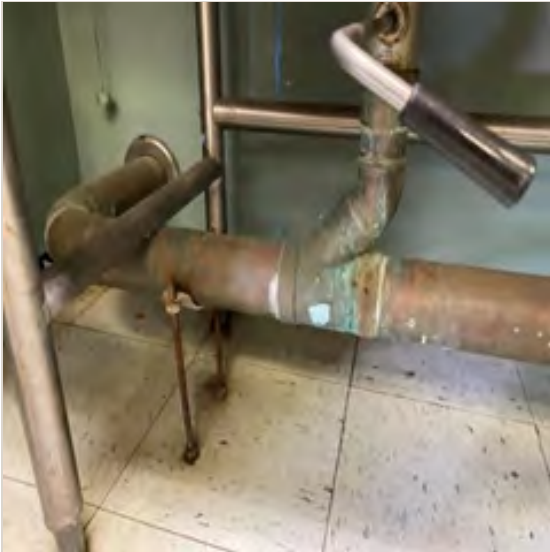
PL-5: Corroded Copper Waste Pipe

Remove existing under-slab piping which has exceeded its service life. Remove existing running trap located at the sanitary sewer exit in Classroom 01.

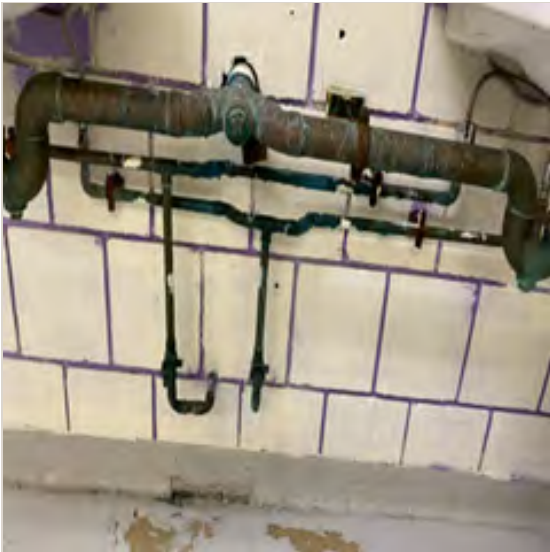
PL-6: Corroded Copper Domestic & Waste Pipe

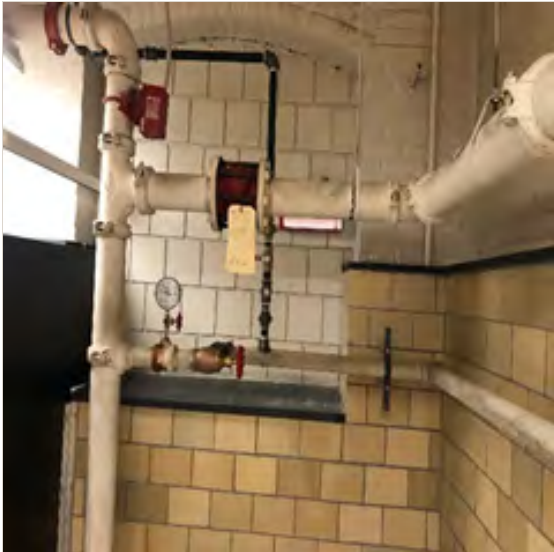
FP-1: Fire Service Entrance

*Recommendations*  
It is recommended the existing sprinkler system be maintained in conformance with the requirements of NFPA 25, Inspection, Testing and Maintenance of Water-Based Fire Protection Systems.  
Extend an automatic sprinkler system to the remainder of the building when required based on proposed building renovations.

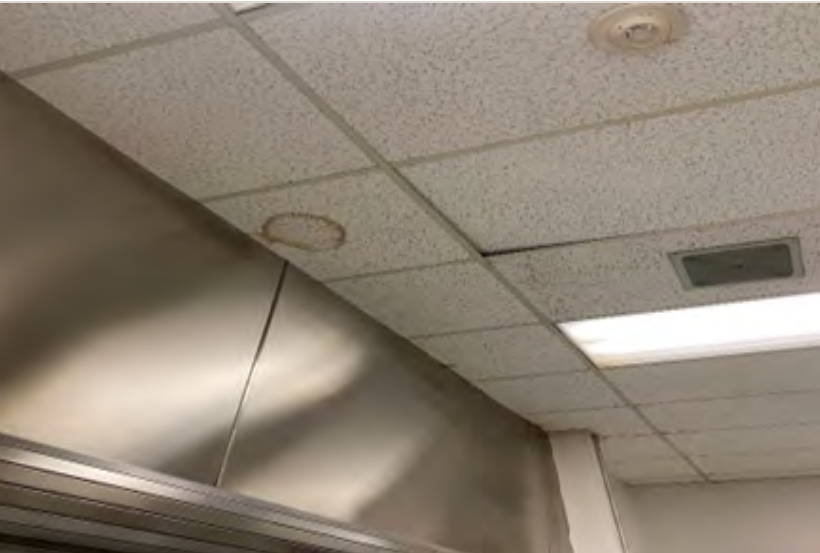
FS-1: The ceiling material in the kitchen space is not a smooth washable surface and shows significant signs of wear and tear and water damage. Ceilings for this kitchen should be updated to meet modern day food code

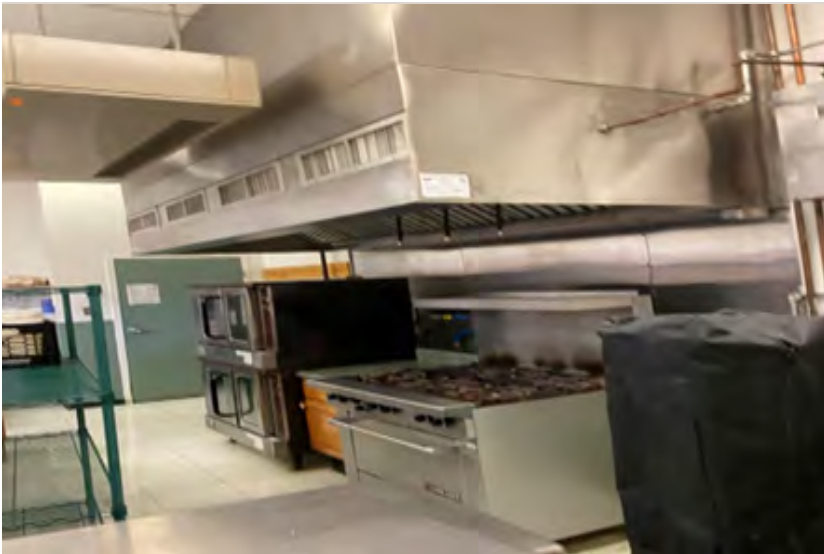
FS-2: Exhaust hood over the cooking equipment is extremely dated and original to the building. The grease filters are not nearly as efficient as the technology that’s available today and are more difficult to clean. There are several locations where utilities penetrate the hood which is not acceptable.

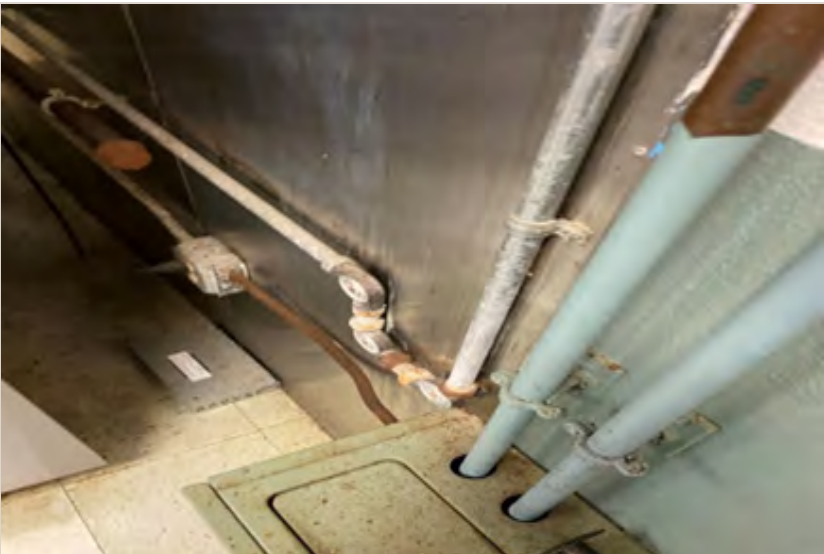
FS-3: Exposed utilities along the cook line building wall present cleanability issues and potential violations of the health code if not properly cleaned. Utilities should be provided within a furred-out wall in these circumstances for proper cleanability.

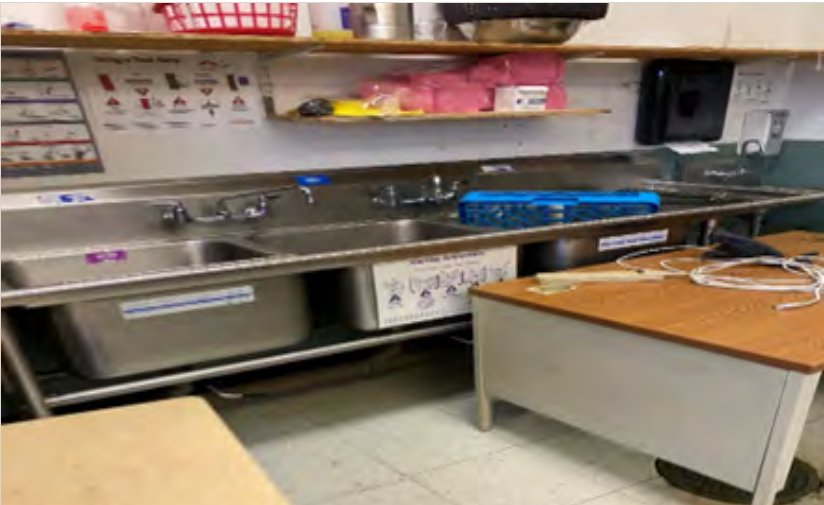
FS-4: Wood wall shelving is present as storage at the pot washing sink. Wood is not an acceptable storage material for storage especially in a wet area. NSF rated shelving systems must be used throughout commercial kitchens.

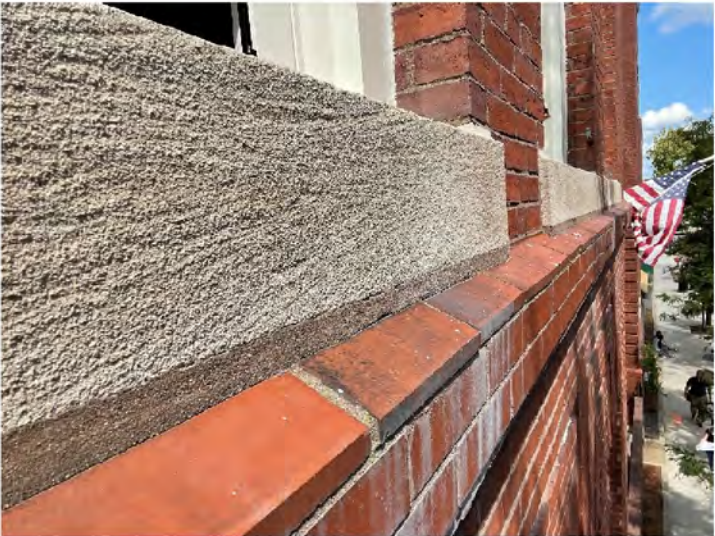
AE-14: Façade condition above bulge in masonry that has been repointed at East Elevation

Masonry:  
A scope of masonry cleaning and repointing should be undertaken in areas of step cracked brick to extend the service life of the masonry and to reduce potential for further issues.

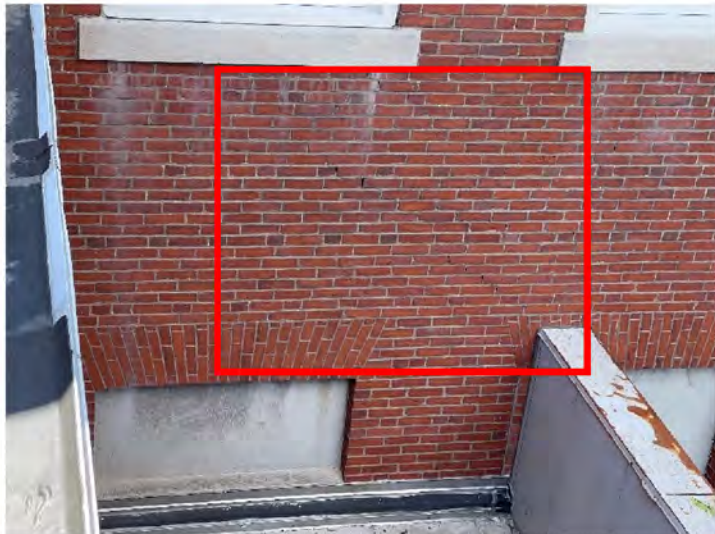
AE-11: Step cracking of brick at West Elevation, North return above roof deck, see next photo

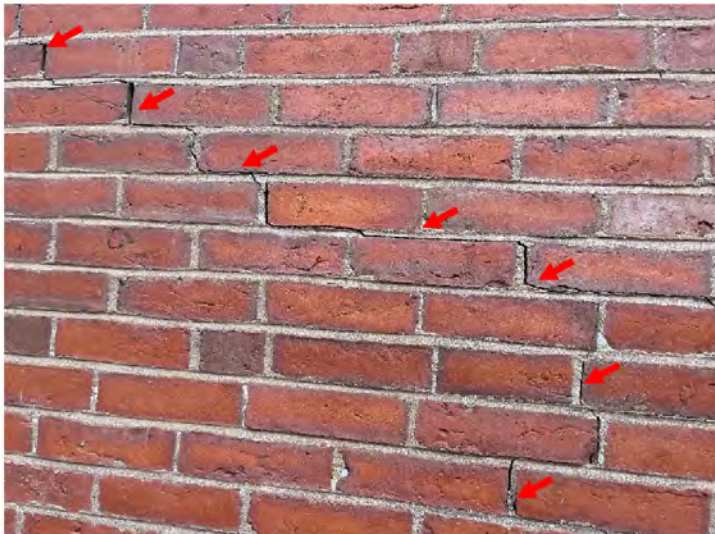
AE-12: Step cracking of brick at West Elevation

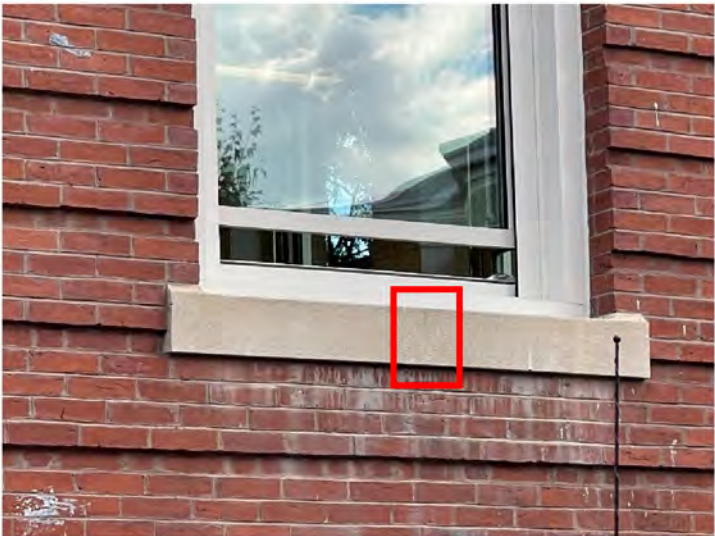
Isolated cracking of the limestone sills is evident at a few locations such as on the South Elevation. (Ref: Photos AE-15-17) Masonry control joint sealants at the North wing have reached the end of their expected service life. (Ref: Photo AE-19)

AE-15: Representative cracking limestone at South Elevation

Repair of cracked limestone sills is also recommended.

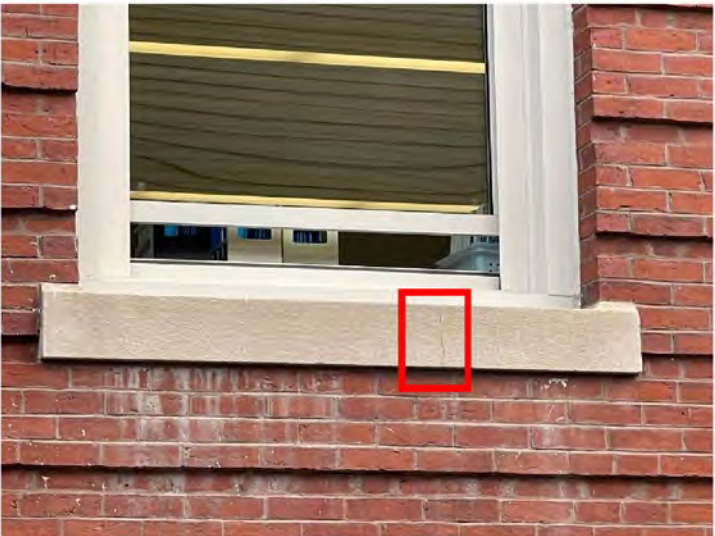
AE-16: Representative cracking limestone at South Elevation

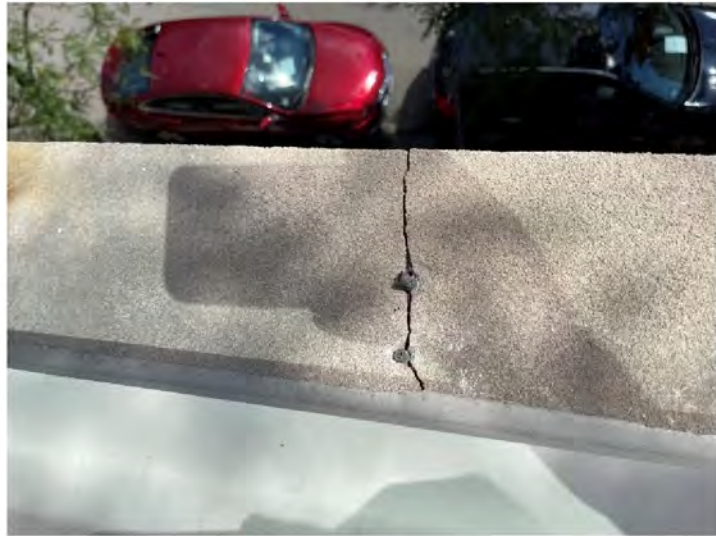
AE-17: Typical cracked limestone as viewed from above at Room 201

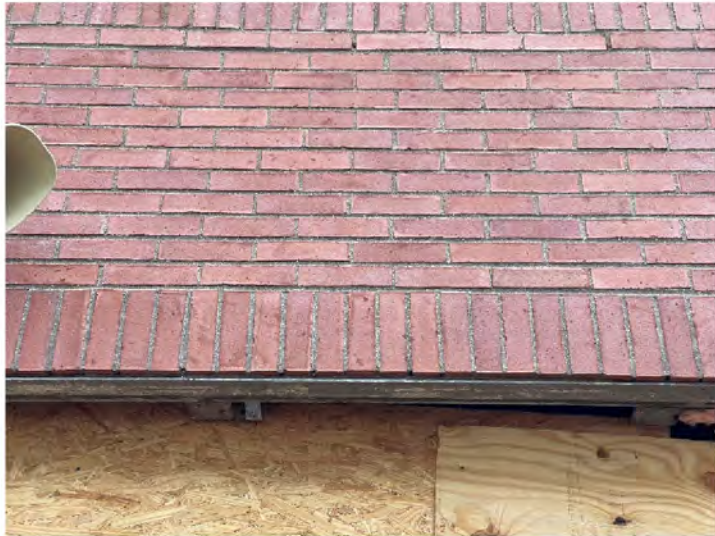
AE-18: Representative brick veneer at North wing addition

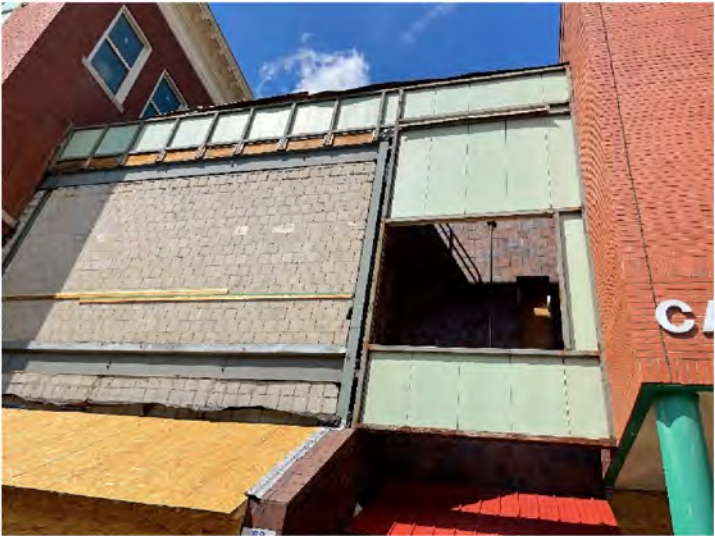
AE-22: Area on East Elevation where existing insulated metal panels have been removed, will be replaced.

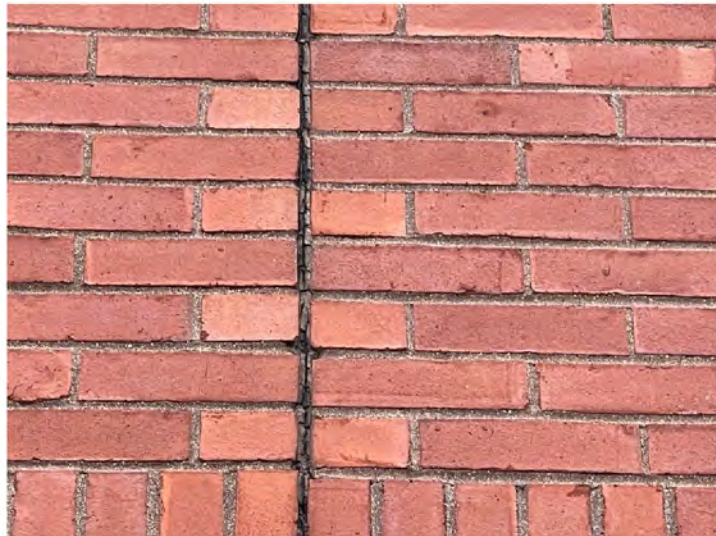
AE-19: Representative failed control joint sealant at masonry façade at North wing addition

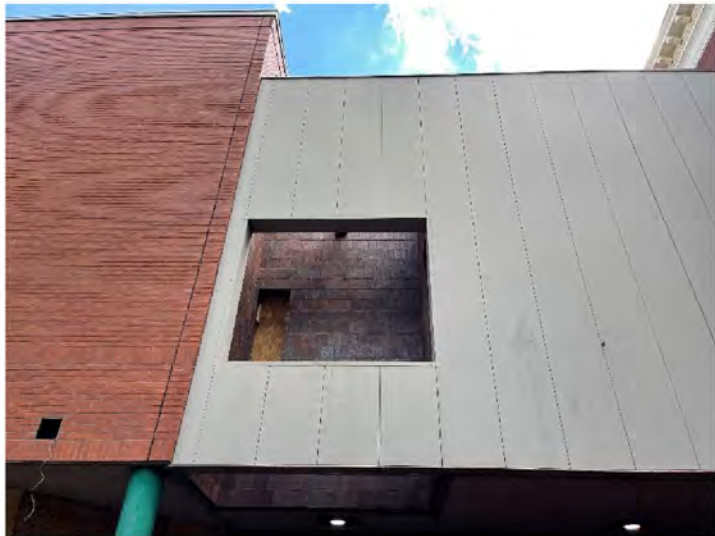
AE-20: Typical insulated metal panel façade along East Elevation of South wing

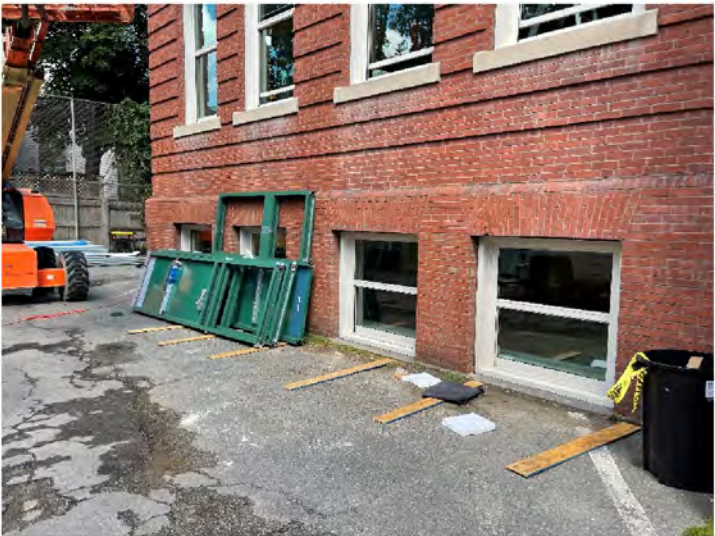
AE-24: Representative thermally broken aluminum storefront entrance stored on site, prior to installation

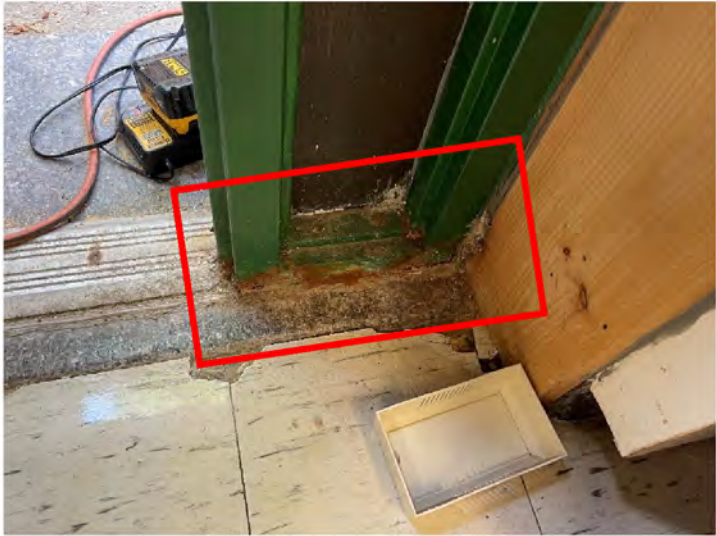
AE-25: Interior of typical hollow metal door assembly. Note rusting on base of frame.

Windows and Doors:  
The replacement of hollow metal doors and frames is recommended if they have not been replaced as part of the current renovation project.

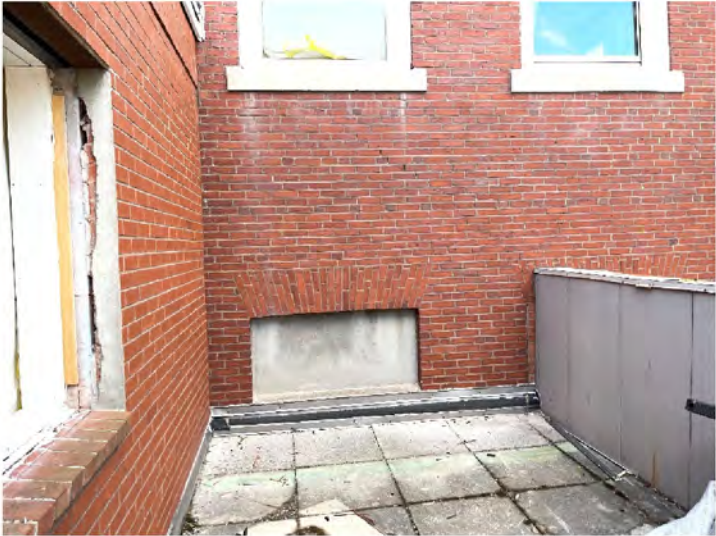
AE-26: West roof deck, covered with pavers

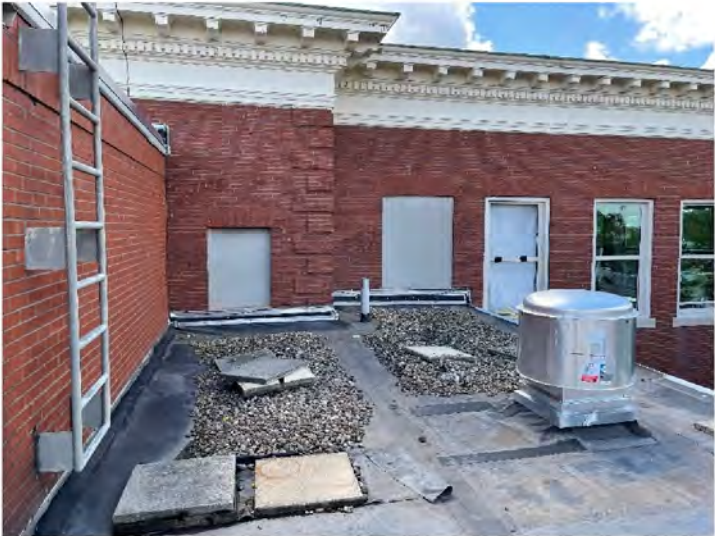
The low sloped roofs at the North wing addition are surfaced with loose laid EPDM covered with stone ballast. (Ref: Photos AE-29-33) Some of the stone ballast has been moved around the roof to expose the EPDM presumably to identify and repair sources of roof leakage. Isolated EPDM field repair patches are visible at various locations throughout the roof, with some failing lap sealants. Some areas of the EPDM appear to be secured to the face of the masonry façade with lap sealant and lacked mechanical means of termination. (Ref: Photo AE-33) The extent of insulation (if any) or other existing roofing systems below the EPDM is unknown.

AE-29: Mid-level roof at West side of North wing. Ballast has been moved around, exposing loose laid EPDM.

Roofing:  
Replacement of all existing roofing systems is recommended. The roof has exceeded its expected service life and should be replaced with a new roofing system with Code compliant insulation and means of secondary drainage. Preparation for re-roofing should include investigation of leak sources at various areas of the building. A scope of repair work based on the results of the leak evaluation should be executed.

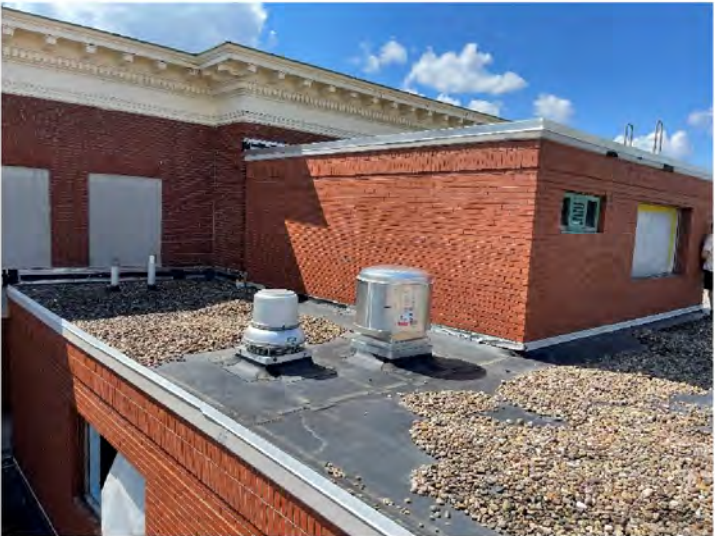
AE-30: Mid-level roof at East side of North wing.

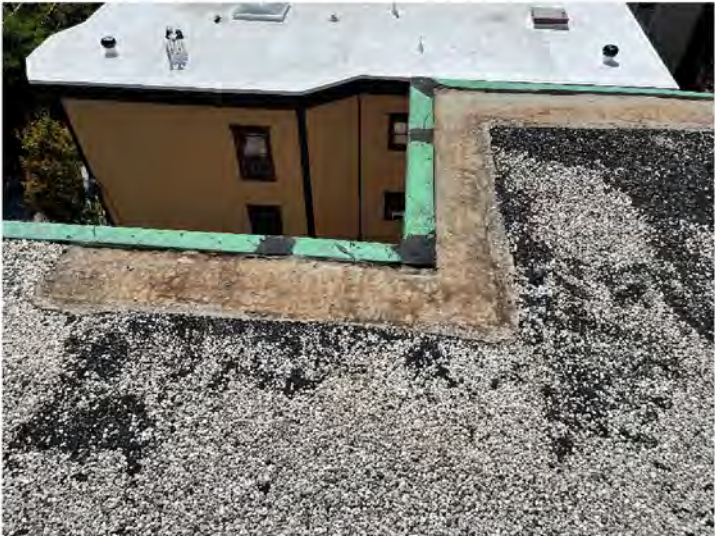
The tar and gravel roof of the South wing appears original to the building. There is evidence of previous repairs to the tar and gravel with use of asphalt in several areas. A wood cornice surrounds the base of this roof and has peeling paint. (Ref: Photo AE-39)

AE-37: Typical tar and gravel repairs along roof edge at South roof

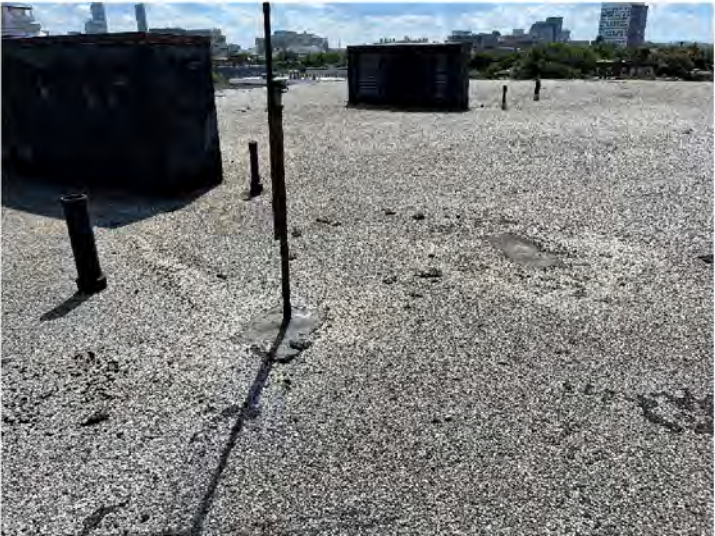
AE-38: Typical penetrations within South roof

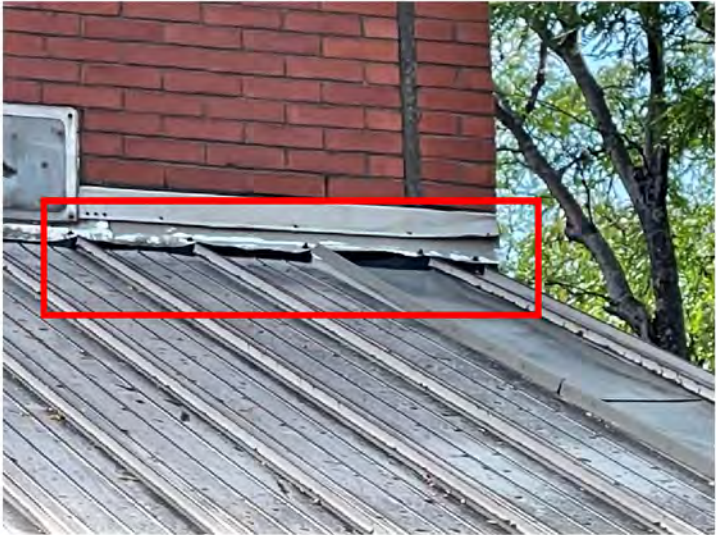
AE-41: Termination of metal roofing at masonry façade on North Elevation. Daylight and drip staining visible on interior in this area.

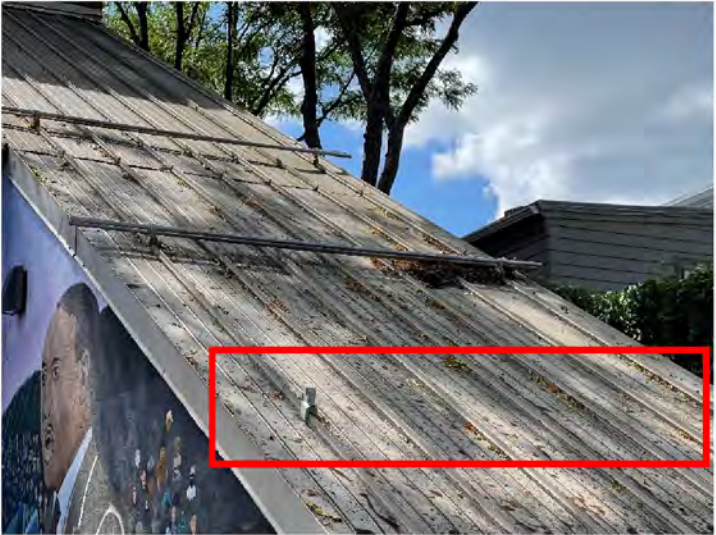
AE-42: Missing snow rail at metal roofing on North Elevation

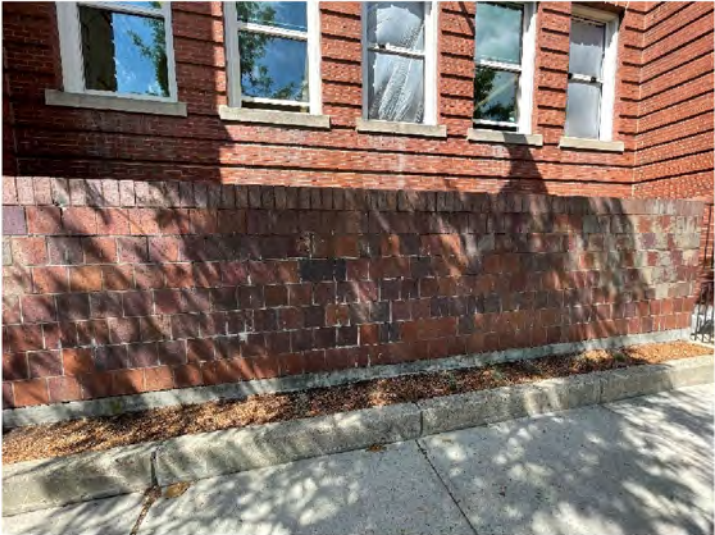
AE-45: Masonry screen wall on East Elevation. Some crazing and efflorescence observed within masonry.

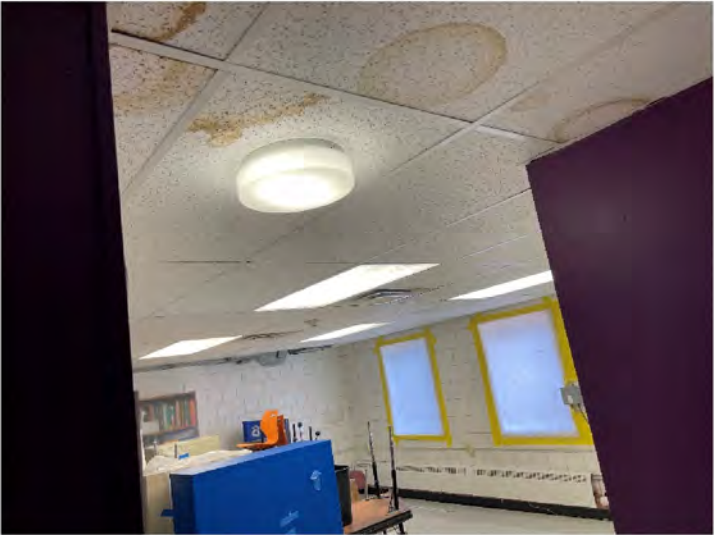
Reported Envelope Issues:  
While on site, discussions were held with facilities personnel to identify any building exterior-related issues that may exist. Those present were shown interior locations of recurrent water leakage that are believed to be related to roofing deficiencies. Roof leaks evidenced by stained ceiling tiles are present in Rooms 301 and 302, as well as within the Main corridor on the third floor. (Ref: Photos AE-46-47)

AE-46: Stained ceiling tiles due to roof leakage within Room 301

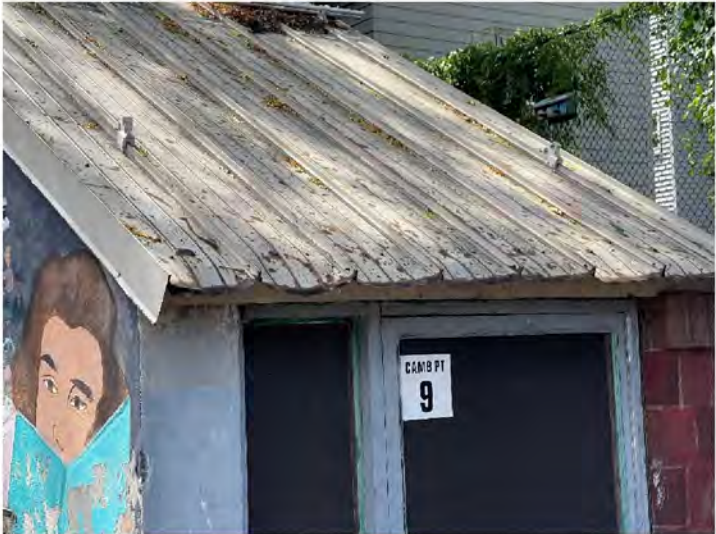
AE-43: Damaged metal roofing at eave of North Elevation entrance.

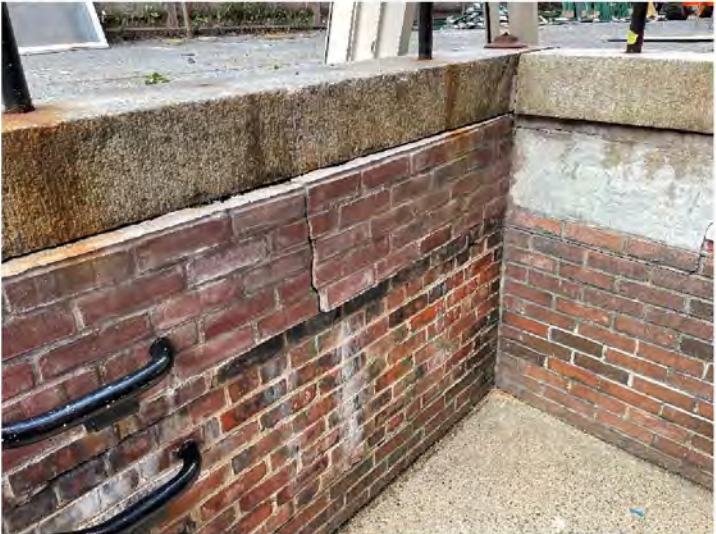
AE-44: Representative displaced and cracked brick at lower level building entrance on West Elevation

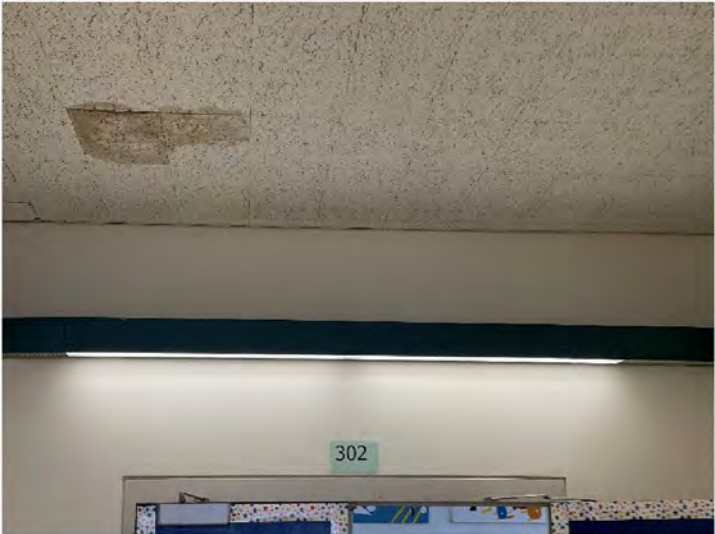
AE-47: Stained ceiling tiles due to roof leakage within Corridor outside Room 302

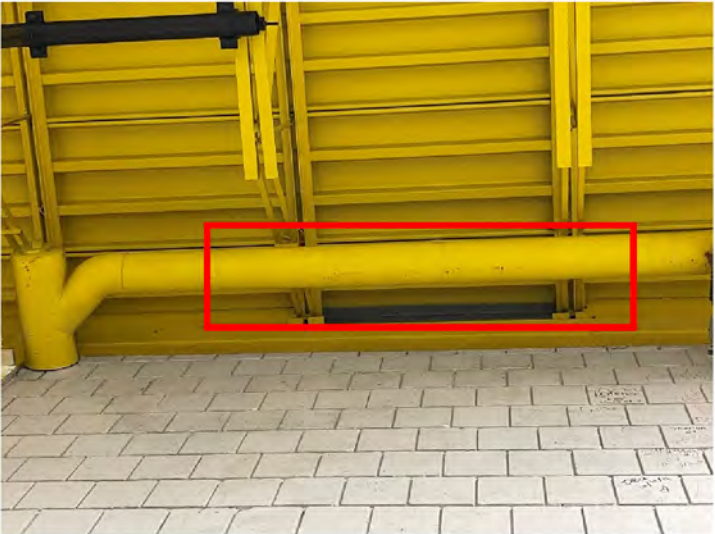
There are multiple leaks in the Gymnasium, including at middle of the gym and above the stage below the transition from metal roofing to masonry on the exterior. BEA observed drip stains and daylight appears to be visible on the interior at this transition. (Ref: Photos AE-48-52)

AE-48: Drip staining on exposed piping within Gymnasium due to roof leakage

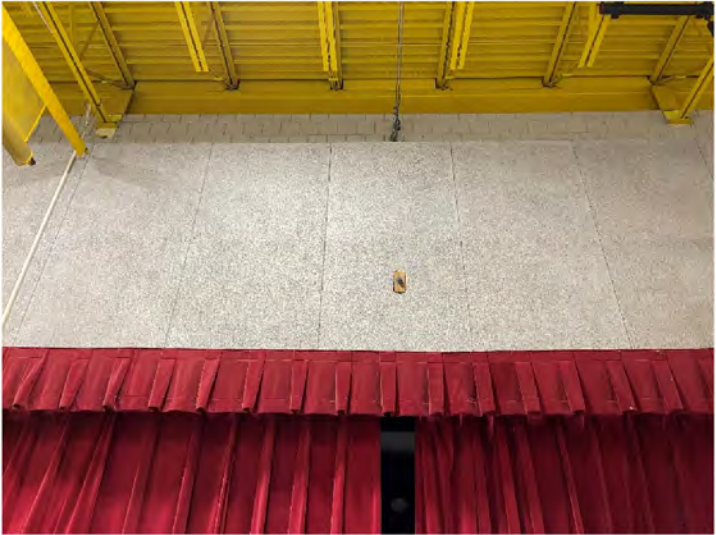
AE-49: North elevation within Gymnasium where leakage occurs at Stage

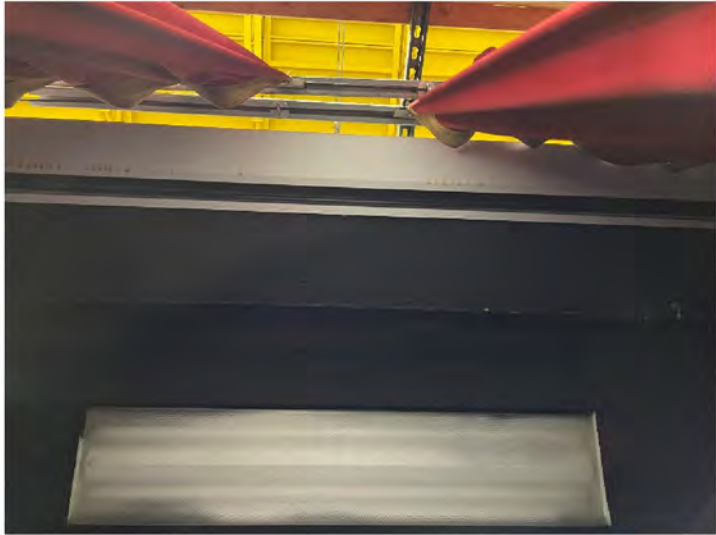
AE-50: Drip stains behind stage curtains due to roof leakage at Gymnasium

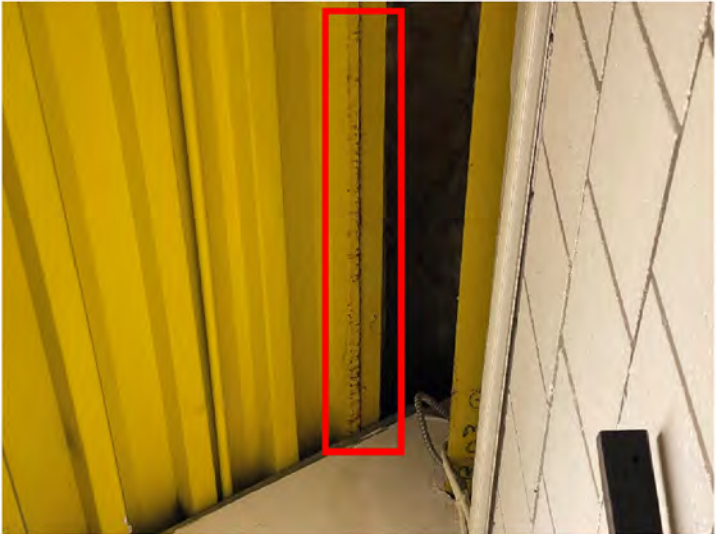
AE-51: Interior view at intersection of metal roofing and masonry façade within Stage area at Gymnasium. Water drip staining and surface rusting observed.

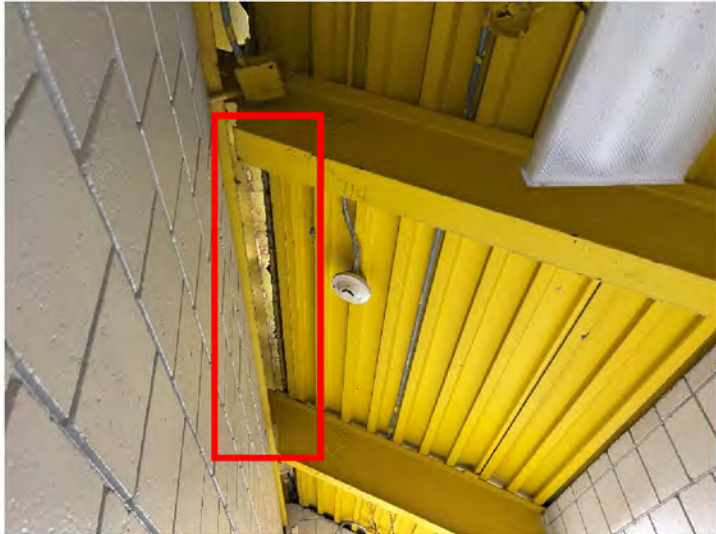
AE-52: Interior view at intersection of metal roofing and masonry façade within Stage area at Gymnasium. Daylight visible between these assemblies.
