# HAGGERTY SCHOOL

110 Cushing Street  
Cambridge, MA 02138

## Facilities Condition Assessment : October 14, 2022

# 7.6 | HAGGERTY SCHOOL BUILDING APPENDIX

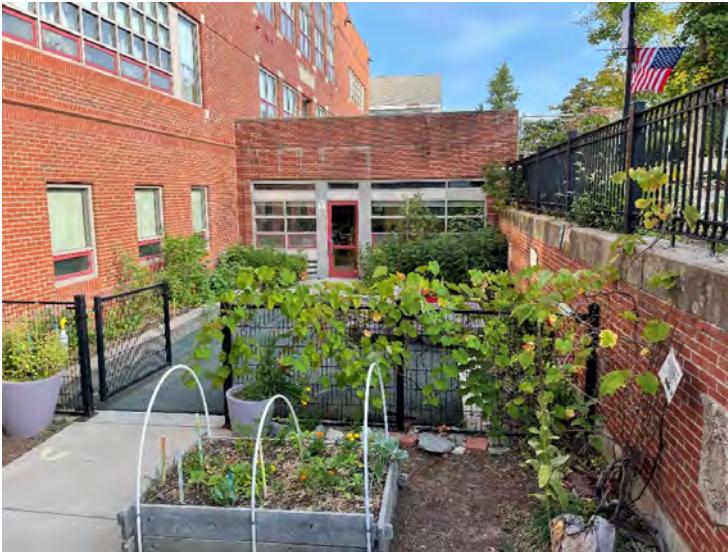
At the West Wing and East Classrooms below the Main Entrance, the brick façade is considered in fair to poor condition, with efflorescence present on the brick in most of these areas, indicative of excess moisture penetration. The relieving angle supporting this brick is exposed on the exterior of the façade as well on the interior of the classrooms. Water leakage is a recurrent issue on the interior side of these masonry walls. Efflorescence, peeling paint and damage to the drywall and storefront assemblies below the relieving angles was evident in all six (6) classrooms located in these areas. (Ref: Photos AE-10-14)

AE-A: East classroom wing below Main Entrance sidewalk

Masonry:  
Review of the as-built detailing of the masonry facades at the West Wing and the East Classrooms below the Entrance sidewalk is recommended in conjunction with exploratory demolition to confirm how these assemblies were built, particularly the throughwall flashings and coping caps. Active leakage in these areas appears to consistently appear along the throughwall flashings on the interior and it is possible that masonry removal and reconstruction of these assemblies may be needed, depending on the as-built conditions and deficiencies discovered. It is also possible that the water leakage observed below the sloped glazing in the West Wing Corridor is associated with a masonry issue.

A potential short term repair to address the leakage in these areas could include cleaning the masonry, replacing the façade sealants and coating the masonry with a breathable coating to reduce the amount of moisture that is able to penetrate the brick façade, thus reducing the reliance on defective flashings.

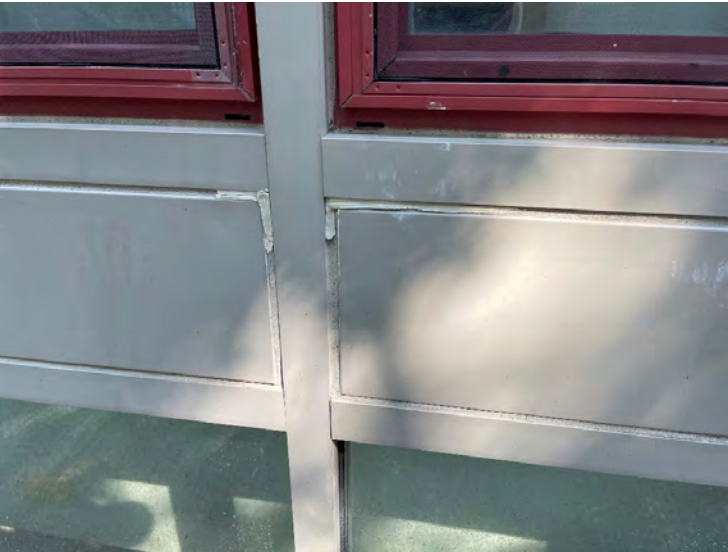
The windows and storefront consist of aluminum thermally broken frames with fixed and awning components with insulated glazing. The fenestration assemblies appear to be in good condition overall, with exception for some of the storefront at the West Wing which exhibit failing glazing gaskets and layers of sealant previously applied over the glazing gaskets and spandrel panels. (Ref: Photos AE-21-22, 24-26)

AE-C: Typical storefront spandrel panels with added sealants

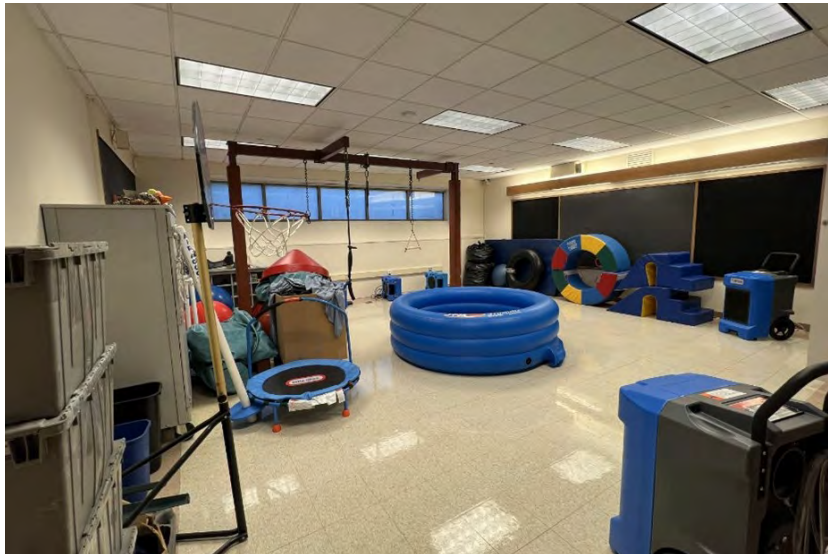
Sensory Room - Basement (Water Damage)

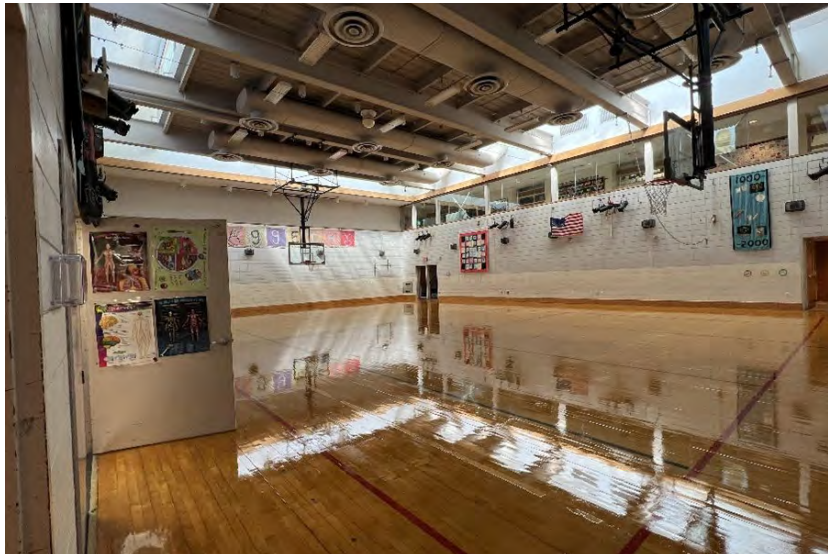
Floors:  
All bathroom floors have ceramic tile and are in good condition. The gym has a wood floor which appears to be in good condition however, it does have some significant gapping which might be evidence of changes in moisture content over time. The remainder of the school has VCT floors. These are predominantly in good condition with about one third of them being in adequate to marginal condition. Those rooms on the lower end are typically service or storage rooms which appear to be getting less annual maintenance and limited cleaning/ upkeep.

Gym (Wood floor gaps)

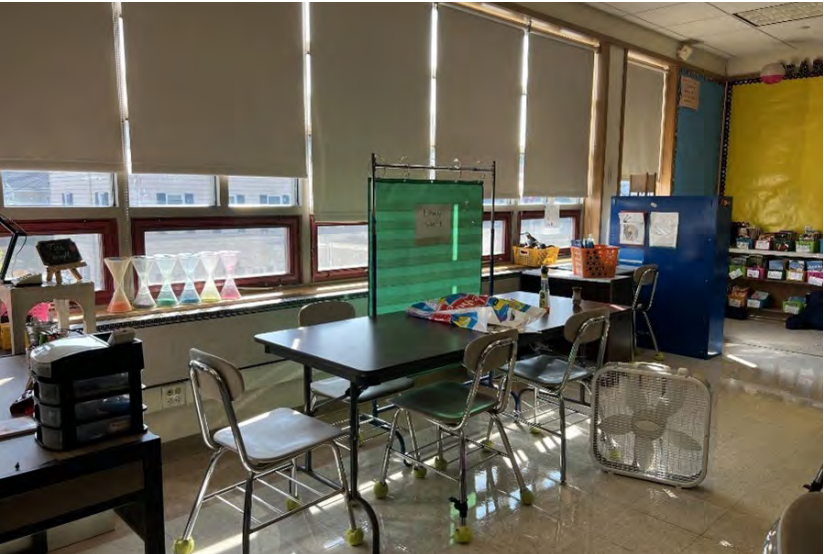
Third Floor Classroom (mold possible)

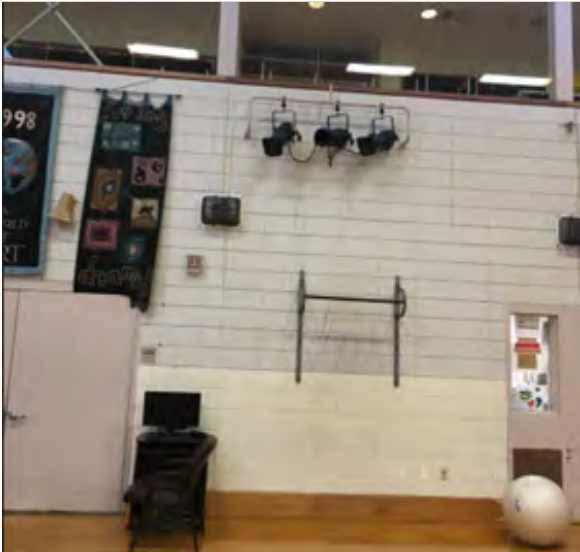
Existing Theatrical Lighting Position and Fixtures

Theatrical Lighting:  
This system should be upgraded. LED theatrical fixtures should replace existing incandescent fixtures. New control infrastructure, control rack, and user interface should be installed. Existing power infrastructure may be reused but dimming equipment should be removed and existing panelboards should be replaced with theatrical lighting relay panels.

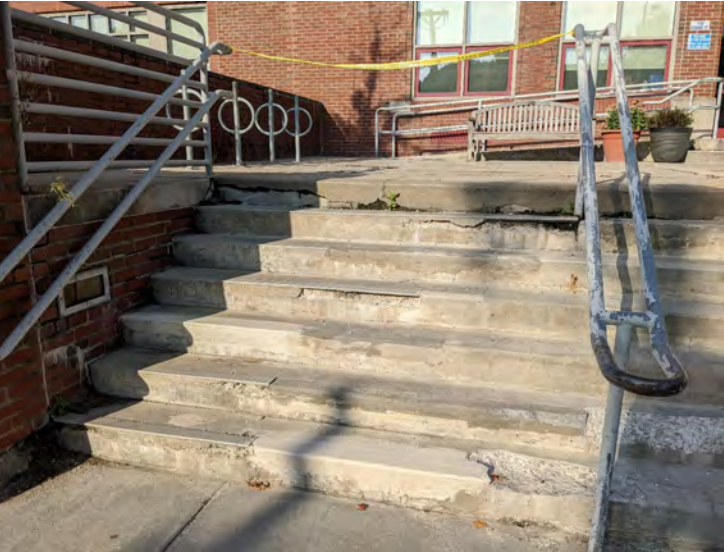
Photo ST-1: Spalling Concrete at Site Stair

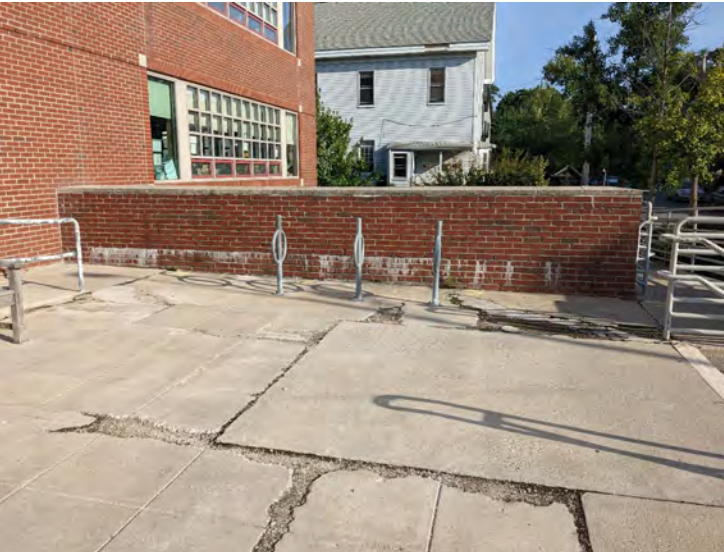
Photo ST-2: Deteriorating Site Paving

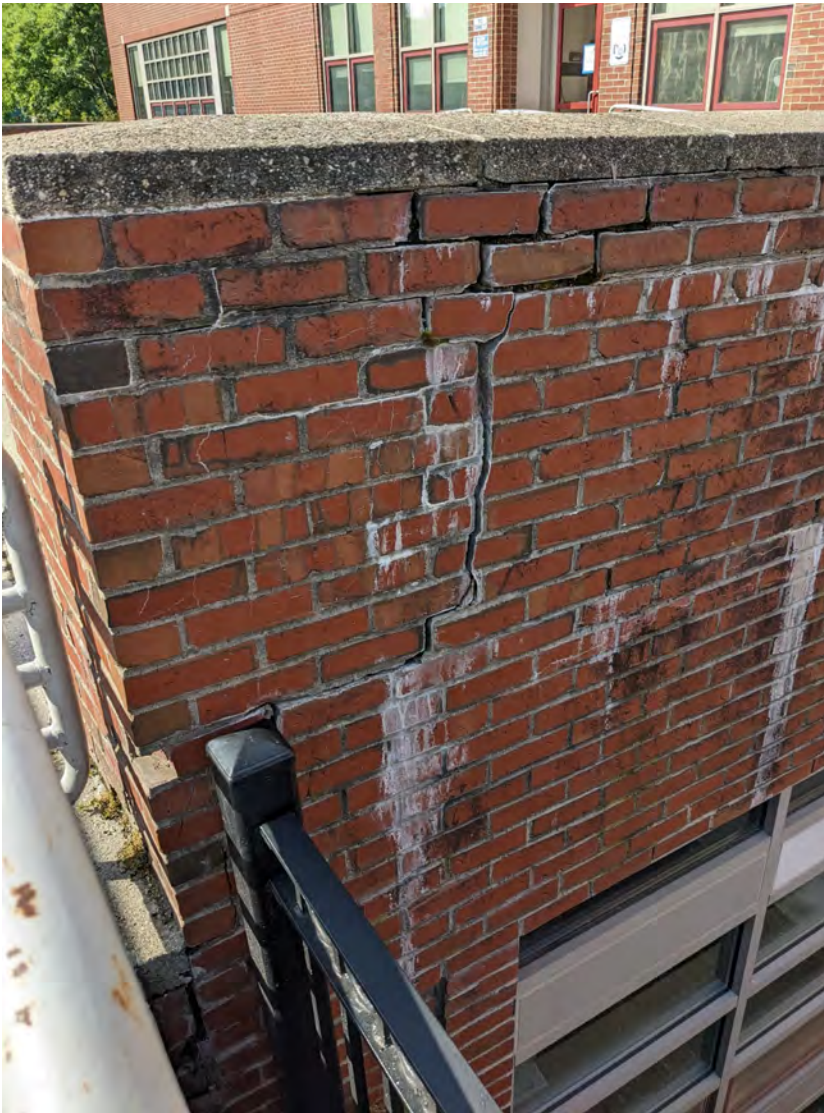
Photo ST-3: Cracked Masonry at Site Wall

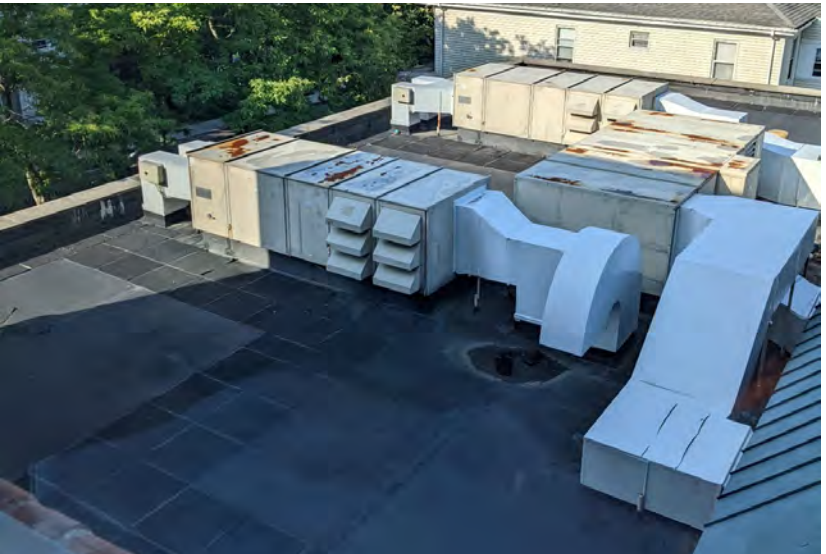
Photo ST-4: Ponding Water

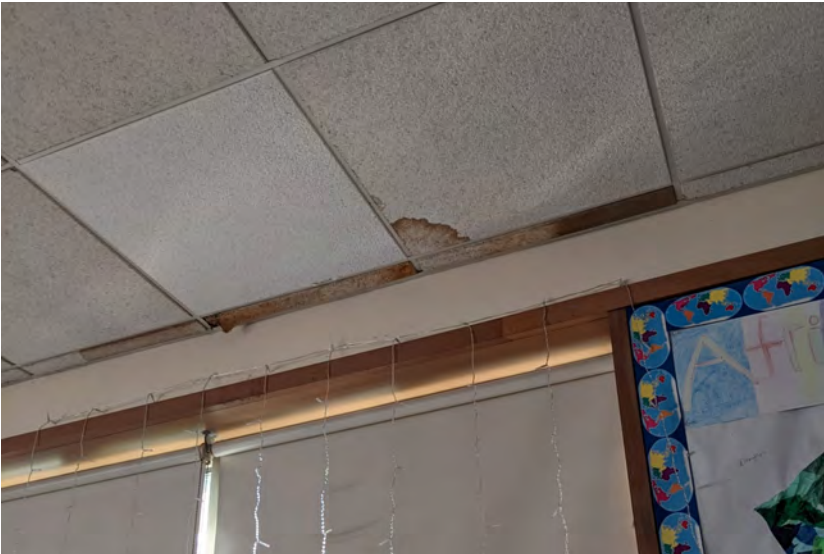
Photo ST-6: Water-Stained Ceiling Tiles

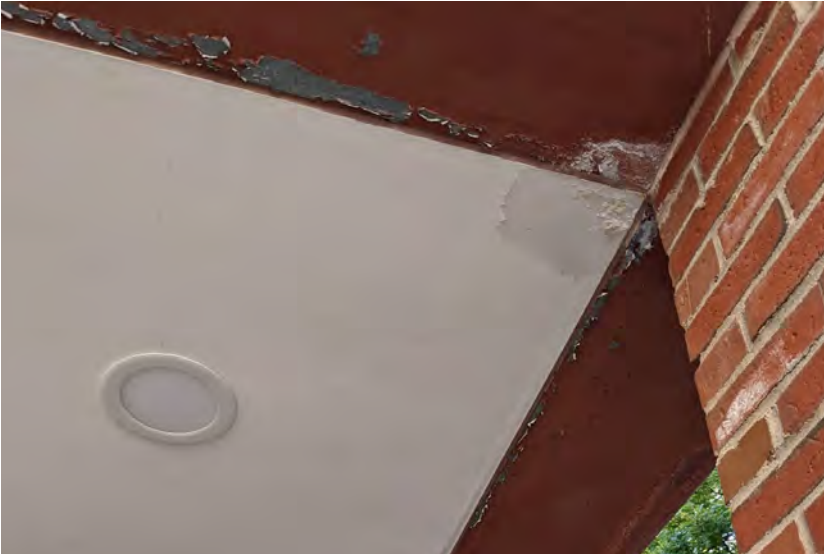
Photo ST-8: Peeling Paint at Exterior Soffit

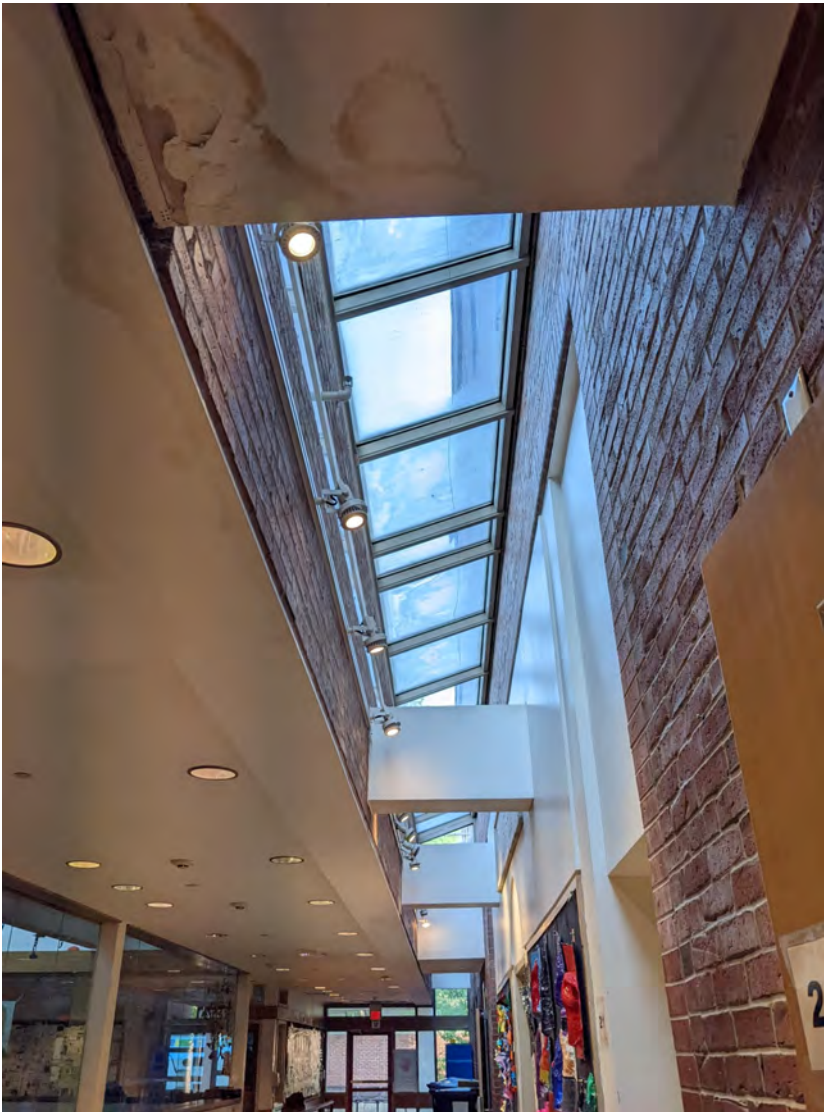
Photo ST-7: Evidence of Water Infiltration in Ceiling Finishes

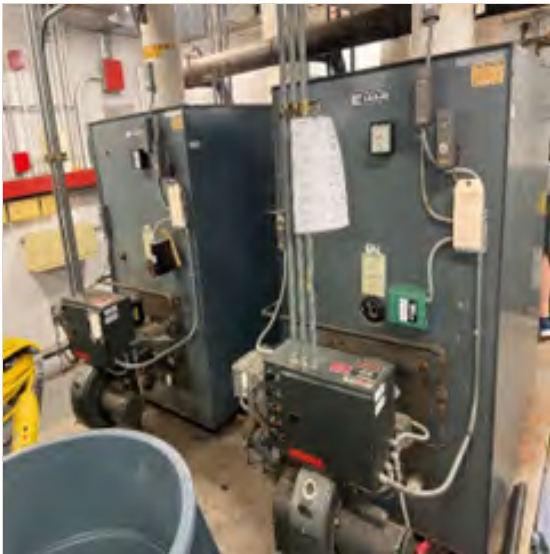
M-1: Original Cast-Iron Boilers

*Recommendations*  
Heating system equipment is at or beyond expected service life and should be considered for replacement in the short-term. Life expectancy is 30-years for cast-iron boilers and 20-years for pumps and accessories. Dual temperature piping system should be considered for replacement along with equipment upgrades as service life is variable and dependent on system tightness, isolation of dissimilar metals and water treatment program. At a minimum, piping systems should be inspected if intended to be re-used as part of equipment upgrades.

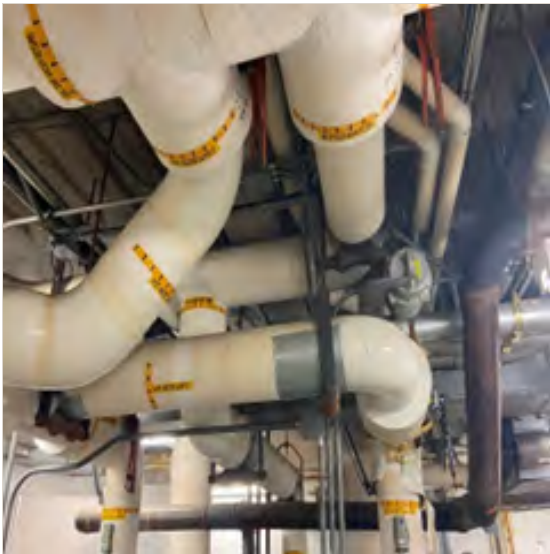
M-3: Original Dual Temperature Piping and Valving

*Recommendations*  
The chillers appear in excellent condition and have 15-years' service life remaining. Other components of the dual temperature system are at or beyond expected service life and should be considered for replacement in the short-term (see heating system description). Dual temperature piping systems should be considered for replacement along with equipment upgrades (see heating system description).

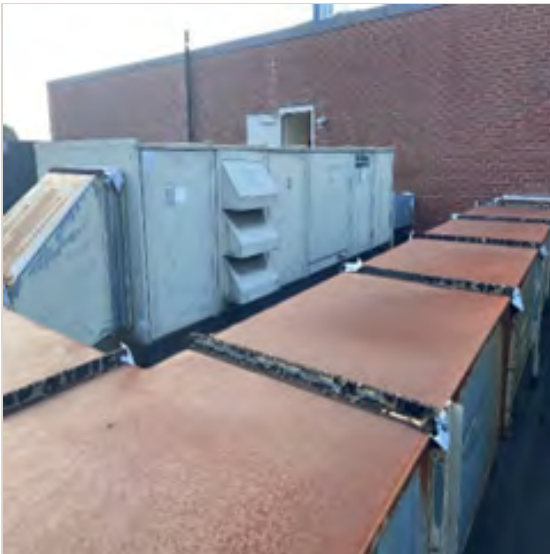
M-5: Rooftop Air Handling Unit and Ductwork

*Recommendations*  
Most of the ventilation and air conditioning equipment is beyond expected service life and should be considered for replacement in the short-term. Life expectancy is 15-years for rooftop units and 20-years for unit ventilators, fan coil units, and roof mounted exhaust fans. Ductwork systems are approaching the end of expected service life of 30-years and should be considered for replacement along with equipment upgrades. Dual temperature piping systems should be considered for replacement along with equipment upgrades (see heating system description).

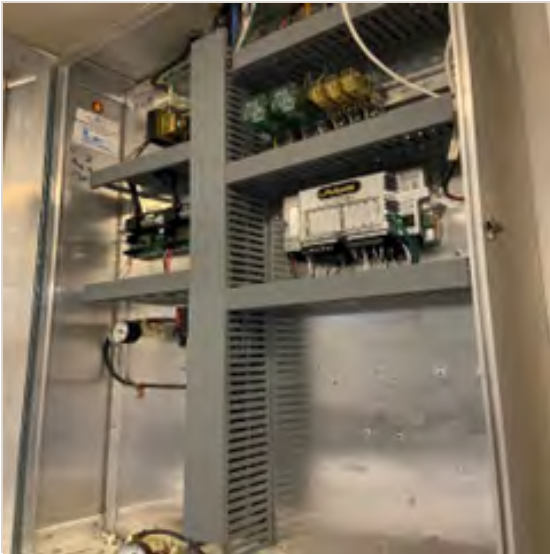
M-7: Original DDC Controller with Pneumatics

*Recommendations*  
Most of the building automation system is beyond expected service life and should be replaced concurrent with equipment replacements. Life expectancy is 20-years for pneumatic systems and 15-years for electric/electronic systems. Replacement systems should include a complete system of DDC controllers, sensors, actuators, and head-end graphics.

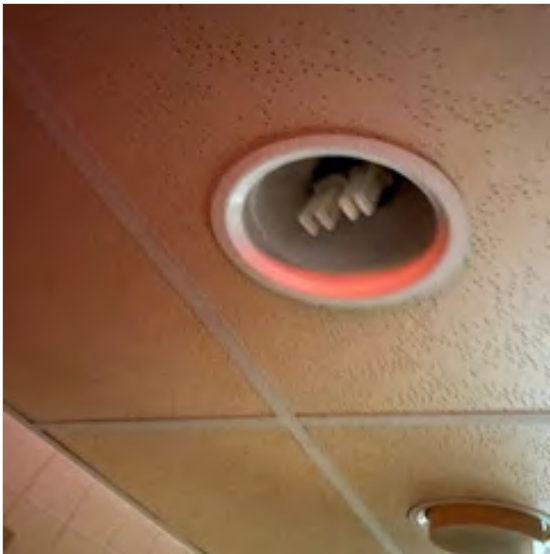
E-5: Down Light (CFL)

It is recommended that all devices be replaced with the next major renovation, as ceilings will need to be removed for MEP work.

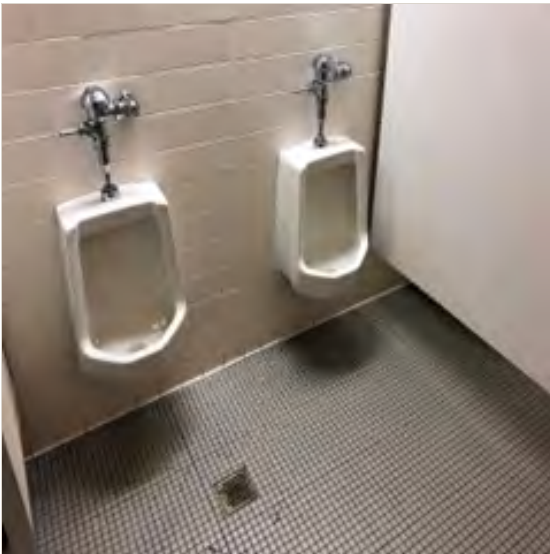
PL-4: Privacy shields should be provided

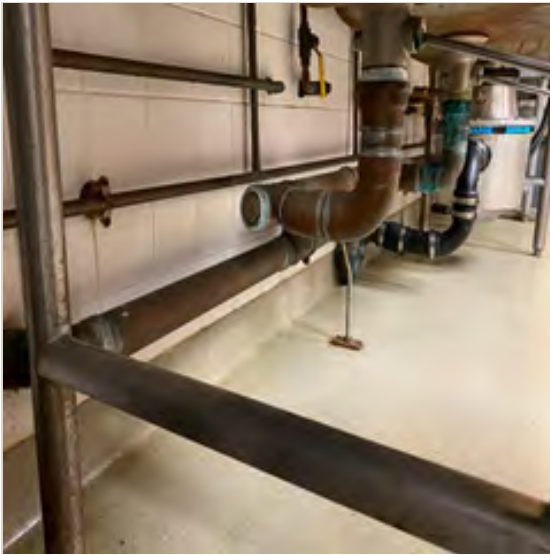
PL-6: Corroded Waste Pipe at Pot Sink

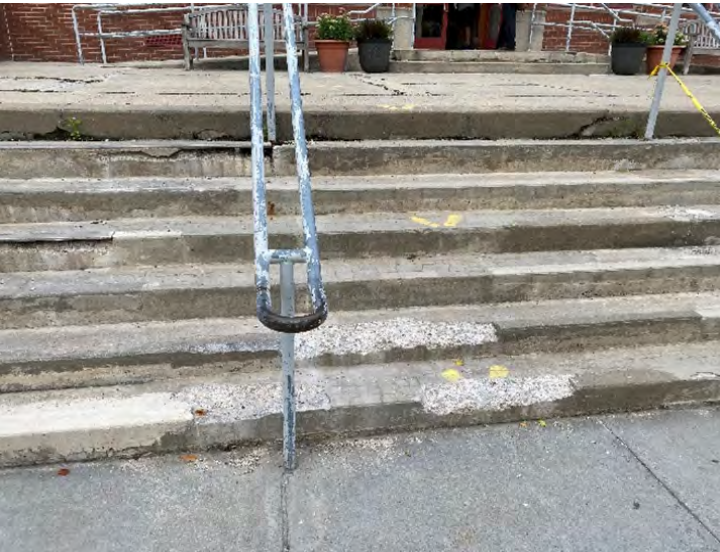
Deteriorated Front Steps

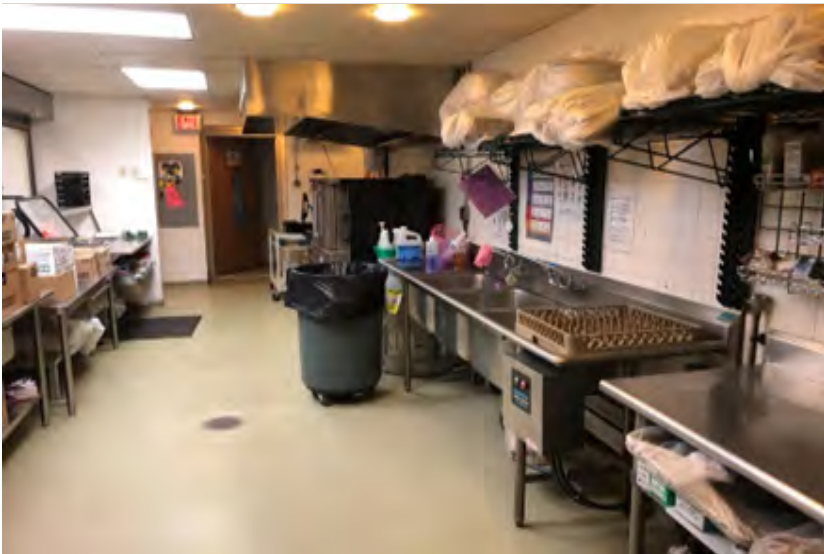
FS-1: The three-compartment sink is located directly adjacent to the cookline. With no dedicated food prep area, this sink is serving dual purpose as both preparation and ware washing. This situation presents cross contamination issues with modern day food code. The food code states that preparation and pot washing areas must be separated and labeled accordingly.

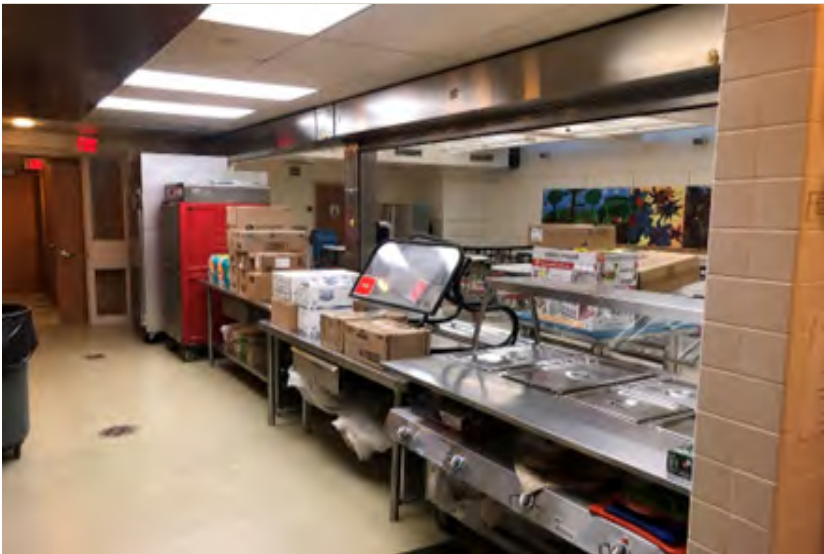
FS-2: Serving line components are made up of several different tables all at different heights. The tables also lack undershelves for additional storage capacity. The differential in heights make the serving area difficult to operate and challenging to clean. This photo also shows no refrigerated components which limit the ability to store and serve cold foods at proper temperatures.

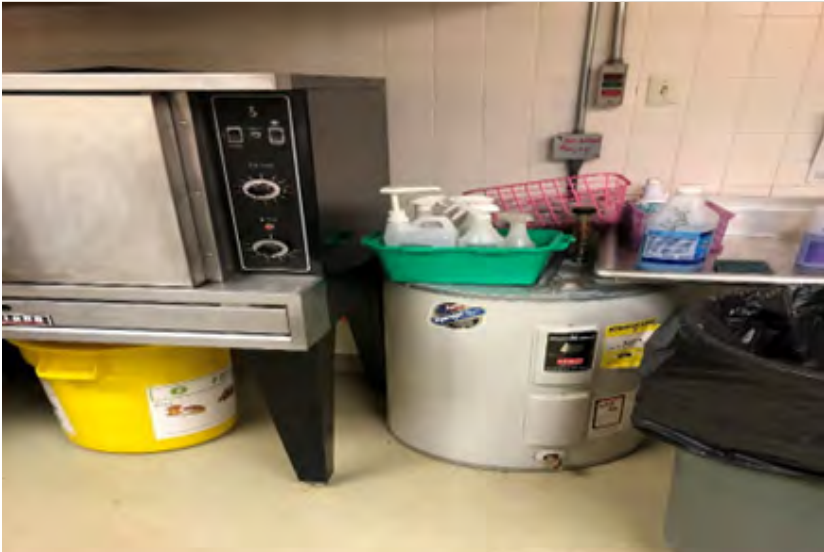
FS-4: There is a water heater located within the kitchen in between cooking and pot washing equipment. Normally this type of equipment is located remotely in a mechanical closet. With the location this equipment is in, it’s difficult to clean, and ends up being used to store items that do not belong. This location presents issues with cleanability of the kitchen and damage to the water heater itself. This equipment should be relocated out of the kitchen space.

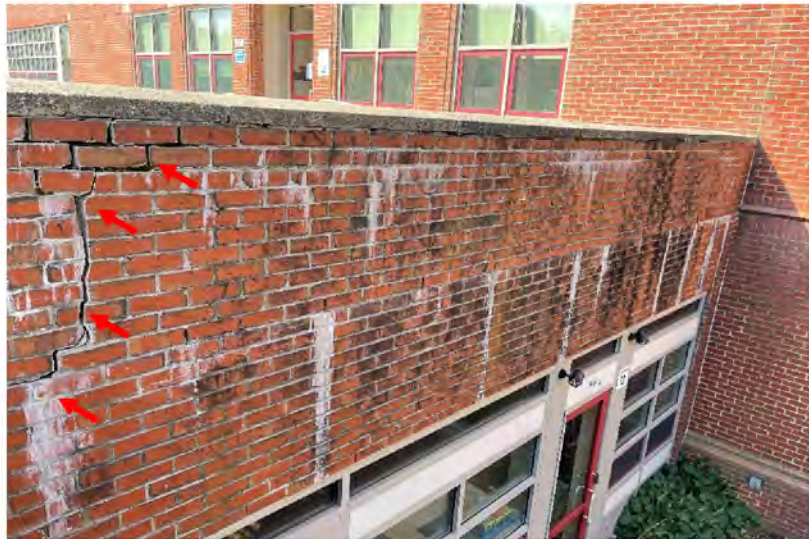
Isolated cracked and displaced brick was observed on the East Elevation masonry facades adjacent to the entry sidewalk. (Ref: Photo AE-11)

AE-11: Representative East Classrooms below Main Entry: Conditions typical throughout West Wing and East classrooms: Efflorescence, cracked and displaced brick

Replacement of any cracked brick and repointing of any deteriorated mortar is recommended, including at the East side of the building where this issue was documented. (Ref: Photo AE-11)

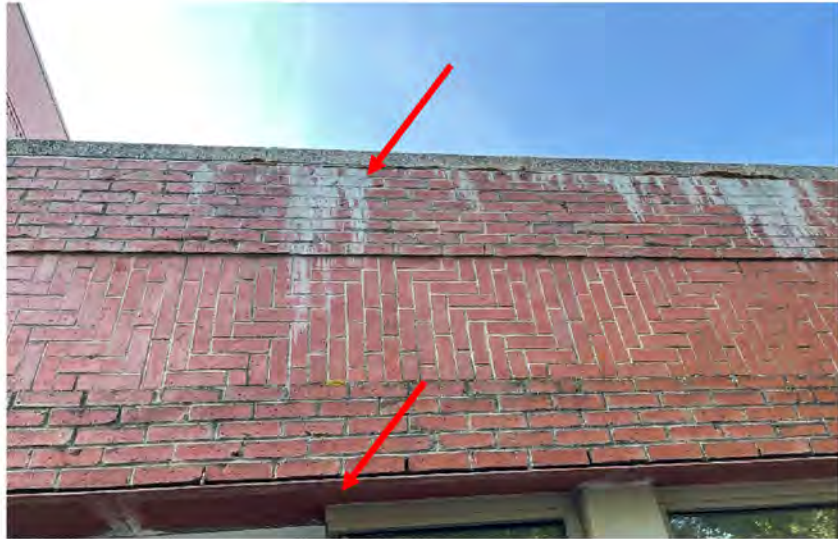
AE-10: West Wing: Conditions typical throughout West Wing and East classrooms below Main Entry. Typical efflorescence on masonry due to excess moisture, note relieving angle is exposed at head of storefront, continues from exterior to interior

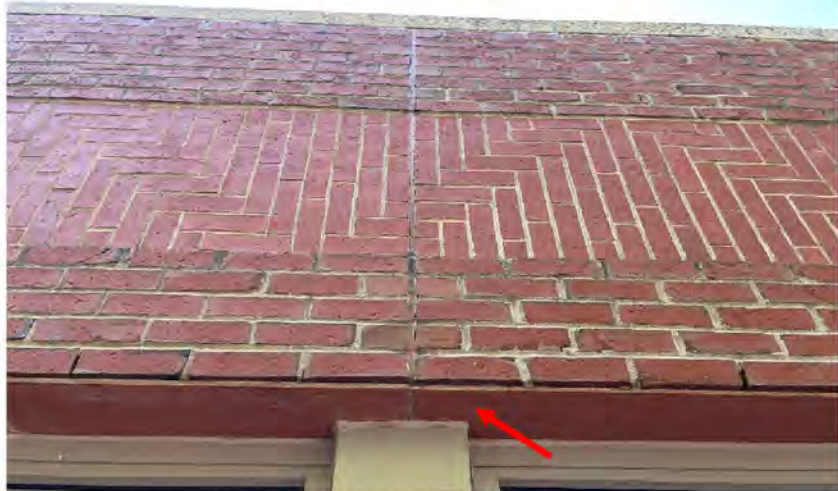
AE-12: Representative brick masonry façade along West Wing: Less efflorescence observed in this area. Note relieving angle is continuous from exterior to interior at head of all storefront

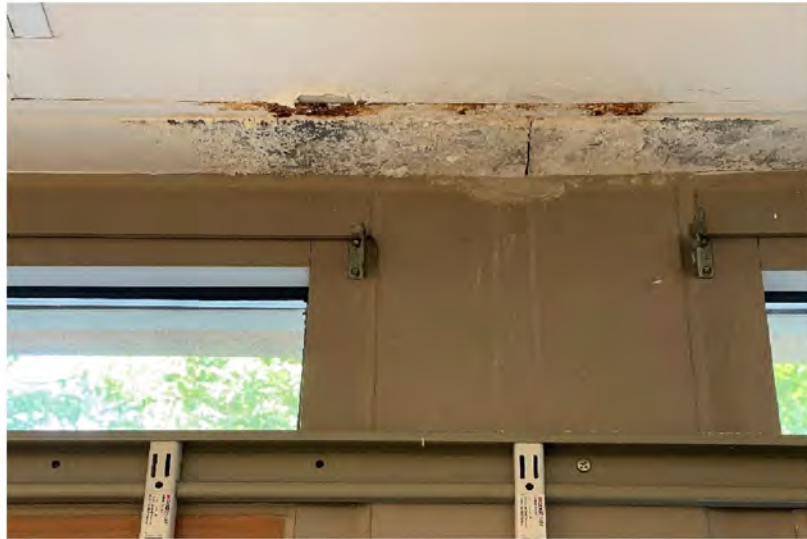
AE-13: Interior of typical classroom at West Wing, East classrooms below Main Entry: Similar conditions observed in all of these classrooms. Water leakage, rusting and peeling paint at interior side of relieving angles.

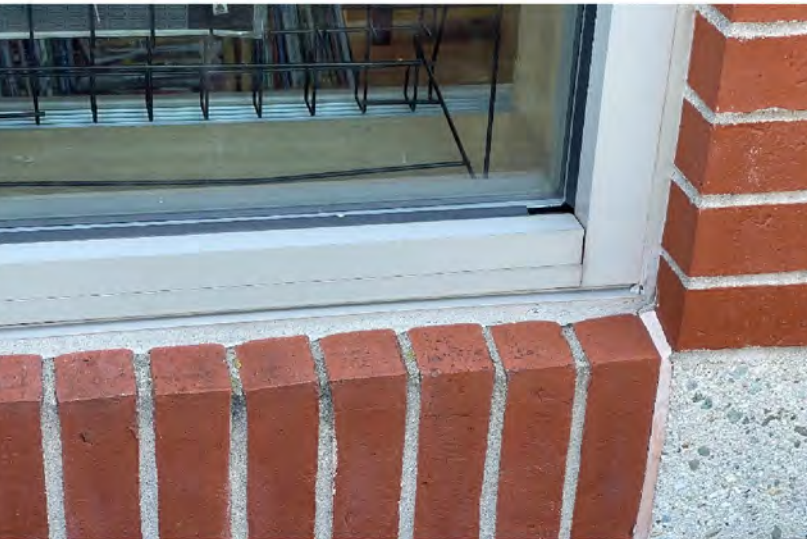
Façade sealants including those at masonry control joint locations and at the perimeter of fenestrations are reaching the end of their useful service life and have failed in some locations. (Ref: Photos AE-15-16)

AE-15: Representative brick masonry façade at perimeter of window: Note perimeter sealants and masonry control joint sealants are reaching the end of their service lives.

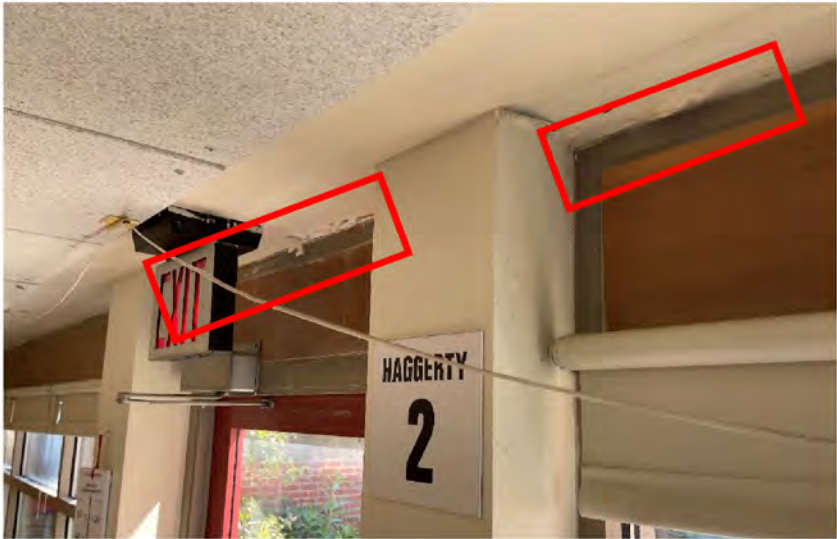
AE-14: Interior of typical classroom at West Wing, East classrooms below Main Entry: Water leakage, drywall damage and peeling paint at interior side of relieving angles and adjacent drywall, storefront spandrel panels.

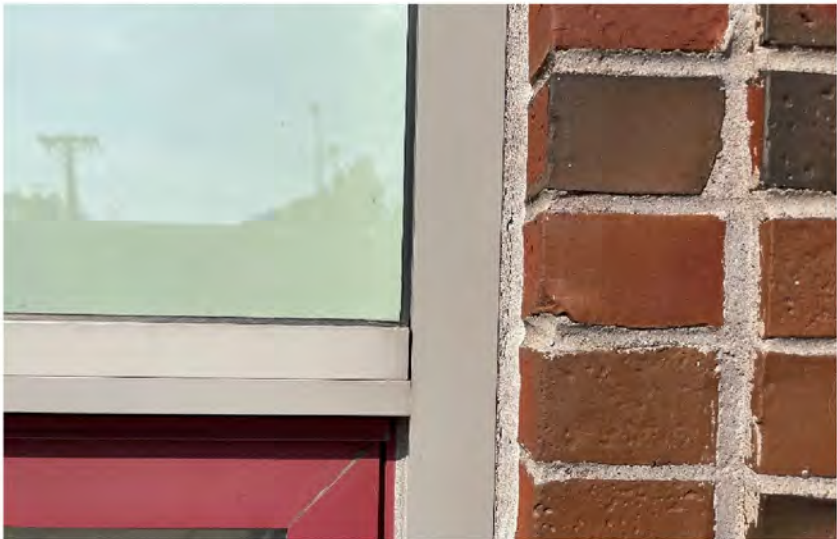
AE-16: Representative brick masonry façade at perimeter of window: Note perimeter sealants and masonry control joint sealants are reaching the end of their service lives.

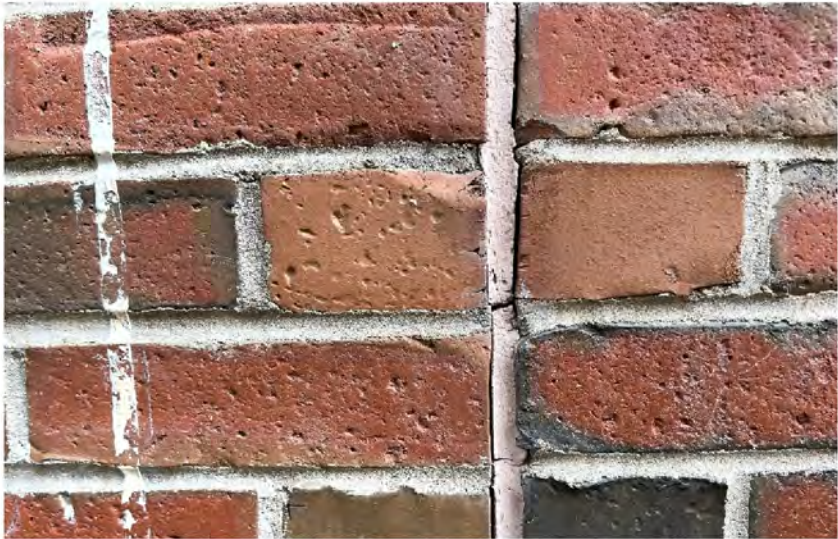
AE-17: Typical failed masonry control joint sealant

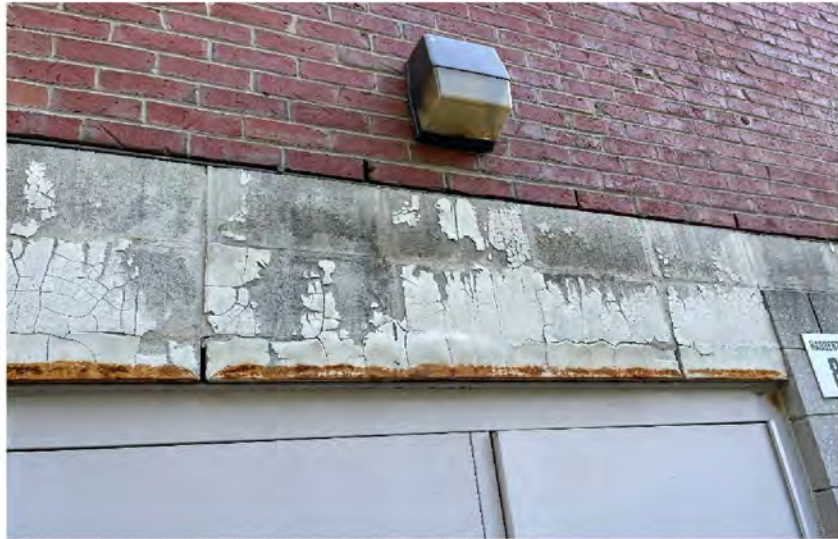
Portions of the West Elevation are clad with exposed concrete block, which was painted. Most of the paint has peeled from these surfaces, with rusting lintels observed at door openings in this area. (Ref: Photo AE-18)

AE-18: West Elevation: Typical failed coating on CMU

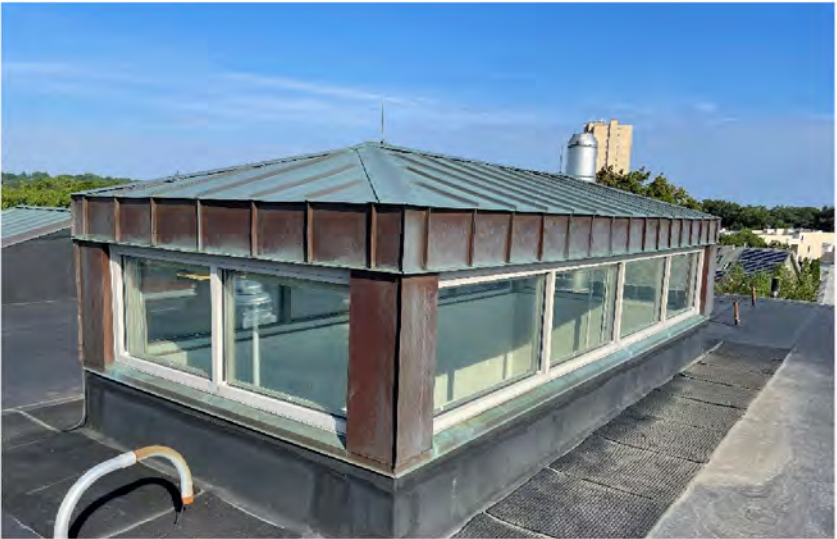
AE-21: Clerestory above Media Center / Library: Storefront here have misc. sealants at perimeter and on glazing.

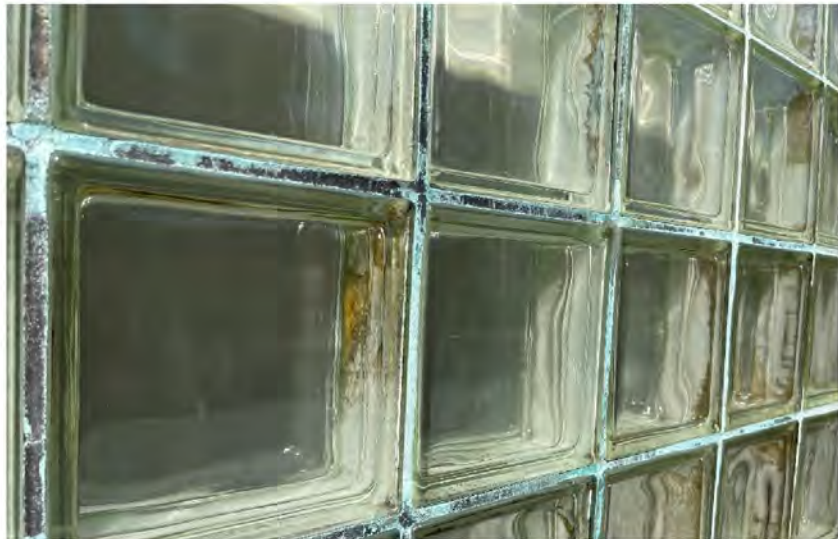
Windows and Doors:  
Glass block forms a clerestory façade around the play roof above the Gymnasium at the West Wing. Facilities personnel did not indicate any water penetration issues with the glass block, however there is water staining and discoloration within the mortar surrounding the glass block in most locations. There is some condensation within the glass block in this area. (Ref: Photo AE-19-20)

AE-20: Typical water drip staining within mortar joints between glass block, condensation within block itself. Condition typical throughout most of these facades .

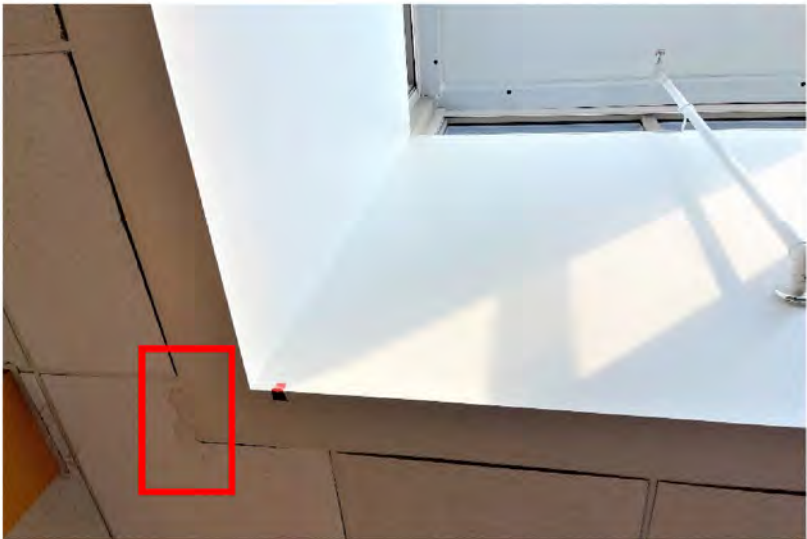
Evidence of water leakage is visible in proximity of storefront units within the Library below the clerestory (Ref: Photo AE-23) and within the Cafeteria located below grade in the West Wing. Stained ceiling tiles are visible in the Library. In the Cafeteria, drywall was removed at the perimeter of the clerestory portion of this space at the sill of the storefront due to recurrent leakage issues. In these areas, it is unknown if the leakage and interior damage is resulting from deficient storefront assemblies or the adjacent perimeter conditions around these storefronts. (Ref: Photos AE-25-28)

AE-23: Interior of clerestory at Library/Media Center: Typical water leakage staining observed on ceiling surrounding clerestory

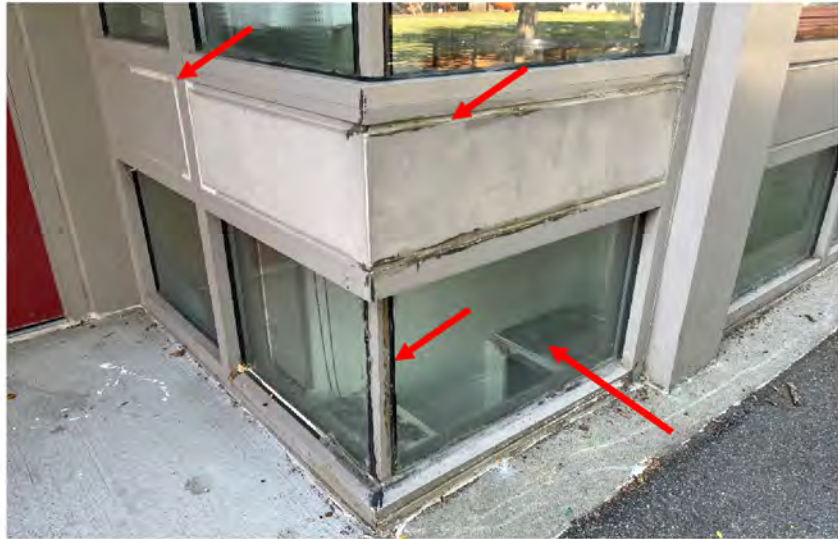
AE-26: West Wing and East classrooms below Main Entrance: Typical storefront near classroom entry door. Note added sealants at glass and spandrel panels, missing drywall due to leakage in Cafeteria below.

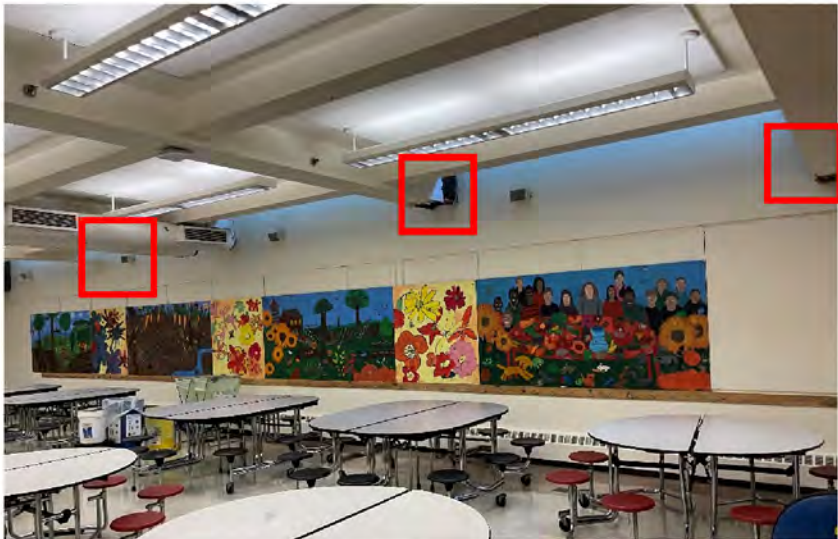
AE-27: Interior of Cafeteria below West Wing: Typical removed drywall, rusting beams and soffit framing due to active water leakage from storefront and storefront perimeter above, see AE-28.

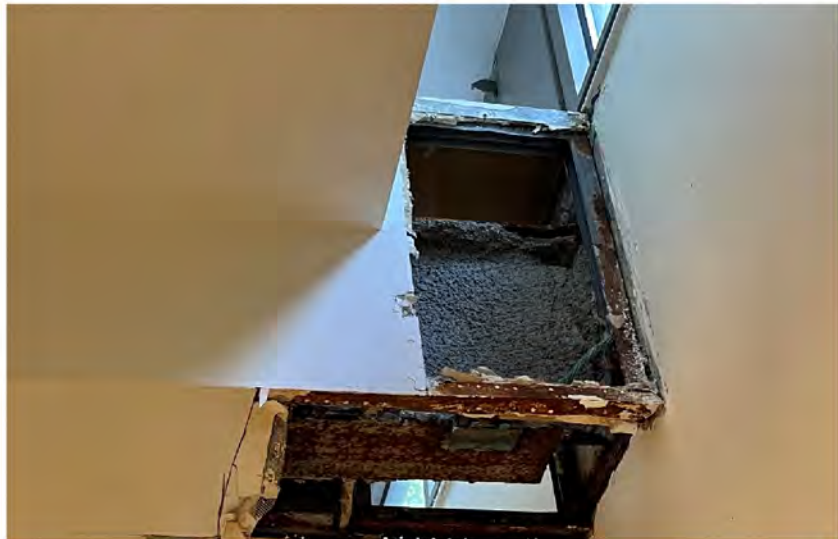
AE-28: Typical removed drywall, rusting beams and soffit framing due to active water leakage from storefront and storefront perimeter above

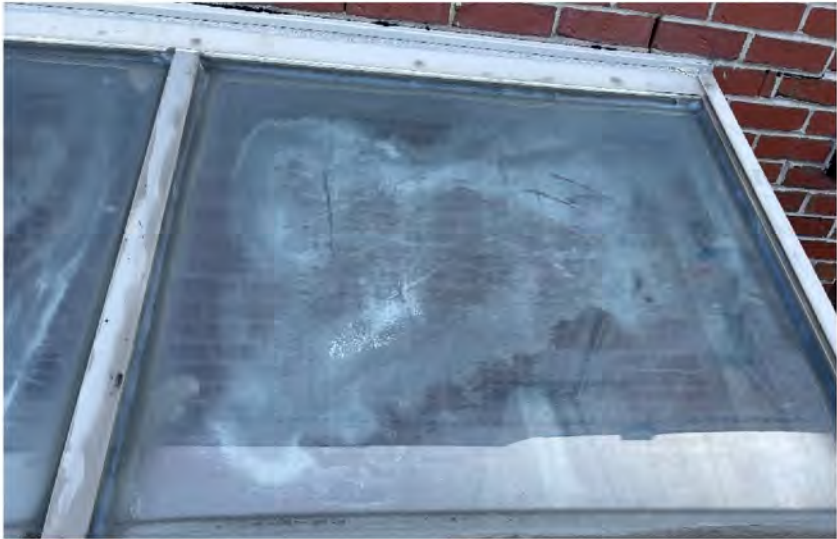
Aluminum framed sloped glazing assemblies are located at the transition from the Main Building to the West Wing. These sloped glazing are in fair condition overall, with failed IGU observed in multiple locations, as evidenced by condensation between the panes of glass. Multiple locations of active water leakage exist within the Corridor below the sloped glazing, as evidenced by damaged drywall, peeling paint and staining on the exposed masonry in this area. (Ref: Photos AE-29-32) The sill of the sloped glazing terminates at a masonry wall with a concrete cap, and it is possible that the leakage issues are a combination of masonry and glazing failures.

AE-30: Sloped glazing at transition between Main Building and West Wing, located above interior corridor: Typical failed IGU, as evidenced by condensation between panes of glass.

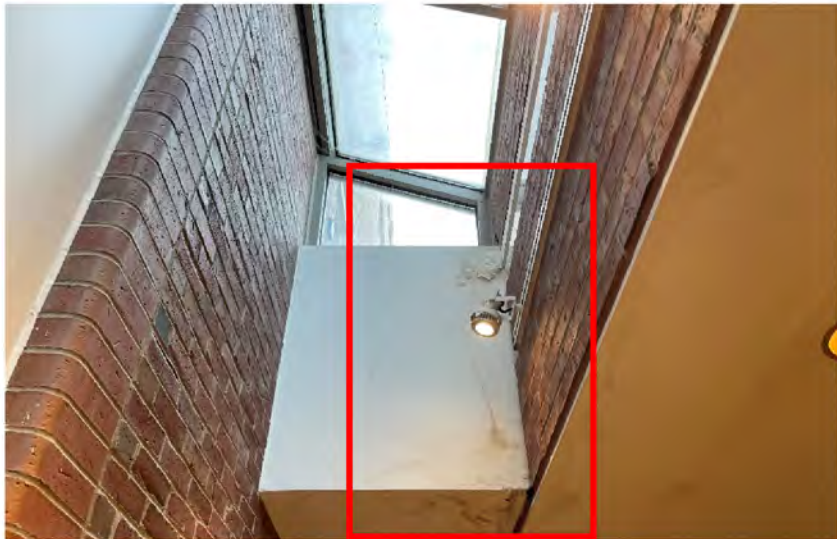
AE-31: Interior of Corridor below Sloped glazing at transition between Main Building and West Wing: Typical area of active water leakage, note staining and peeling paint at drywall.

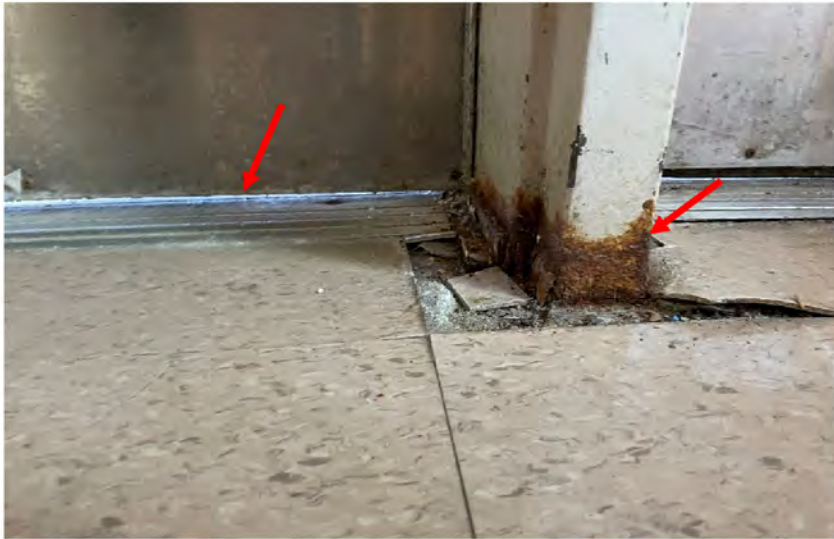
The exterior doors are hollow-metal framed with surface rusting and peeling paint present at the base of these frames at most locations. Some daylight was visible around a few exterior doors due to insufficient weatherstripping. (Ref: Photos AE-33-35)

AE-33: Interior of typical exterior door: Typical rusting at base of door frame, daylight visible below door at deficient weatherstripping.

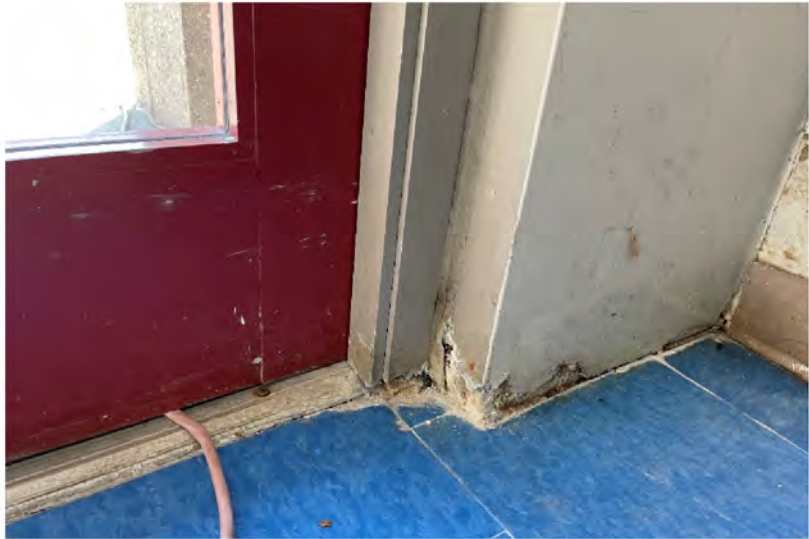
AE-34: Representative drywall damage due to moisture adjacent to Main Entry doors

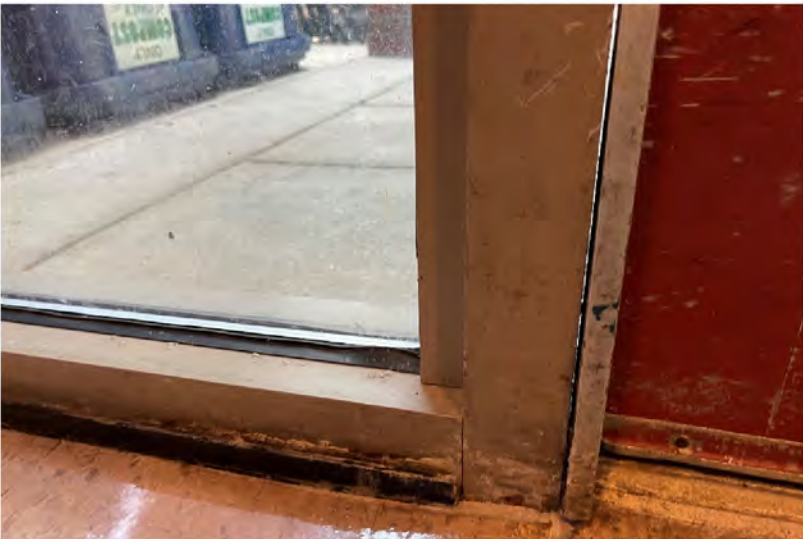
AE-35: Representative daylight visible between door and storefront framing at West Wing: Some corrosion on base of storefront door frame.
