# HAGGERTY SCHOOL

110 Cushing Street  
Cambridge, MA 02138

## Facilities Condition Assessment : October 14, 2022

# 7.6 | HAGGERTY SCHOOL BUILDING APPENDIX

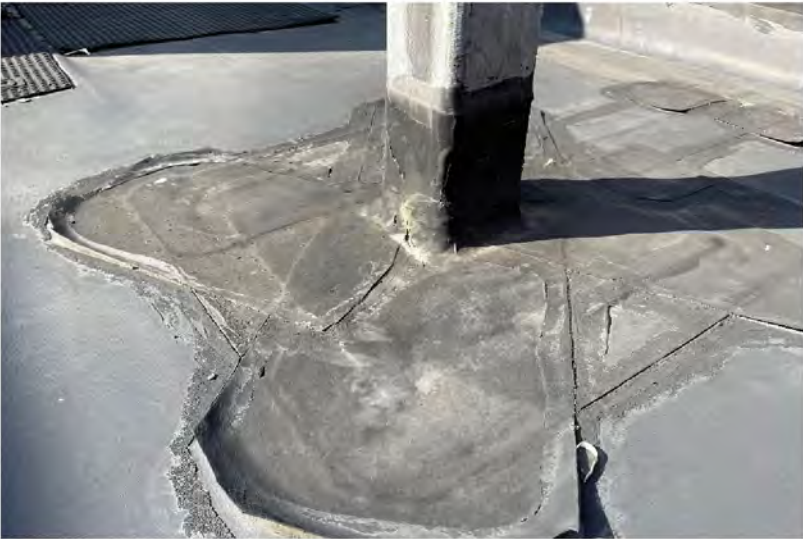
AE-41: Typical EPDM patch with failed lap sealants that has become unadhered

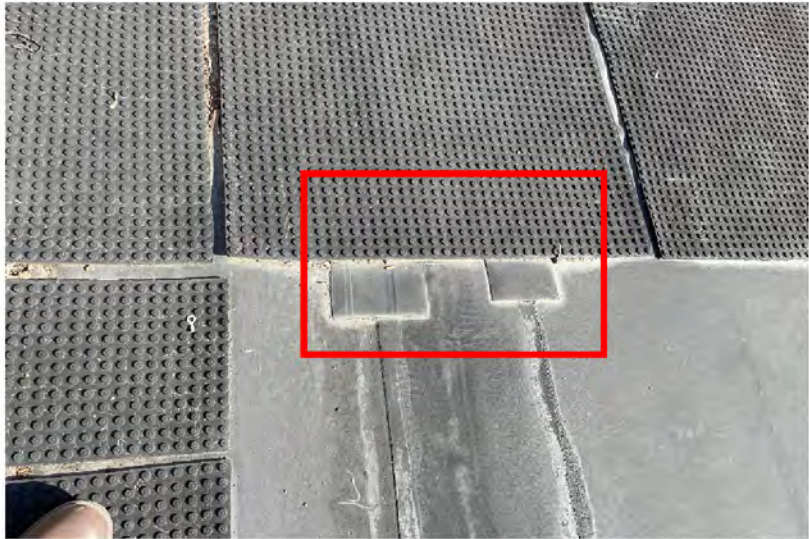
AE-42: Typical EPDM patches without lap sealant at field cut edges

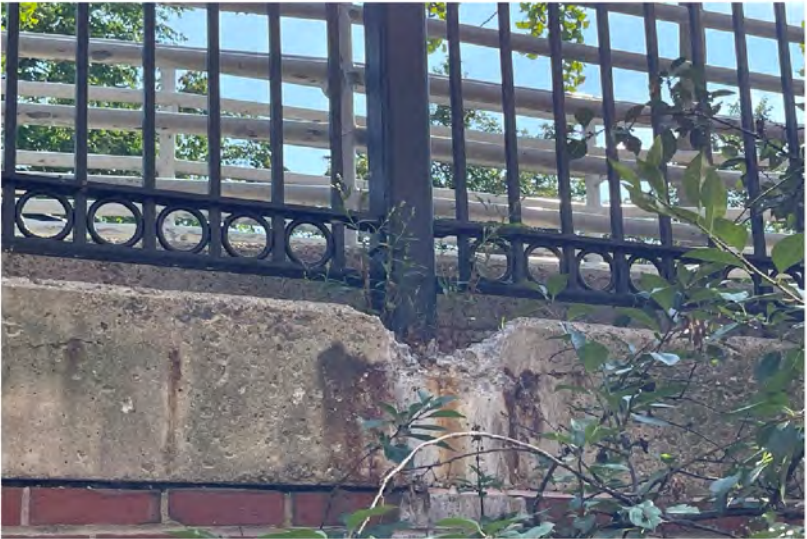
Miscellaneous:  
Spalling of concrete within the retaining walls along the East side of the building was observed in multiple locations, typically at the penetration for the metal guardrails above. (Ref: Photo AE-46)

AE-46: Typical spalling concrete at retaining wall around East side of building

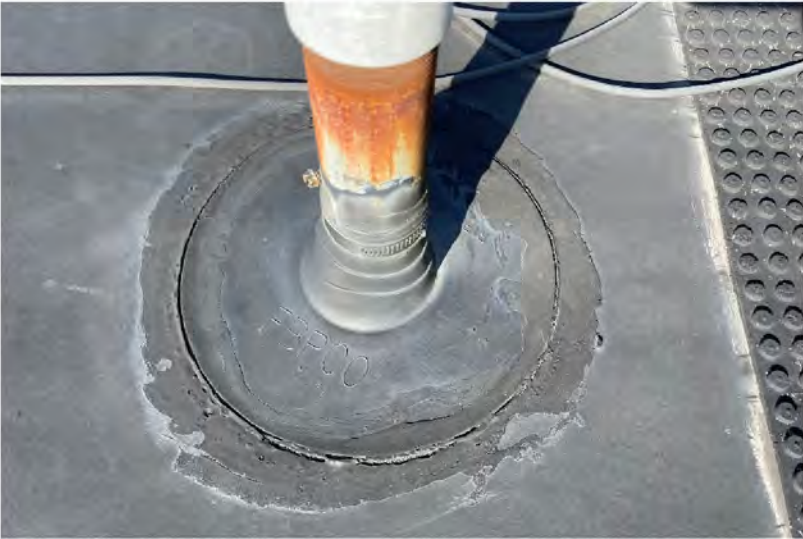
AE-43: Typical prefabricated EPDM flashing boot with failed lap sealant at perimeter. Note perimeter of boot is starting to become unadhered.

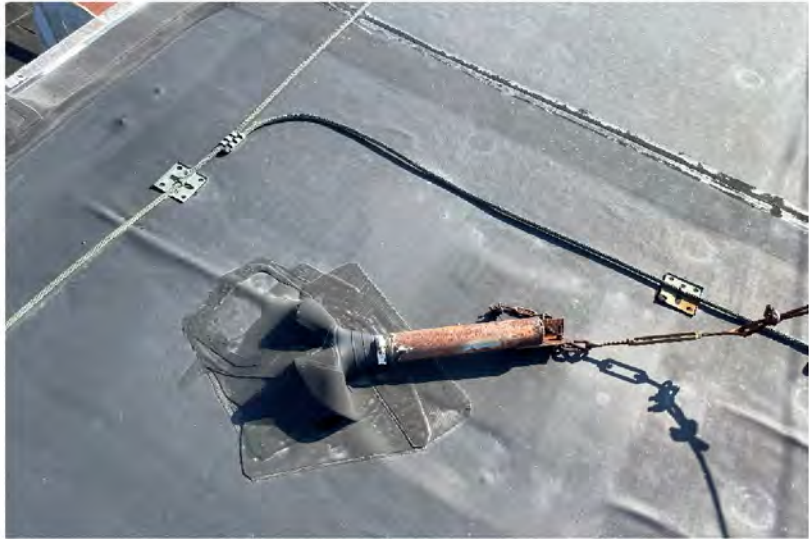
AE-44: Damaged guyline anchor post at flue: Note failed EPDM flashings around anchor.

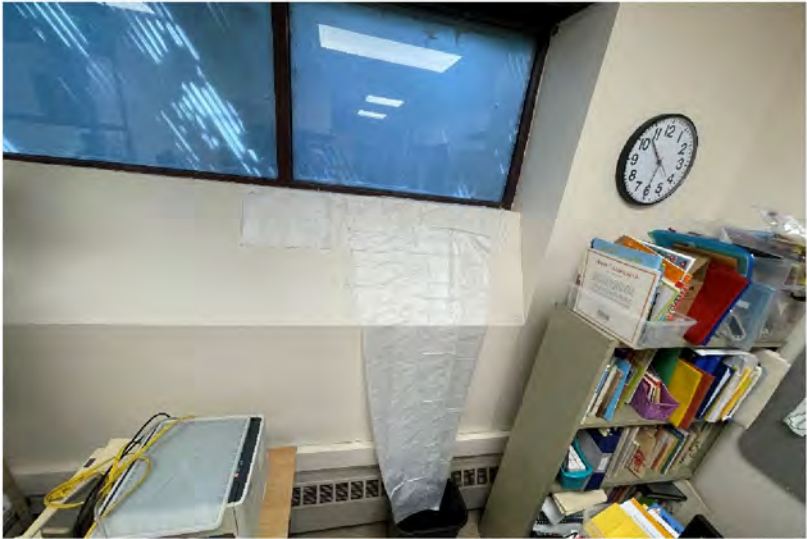
There is roof leakage within Room 109 from near the roof drain. (Ref: Photo AE-48)  
There is also evidence of water leakage within the Community Room L01 where the exterior window is located within a lightwell that is covered with a grate on the South Elevation. (Ref: Photo AE-47)

AE-47: L01 Community Room: Interior leakage at perimeter of window located within lightwell below grating on South Elevation

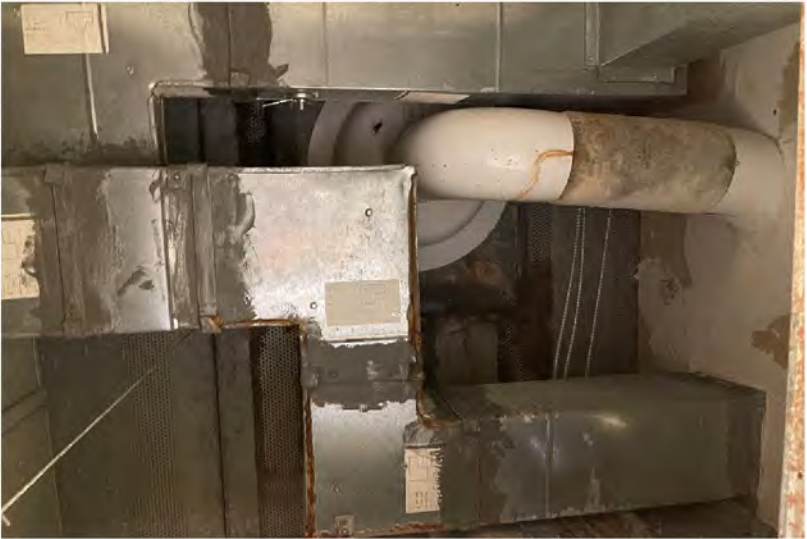
AE-48: Interior of ceiling in Room 109, below roof drain where leakage occurs
