# KENNEDY-LONGFELLOW BUILDING

158 Spring Street  
Cambridge, MA 02141

## Facilities Condition Assessment : October 14, 2022

# 7.7 | KENNEDY-LONGFELLOW SCHOOL BUILDING APPENDIX

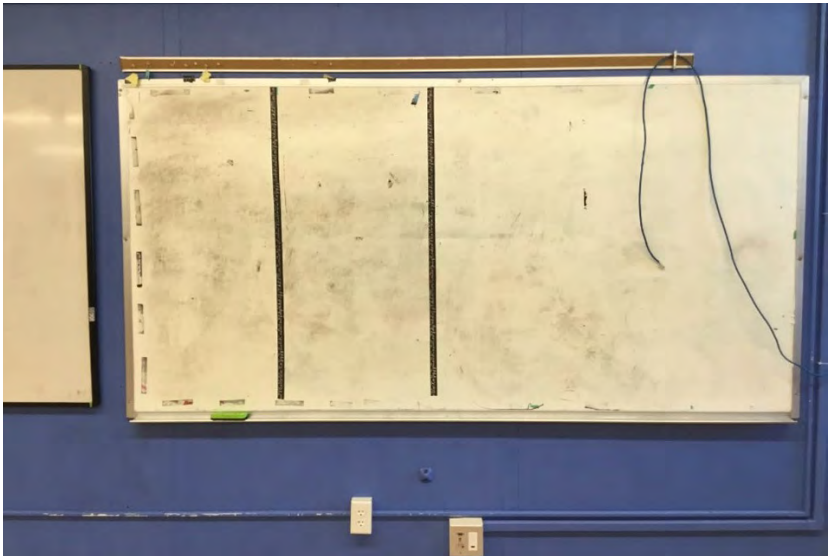
Damaged Visual Display Boards

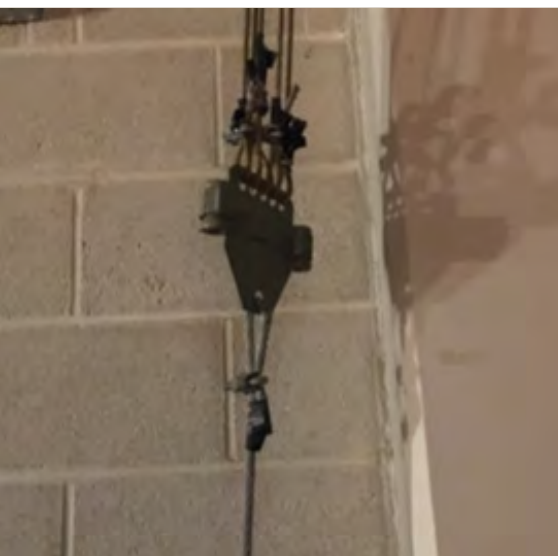
Hand Winch Clew Showing Wear

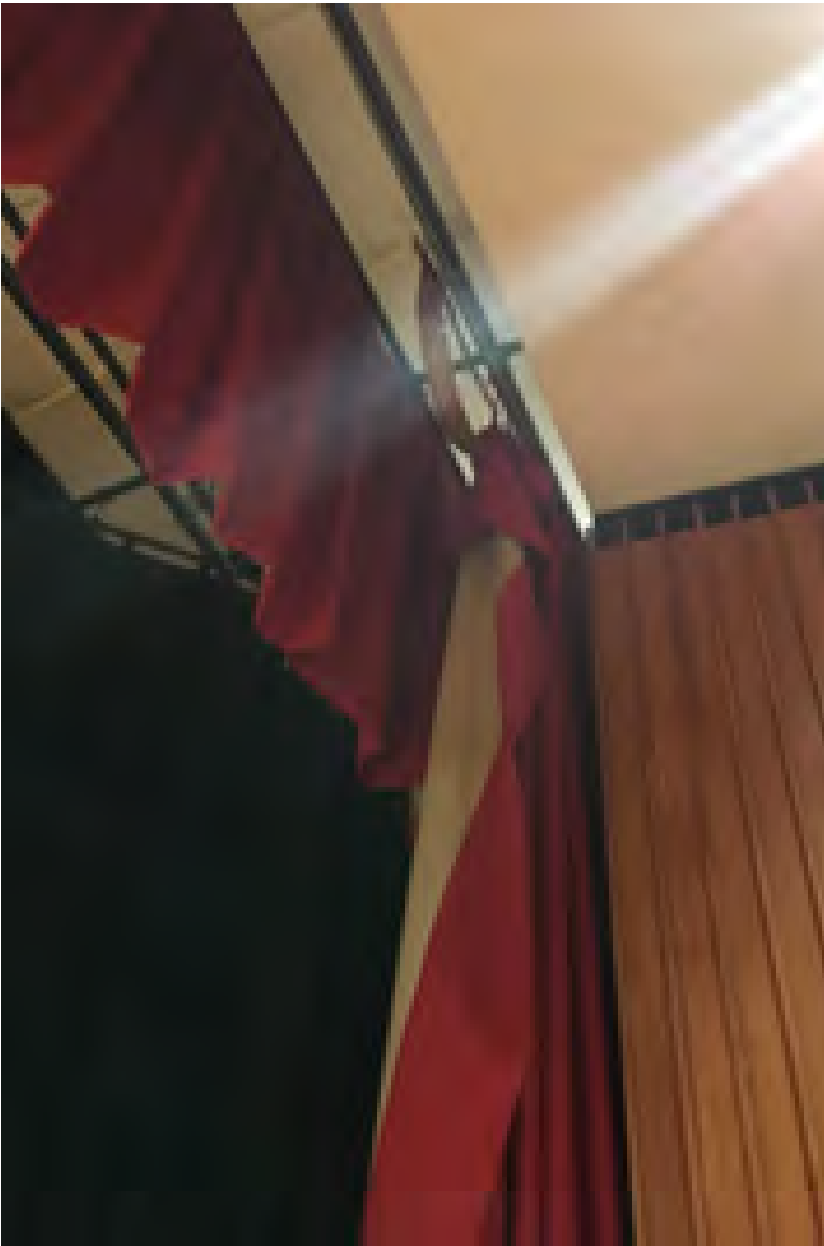
Damaged Stage Drapery

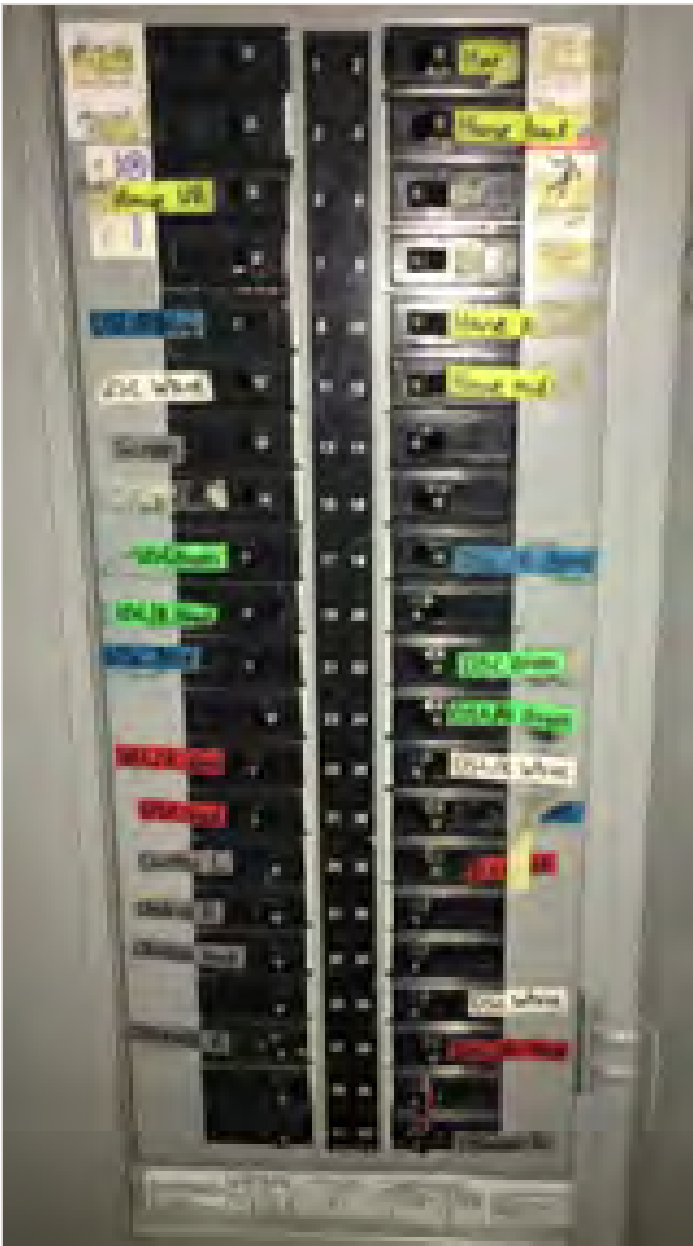
Local Panelboard Used to Control Stage Lighting

Theatrical Lighting:  
This system should be upgraded. Panelboards serving theatrical lighting should be replaced with relay panels. Fixtures upgraded to LED spot, wash, and strip lights. Existing power infrastructure is likely to be able to be reused. Low-voltage control wiring (category cable) must be added to serve each lighting position.

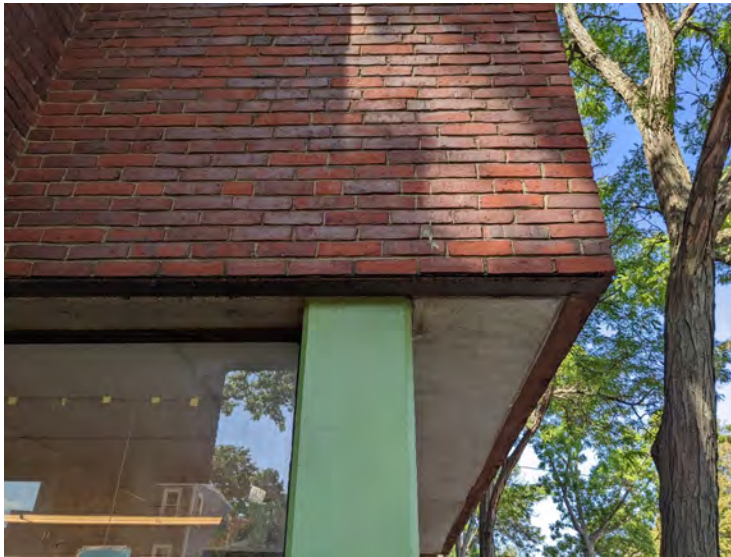
Photo ST-1: Brick Joints and Rusted Lintels

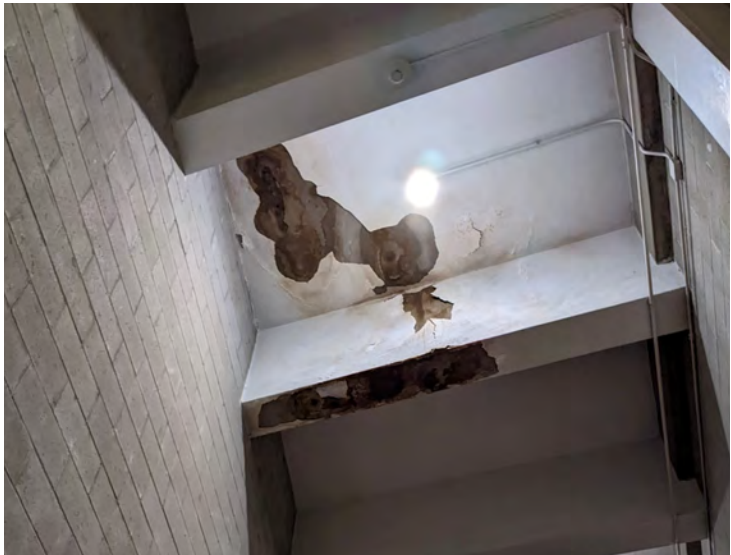
Photo ST-2: Water-Stained Finishes above Stage

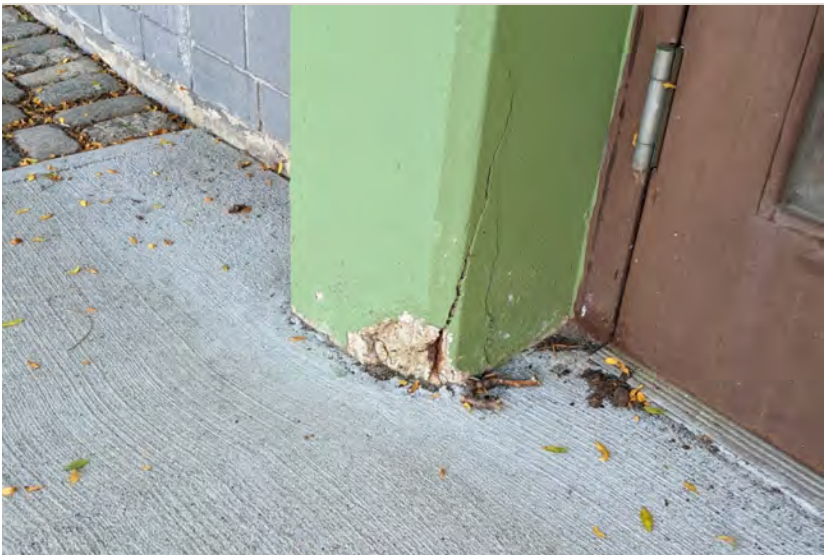
Minor cracks and limited areas of spalling concrete were observed around the building exterior. It does not appear that the building structure has been affected. However, patching, filling and/or other minor repairs may be required to prevent further deterioration. Refer to Photos ST-3 and ST-4.

Photo ST-3: Cracked Concrete Encasement

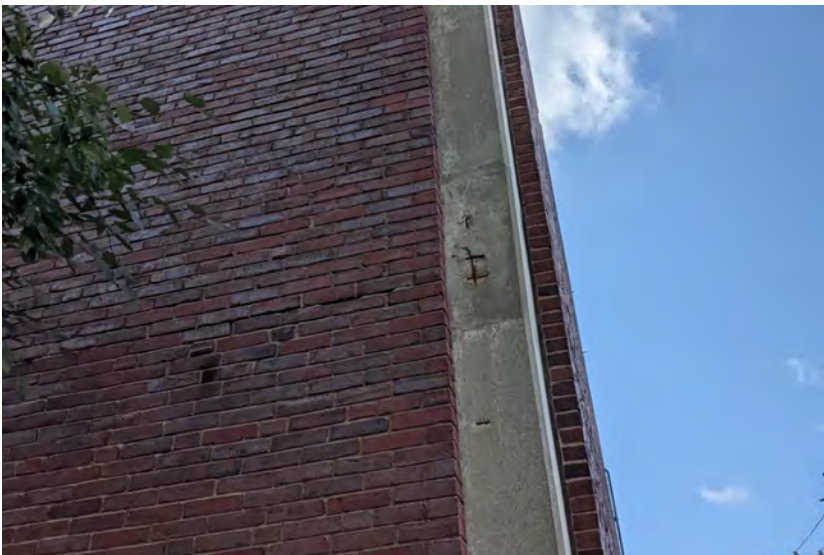
Photo ST-4: Exposed Reinforcing Steel

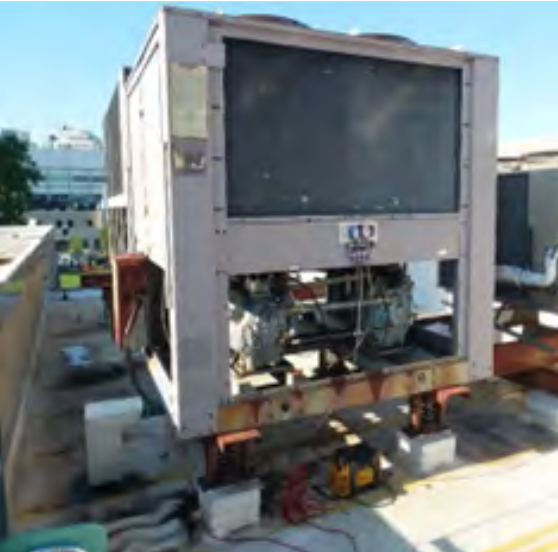
M-3: 2005 Existing Condensing Unit Under Repair

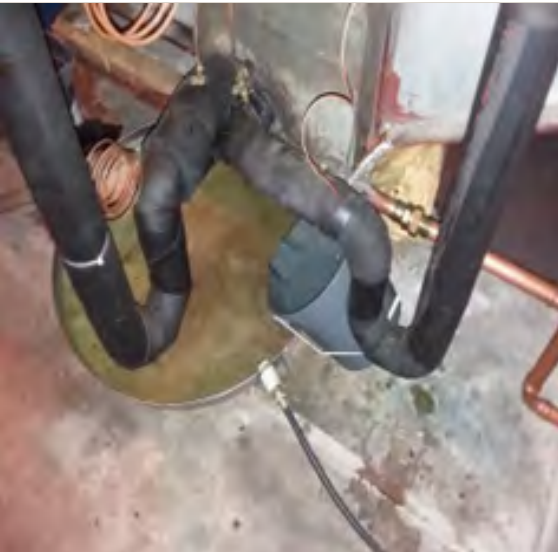
The air handling equipment is generally in poor condition. It was observed that most, if not all, the outside air damper actuators for the units have either been disconnected or removed. Air flow imbalances were noted on the units with mixed air chambers/sections operating in a negative pressure condition (should be somewhat neutral pressure), possibly due to the damper issue previously noted. An excessive amount of air leakage was noted on the duct work mains in the mechanical rooms and from the air unit casings in numerous areas. Fan motor/bearing noises were present indicating operational issues/concerns for some units. Condensate drainage appears to be a problem on the 3rd floor units. Custom temporary drain pans were observed to have been constructed to prevent the condensate which is leaking from the unit casings from leaking down into occupied areas. Corrosion was noted on both the duct work and hot water system piping. Insulation is missing or becoming detached throughout the mechanical rooms in which the air handling units are located. The air handling unit fan motor disconnects were observed to be operating the “hand” position throughout. Also, numerous local exhaust fans were noted to have been shut off at their respective disconnects.

M-4: Existing Air Handling Unit With Condensate Pan Leakage

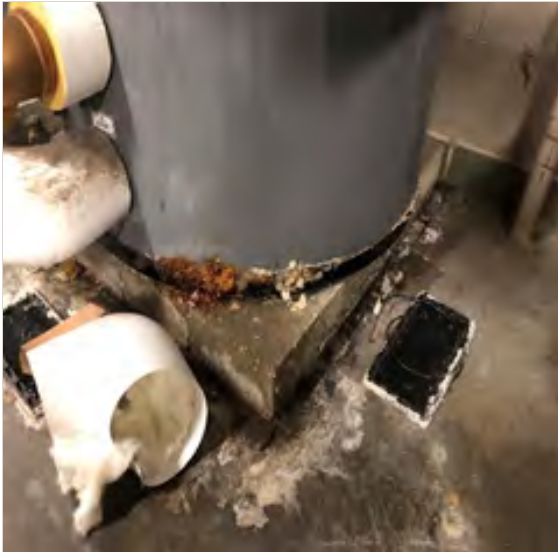
PL-1: Failed Hot Water Tank

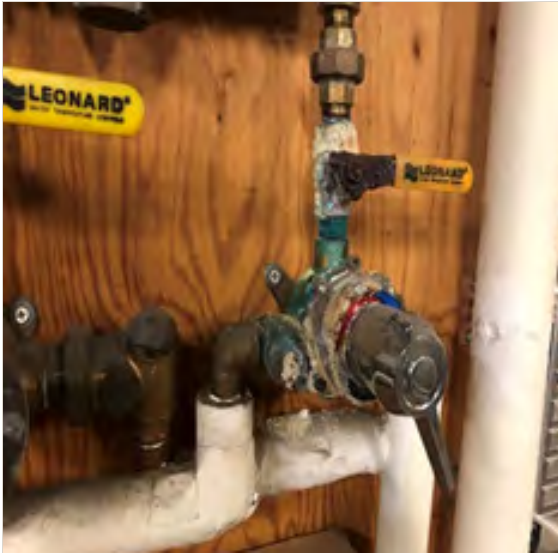
PL-2: Corroded Mixing Valve

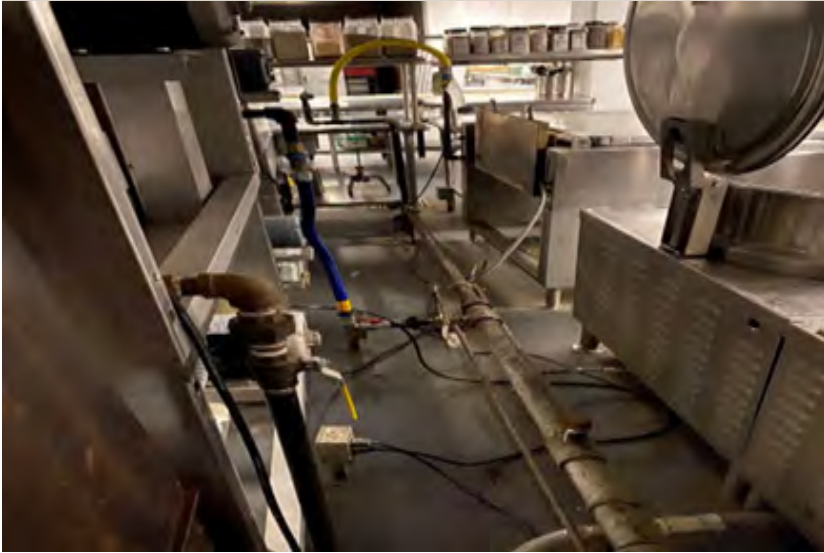
FS-1: Exposed utilities in the cooking area present cleanability issues. Utilities should be enclosed and provided with a smooth washable surface.

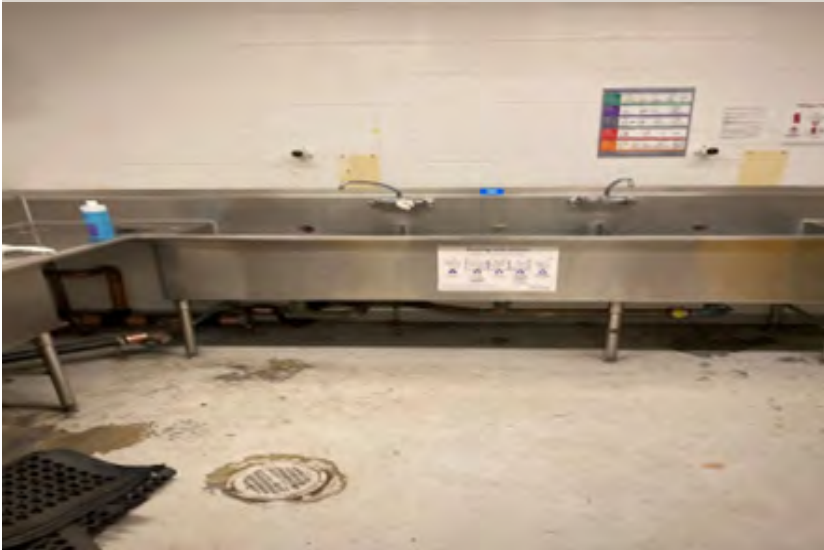
FS-2: Sealed concrete flooring is in poor condition. The seal on the floor is worn and damaged in many locations. The prevent the kitchen floor from being properly cleaned and sanitized.

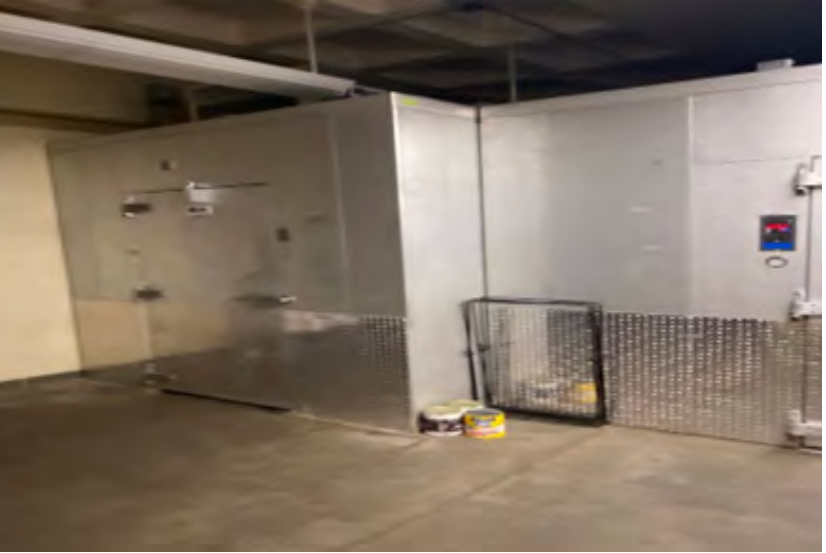
required to be provided with vertical closure panels to the ceiling which do not exist on site. The lack of closure panels allows dirt, dust and debris to collect on top of the walk-in cooler and this space does not get cleaned.

FS-3: Walk-in coolers are required to have vertical closure panels from the top of the box to the finished ceiling. This prevents dirt, dust and debris build up and is required by code. The floor at the exterior of the box is required to be coved in order to properly mop and clean the space. Neither of these requirements are met and require updates.

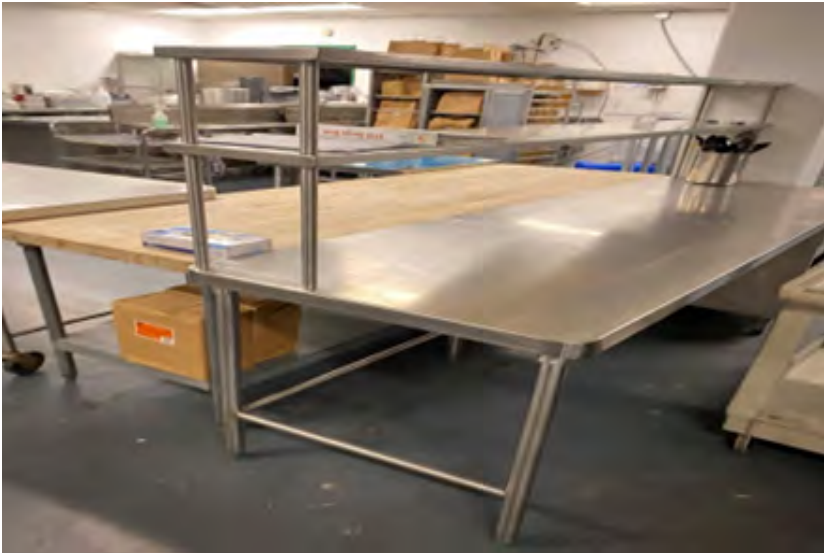
FS-4: Wood surfaces are not allowed in a kitchen unless it is being used in a specific task as part of baking or other dough processing. Wood surfaces are difficult to maintain in the long term and they require frequent oiling and other maintenance. If not oiled the wood shrinks and splits causing health code violation since the gaps fill with debris and it is not possible to clean and sanitize. Replace wood table tops with stainless steel built to NSF standards.

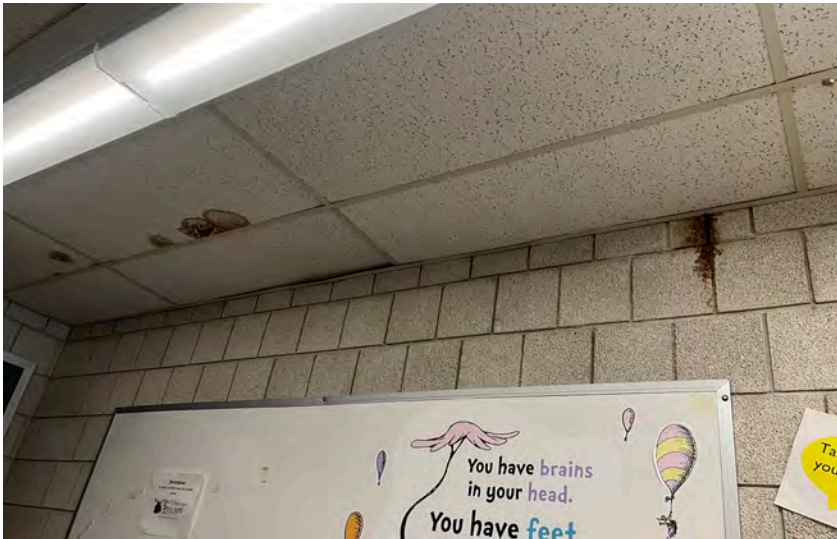
Ceiling and wall damage

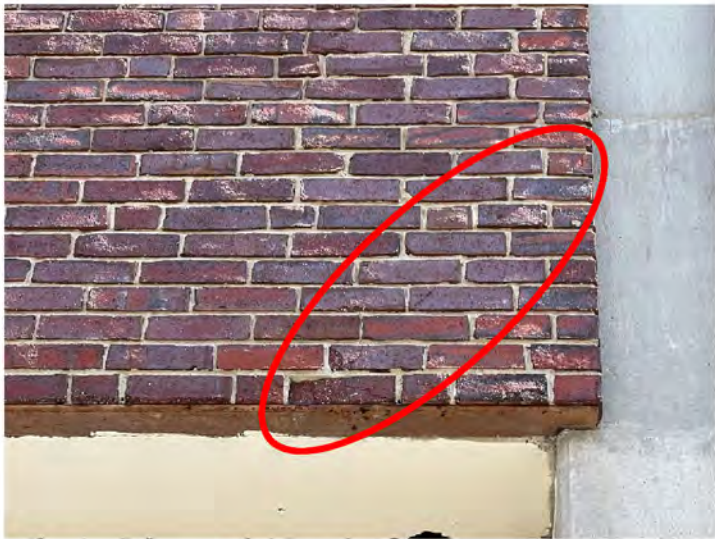
Facade:  
The façade comprises exposed cast in place concrete structure with brick and concrete block infill. The brick and concrete block masonry is in good condition overall with isolated step cracking observed. (Ref: Photo AE-10) The concrete block is primarily located at the exterior of the ground level and has been painted.

AE-10: Typical isolated cracked brick within masonry facade

A scope of masonry cleaning and repointing should be undertaken in areas of deteriorated mortar and any cracked brick shall be replaced. Remove spray foam insulation from abandoned façade penetrations and infill with brick. Provide proper backer rod and sealant joints in conditions where spray foam insulation is installed around current façade penetrations.

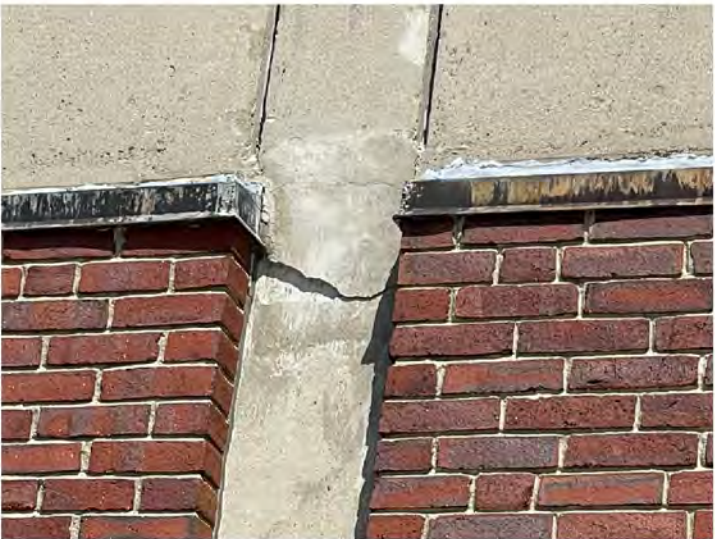
Hairline cracking of the concrete façade elements was typically noted in the form of vertical cracking at the center of the concrete panels between floors. (Ref: Photos AE-11-12) Miscellaneous previous concrete repairs were noted and included repair patches and sealant application. (Ref: Photo AE-18) Some concrete patches have begun to fail and spall. (Ref: Photo AE-14)

AE-14: Typical previous concrete repair at exposed cast in place concrete that has cracked and spalled.

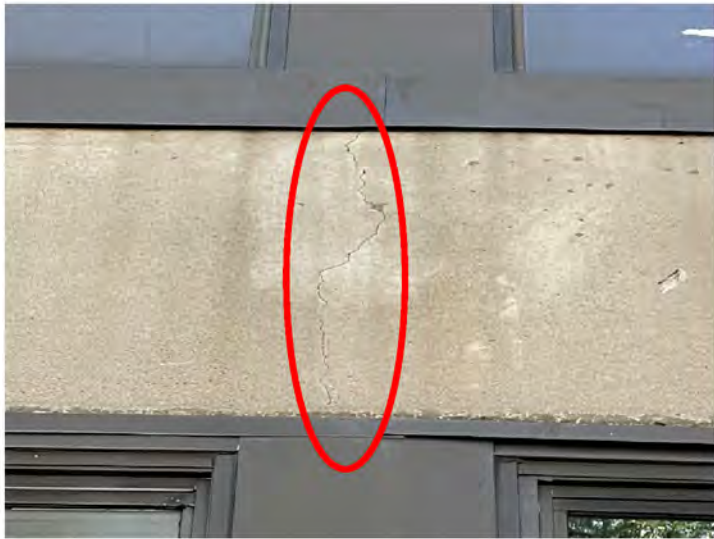
AE-11: Representative vertical cracking at exposed concrete between floors. Condition observed in many locations throughout building.

Isolated crack repair is recommended for all hairline concrete cracking areas discovered.

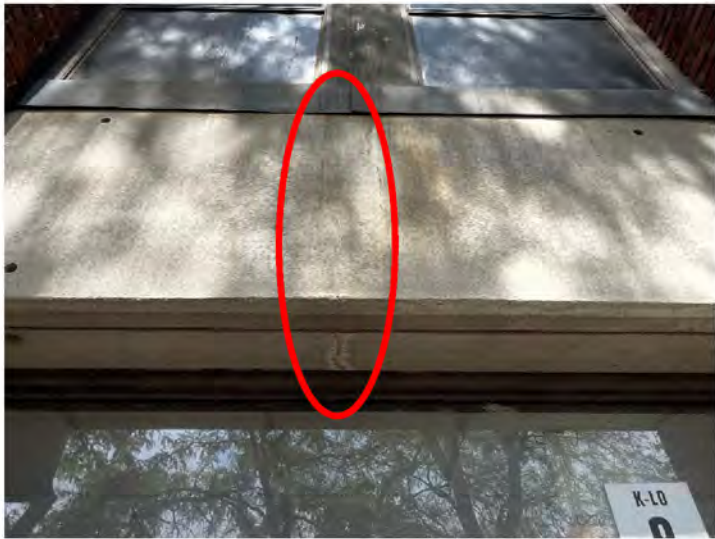
AE-12: Representative vertical cracking at exposed concrete between floors. Condition observed in many locations throughout building.

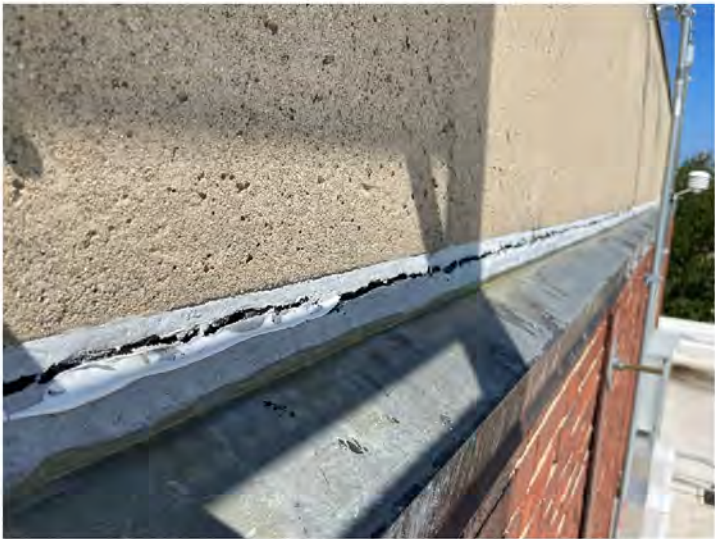
Metal flashings terminated with a lap sealant are located along the top of the brick masonry facades, with several areas observed where the metal flashing is no longer fully secured, and the sealant has failed. (Ref: Photos AE-13-16)

AE-15: Typical failed sealant along top of metal flashing located on top of brick masonry façade.

Replace all metal flashings located at the top of the brick facades with new metal reglet flashings and lap sealants.

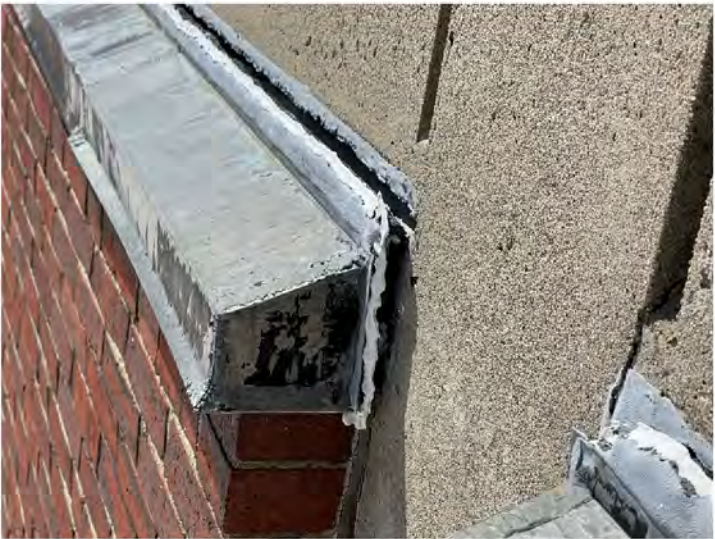
AE-16: Representative metal flashing along top of brick masonry façade. Note flashing is no longer engaged to concrete facade, sealants have failed.

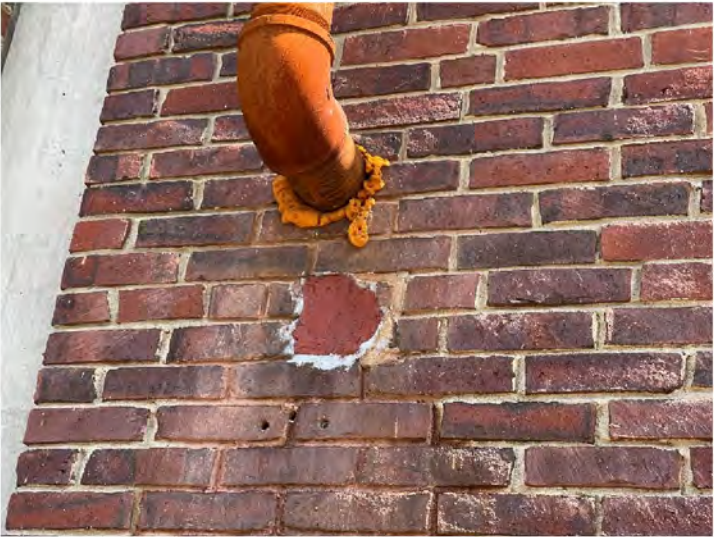
The façade sealants at transitions between masonry and concrete and around the steel window and louver assemblies has reached the end of its service life. (Ref: Photos AE-19, 36) Exterior perimeter sealants around the newer aluminum windows are in fair condition. A few penetrations in the façade are filled or sealed with spray foam insulation. (Ref: Photo AE-17)

AE-17: Typical façade penetrations filled with spray foam insulation.

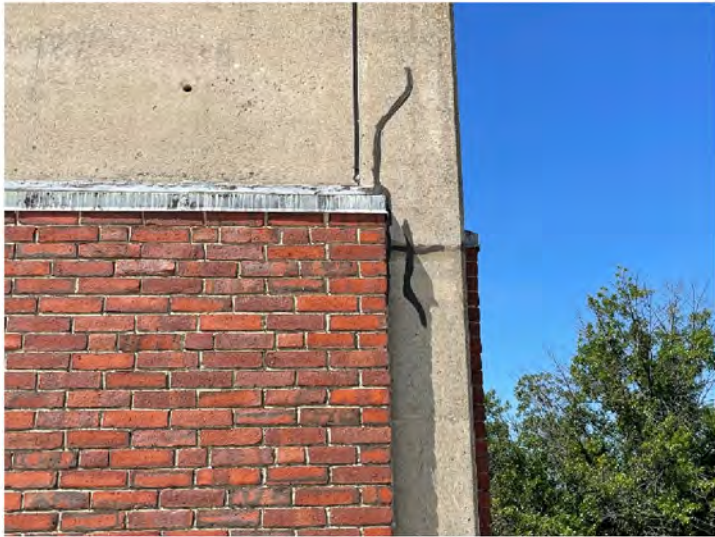
AE-18: Typical sealants applied over cracking in exposed cast in place concrete structural elements.

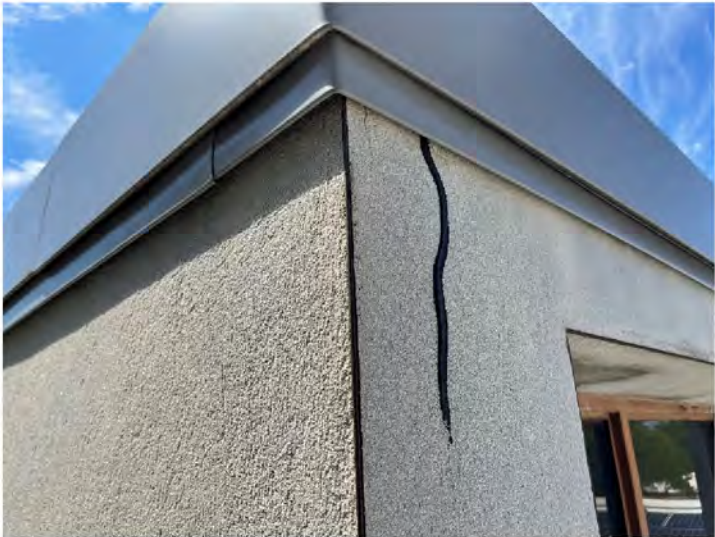
There are a few roof monitors clad with cementitious panels and metal windows. The cementitious panels have hairline cracking and some isolated rusting. There are previous repairs to these panels in the form of sealant application. (Ref: Photos AE-20-22)

AE-21: Typical sealant application on crack in cementitious cladding at roof monitor.

The cementitious panels at the roof monitors should be coated/waterproofed to reduce potential moisture migration within the panels and to reduce potential for further cracking and rusting.

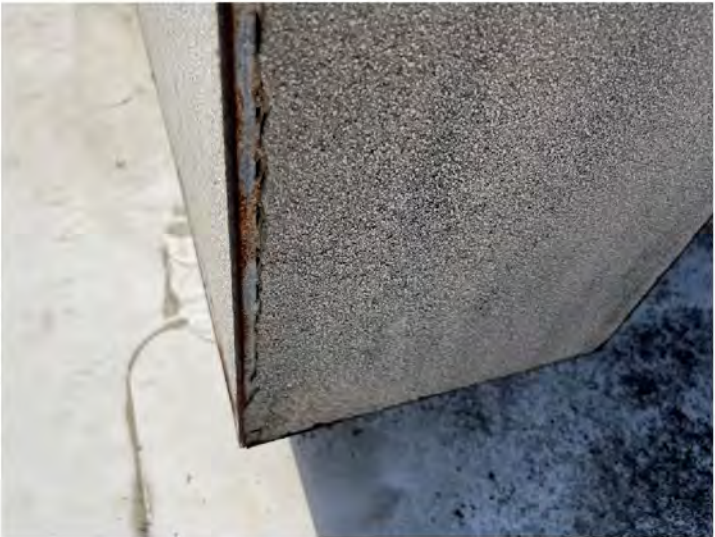
AE-22: Typical surface rusting and some cracking of cementitious cladding at roof monitors.

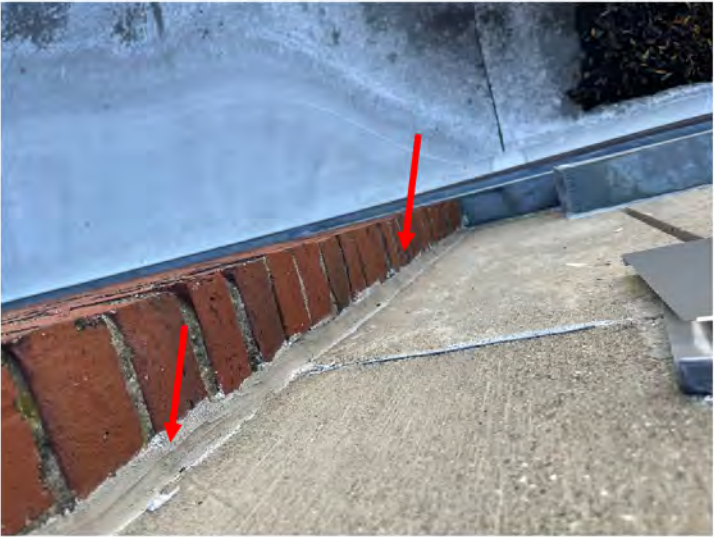
AE-19: Typical sealant at intersection of concrete and brick façade elements, nearing the end of its expected service life.

All façade sealants should be replaced, including those within the masonry facades and at the perimeter of fenestrations and façade penetrations.

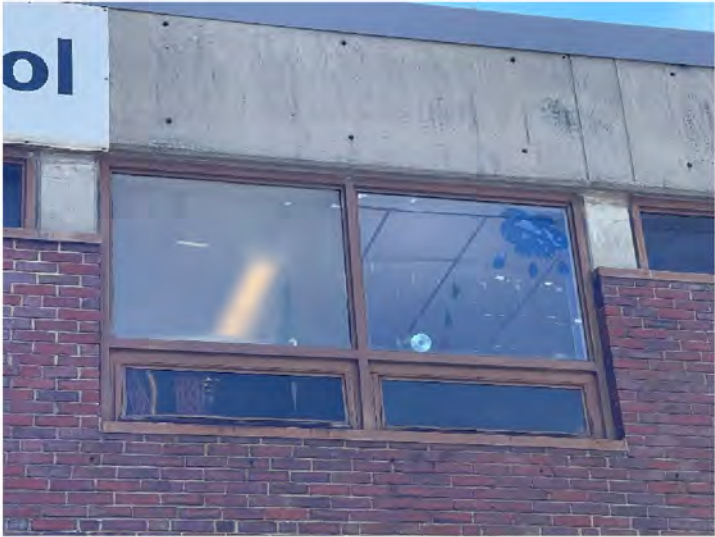
AE-23: Representative steel framed windows with fixed and operable vents, rusting observed on frame.

Replacement of all existing steel windows and door assemblies with new thermally broken aluminum assemblies with insulated glass and Low-E coatings is recommended. Consideration should also be given to replacement of the aluminum windows, or at least the spandrel panels that are corroded.

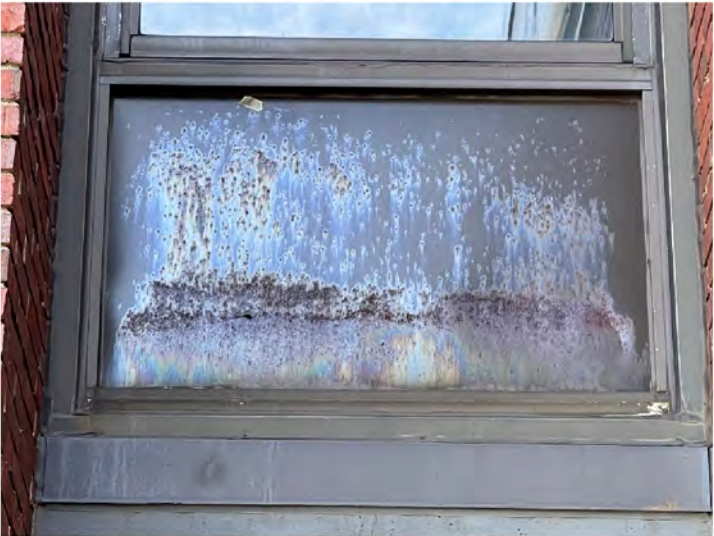
The newer aluminum windows are comprised of thermally broken frames with insulated glazing and are in fair to good condition. The condition of the aluminum spandrel panel below these windows varies as corrosion was observed within these panels in many areas of the building. (Ref: Photos AE-24-26, 33)

AE-25: Typical metal spandrel panel below typical aluminum window assembly. Not corrosion of panel, typical in many locations.

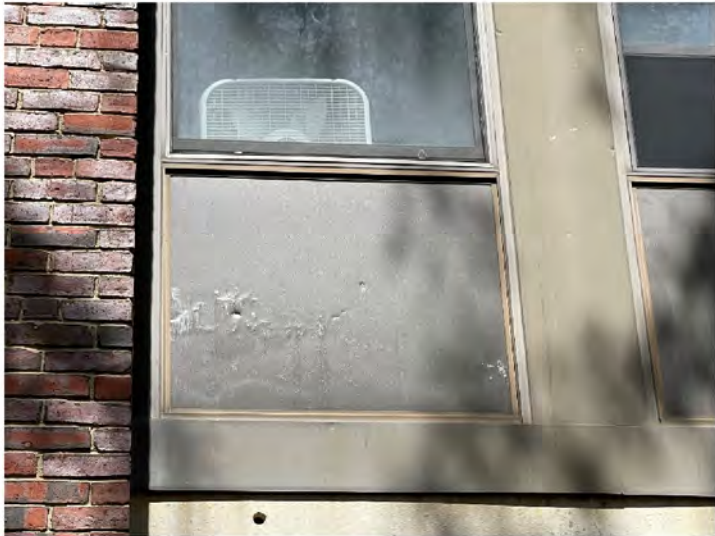
AE-26: Typical metal spandrel panel below typical aluminum window assembly. Not corrosion of panel, typical in many locations.

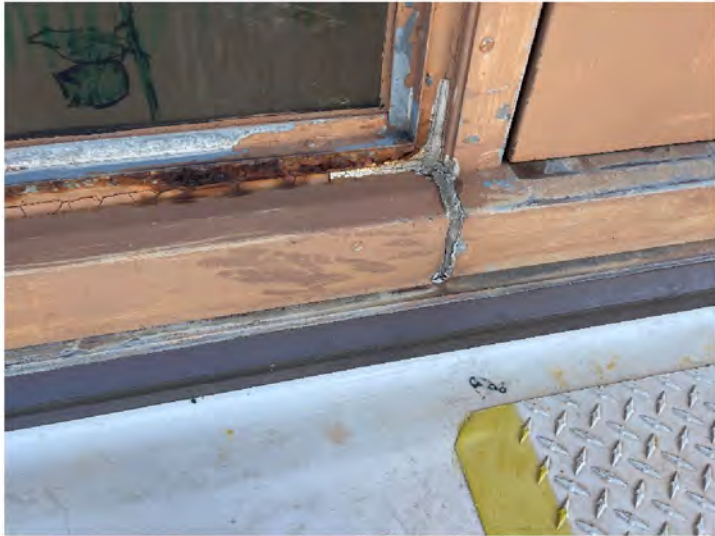
AE-28: Exterior of typical steel framed window assembly located above roof. Note rusting of window frame and various layers of failed sealant.

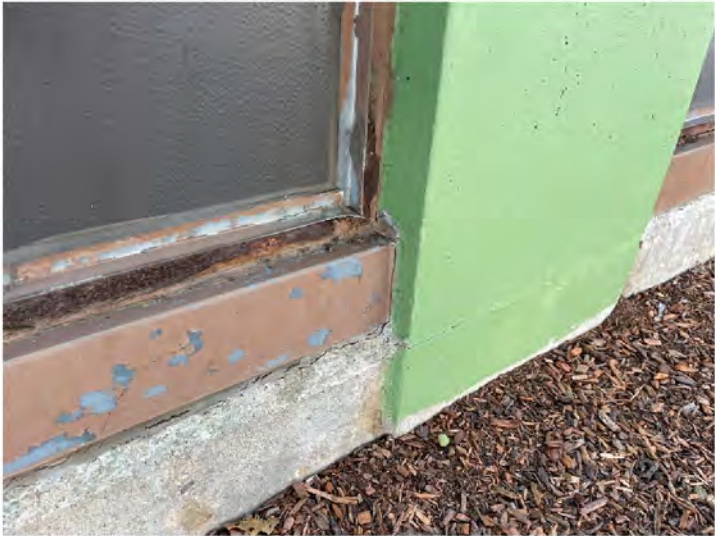
AE-31: Exterior of typical steel framed window with glass lites and metal spandrel panels. Note rusting of framing throughout.

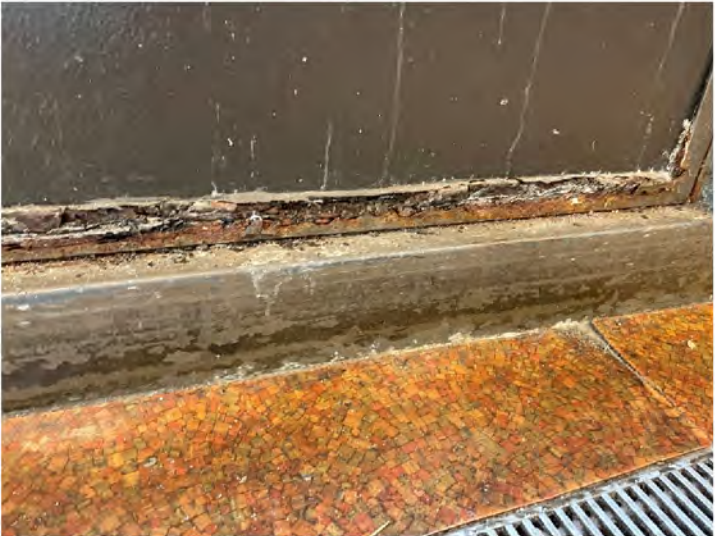
AE-32: Interior of typical steel window frame where rusting is occurring

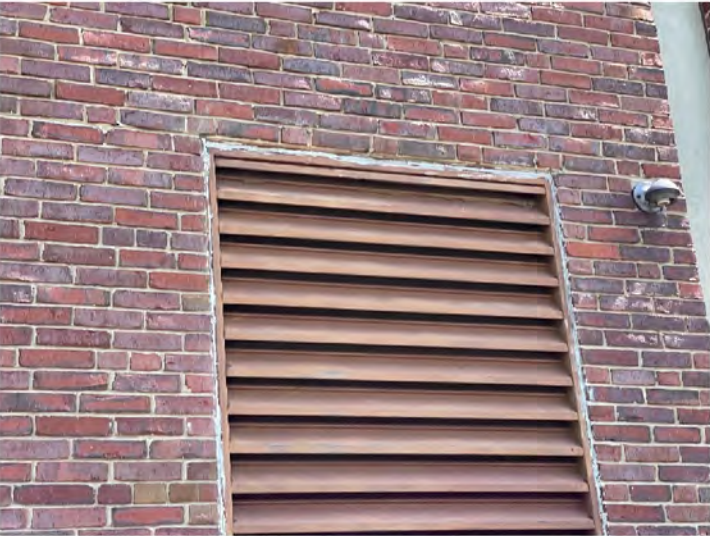
AE-36: Representative mechanical louver on exterior of building, note failed perimeter sealant

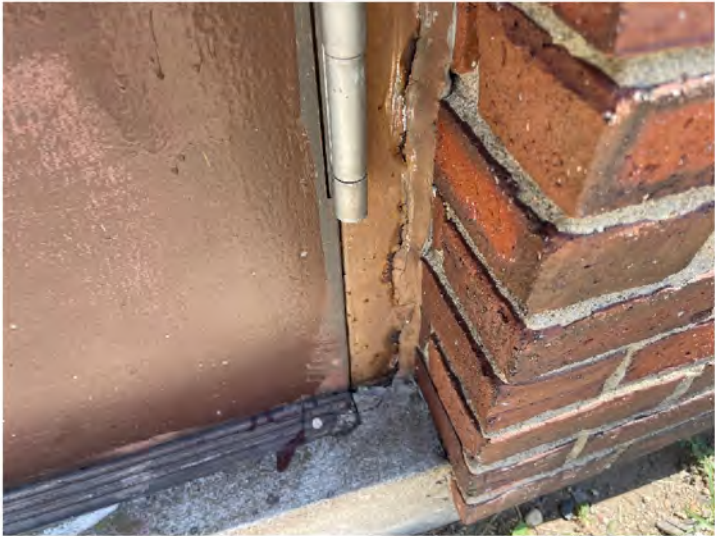
The building’s exterior doors are in poor condition in most locations and comprise hollow-metal framed doors that exhibit rusting and peeling paint on the base of these frames at most locations. Daylight is visible around some of the doors from the interior due to deficient weatherstripping. (Ref: Photos AE-37-42)

AE-39: Typical failed perimeter sealant at typical exterior door

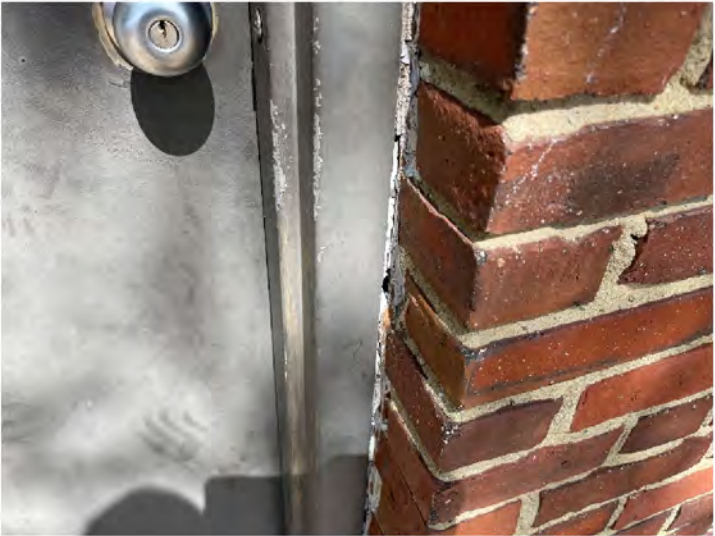
AE-40: Typical failed perimeter sealant at typical exterior door

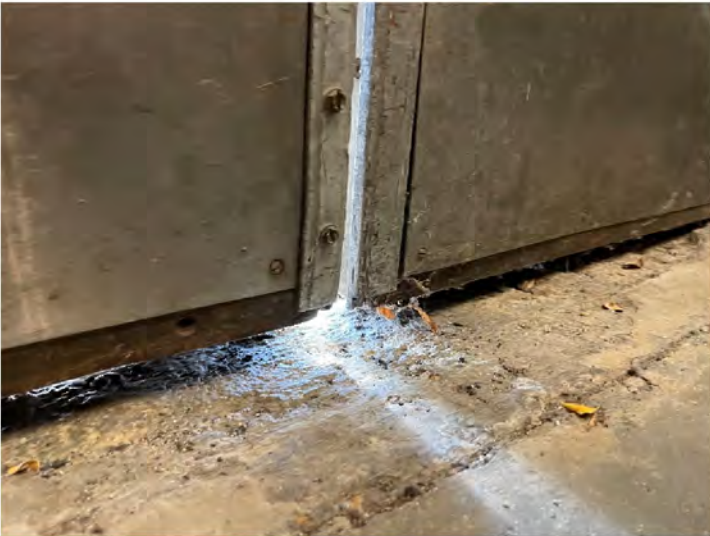
AE-41: Interior condition at base of door where daylight is visible due to failed weatherstripping

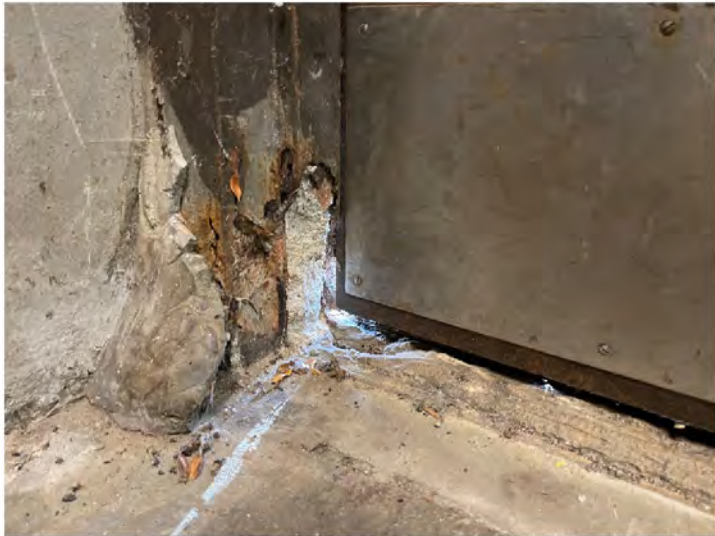
AE-42: Interior at base of typical metal door frame. Note rusting of frame has created a gap at base of door.

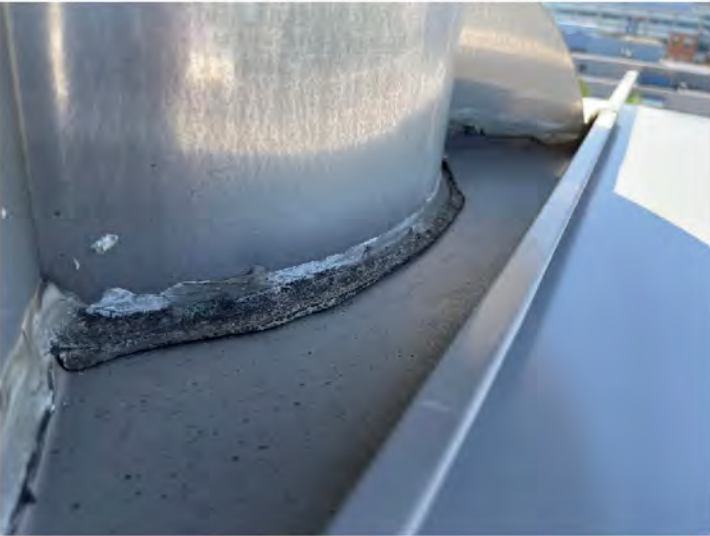
AE-60: Failing sealant at flue penetration in chimney cap

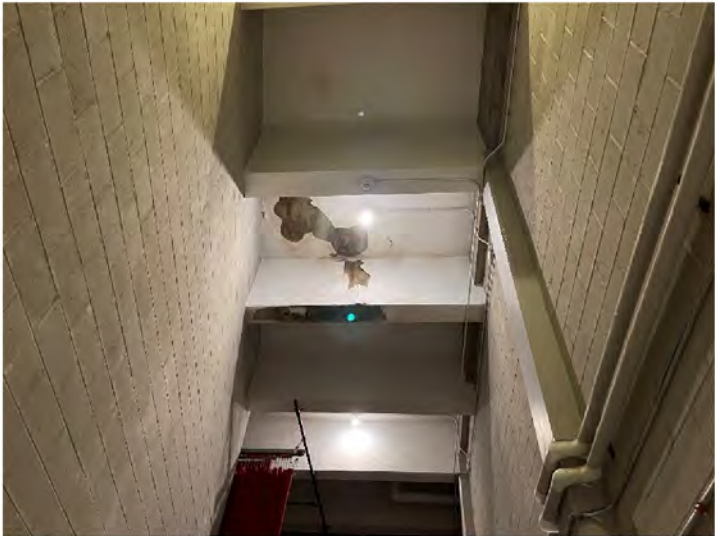
There are water leaks near a roof drain above the Auditorium which reportedly existed prior to when the roof was replaced and continues to be an issue. The interior CMU wall within this space shows efflorescence and moisture on the floor due to this leakage. (Ref: Photos AE-61-63)

AE-61: View of ceiling above active leakage location at hallway adjacent to Auditorium.

A scope of diagnostic water leakage field testing is recommended to identify the source(s) of leakage around the unit skylight above the main lobby and above the Auditorium. Repair work identified through this testing is recommended to be completed thereafter.

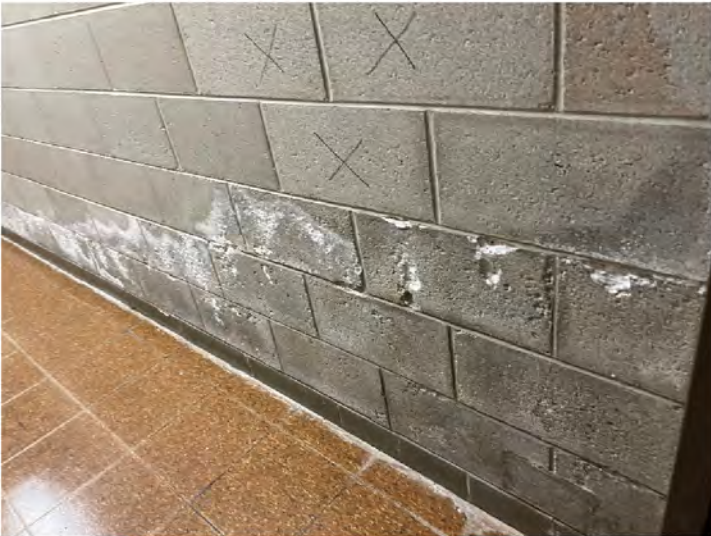
AE-62: Interior of hallway adjacent to Auditorium where efflorescence is present due to active water leakage.

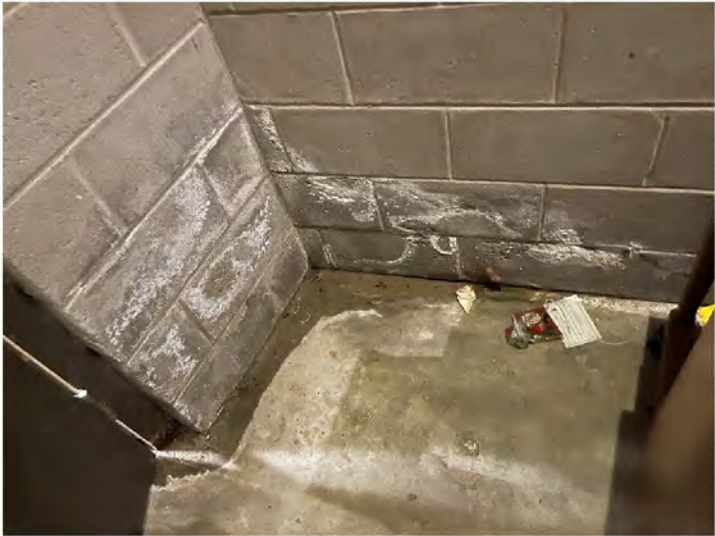
AE-63: Interior of hallway adjacent to Auditorium where ponded water and efflorescence are present due to active water leakage.

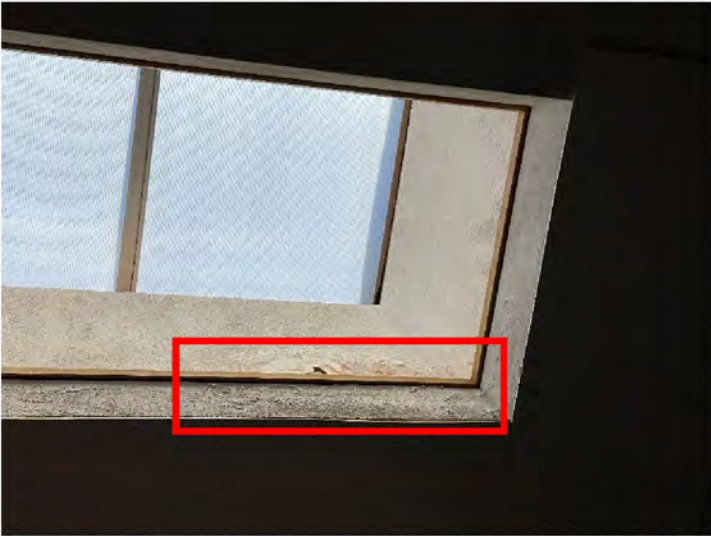
Water leakage also occurs from below the large unit skylight within the main lobby, as evidenced by damaged interior finishes and peeling paint. (Ref: Photo AE-64)

AE-64: Interior of skylight at main lobby where there is ceiling damage from water leakage
