# LONGFELLOW BUILDING

359 Broadway  
Cambridge, MA 02139

**Facilities Condition Assessment : October 19, 2022**

## 7.8 | LONGFELLOW BUILDING BUILDING APPENDIX

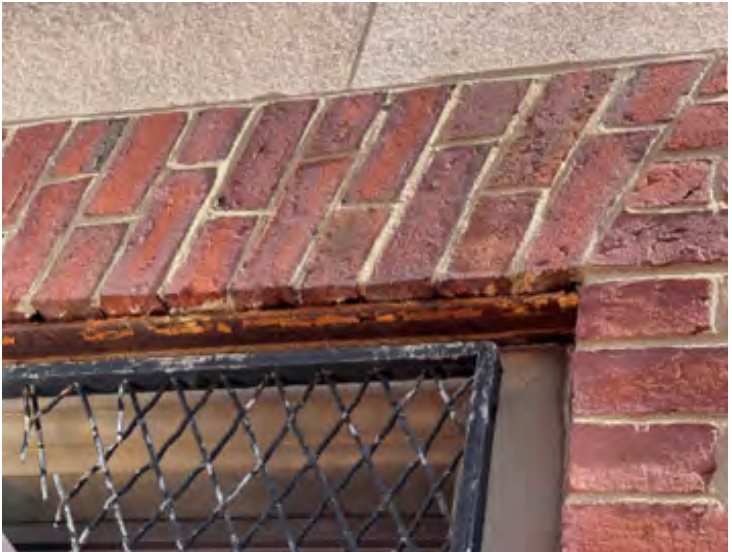
There are isolated locations of cracked and displaced brick and mortar as a result of rust jacking of steel lintels at the head of window openings on the East and North Elevations and at infilled window openings on the North Elevation. (Ref: Photos AE-11-12) Some peeling paint and rusting of the steel lintels was also observed. (Ref: Photos AE-22, AE-B)

AE-B: Representative rusting steel lintel at window head

Masonry:  
In conjunction with window replacement recommended below, the existing steel lintels could be replaced with new galvanized lintels to reduce potential for future rusting and rust jacking damage to the brick and mortar. A short-term repair could include scraping and painting of the existing steel lintels, and introduction of soft joints where the mortar is cracking and becoming displaced due to the rust jacking lintels.

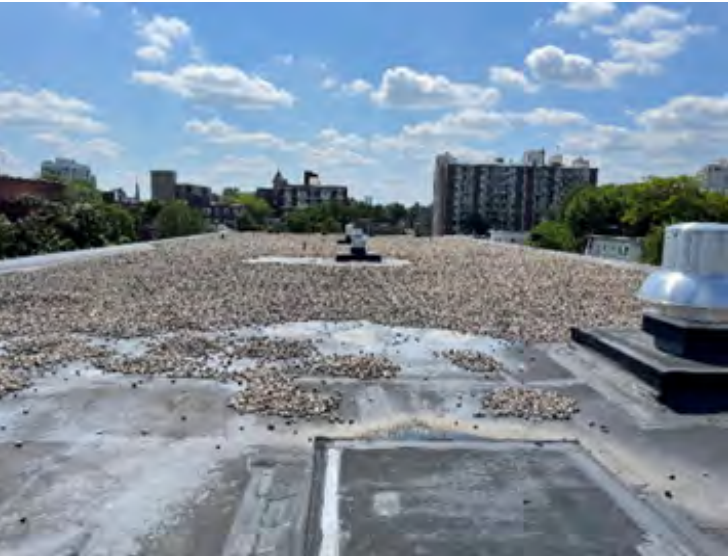
Roofing:  
The roofing assembly is surfaced with a ballasted EPDM on a concrete waffle slab deck, with access via a roof hatch. The EPDM roof is in poor condition overall and the ballast is not uniformly distributed throughout the roof. (Ref: Photos AE-C-D) Drainage occurs through internal roof drains and no secondary means of drainage was observed.

AE-C: Representative view of roof. Note ballast is not evenly distributed, leaving areas of exposed / unsecured EPDM.

Roofing:  
Replacement of the existing roofing system is recommended. The roof has exceeded its expected service life and should be replaced with a new roofing system with Code compliant insulation.

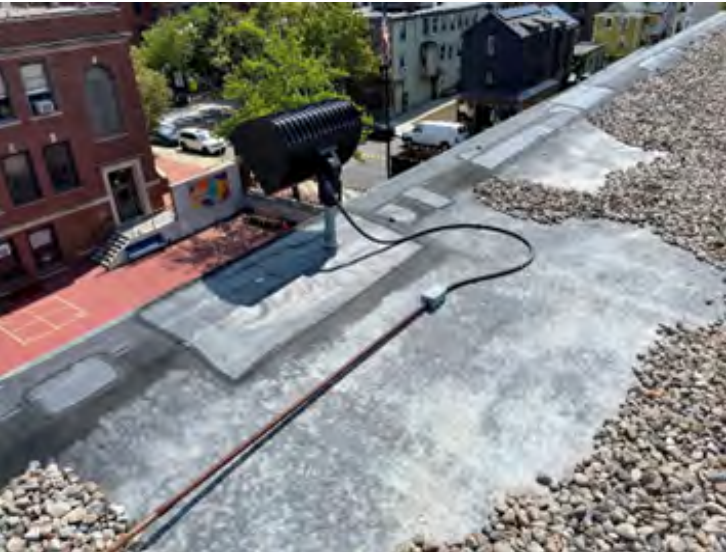
The extent of insulation (if any) or other existing roofing systems below the EPDM is unknown. The EPDM is loose laid below the stone ballast and appears tented along much of the perimeter, with various patches in these areas. (Ref: Photos AE 27-30)

AE-D: Representative roof edge condition at EPDM roof. Note multiple patches due to damage over time.

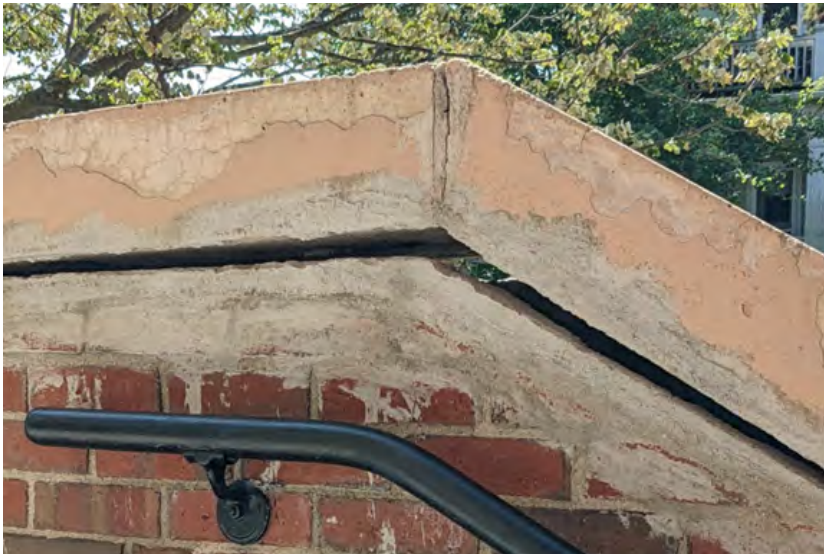
Photo ST-1: Loose Wall Cap at Site Stair

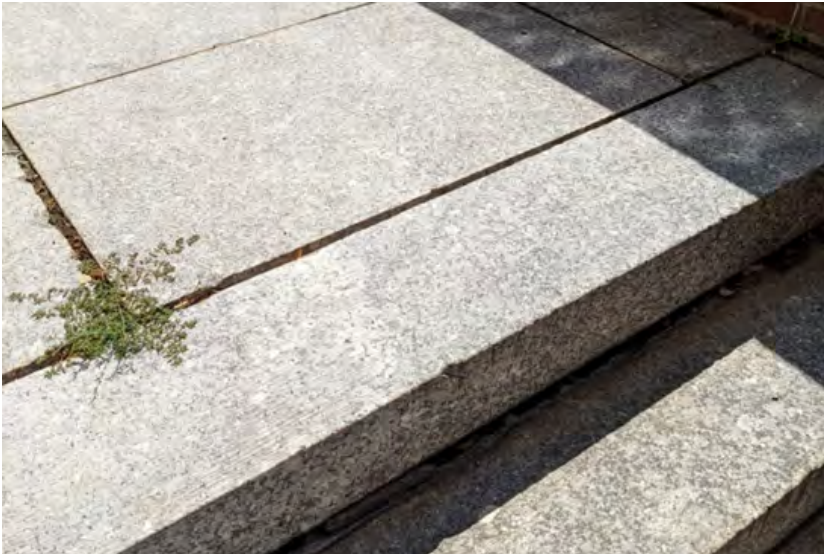
Photo ST-2: Open Joints in Granite

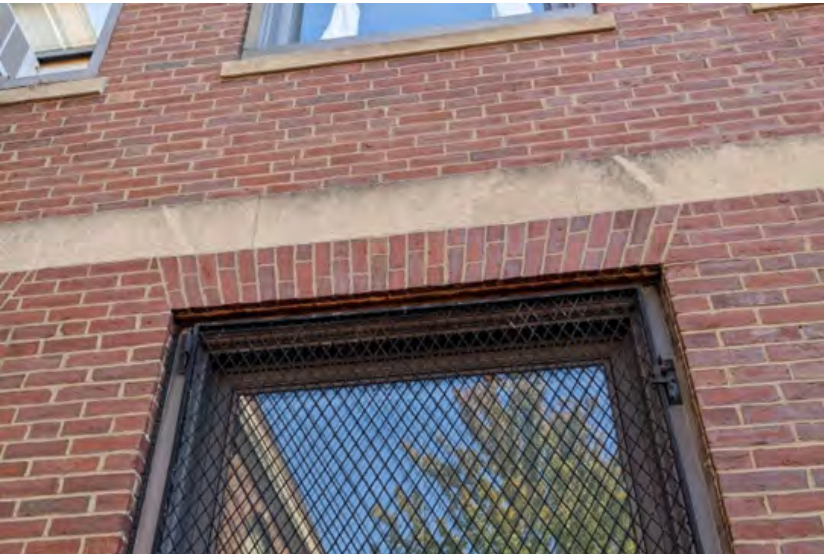
Photo ST-3: Sagging Lintel (Rust-Jacking)

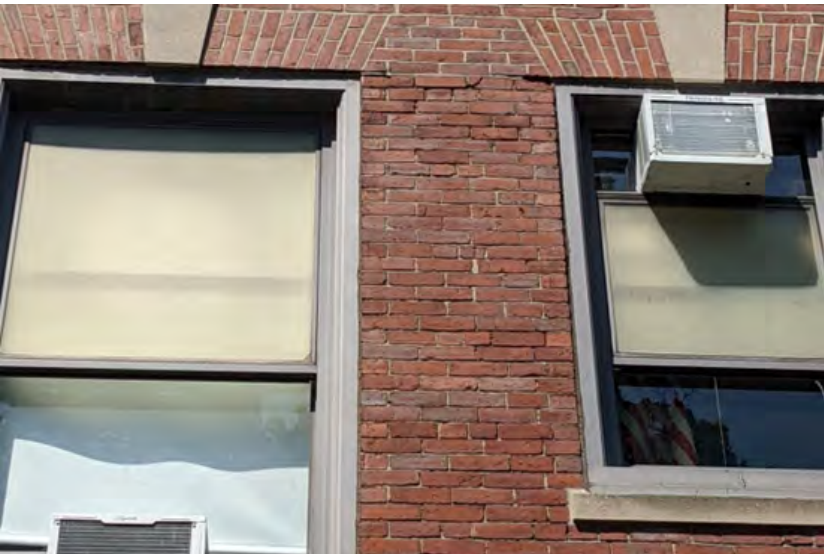
Photo ST-4: Brick Joints in Need of Repointing

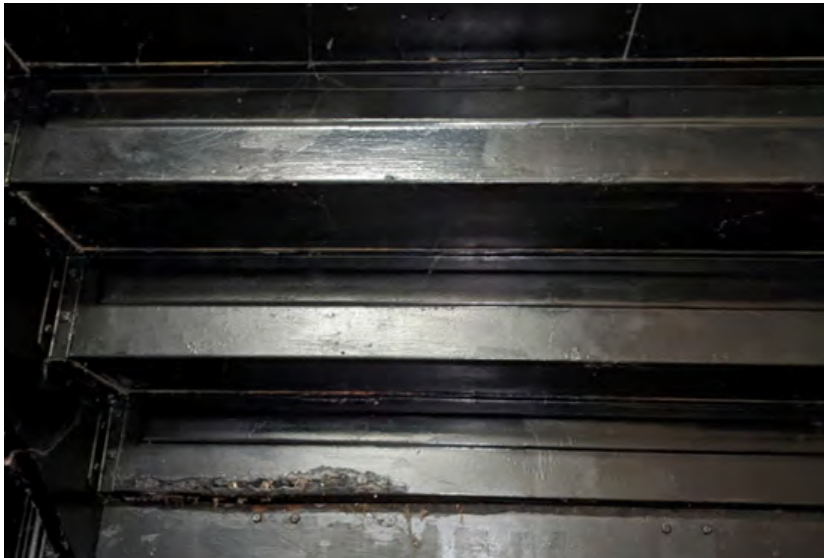
Photo ST-5: Corrosion of Stair Tread/Riser

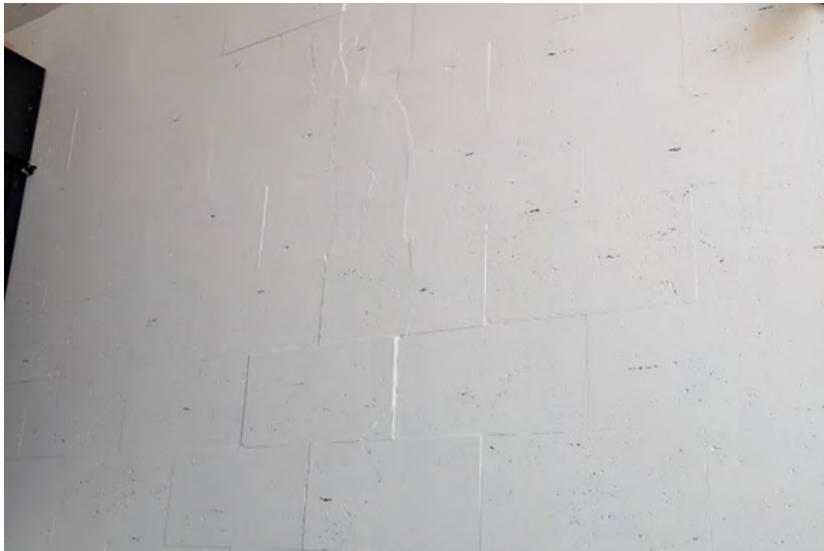
Vertical cracks in the block wall construction and horizontal displacement of masonry units were observed in Stair 1. This condition appears to be structurally related; further investigation is warranted. Additionally, the exterior wall finishes on the southwest elevation of the south wing of the building appeared to bulge outwards below the roof. Further investigation of the exterior wall along this elevation is recommended to confirm structural integrity and stability have not been compromised. Refer to Photos ST-6, ST-7 and ST-8.

Photo ST-6: Cracking and Displacement of Masonry Units - Stair No. 1

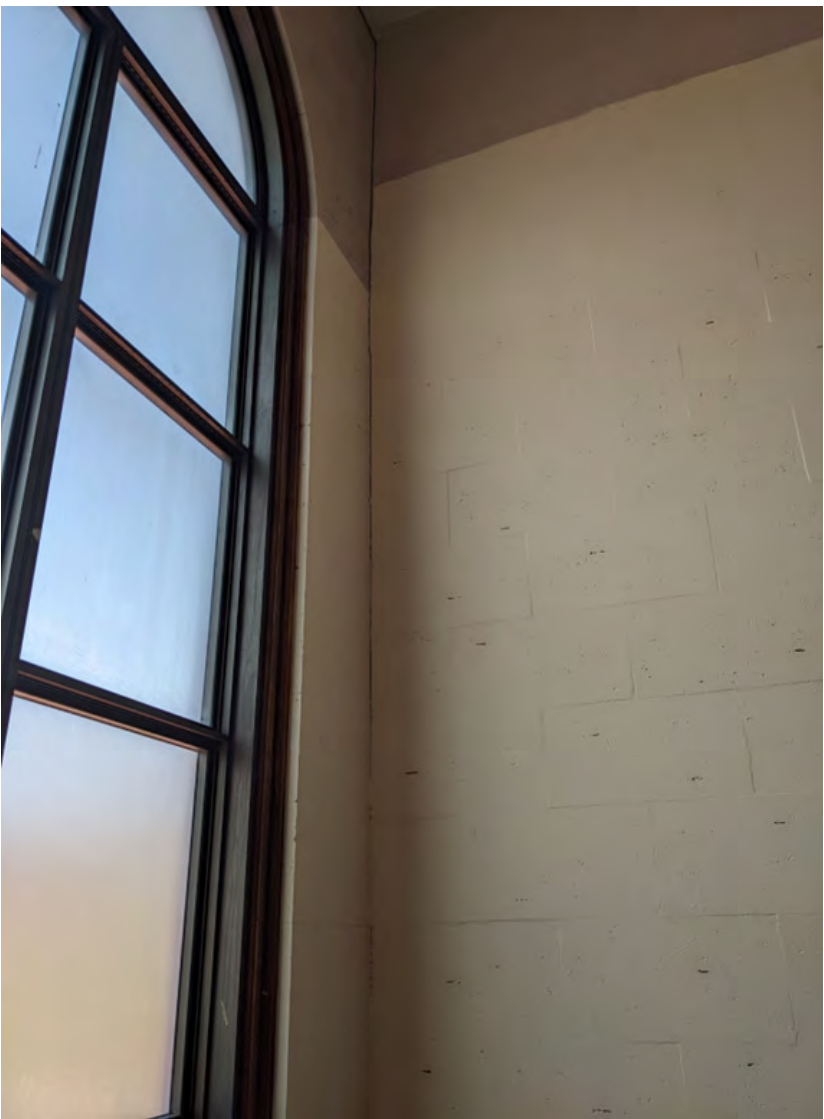
Photo ST-7: Gap Between Perpendicular Walls

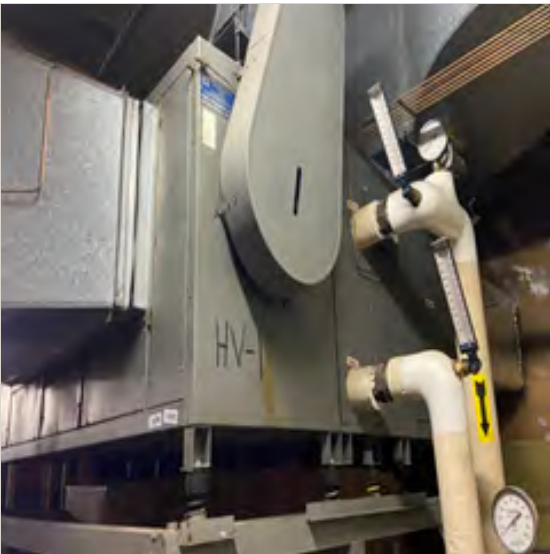
M-3: Air Handler Condition

Ductwork systems are approaching the end of expected service life and should be considered for replacement along with equipment upgrades. Hot water piping system should also be considered for replacement along with equipment upgrades as service life is variable and dependent on system tightness, isolation of dissimilar metals, and water treatment program. At a minimum, piping systems should be inspected if intended to be re-used as part of equipment upgrades. A change-out of system type using heat pumps will require upgrade of the ductwork and piping systems.

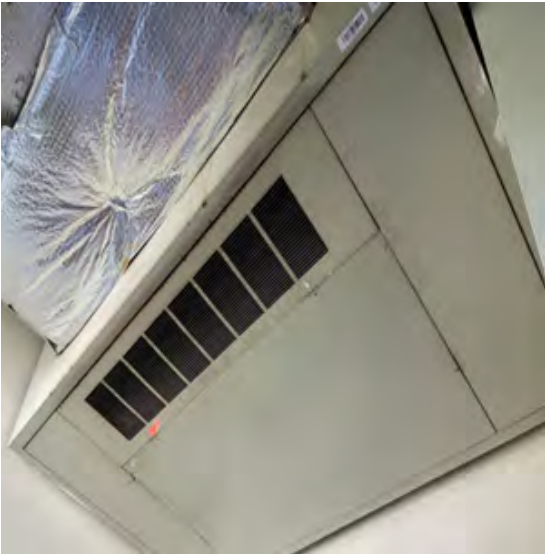
M-4: Fan Coil Unit Condition

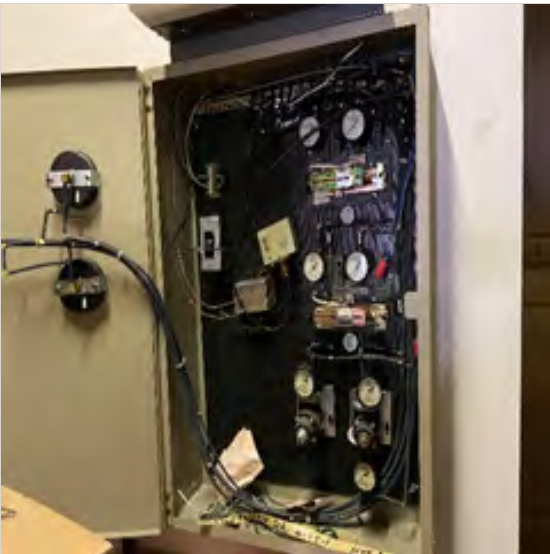
M-6: Original Pneumatic Control Panel

*Recommendations*  
Most of the building automation system is beyond expected service life and should be replaced concurrent with equipment replacements. Replacement systems should include a complete system of DDC controllers, sensors, actuators, and head-end graphics.

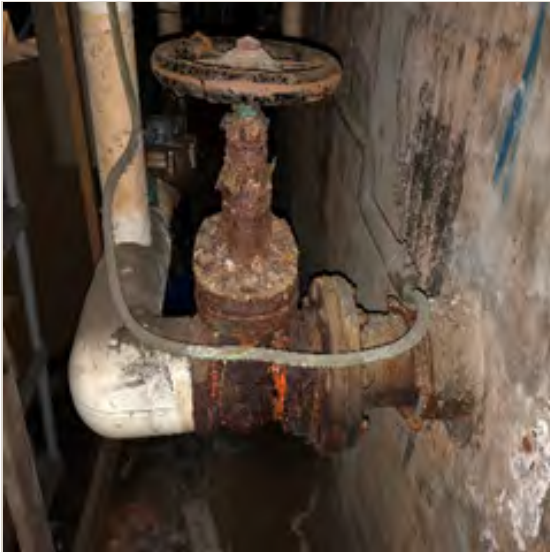
PL-1: Corroded Water Service Valve

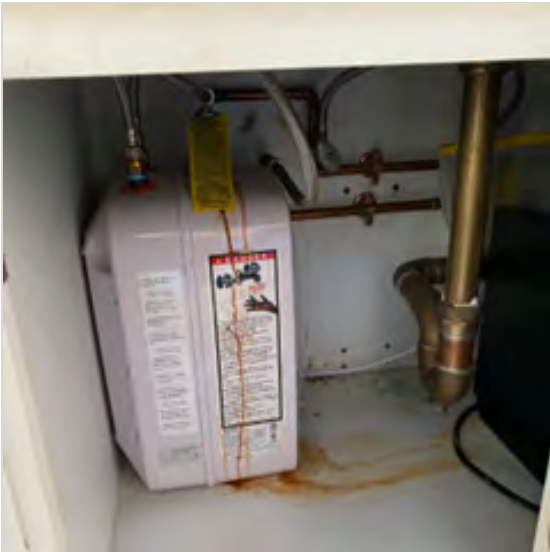
PL-2: Corrosion on Point of use Water Heater

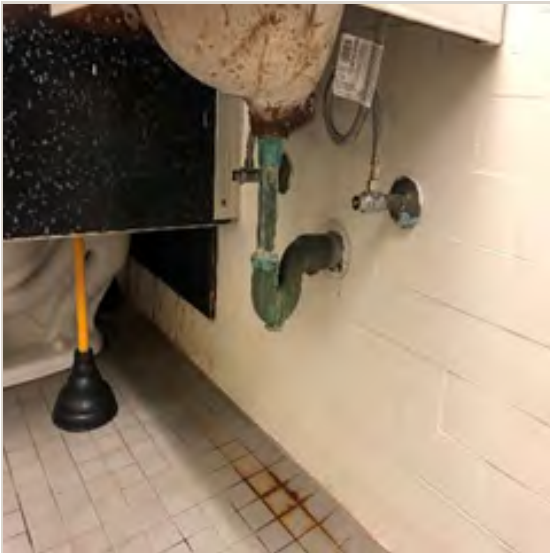
PL-4: Corroded Lavatory

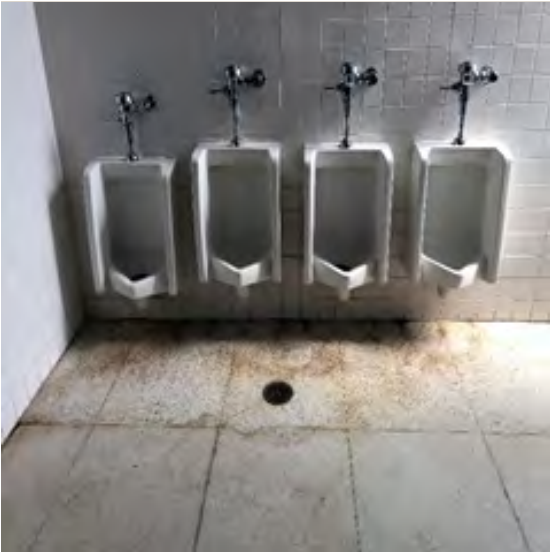
PL-5: Privacy Shields Should Be Provided

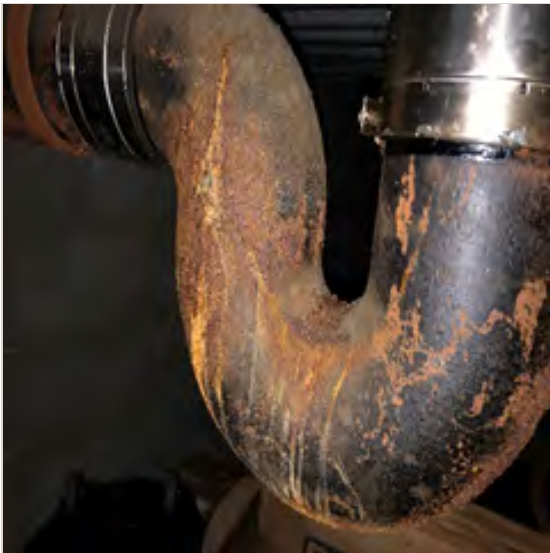
PL-6: Cracked P-Trap

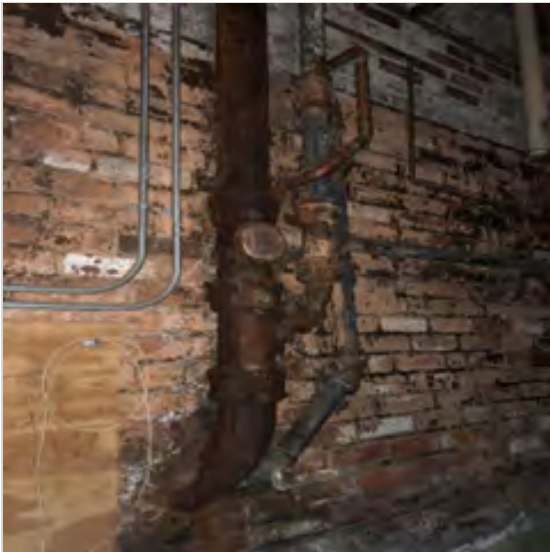
PL-7: Heavily Corroded Cast Iron Pipe

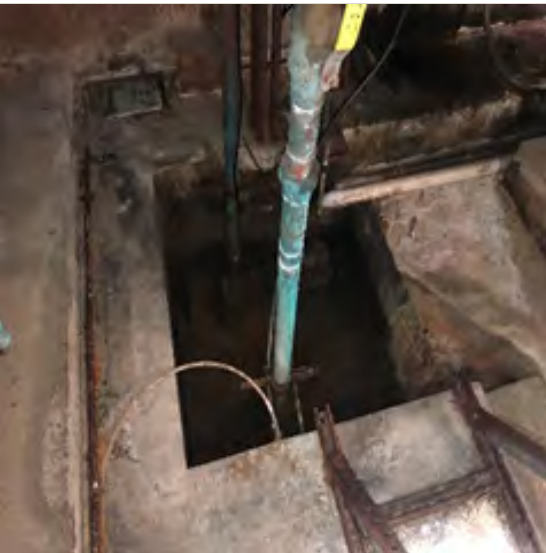
PL-8: Heavily Corroded Sump Pump Discharge Piping

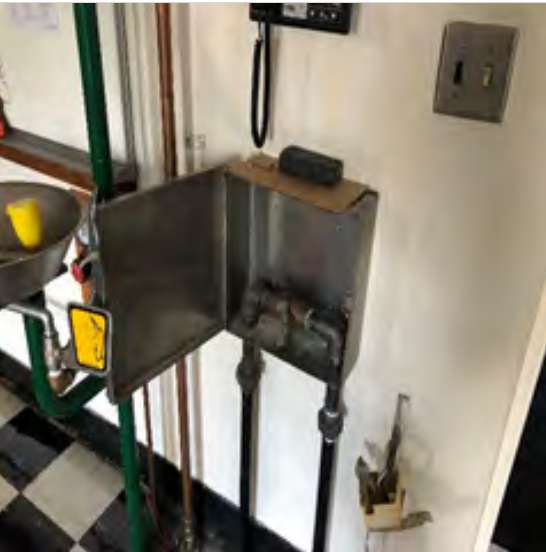
PL-9: Existing Gas Valve Cabinet

*Recommendations*  
The existing gas isolation valves located in each of the science classrooms are in a surface mounted cabinet with a hinged door. The Massachusetts Plumbing Code requires the gas valves to be readily accessible which would prevent the use of the cabinet door.

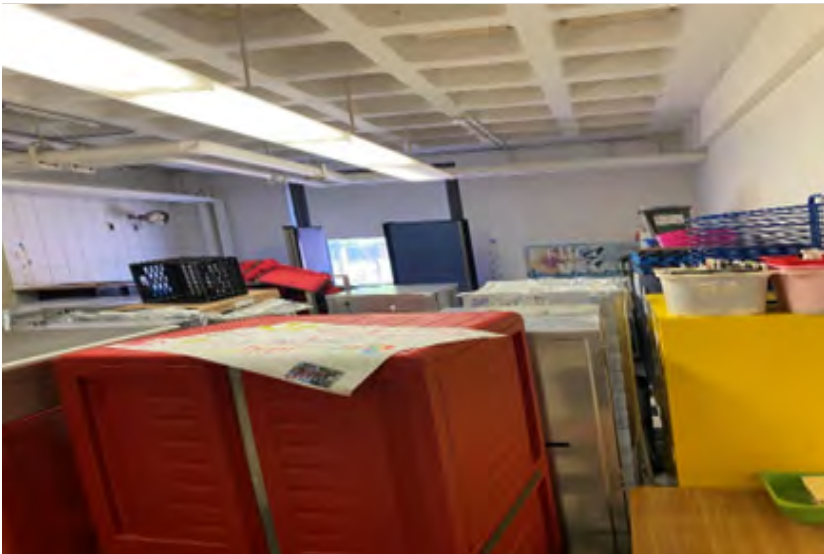
FS-1: There is no finished ceiling in this space which is required by health code in commercial kitchens. Due to the lack of a finished dropped ceiling, all utilities and mechanical equipment is exposed and this prevents proper cleanability of the kitchen space.

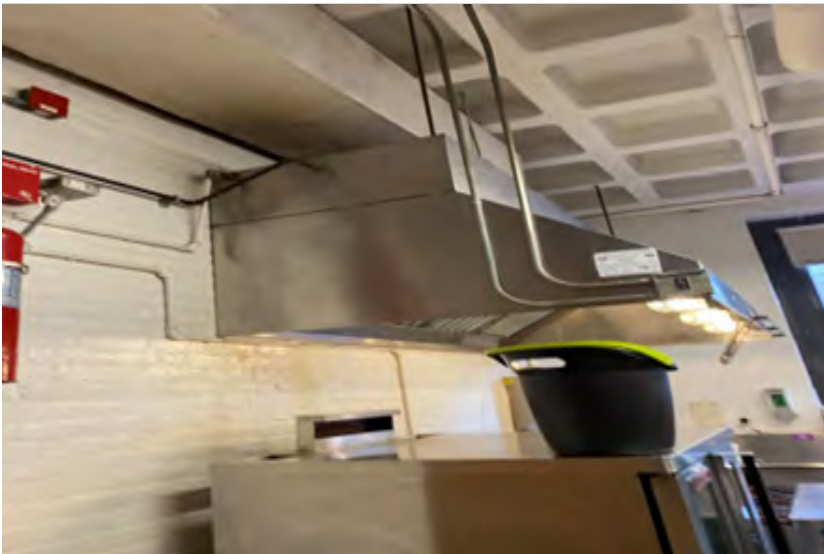
FS-2: The exhaust hood in this kitchen is extremely old and not properly closed off to the ceiling above. The angled surfaces are an area that collect dirt, debris and dust and cannot be properly cleaned. Modern code requires vertical closure panels from the top of the hood to the finished ceiling.

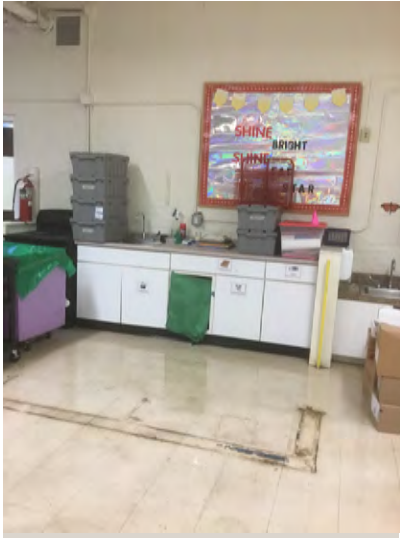
Damaged millwork

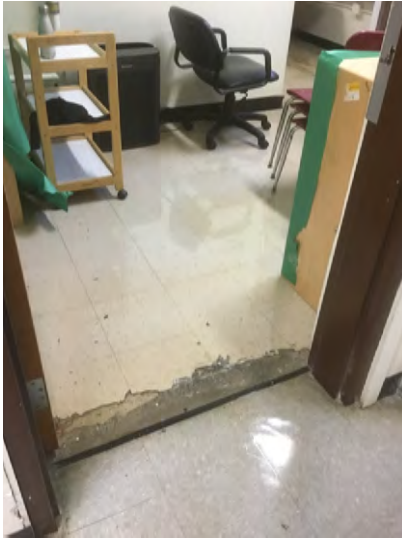
Floor damage

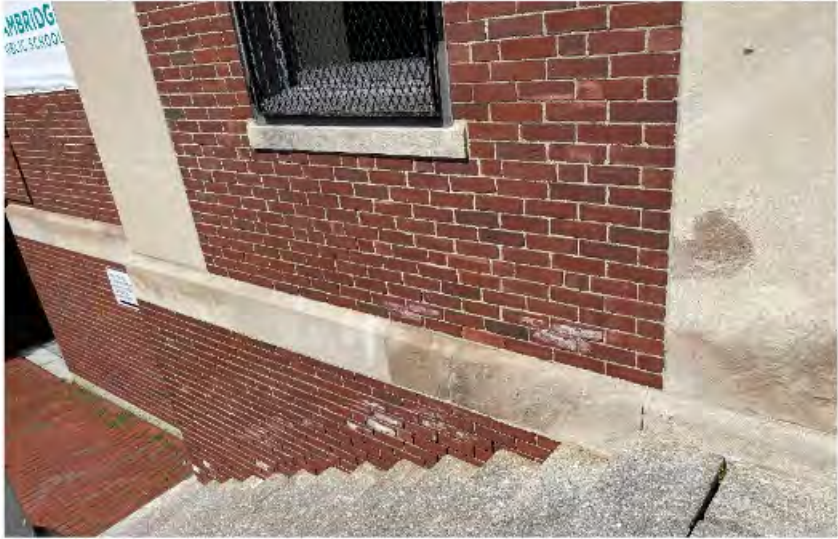
AE-9: Representative precast concrete coping cap at West Wing. Note failed sealants between caps.

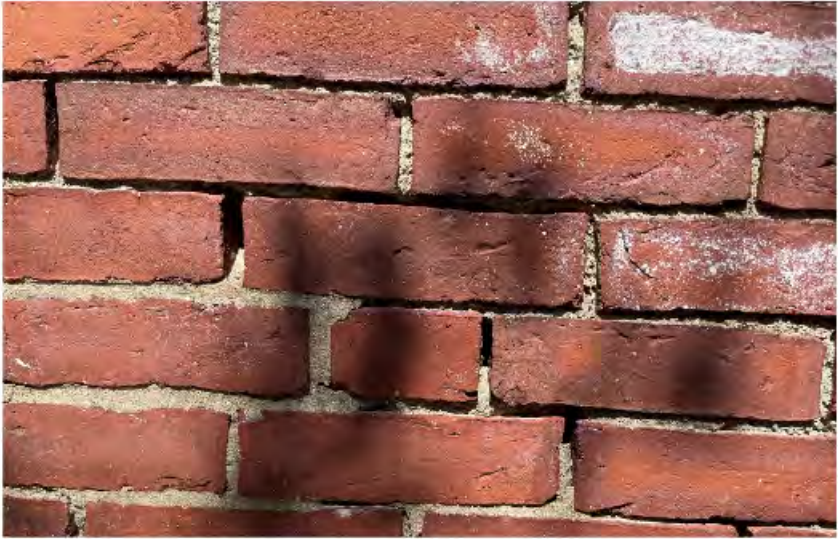
Masonry:  
The masonry façade is largely in good condition and there is evidence of repointing in some areas. Tie backs with steel plates were observed at the West wing of the building, potentially as previous structural repair work, or for securement of gym equipment on the interior. (Ref: Photo AE-8) Deteriorated mortar joints and efflorescence were observed along the South façade near building entrances, along with deteriorated mortar at the adjacent granite steps. (Ref: Photo AE-10)

AE-10: Representative brick masonry with deteriorated mortar, typical near stairs at building entrances

A scope of masonry cleaning and repointing should be undertaken in areas of deteriorated mortar near building entrances to extend the service life of the masonry and to reduce potential for interior water leakage.

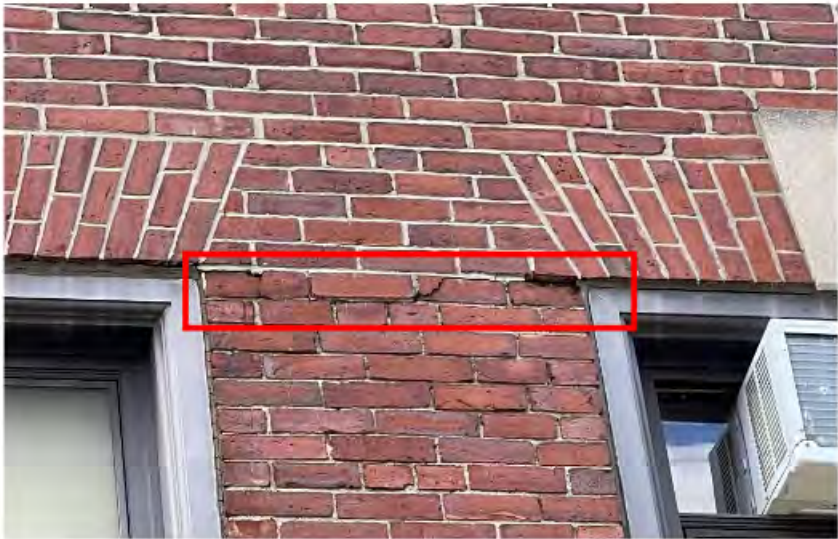
AE-11: Representative rust jacking of steel lintels, resulting in cracked brick and mortar

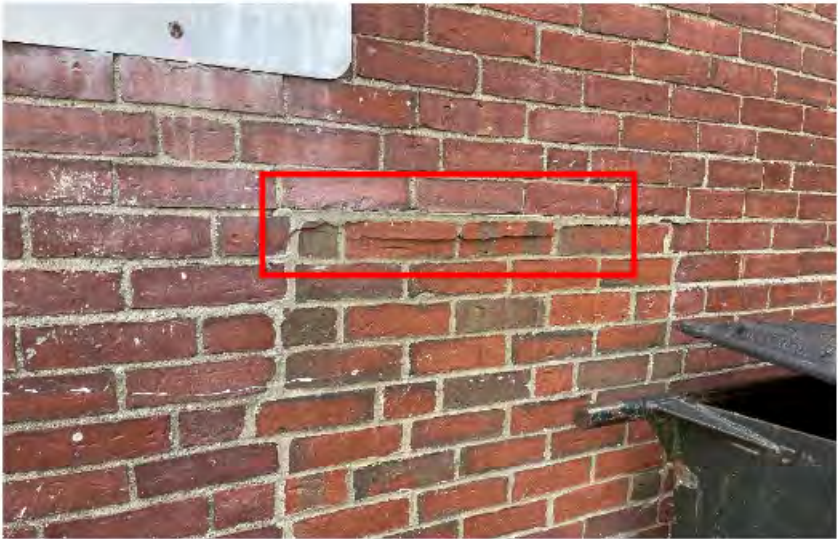
AE-12: Representative cracked brick and mortar at rust jacked lintel at infilled opening within façade

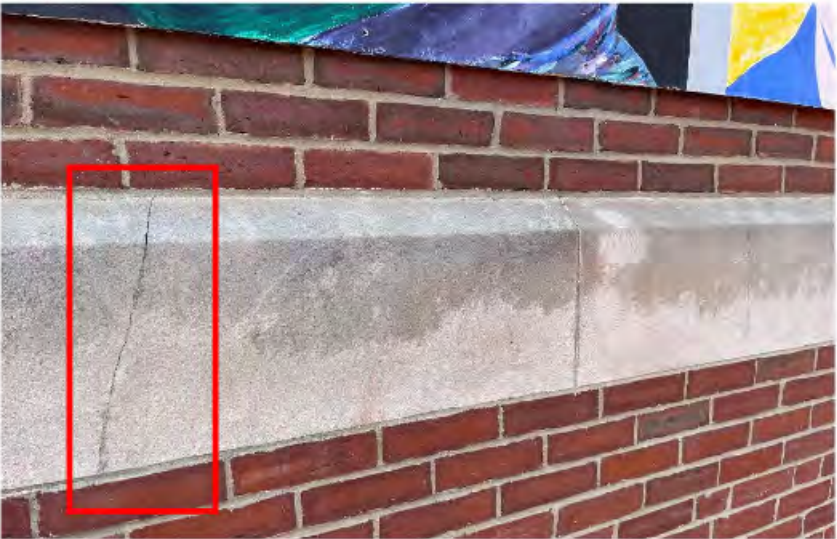
Cracking of the limestone is evident at various locations throughout the façade, including at the horizontal accent bands and at decorative stonework surrounding building entrances. (Ref: Photos AE-13-17)

AE-13: Representative cracked limestone band

Repair of cracked limestone and the foundation wall is also recommended. Further investigation is needed to determine the source(s) of leakage into the lower level below the East entrance on the South Elevation, although there is potential that is related to deficiencies in the masonry façade outside of this area.

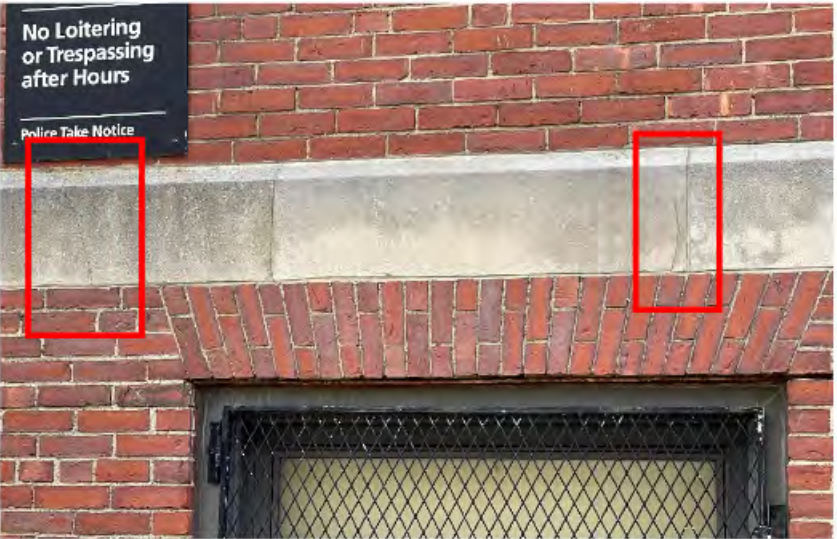
AE-14: Representative cracked limestone band

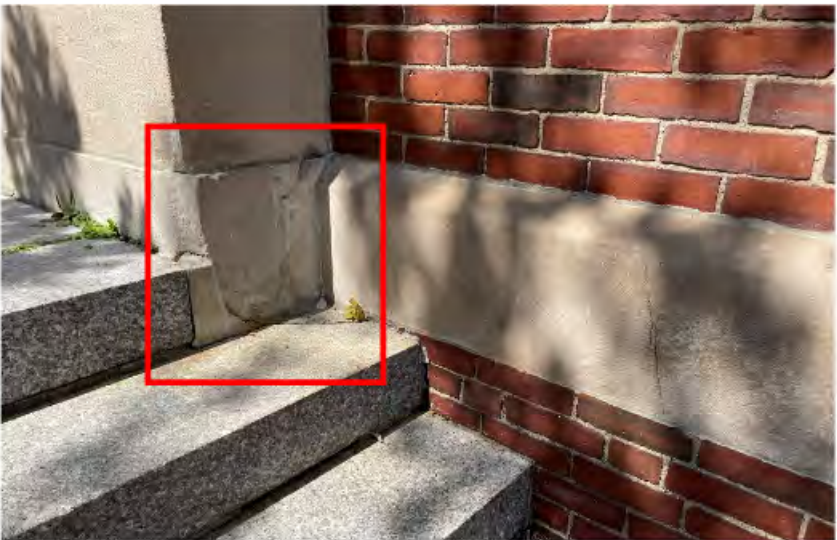
AE-15: Representative spalled limestone near building entrance, cracked limestone band

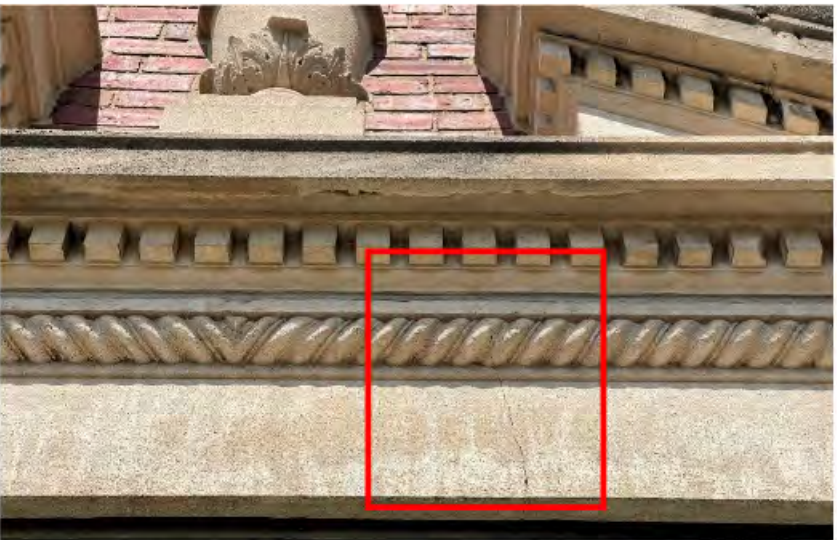
AE-16: Representative cracked limestone at building entrance

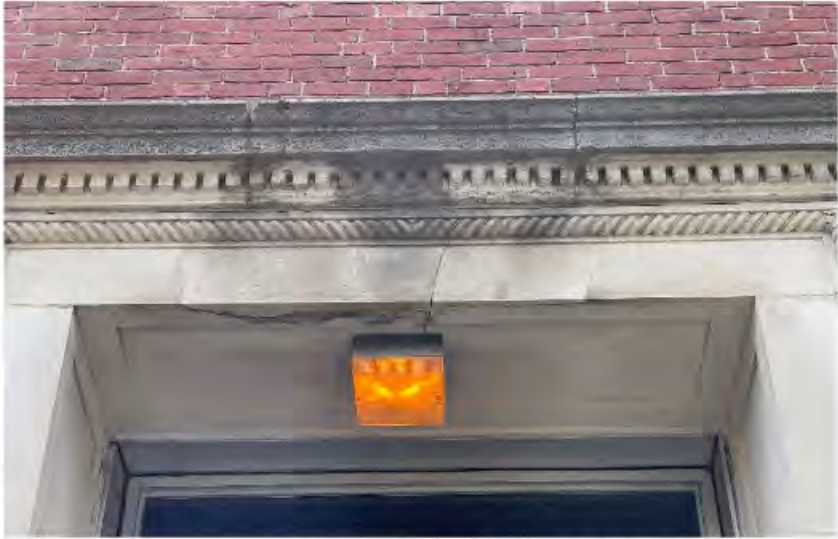
AE-17: Representative cracked limestone at building entrance

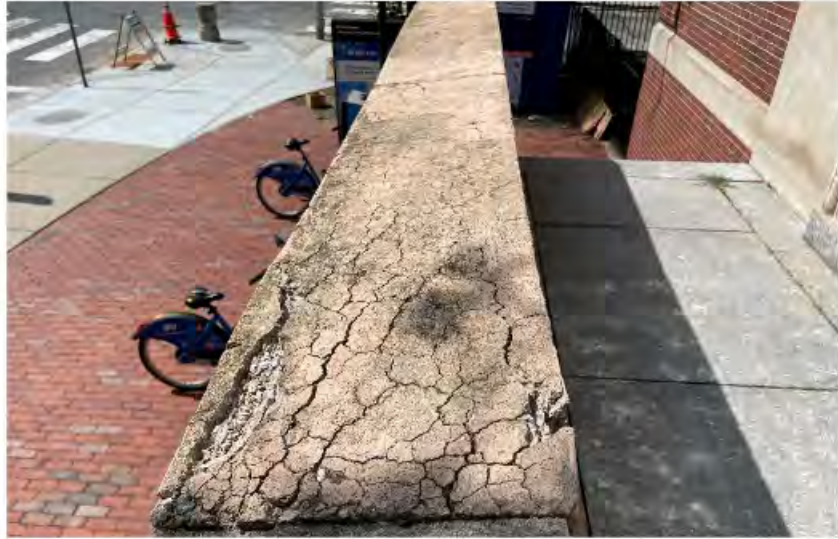
AE-18: Typical spalled cast stone cap at exterior stair to building entrance

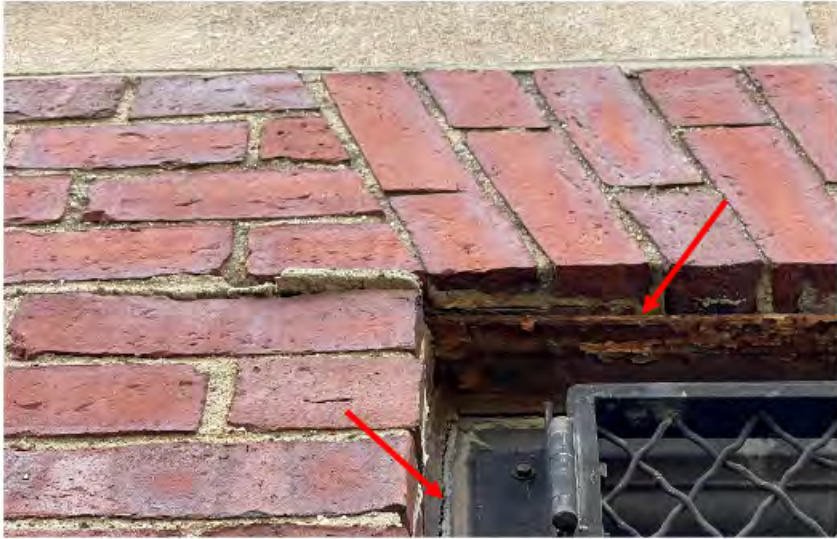
Windows and Doors:  
The windows are aluminum double hung replacement assemblies with single pane glass and non-thermally broken frames. The windows are in fair condition overall. Security grilles are installed on the exterior at the lower floors, and some windows have been retrofitted to accommodate air conditioners. Exterior perimeter sealants have failed at most windows observed. (Ref: Photo AE-22)

AE-22: Representative aluminum window: Typical rusted lintel with peeling paint, typical failed window perimeter sealant

Windows and Doors:  
The existing windows be replaced with new aluminum windows with thermally broken frames and insulated glazing with Low-E coatings.

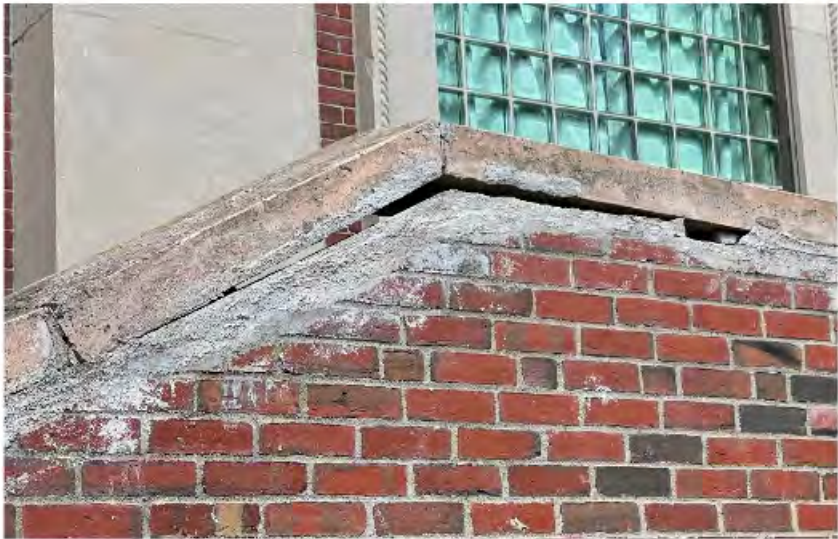
AE-19: Typical spalled and displaced cast stone cap at building entrance

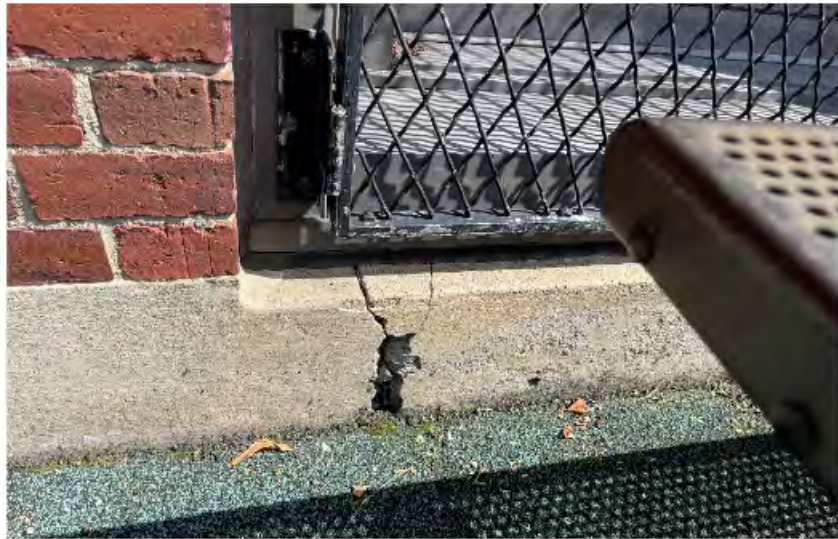
Cast stone caps installed at exterior walls surrounding the building’s entrances are cracking and spalling, with displacement of the caps observed at the West entrance. (Ref: Photos AE-18-19) Minor cracking of the foundation was observed on the West Elevation. (Ref: Photo AE-20)

AE-20: Typical cracked and spalled foundation wall

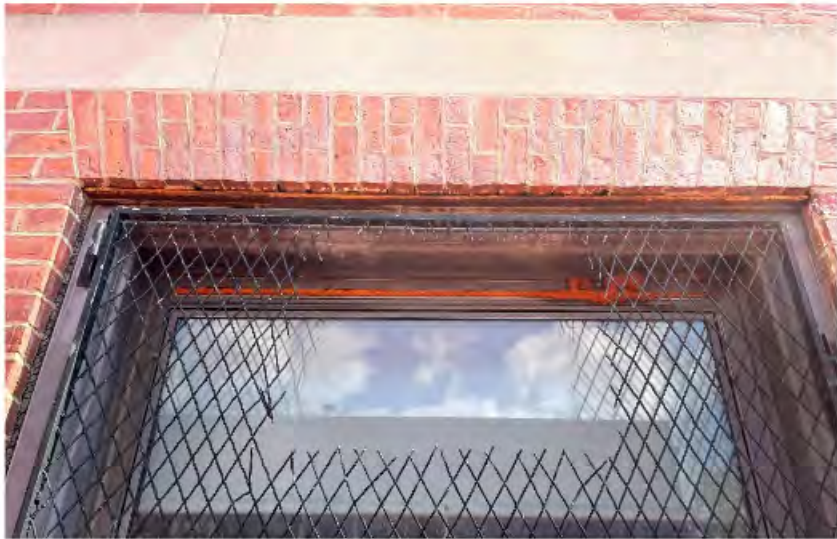
AE-23: Window at lower level where perimeter of upper sash is filled with spray foam insulation

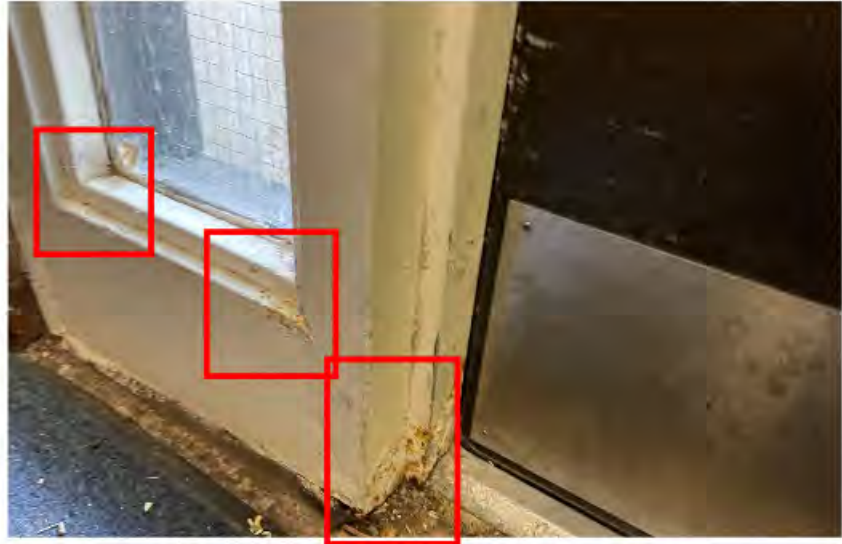
AE-25: Interior of typical exterior door: Note rusting of door frame

Some of the surface rusting observed at the hollow metal doors and frames may be due to use of deicing salts during the winter months. Reduction in use of these materials against these metal assemblies should reduce potential for further damage. The replacement of doors and frame is recommended.

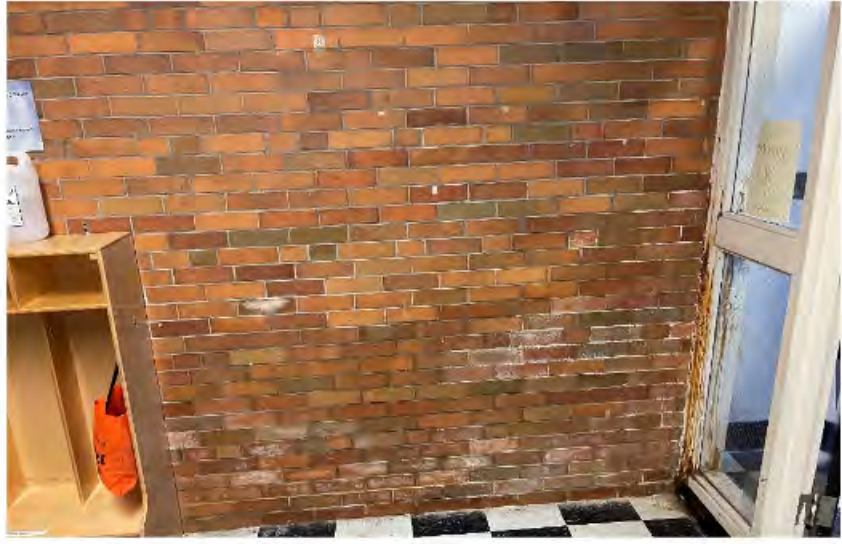
There is efflorescence on the interior brick wall and rusting on the adjacent interior hollow metal door assembly located on the lower level below the East entrance at the South Elevation. (Ref: Photo AE-26)

AE-26: Efflorescence on brick and rusting of door frame on interior of building at lower level below Main entrance at East Wing

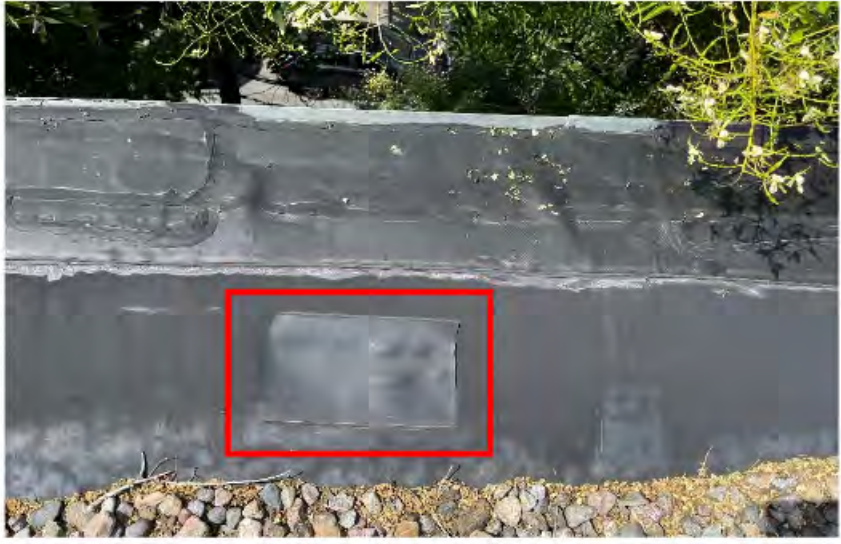
AE-29: Typical patch in EPDM roofing lacking termination lap sealant at perimeter

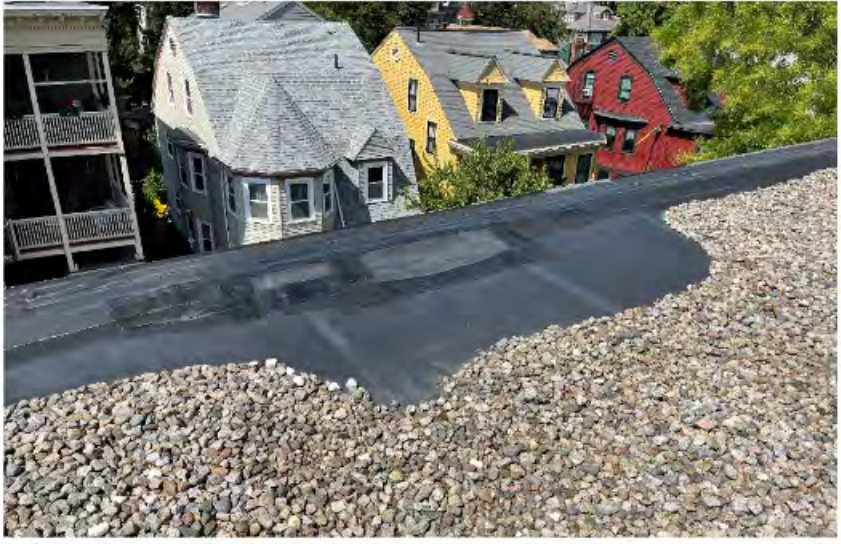
AE-30: Typical patches in EPDM at perimeter of roof. Note, EPDM is loose laid on this roof, is tented along perimeter in most conditions.

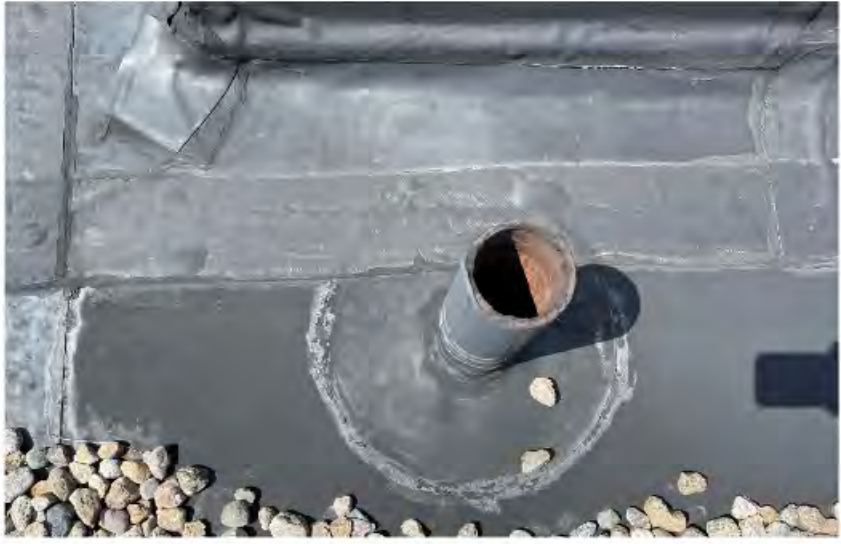
Prefabricated flashing boots and miscellaneous EPDM field repair patches were observed at various locations throughout the roof, with some failing lap sealants and associated flashings becoming unadhered. (Ref: Photos AE-31-32)

AE-31: Typical vent pipe penetration through roof, failing lap sealant at perimeter of flashing boot

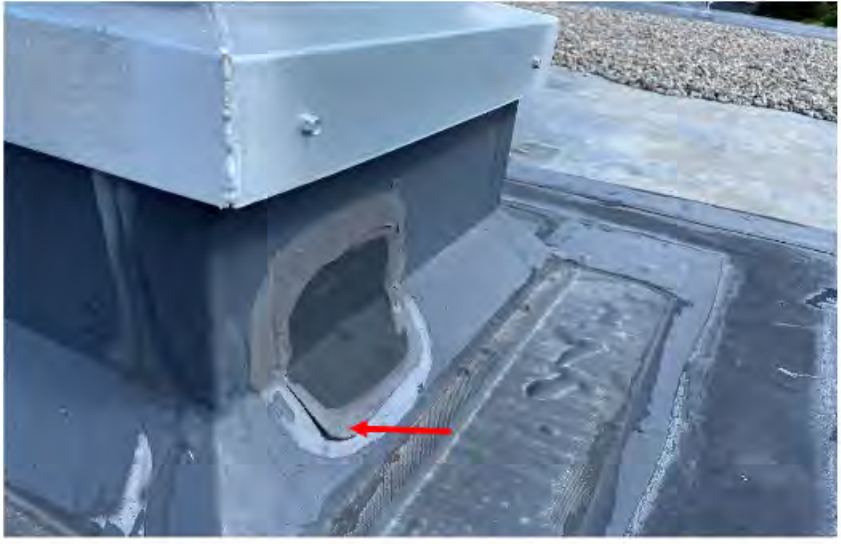
AE-32: Typical EPDM patch applied to MEP curb that is lacking adhesion, lap sealant has failed

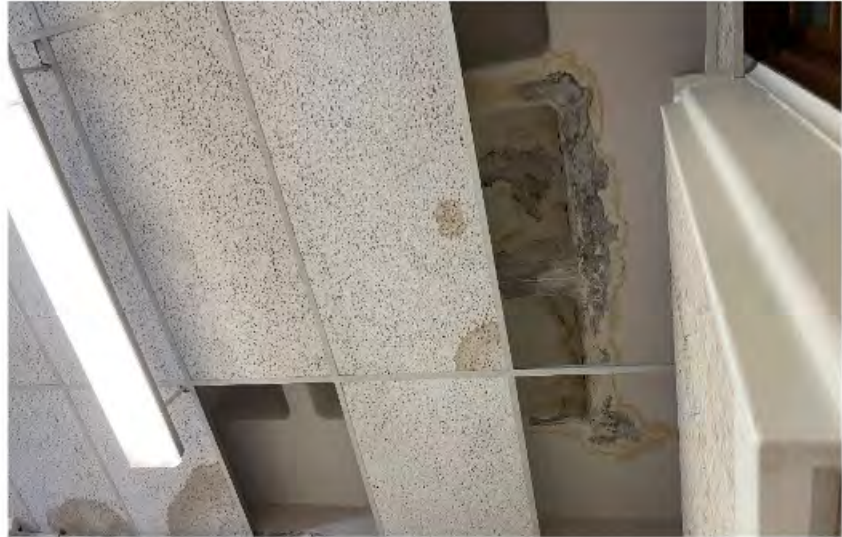
Reported Envelope Issues:  
While on site, discussions were held with facilities personnel to identify any building exterior-related issues that may exist. Those present were shown interior locations of recurring water leakage at Room 109 and the adjacent Hallway. (Ref: Photos AE-33-35).

AE-33: Interior leak within Room 109 and adjacent hallway. Leak is within interior of building, not near roof edge

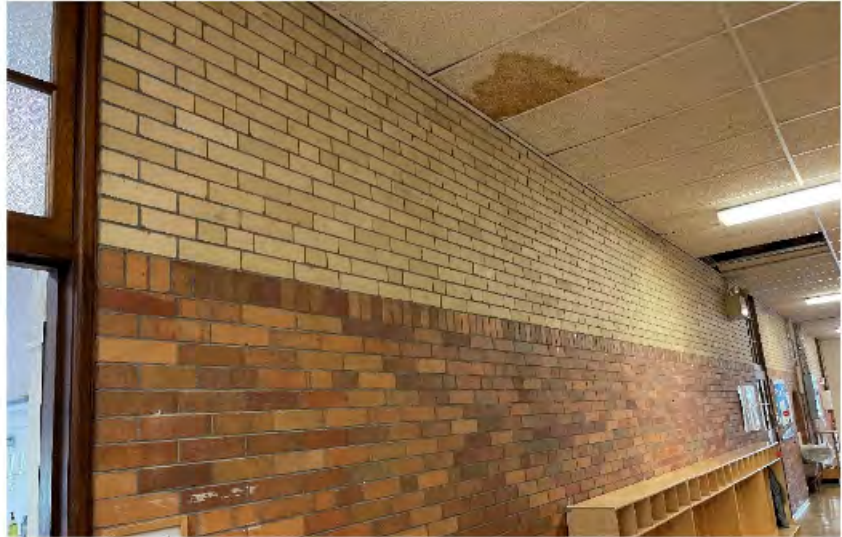
AE-34: Interior leak within hallway adjacent to Room 109. Leak is within interior of building, not near roof edge

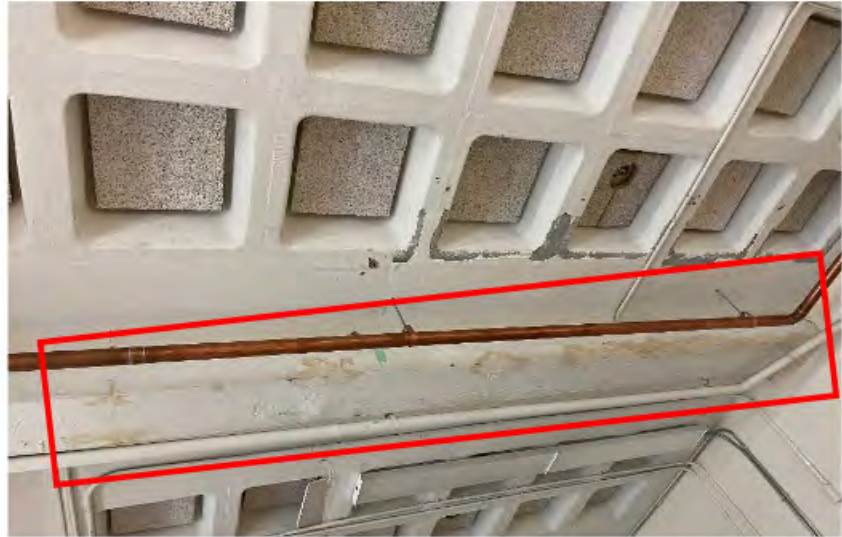
AE-35: Interior leak within Room 7, located below Room 109 above
