# LONGFELLOW BUILDING

359 Broadway  
Cambridge, MA 02139

**Facilities Condition Assessment : October 19, 2022**

## 7.8 | LONGFELLOW BUILDING BUILDING APPENDIX

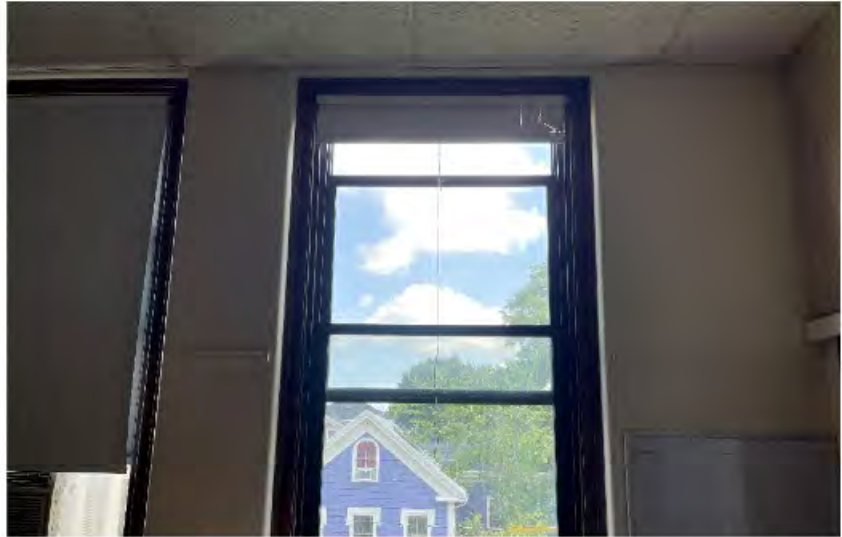
There are some operability issues reported with the windows, including some which do not easily open and close. There is at least one window where spray foam insulation was applied around the sash to improve weathertightness, and another where the sash cord was exposed on the exterior. (Ref: Photos AE-21-24, 36) The exterior doors are hollow-metal framed with surface rusting and peeling paint on the base of these frames at most locations.

AE-36: Interior of representative window where upper sash is difficult to remain closed

Windows and Doors:  
The existing windows be replaced with new aluminum windows with thermally broken frames and insulated glazing with Low-E coatings.
