# MORSE ELEMENTARY SCHOOL

## Facilities Condition Assessment : October 19, 2022

Facilities Condition Assessment, Capacity Analysis and Master Plan for CPS

# 7.9 | MORSE SCHOOL BUILDING APPENDIX

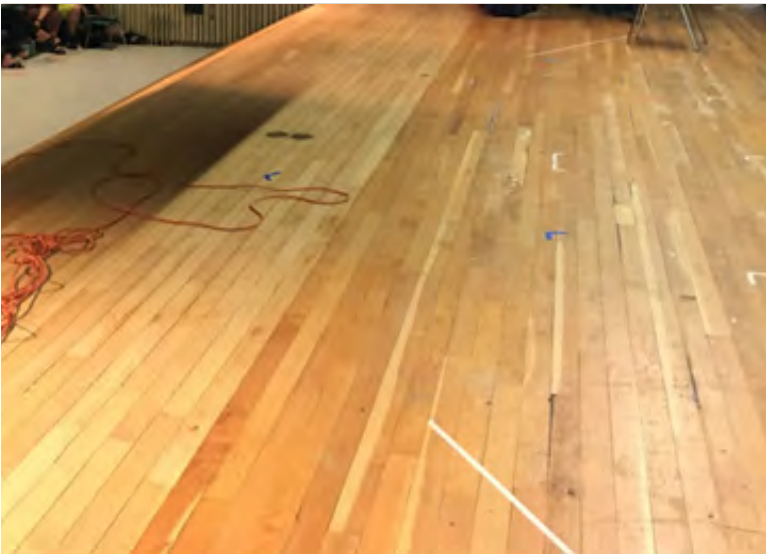
Stage Floor in Poor Condition

Stage Floor:  
The stage floor should be sanded and refinished. If refinishing is impractical the top surface of the floor should be replaced.

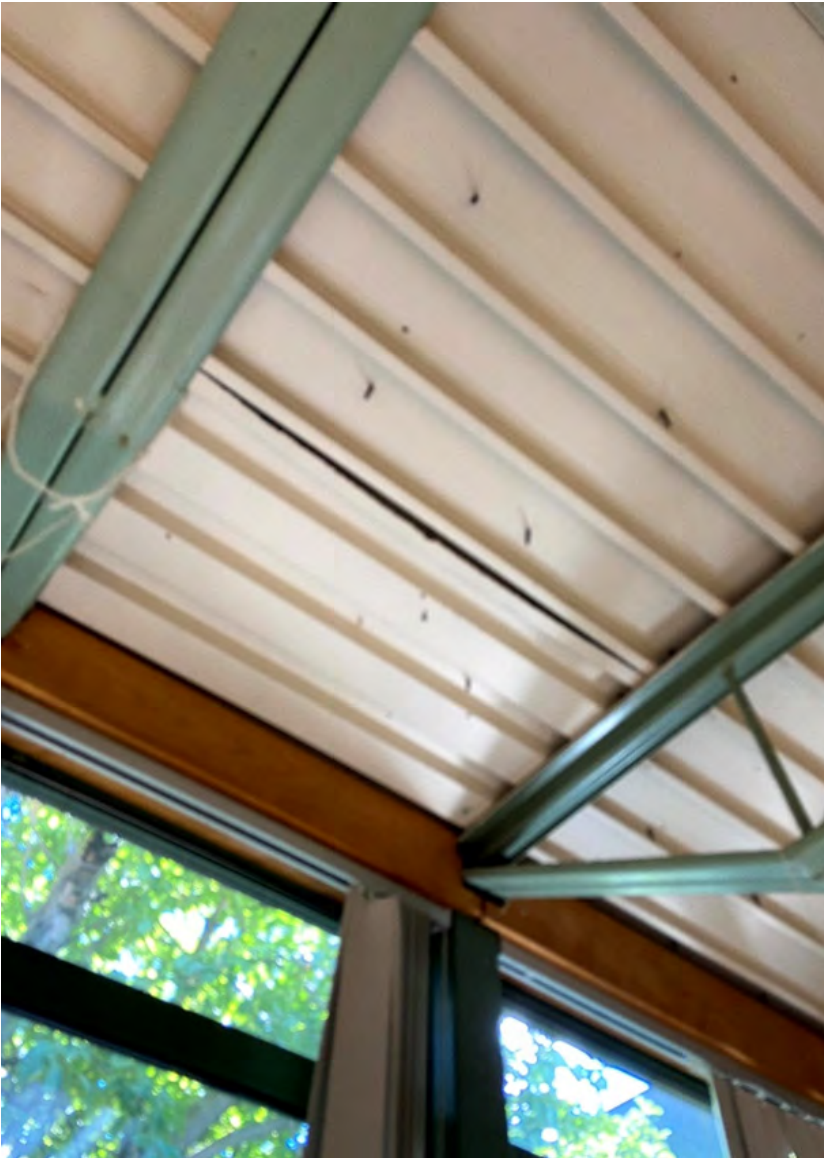
Photo ST-7: Steel roof deck separated side lap

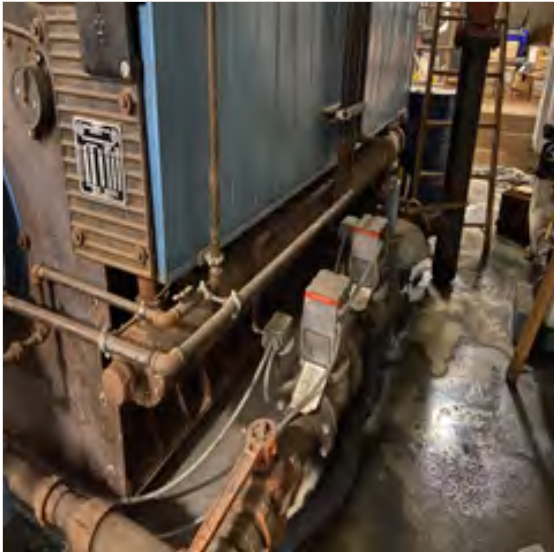
M-1: Mechanical Room Conditions

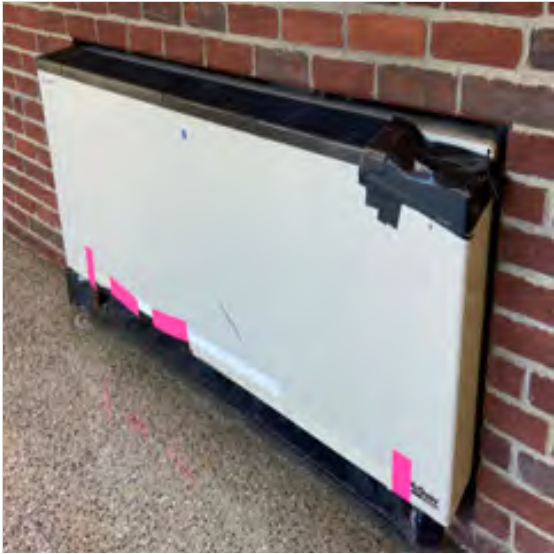
M-2: Cabinet Unit Heater Conditions

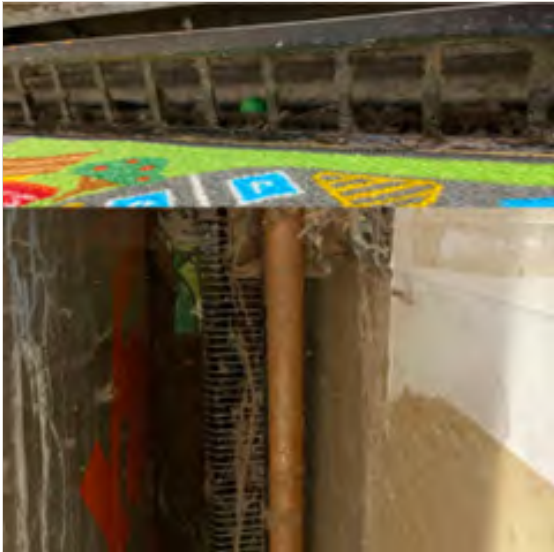
M-3: Unit Ventilator and Fin Tube Conditions

Fan coil units and unit ventilators should be replaced within the next year.

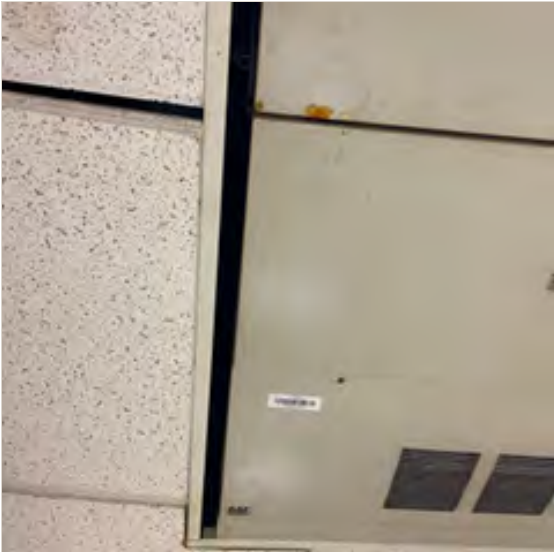
M-4: Fan Coil Unit

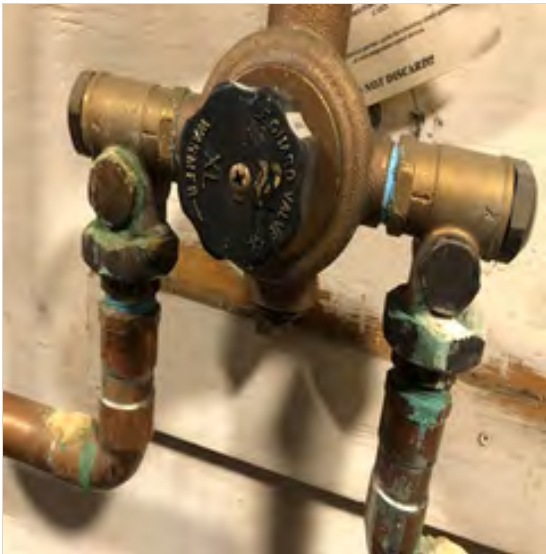
PL-1: Corroded Mixing Valve

*Recommendations*  
Public lavatories shall be provided with thermostatic mixing valves to limit the outlet temperature to a maximum of 110-degrees. Insulation kits shall be provided at all ADA lavatories at the supplies, stops, p-trap and tailpiece. Replace plumbing fixtures and floor drains which are heavily corroded and exceeded their useful service life.

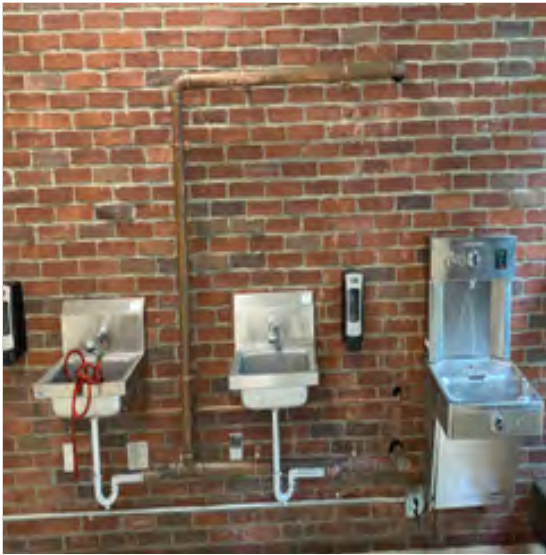
PL-2: Cafeteria Handwash Sinks Missing Hot Water

Investigate domestic water piping serving handwash sinks at building main entrance. Provide hot water to sinks as required by 248 CMR.

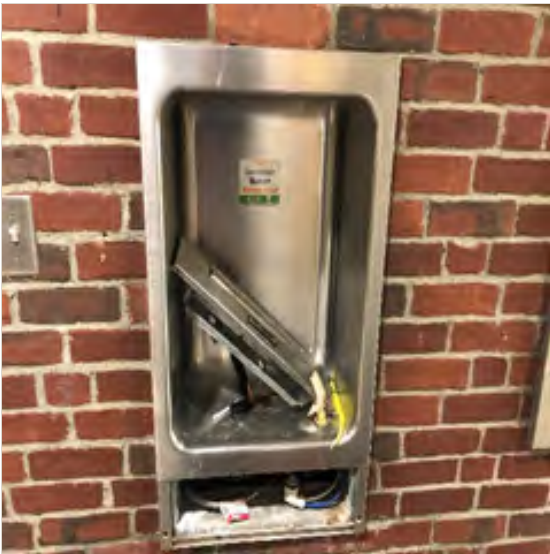
PL-3: Broken Drinking Fountain

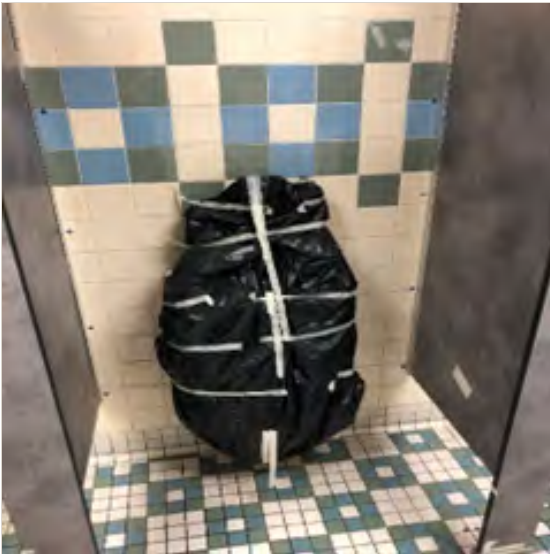
PL-4: Broken Urinal

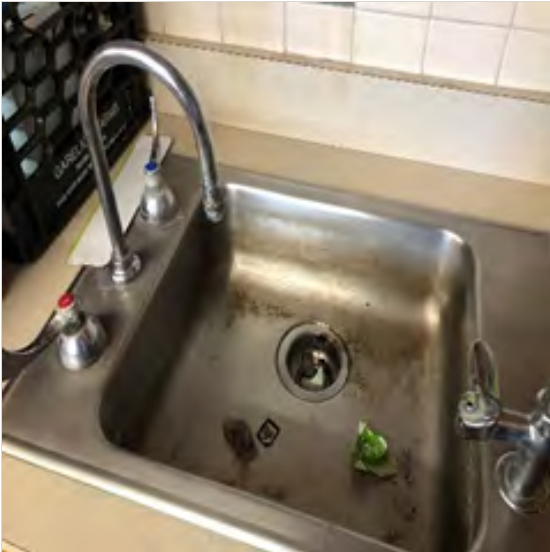
PL-5: Corroded Classroom Sink

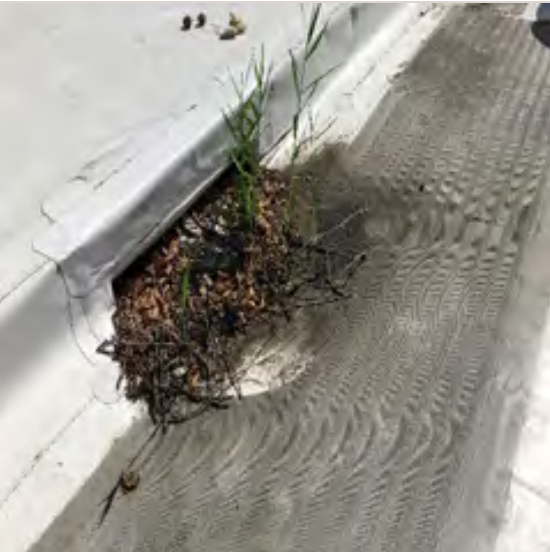
PL-6: Clogged Roof Drain

*Recommendations*  
Perform periodic maintenance on all roof drain bodies to assure they are free and clear of debris.

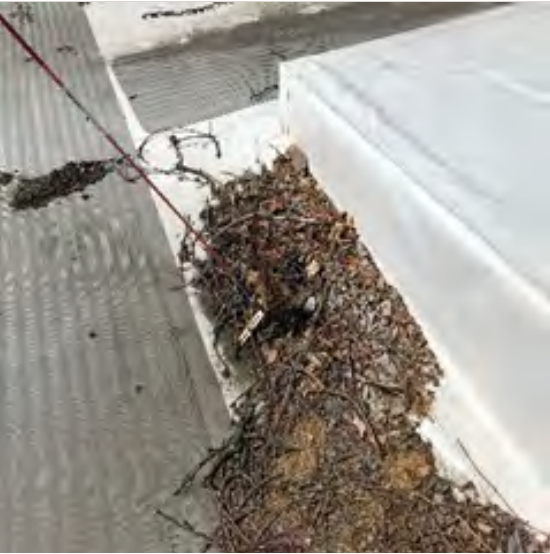
PL-7: Obstructed Roof Drain

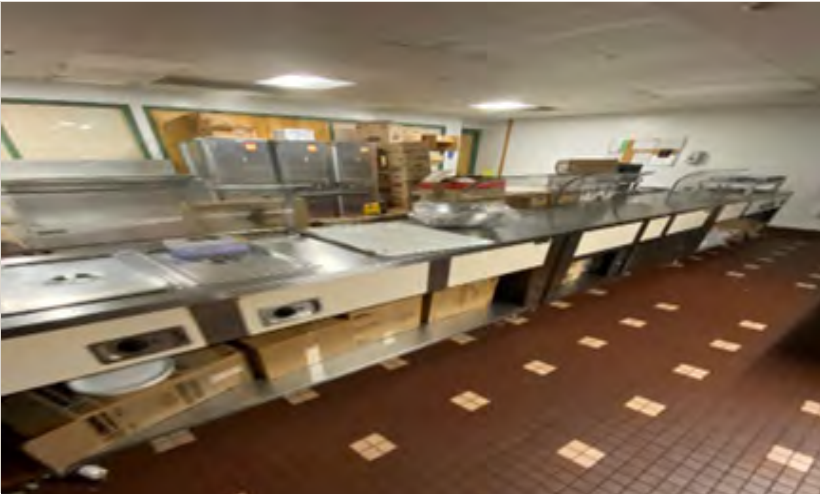
FS-1: The serving line is large enough for the school but does contain any refrigerated cold pans for safe display of cold food product at the proper temperatures.

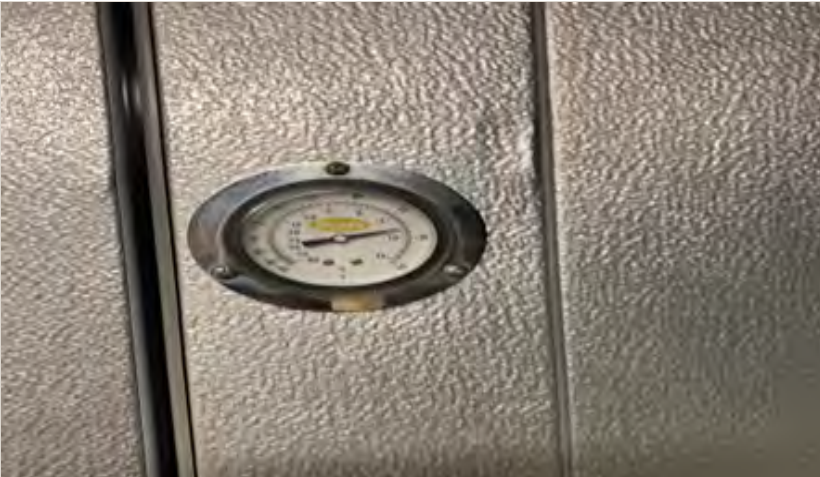
FS-2: The walk-in cooler shows clear signs of refrigeration issues as it’s currently holding at approximately 50°. This temperature is not within a safe range and the system requires service and repairs in the immediate future.

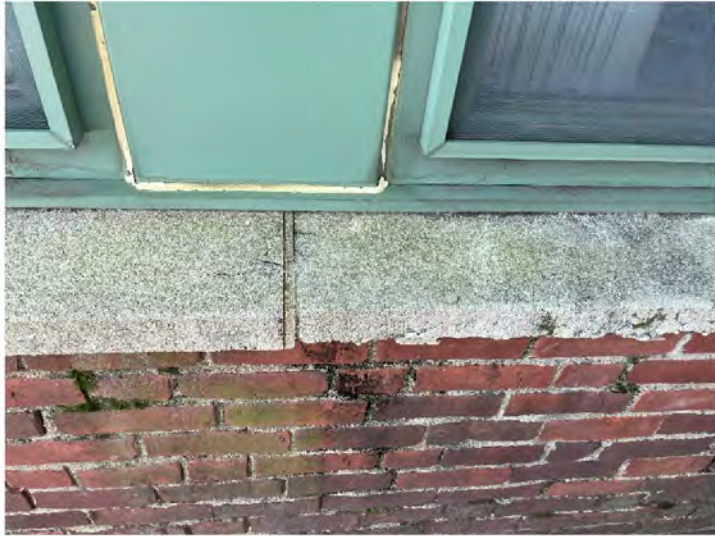
The masonry portions of the façade consist of brick masonry veneer, glazed brick accents and painted concrete block. The masonry is largely in good condition, with isolated areas of cracked glazed block (Ref: Photo AE-15) and peeling paint. (Ref: Photo AE-16) Some areas of mortar deterioration, staining and moss growth were observed on the East Elevation where the roof drains to the adjacent ground areas, splashing on the facade. Localized mortar deterioration was noted behind some downspouts. (Ref: Photos AE-14, 17-19)

AE-14: Atypical precast concrete window sill and brick masonry with evidence of excess moisture due to moss growth.

Facade:  
A scope of masonry cleaning and repointing should be undertaken in areas of deteriorated mortar and any cracked brick or concrete block shall be replaced. This work should also be performed at the East Elevation of D Wing and in any other areas where the roof drains to the ground and splashes onto the façade.

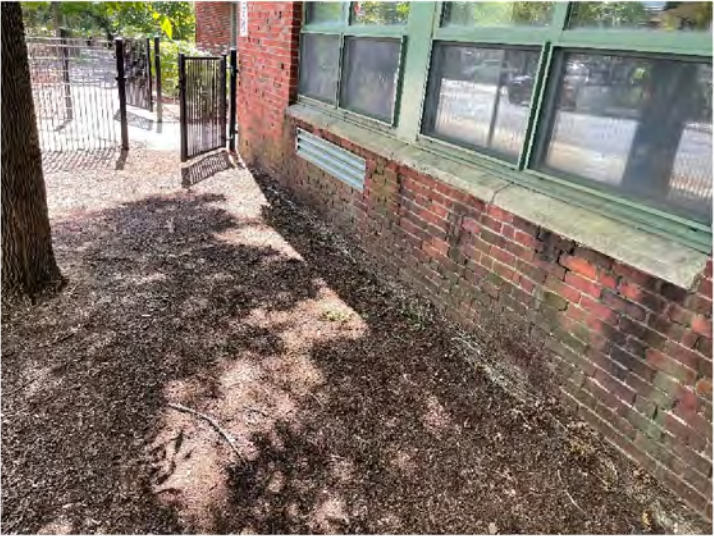
AE-17: Section of East Elevation at D Wing where roof drains to grade, splashing onto masonry façade. Some deteriorated mortar and vegetation growth on façade.

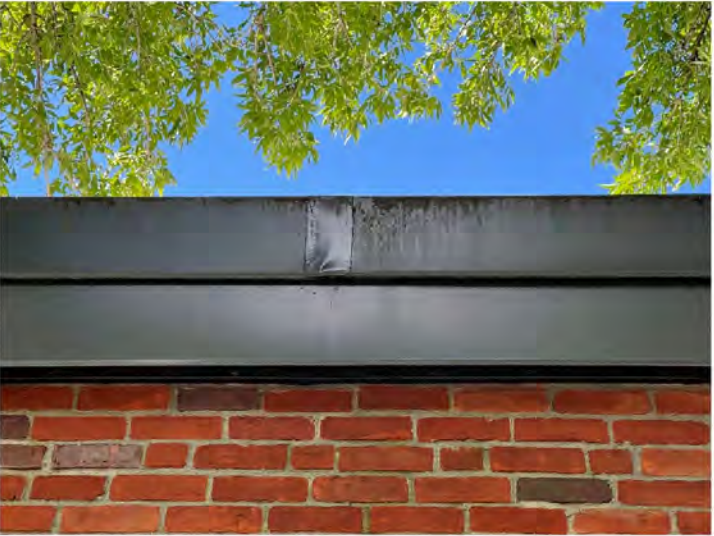
AE-18: Roof edge at D Wing where roof drains over roof edge, onto façade below.

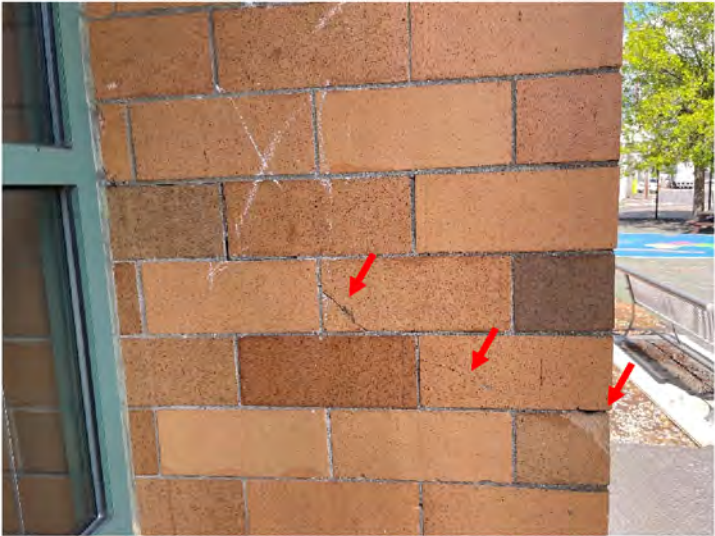
AE-15: Typical glazed brick accent wall. Typical cracking and some spalling observed.

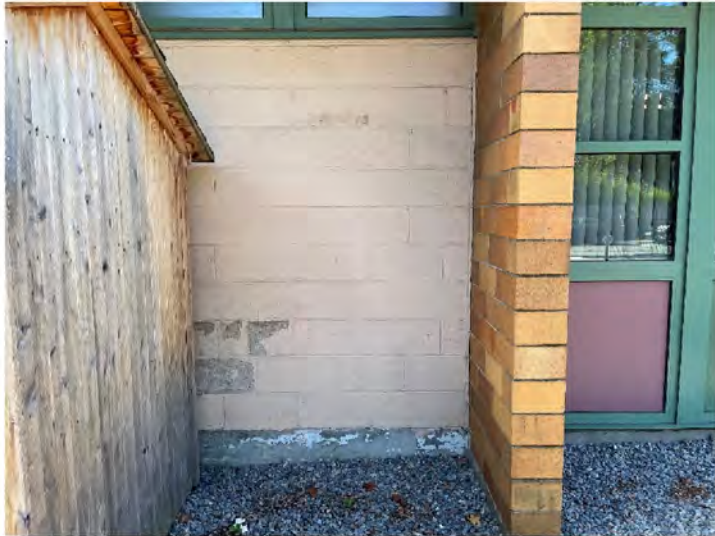
AE-16: Typical peeling paint at concrete block facade

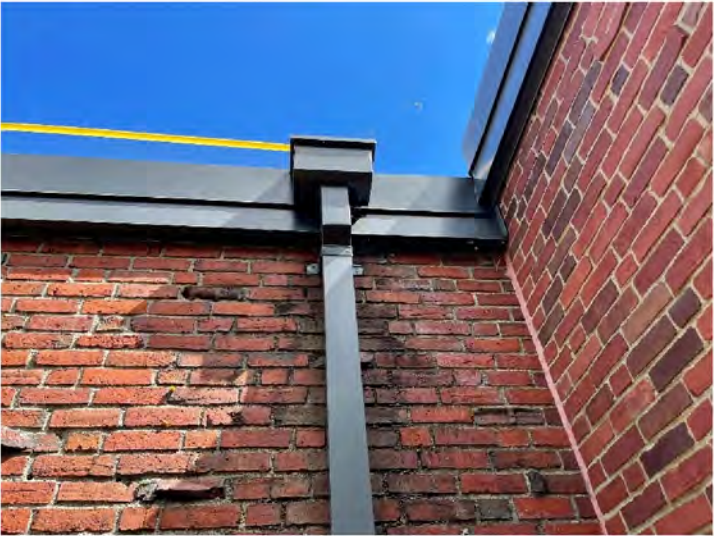
AE-19: Typical staining and isolated mortar deterioration around gutter at West Elevation near Cafeteria

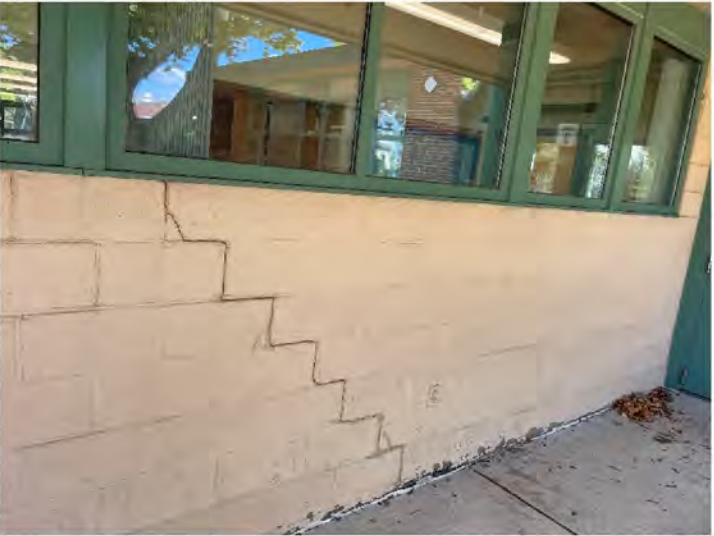
There is isolated step cracking of concrete block in locations such as the East entrance to B Wing. On the exterior of most façade areas, the steel roof trusses penetrate through the façade and are exposed along the top of the brick masonry and soffit areas. (Ref: Photos AE-21-23)

AE-20: Step cracking of concrete block at East entrance to B Wing

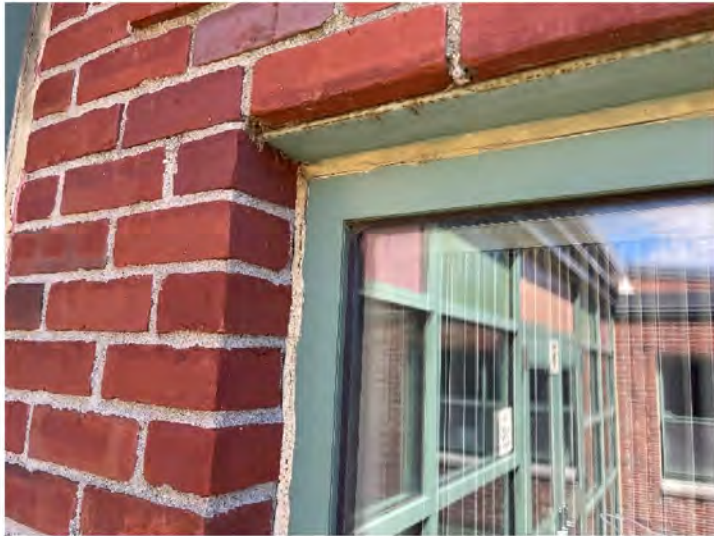
The façade sealants at transitions within the masonry and around the fenestrations has reached the end of its service life in most locations. There is some rusting of steel lintels at the few punched openings in the building. (Ref: Photos AE-24-25, 37-38)

AE-25: Representative rusting of lintel at head of window opening, typical perimeter sealant reaching end of expected service life

All façade sealants should be replaced, including those within the facades and at the perimeter of fenestrations and façade penetrations.

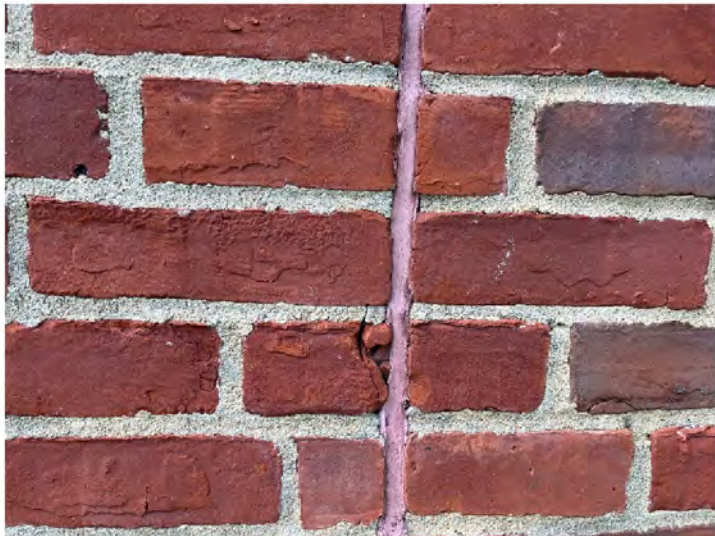
AE-24: Representative failing masonry control joint sealant

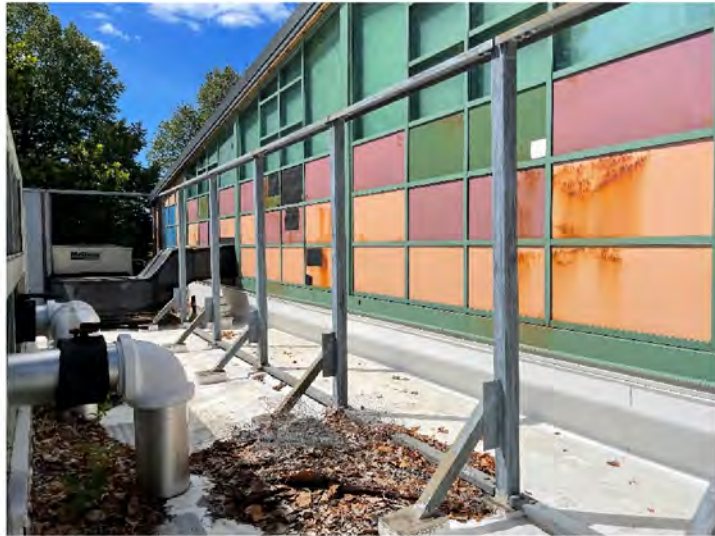
AE-29: Typical curtain wall with fixed lites and insulated metal spandrel panels. Note rusting / corrosion of spandrel panels in many locations.

Fenestrations:  
Replacement of all existing insulated metal spandrel panels is recommended.

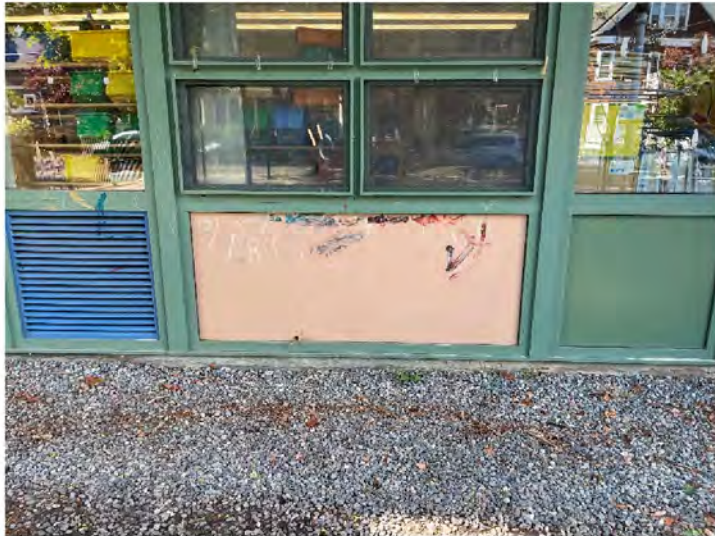
AE-30: Typical peeling paint on spandrel panel installed within storefront assembly

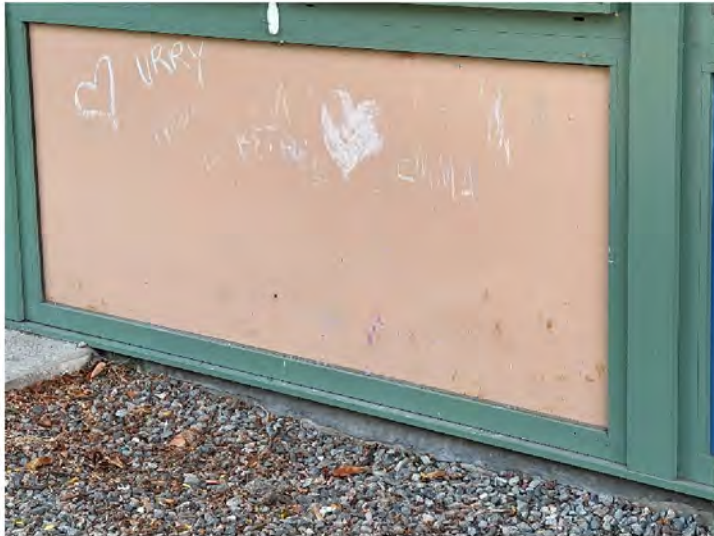
AE-33: Typical light surface rusting on typical spandrel panel within storefront assembly

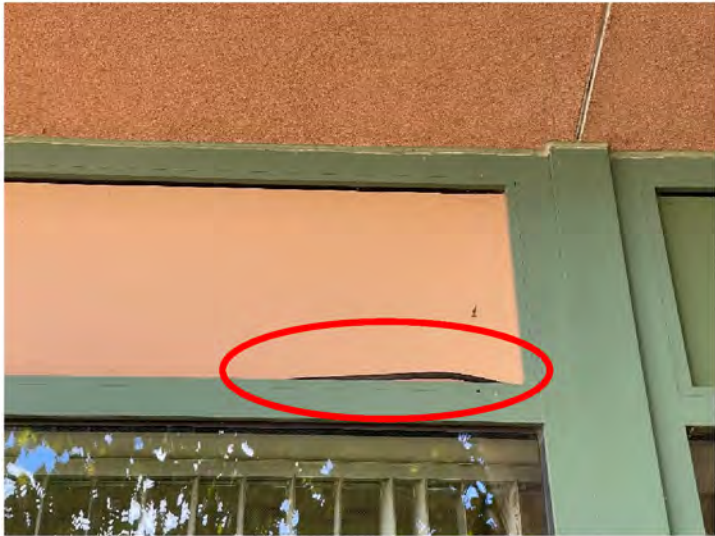
The fenestrations consist of thermally broken aluminum storefront assemblies with fixed and operable components and insulated metal spandrel panels. There are isolated locations of curtain walls such as within the Library and Gymnasium. (Ref: Photos 39-40) The aluminum storefront windows are in fair condition overall, but the insulated metal spandrel panels within the storefront and curtain wall are in poor condition with rusting, corrosion and delamination of many panels observed throughout the building. (Ref: Photos AE-29-33, 35-36) Isolated locations of unsecured glazing gaskets around the spandrel were observed. (Ref: Photo AE-34)

AE-34: Atypical glazing gasket at perimeter of spandrel panel that is not fully engaged to storefront assembly

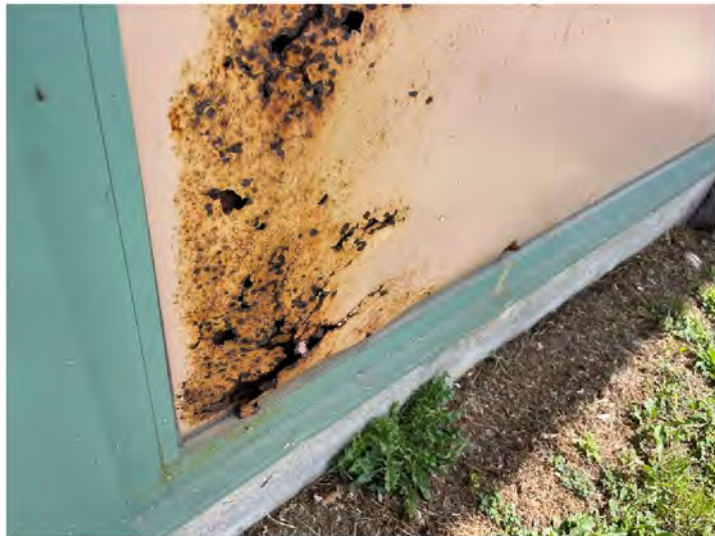
AE-31: Typical rusting of spandrel panel within storefront assembly

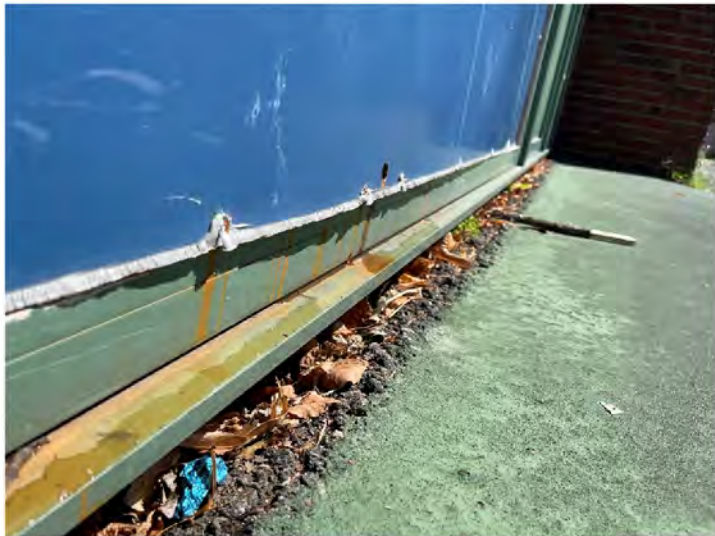
AE-32: Typical delamination of spandrel panel, failed repair sealant and rusting within storefront assembly

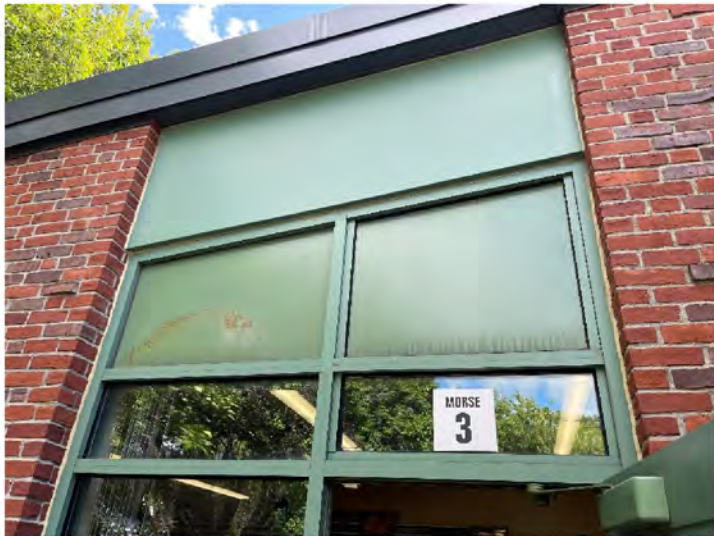
AE-35: Typical storefront assembly with metal panel above, rusting of insulated metal spandrel panel within storefront

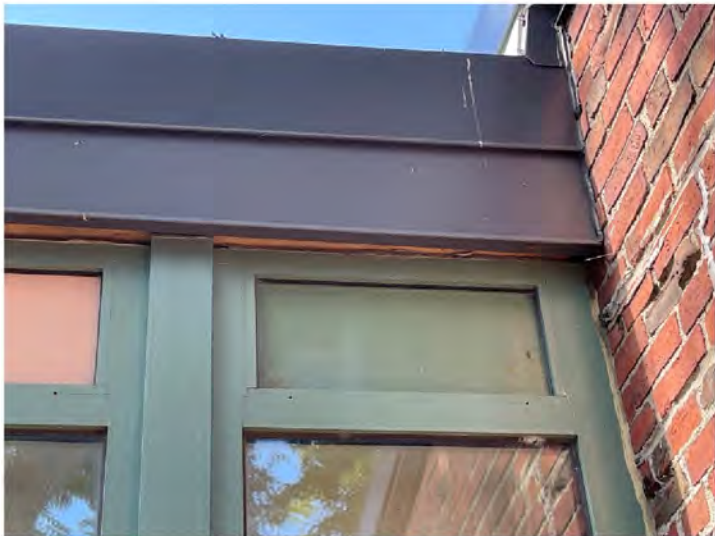
AE-36: Representative rusting of spandrel panel installed within storefront assembly

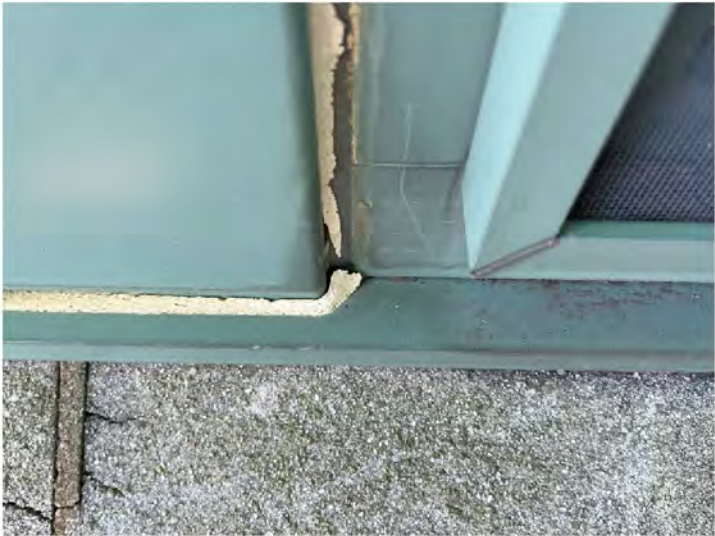
AE-37: Typical failed perimeter sealant at storefront assembly

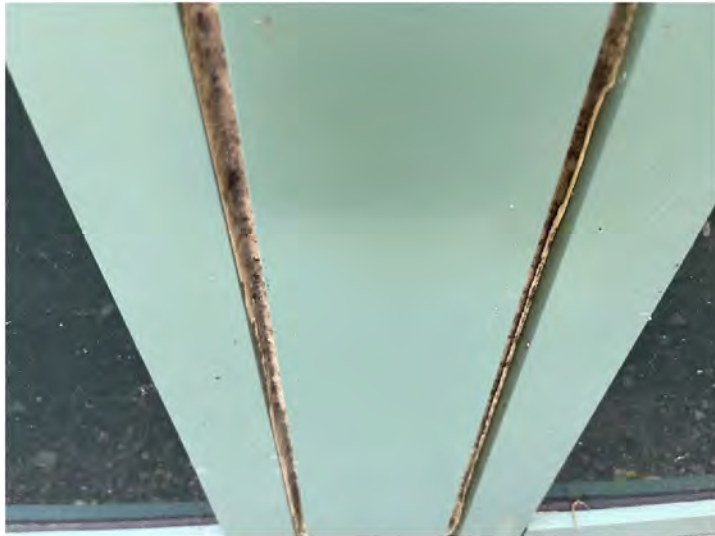
AE-38: Representative failed sealant between storefront assemblies

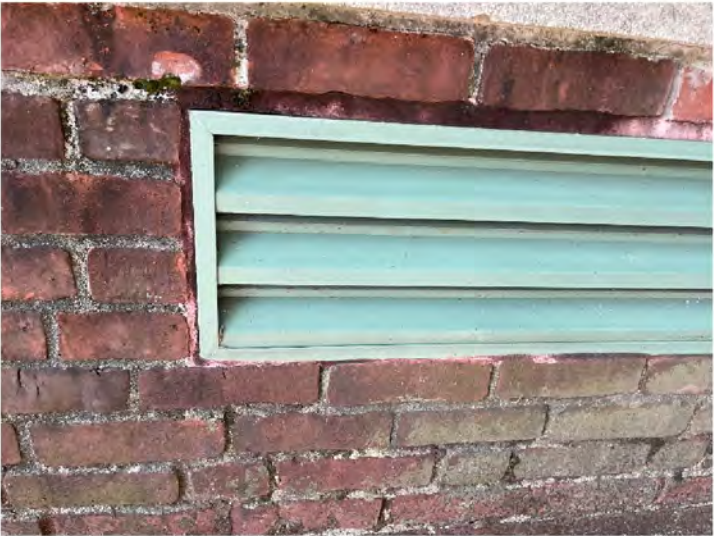
AE-41: Typical louver within masonry façade, perimeter sealant nearing end of expected service life

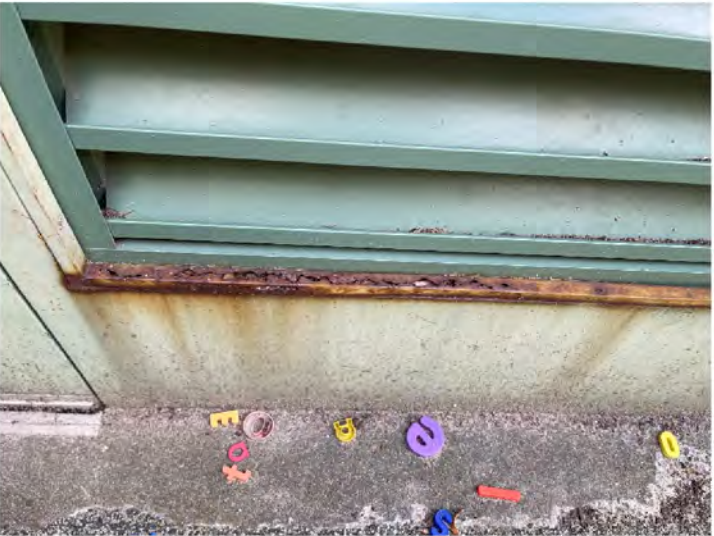
AE-42: Rusting of hollow metal frame below louver infill

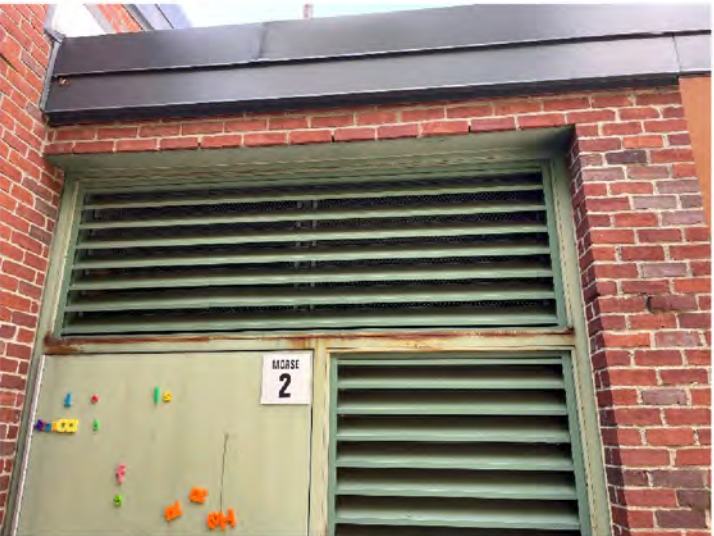
AE-44: Typical metal framed door assembly with louvers, note surface rusting in various areas

Replacement of exterior door frames, weatherstripping and hardware is recommended.

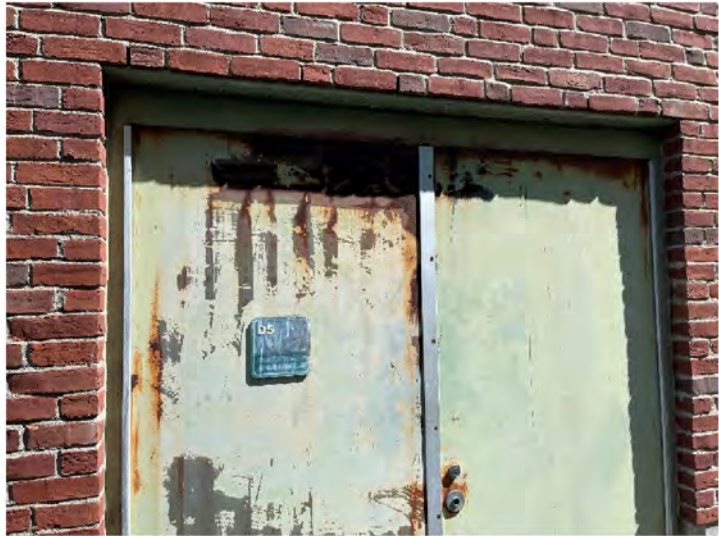
AE-45: Representative exterior metal door with significant rusting

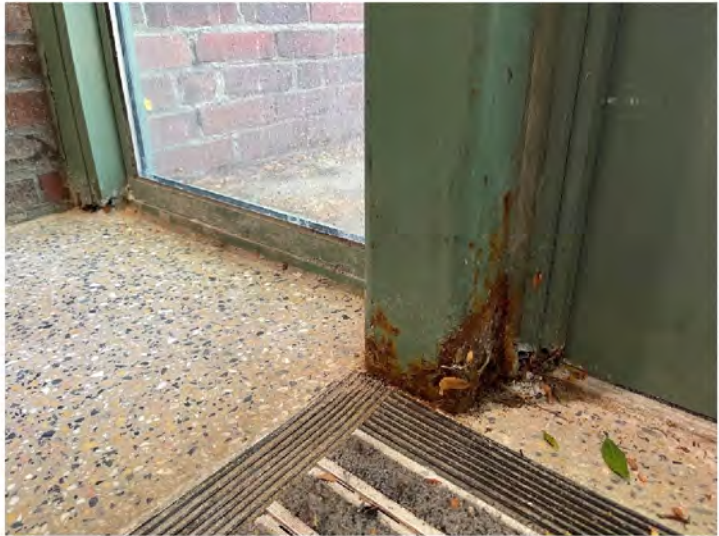
AE-46: Interior of typical exterior metal door frame with rusting at base of jamb framing.

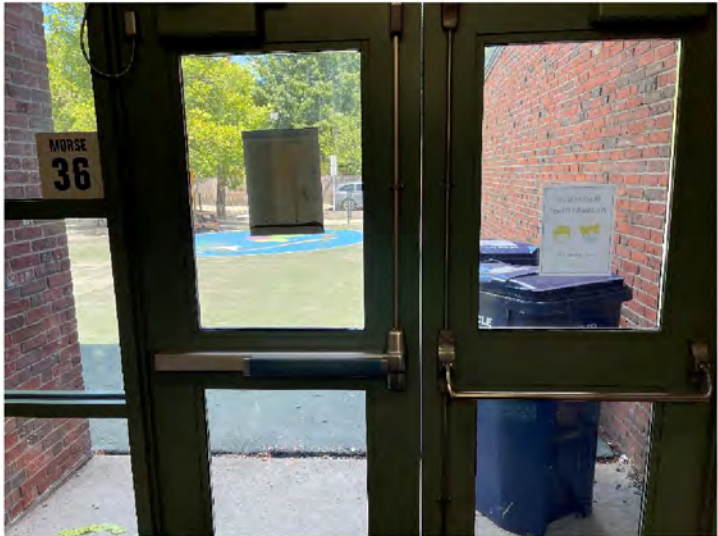
E-49: Interior of door 36 where no weatherstripping was observed at interior between door panels.

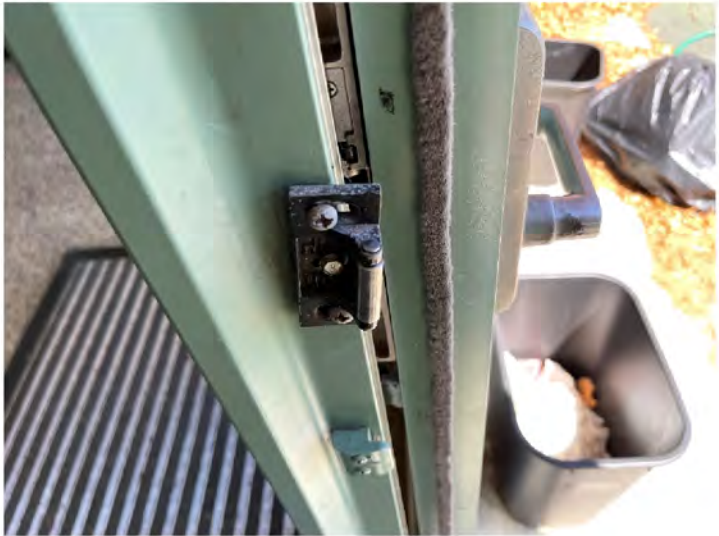
AE-50: Typical door hardware lacking full securement, is loose.

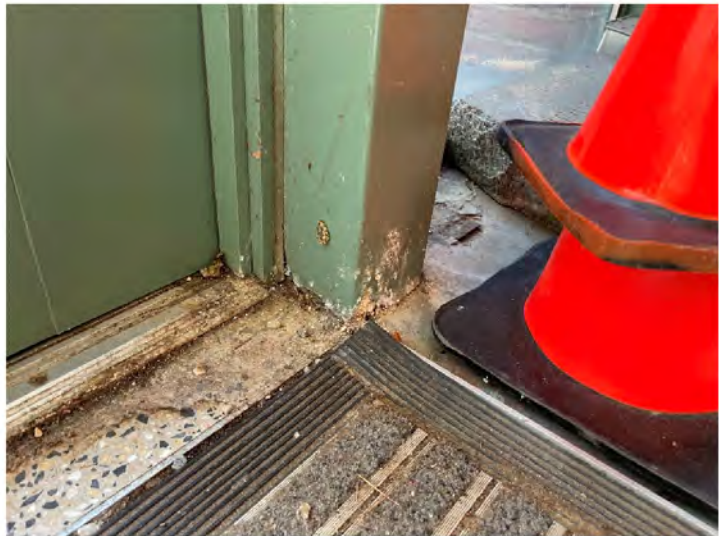
AE-47: Early signs of corrosion on interior at base of exterior door.

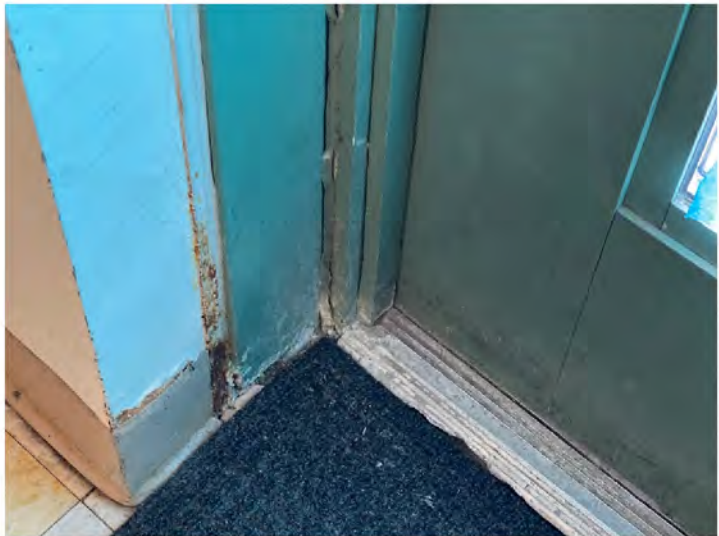
AE-48: Typical surface rusting on interior at base of typical exterior door.

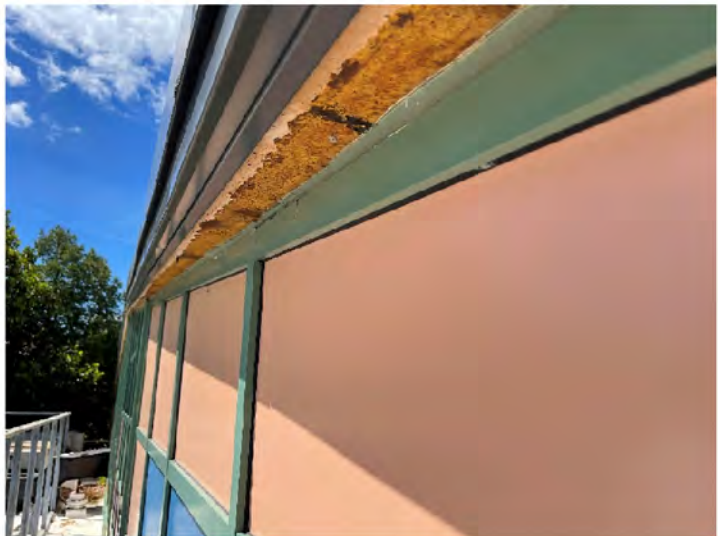
The underside of the metal roof deck is painted and exposed as soffits surrounding the perimeter of the building. The paint is peeling and there is surface rusting in many of these areas. Fasteners from the roof penetrate through the soffits and are exposed on the exterior in some locations. (Ref: Photos AE-51-53)

AE-51: Typical rusting of exposed underside of metal roof decking

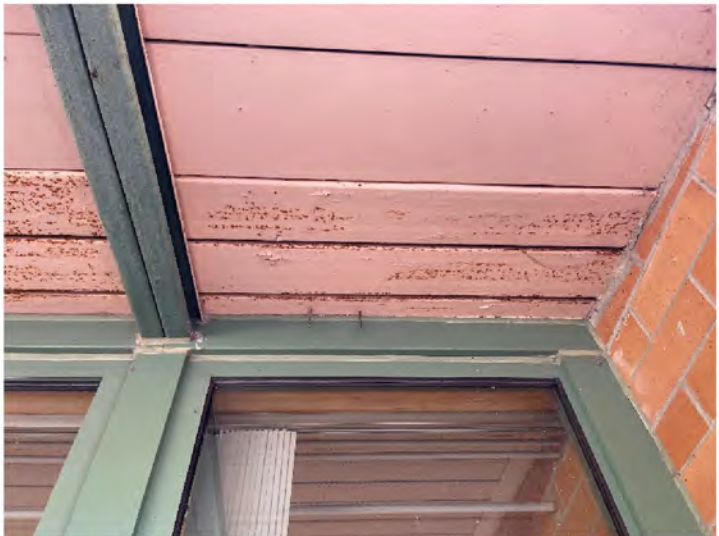
AE-52: Typical rusting and peeling paint at exposed underside of metal roof decking, typical in most locations.

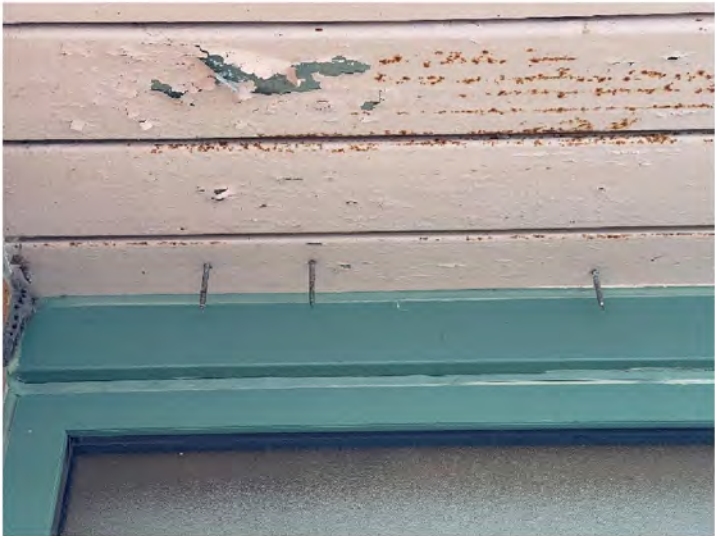
AE-53: Typical rusting and peeling paint at exposed underside of metal roof decking, typical in most locations. Not exposed fasteners from roof securement above.

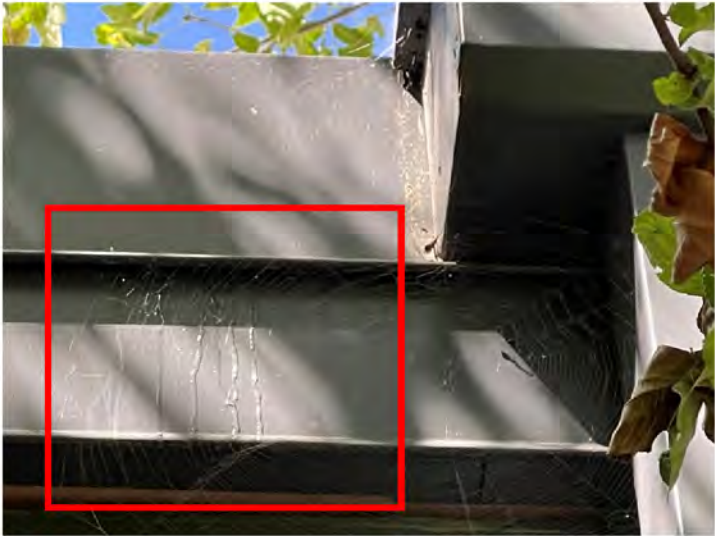
AE-61: Water leakage observed between aluminum fascia components in area of ponded water at clogged downspout within Courtyard

Further review into the roofing around the North downspout at the Courtyard is recommended to determine if there are any failures in the roofing system contributing to the water leakage noted within the fascia.

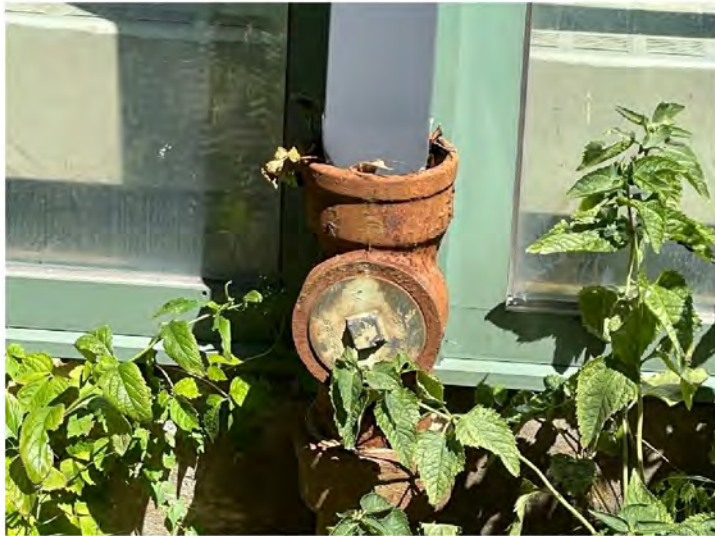
AE-62: Base of downspout in Courtyard appears clogged with leaves

Roofing:  
Bi-monthly cleaning of the roof including removal of leaves and associated debris is recommended to reduce potential for drainage issues.
