# PEABODY SCHOOL

## Facilities Condition Assessment : October 14, 2022

Facilities Condition Assessment, Capacity Analysis and Master Plan for CPS

## 7.10 | PEABODY SCHOOL BUILDING APPENDIX

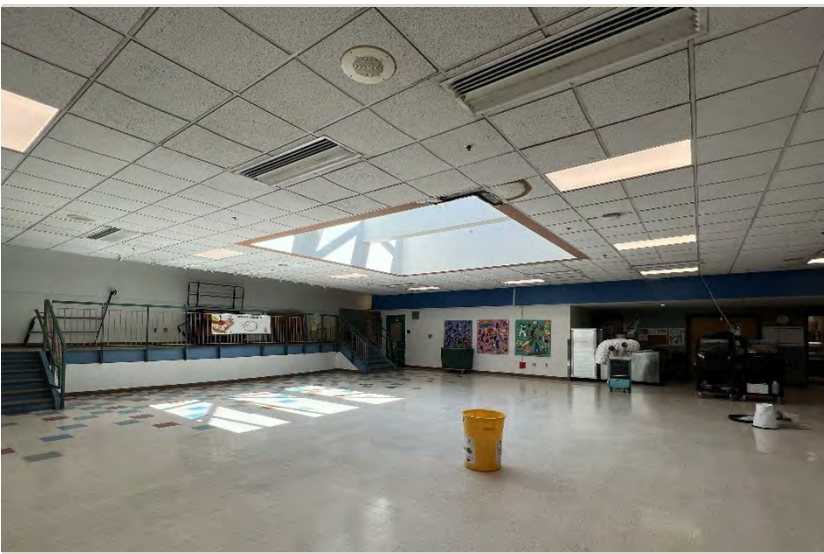
The shared use space such as gym and library are in good condition and appear to have had some upgrades over time. The cafeteria, however, is one of the area’s most in need of repair with immediate attention needed to roof leaks and associated water damage. The toilet rooms, which are predominantly multi-user, appear to be ADA compliant and have had some upgrades; they are in good condition.

Cafeteria (leaks at skylight)

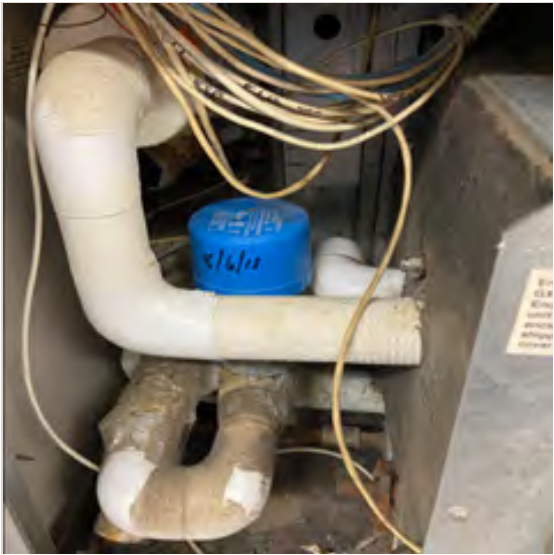
Unit Ventilators: Replace as they are internally damaged from water corrosion and physical wear.

M-2: Unit Ventilator Interior Conditions

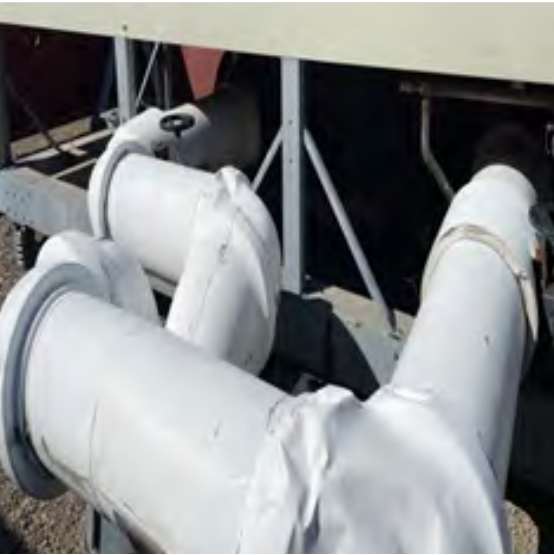
M-4: Chiller Piping Conditions

*Recommendations*  
The current chiller is in poor condition and does not function. Replacing the chiller is necessary. The exterior piping should also be replaced by the chiller as it is considerably weathered and damaged. The unit ventilators need to be replaced immediately as there is no condensate collection causing condensate to drip into the unit ventilators and fin tube. They are on year 22 of their 20 year service life.

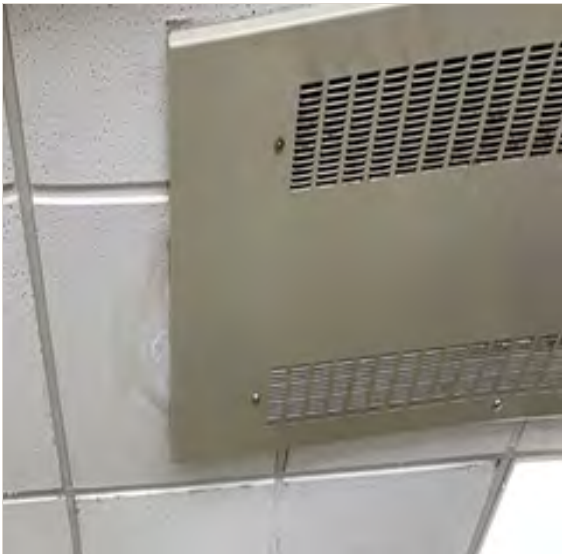
M-5: Water Damage by FCU

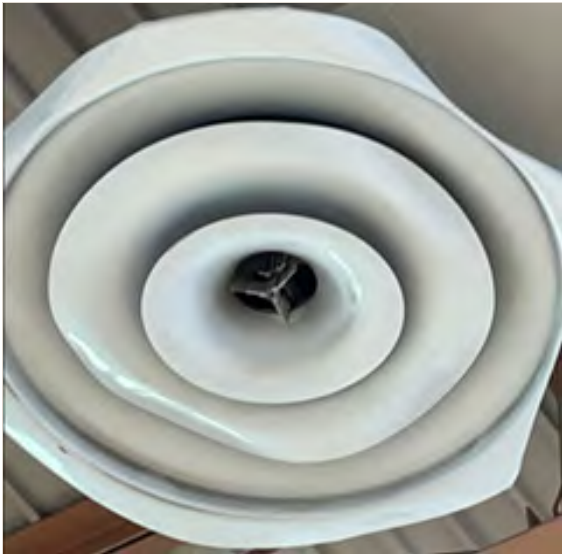
M-6: Gymnasium Diffuser Condition

*Recommendations*  
The air handlers are in okay condition but are 5 years past their service life and should be replaced within the next couple years. The gymnasium diffusers should be repaired or replaced to ensure proper airflow. The ladder up to the roof should be fixed to ensure proper maintenance is being done on the rooftop equipment.

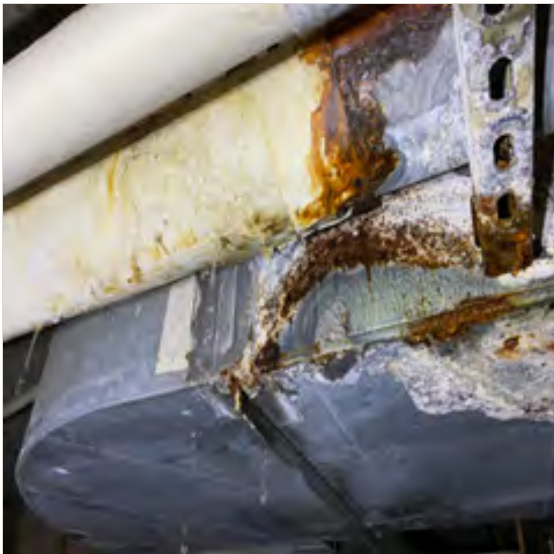
The 4” domestic cold water main in the crawl space below level has failed and is constantly leaking.

PL-1: Domestic Main Failure in Crawl Space

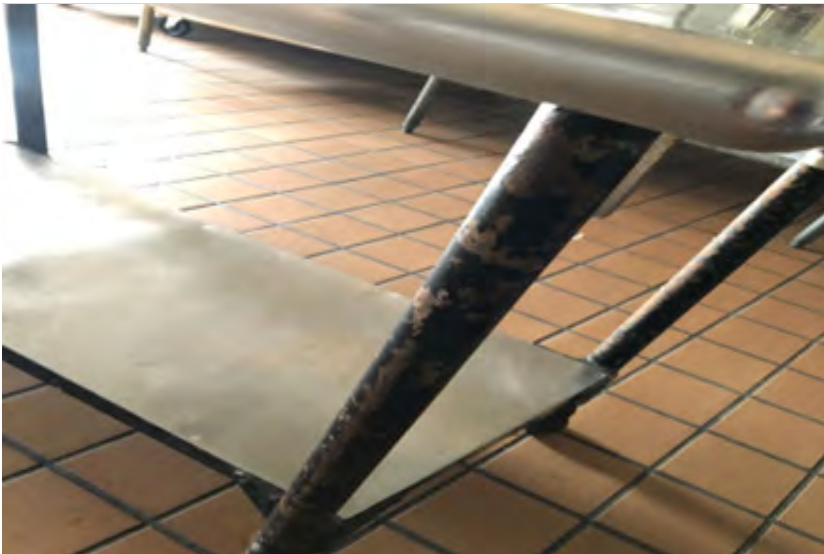
FS-1: Galvanized legs on work tables is a dated construction method. The galvanized steel chips and rusts and requires frequent painting to maintain. Stainless steel tables should be replaced with all stainless steel construction manufactured to meet NSF standards.

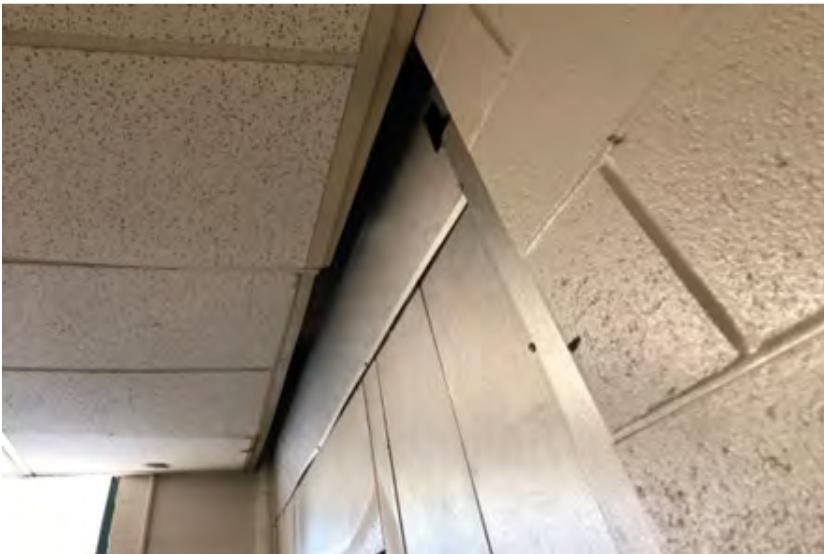
FS-2: Gaps in kitchens are not acceptable by health code. The ceiling track and/or the stainless closure should be provided to prevent large gaps within commercial kitchens per health code. Large gaps within kitchen spaces allow vermin and or insects entry points to food zones.

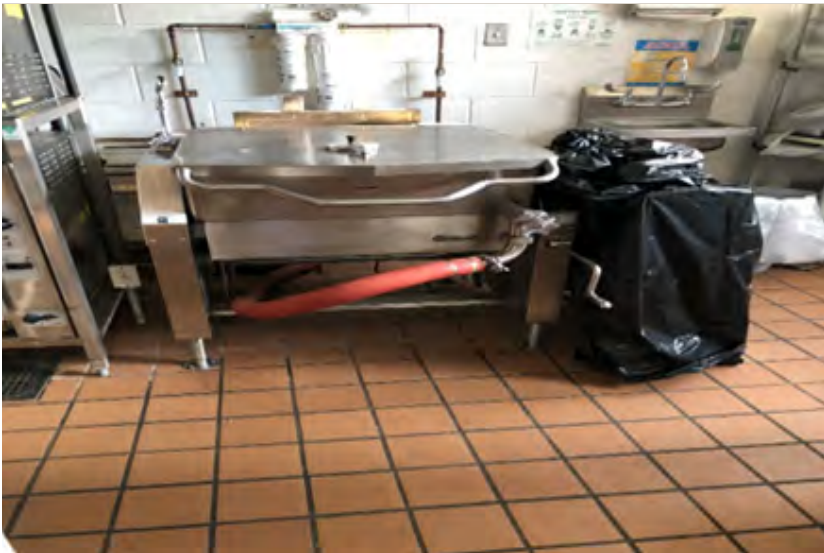
FS-3: Braising pans in efficient designs are provided with floor troughs with non-slip grating for proper cleaning and containment of the units' operation. The tangent draw-off valve is currently piped to a floor sink which presents several issues to the buildings plumbing system. The purpose of the tangent draw-off valve is to be able to prevent grease and other unwanted product from entering to entering the building drainage system.

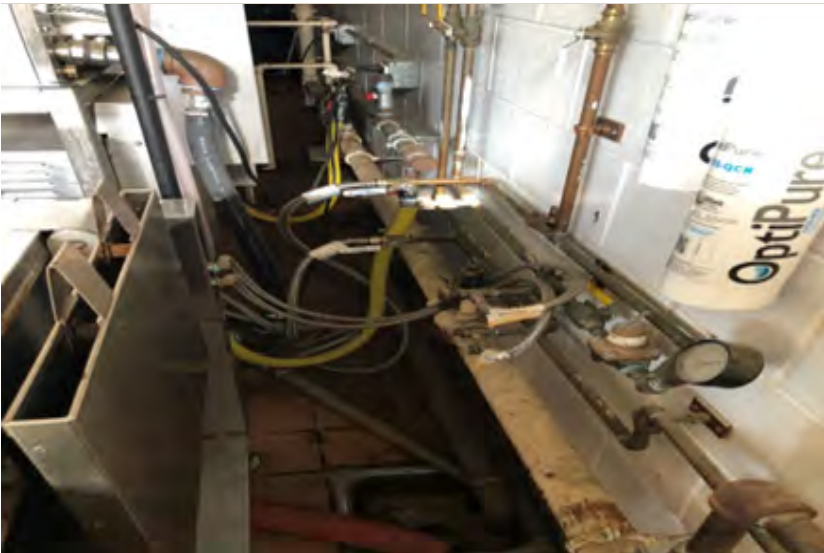
FS-4: Exposed utilities along the cook line building wall present cleanability issues and potential violations of the health code if not properly cleaned. Utilities should be provided within a furred-out wall in these circumstances for proper cleanability.

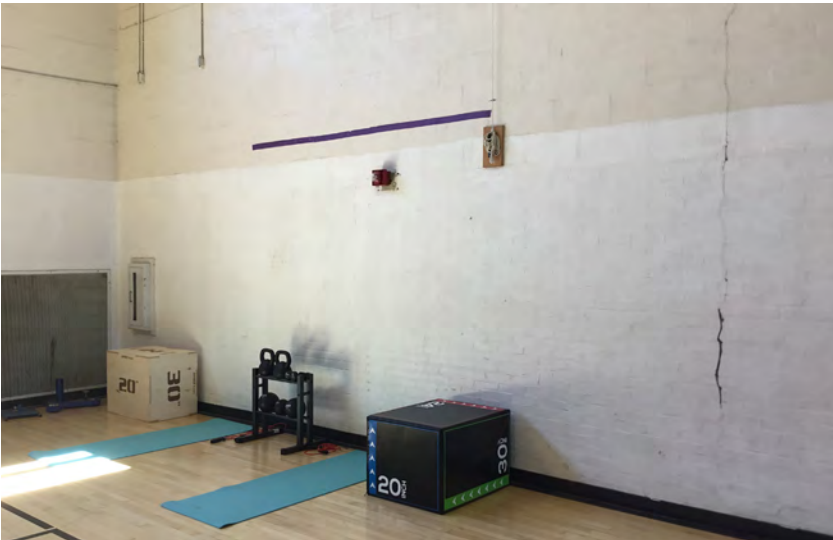
Crack in walls

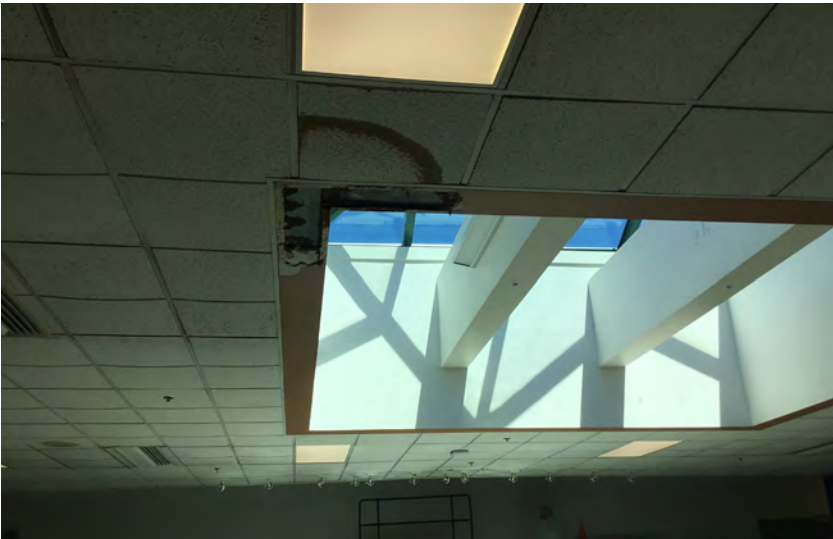
Water damage at skylight

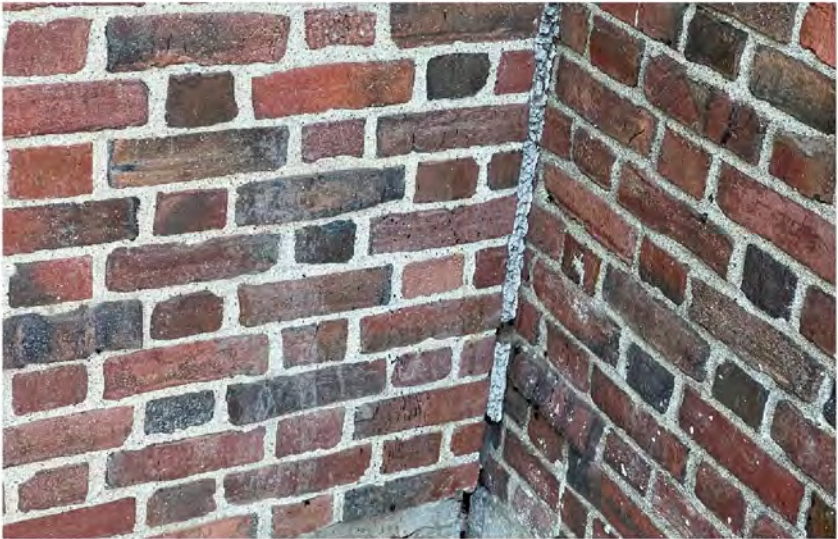
Control joint sealants within the façade have reached the end of their expected service life and have failed in many locations. (Ref: Photo AE-10, 15, 22). Peeling paint at lintels is visible throughout the façade. (Ref: Photo AE-20)

AE-10: Representative brick masonry at older portion of building. Note some failed control joint sealants.

All façade sealants are recommended for replacement, including those within the masonry facades and at the perimeter of fenestrations. Preparation, priming and repainting efforts are recommended at the steel lintels where paint is peeling.

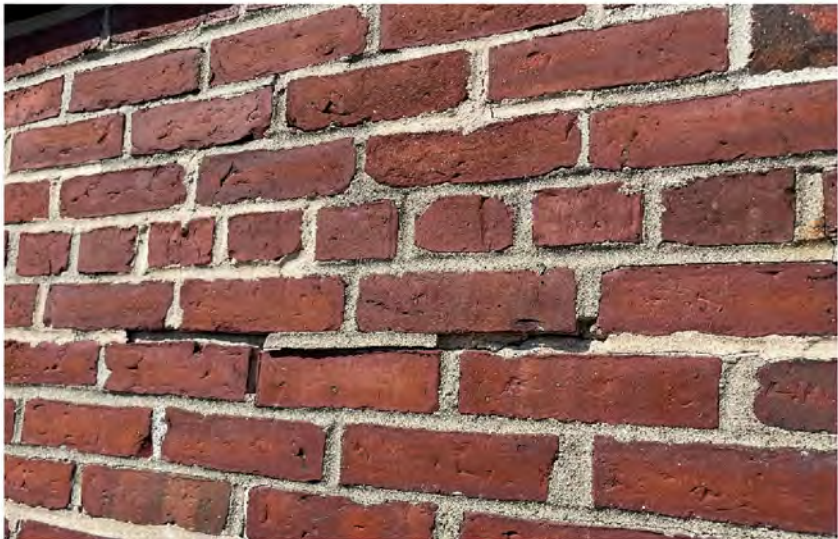
Isolated cracked and spalled mortar was observed at the older portion of the building where steel lintels were observed within the facade. (Ref: Photo AE-11) Deteriorated mortar and some displaced brick was noted at the top of the chimney located at the Northwest corner of the building. (Ref: Photo AE-12) Isolated cracked and spalled mortar exists at mortar joints between the precast sill components. (Ref: Photo AE-14) and isolated cracking and spalling of the limestone sills was observed at the older portion of the building. (Ref: Photo AE-16)

AE-11: Typical isolated deteriorated mortar at steel lintel

Masonry:  
A scope of masonry cleaning and repointing should be undertaken in areas of deteriorated mortar within the glazed block facades, at precast sills and brick masonry conditions. Remove any existing vegetative growth from masonry facades should be part of this work.

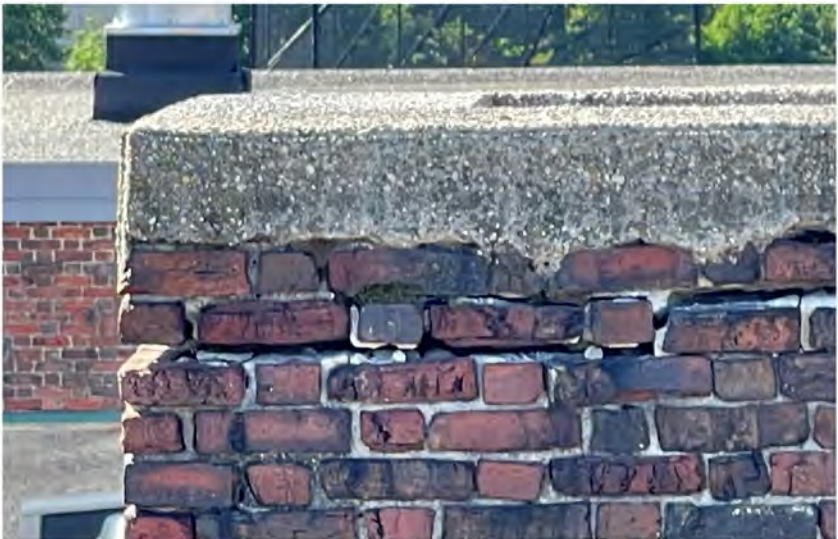
AE-12: Deteriorated mortar, displaced brick at chimney

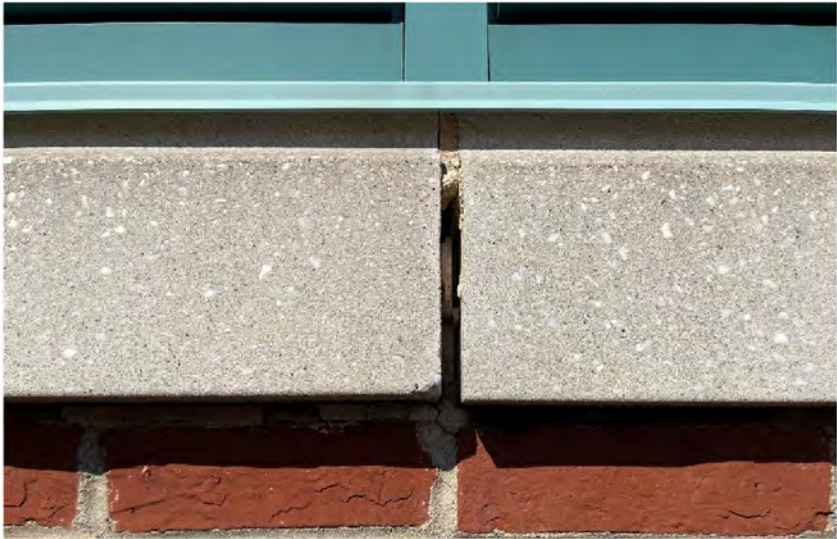
AE-14: Isolated cracked, spalled mortar between precast sills

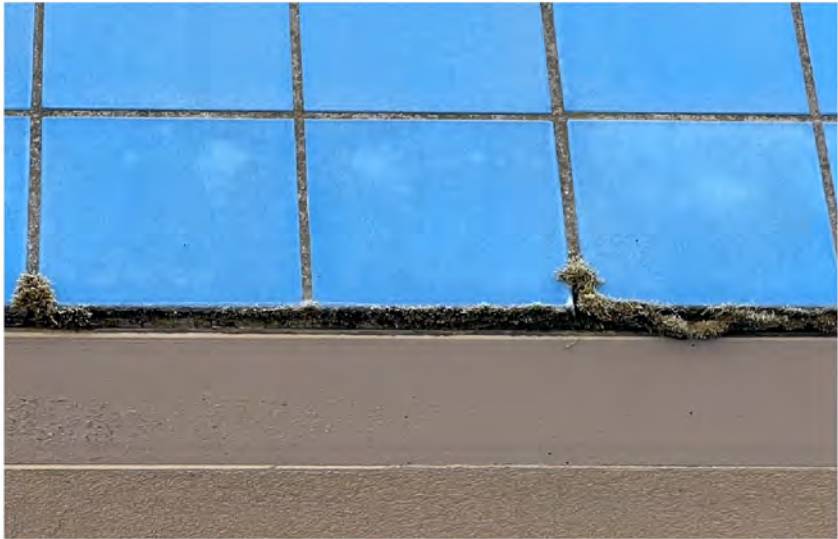
AE-17: Typical moss growth along base of glazed block façade at relieving angle / throughwall flashing

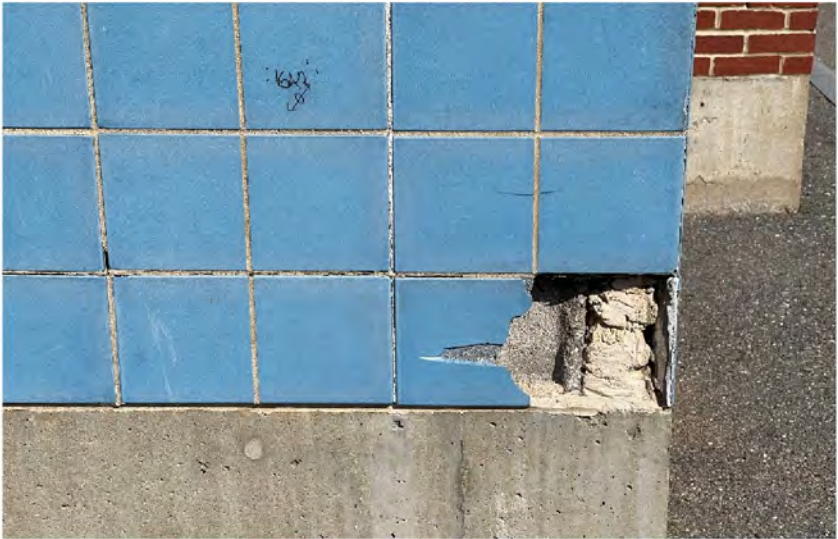
AE-18: Damaged glazed block at base of facade on Southeast corner

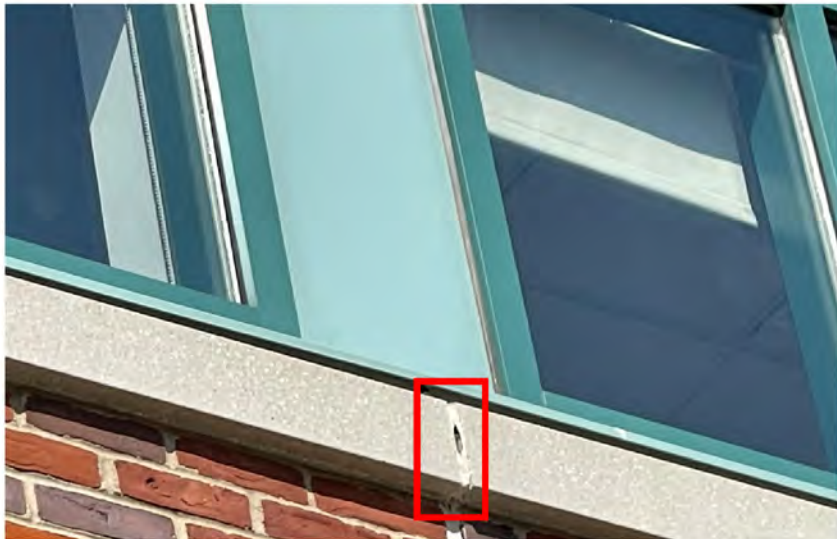
AE-15: Typical failed sealant at joint between precast sills

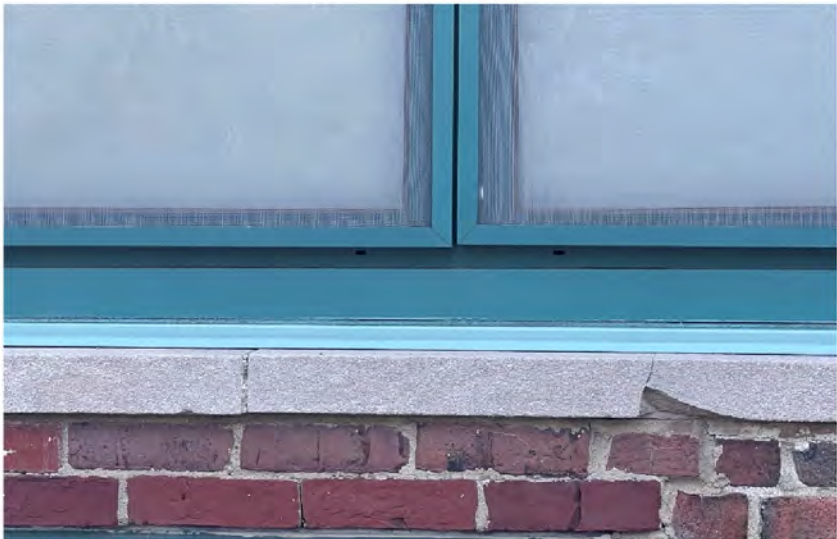
AE-16: Representative cracked and spalled limestone sill at older portion of building

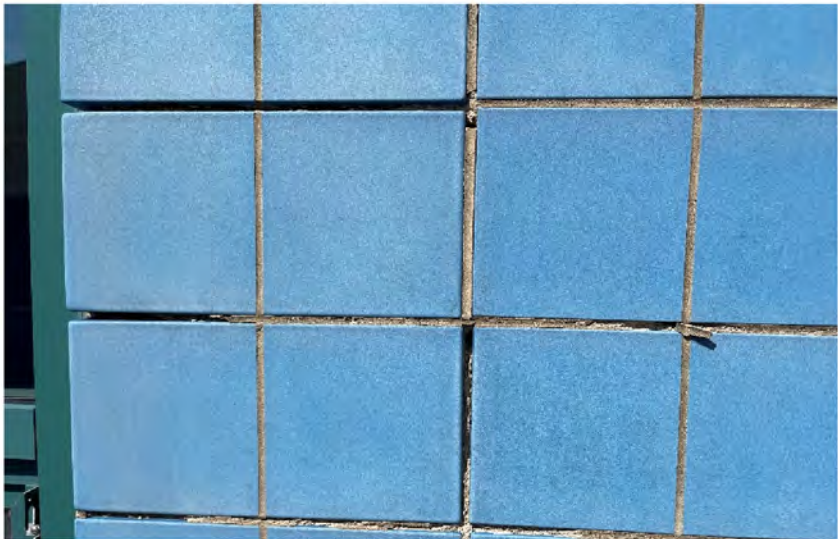
AE-19: Typical failed mortar joints between glazed block, observed in multiple façade areas above the roof.

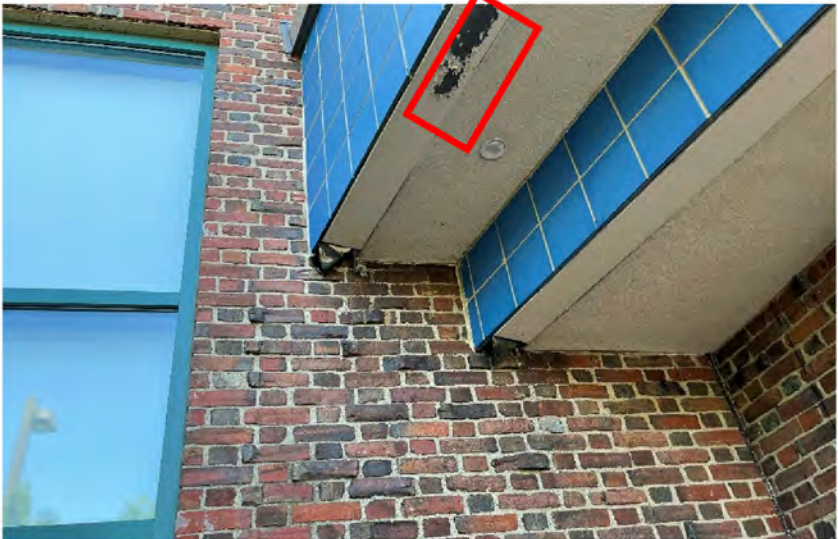
AE-20: Typical peeling paint at relieving angle

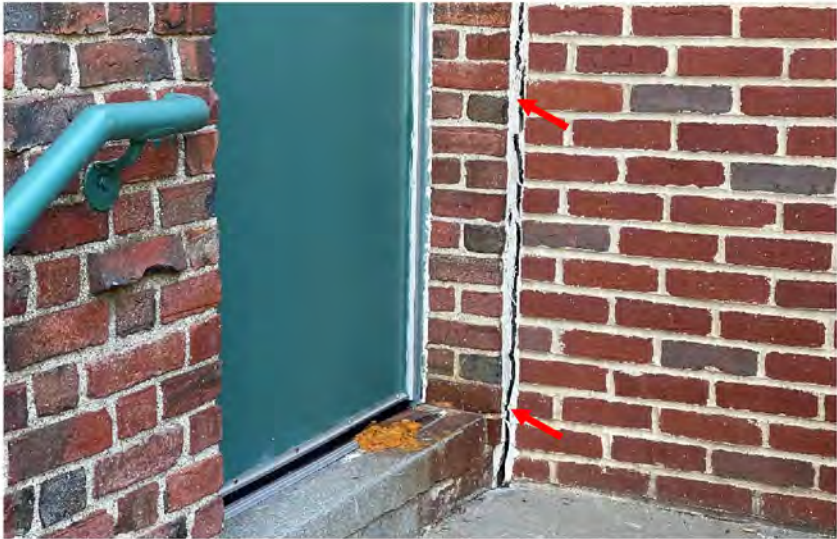
AE-22: Control joint at intersection of older building and addition, failed sealant at this joint.

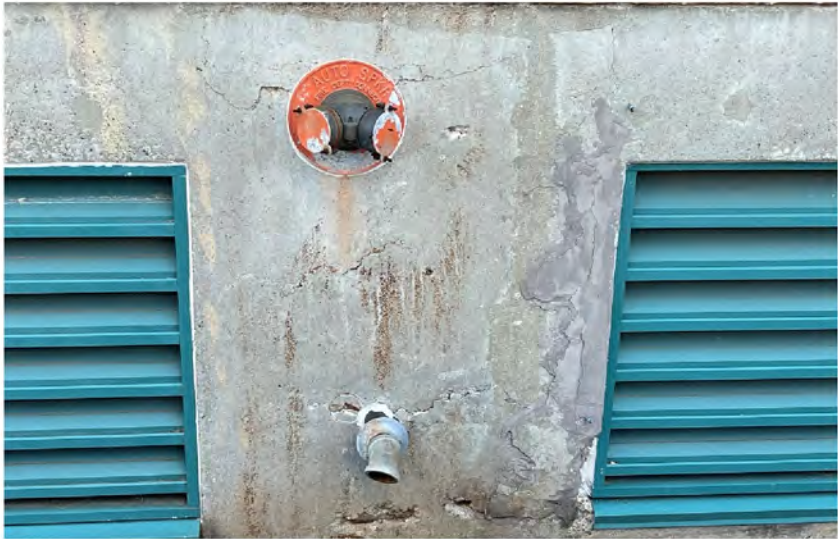
Isolated cracking, spalling and exposed steel rebar was noted at the foundation walls of the older portion of the building. (Ref: Photos 23-25) Some exposed concrete has been painted, with some peeling paint in these areas. (Ref: Photo AE-26) Above the roof, facades around the Youth Center have been clad in stucco and the roof penthouse and dormers are clad in metal panels. (Ref: Photos AE-27, 28) There are exposed steel beams at the top of the Southwest Stairwell, which likely contribute to thermal bridging through the façade. (Ref: Photo AE-33)

AE-25: Representative cracking and isolated spalling, exposed rebar at foundation wall of older portion of building, noted along East Elevation.

Preparation and patching of the spalled concrete foundation and façade areas is recommended. Coat any exposed reinforcing steel with a corrosion inhibiting coating prior to performing the concrete repair.  
Install rodent-proof mesh or alternative cladding along base of North Elevation, extending below grade to address issues related to rodents burrowing/nesting in this area.

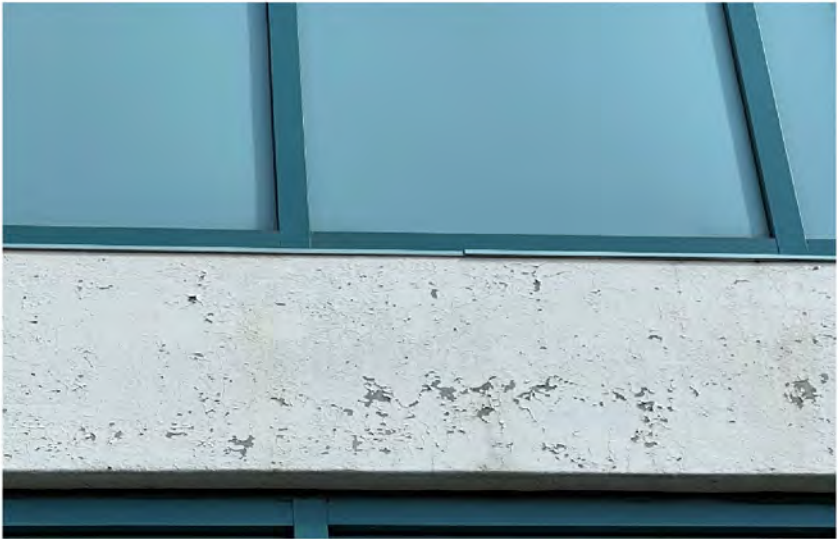
AE-26: Typical peeling paint at concrete facade

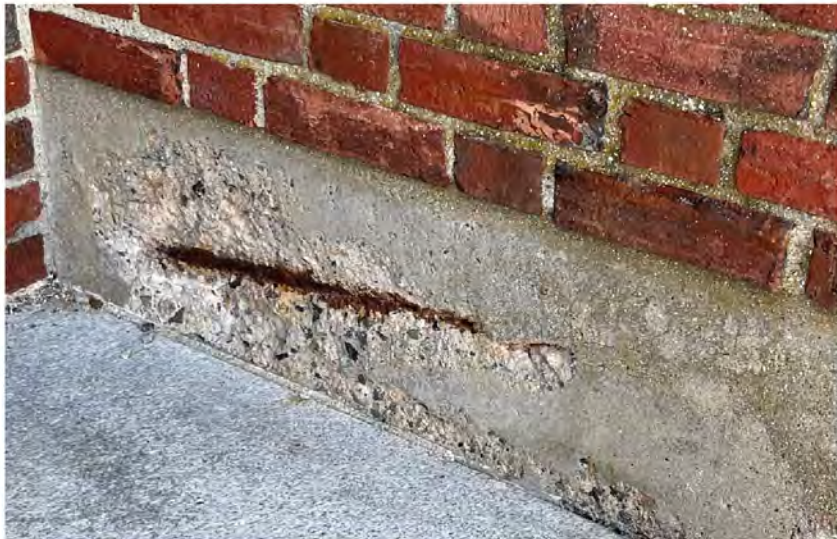
AE-23: Isolated exposed rebar at foundation of older portion of building near building entrance.

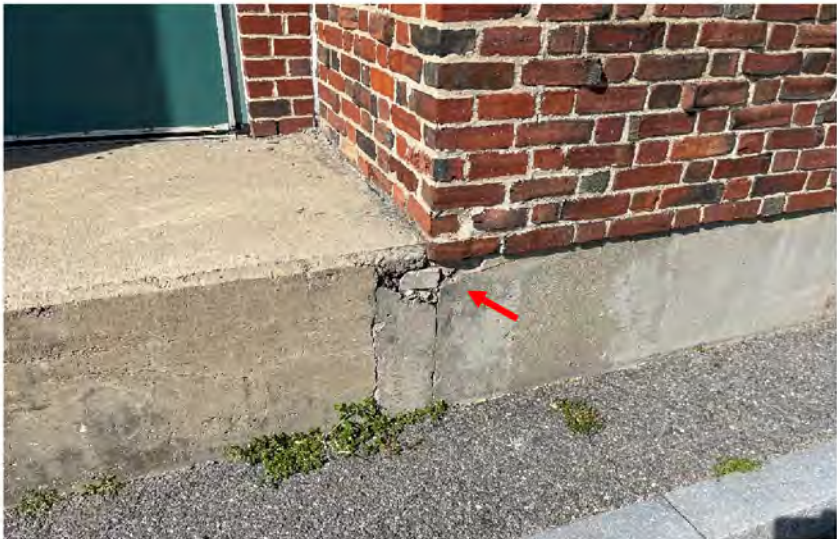
AE-24: Representative cracked and spalled concrete.

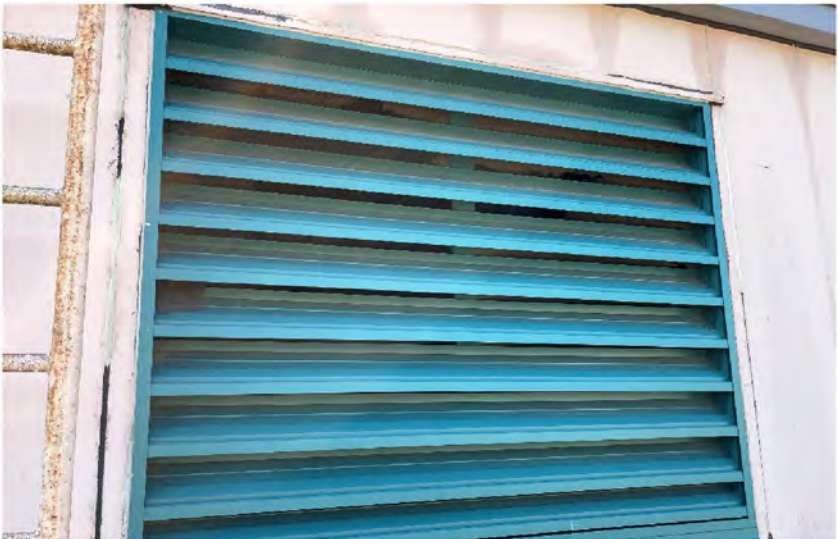
AE-28: Typical louver installed in mechanical penthouse, note multiple perimeter sealant colors around louver due to repairs made over time.

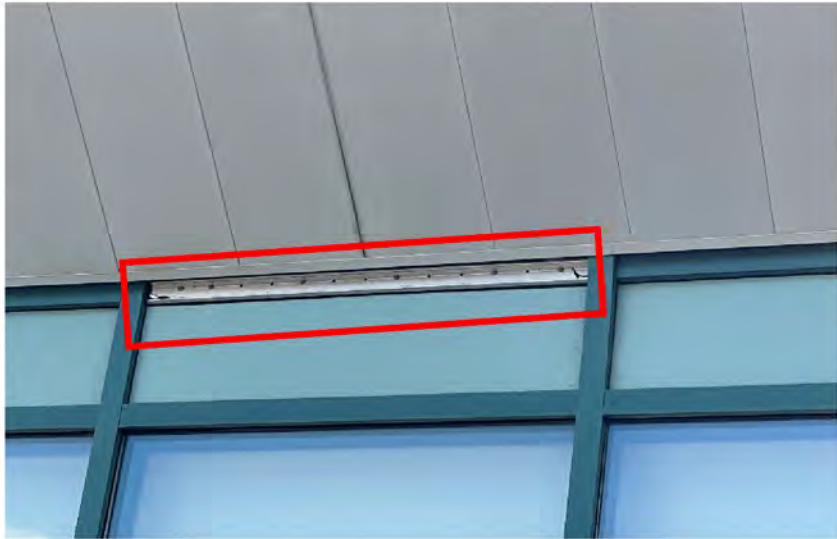
Isolated conditions in need of repair or replacement include missing or improperly secured curtain wall pressure bar snap covers (Ref: Photo AE-29-30) and broken glass lites. (Ref: Photo AE-32) A few areas were noted where sealants were applied over the base of the curtain wall snap covers where drainage is supposed to occur by design. It is unclear if these sealants have resulted in curtain wall drainage issues. (Ref: Photo AE-31)

AE-29: Typical curtain wall assembly missing snap cover at North Elevation.

Fenestrations:  
Replacement of missing or deficient curtain wall snap covers and cracked glass is recommended. Replacement of damaged or missing insect screens can be performed if desired.

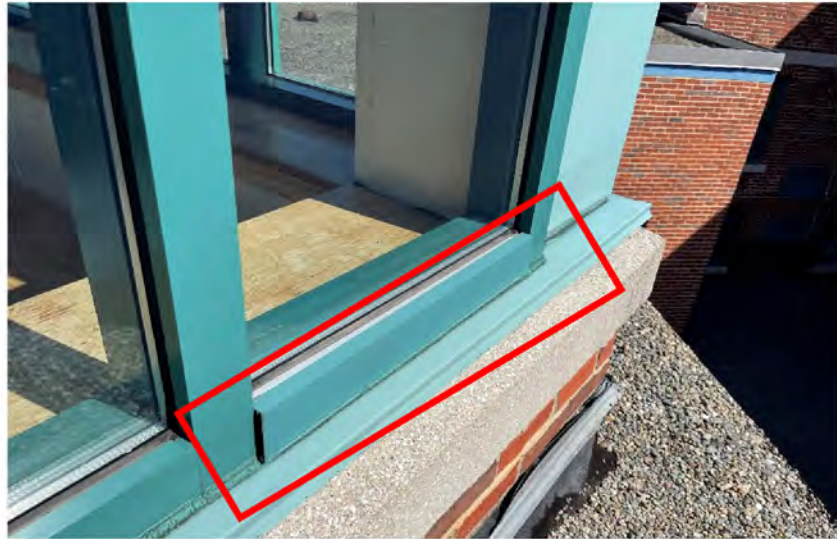
AE-30: Typical curtain wall snap cover that is not fully engaged to pressure plate at curtain wall located at East Elevation of West Wing

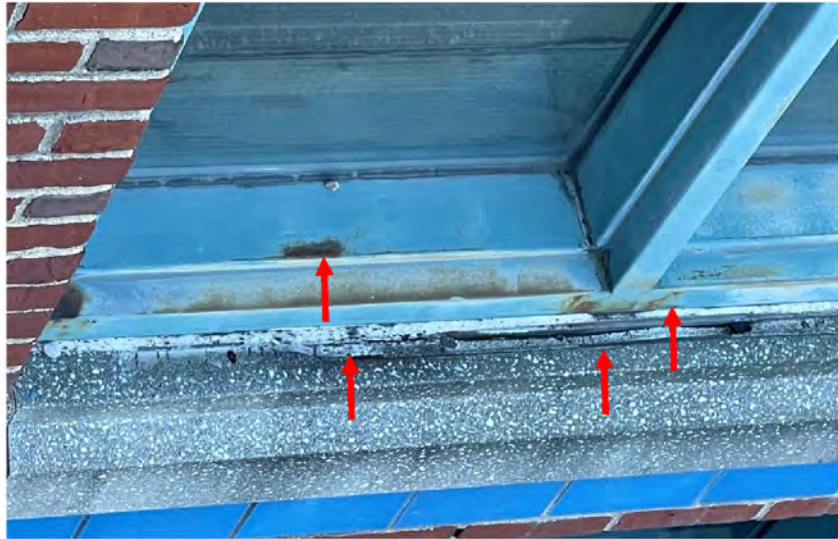
Reported Envelope Issues:  
While on site, discussions were held with facilities personnel to identify any building exterior-related issues that may exist. Those present were shown portions of the North Elevation where rodents are able to burrow below the building’s floor and façade, which has been an on-going issue. (Ref: Photo AE-21). Additional reported issues include roof leaks at the base of a metal-framed skylight in the Cafeteria and within the Hallway outside the Girl’s Bathroom. (Ref: Photos AE-55-56) Leakage issues also reported within the Southwest Stairwell around the metal framed windows. (Ref: Photos AE-34-36)

AE-34: Typical failed sealant joint between precast sill and hollow metal window assembly at Southwest Stairwell. Note rusting of metal frame.

At the hollow metal window assemblies in the Southwest Stairwell, replacement of all perimeter sealants is recommended, as well as preparation, priming and repainting of the window frames.

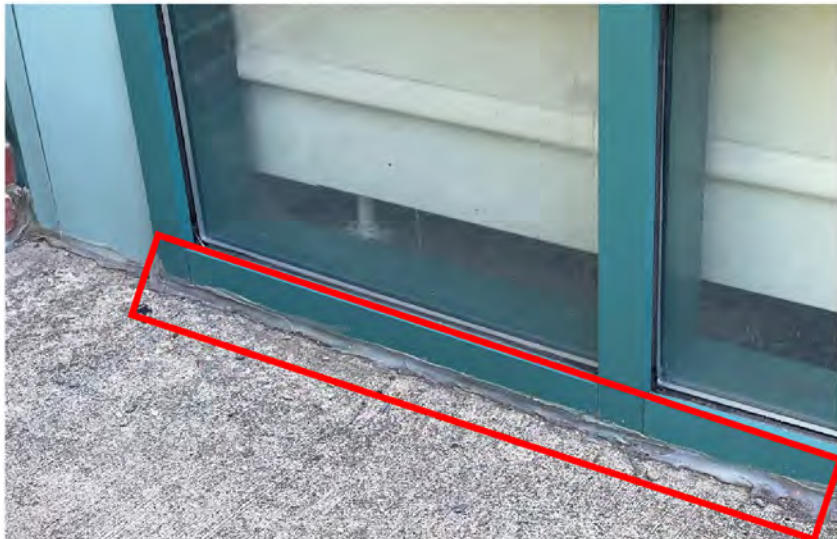
AE-31: Typical curtain wall where sealant has been applied over base of snap covers where drainage from curtain wall occurs

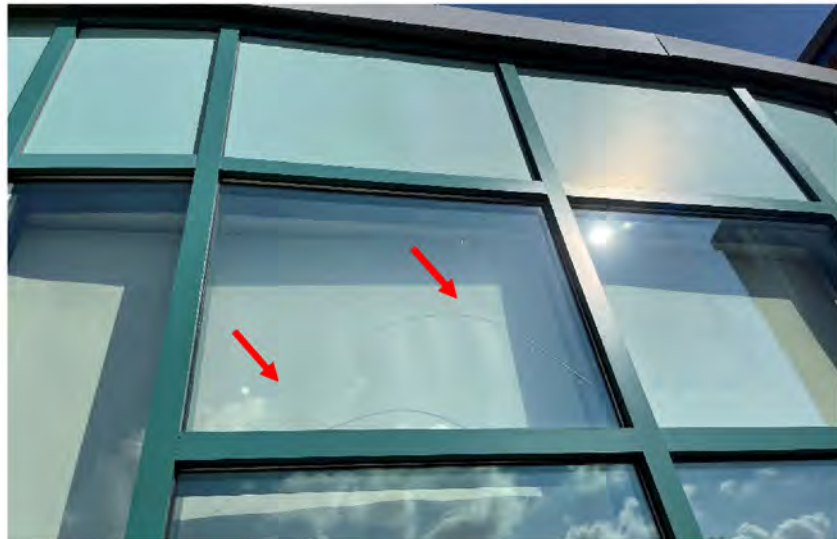
AE-32: Cracked glass within curtain wall on West Elevation at curved facade

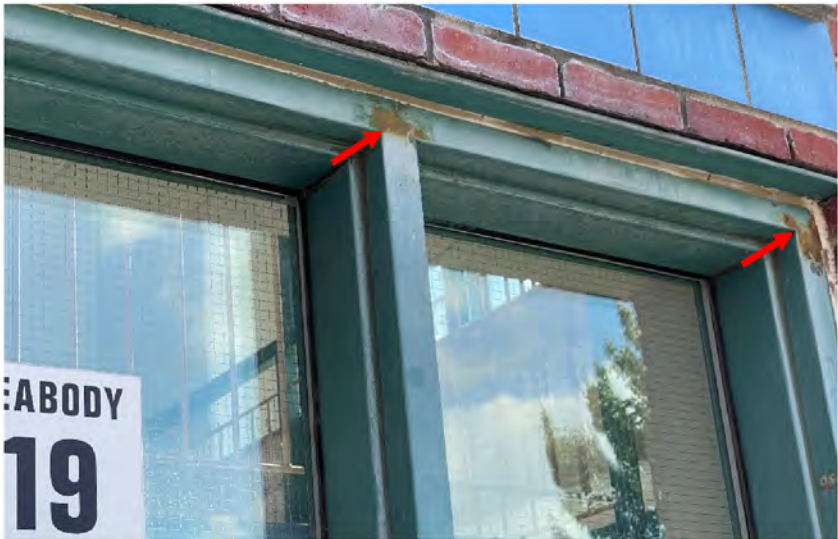
Hollow metal window assemblies are installed at the Southwest Stairwell by Door 19. The perimeter sealants around these units have failed and the frames are rusting, resulting in interior water leakage issues in this space. (Ref: Photos AE-34-36) Exterior hollow-metal framed doors exhibit surface rusting and peeling paint on the base of these frames at most locations. (Ref: Photos AE-27-28) Some damaged insect screens were also noted. (Ref: Photo AE-40)

AE-35: Typical rusting of hollow metal window assemblies at Southwest Stairwell above Door 19.

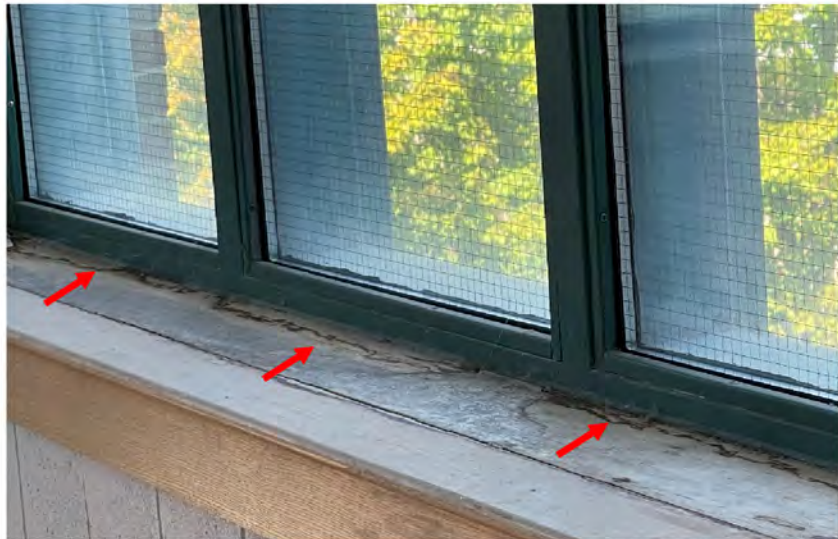
AE-36: Interior of Southwest stairwell where staining evident of water leakage was observed around hollow metal window assemblies.

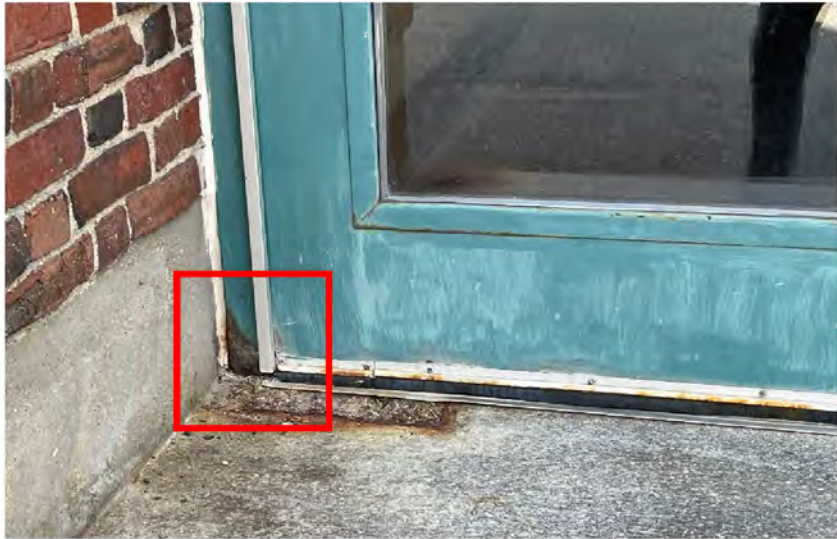
AE-37: Typical rusting at exterior base of metal framed door, typical in most locations.

Some of the surface rusting observed at the hollow metal doors and frames may be due to use of deicing salts during the winter months. Reduction in use of these materials against these metal assemblies should reduce potential for further damage. Preparation, priming and repainting of these doors and frames is advised.

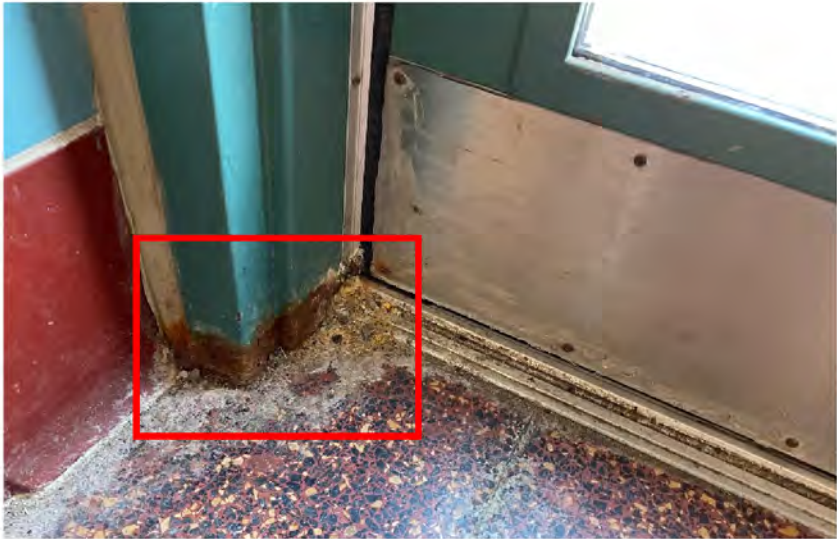
AE-38: Typical rusting at interior base of metal framed door, typical in most locations.

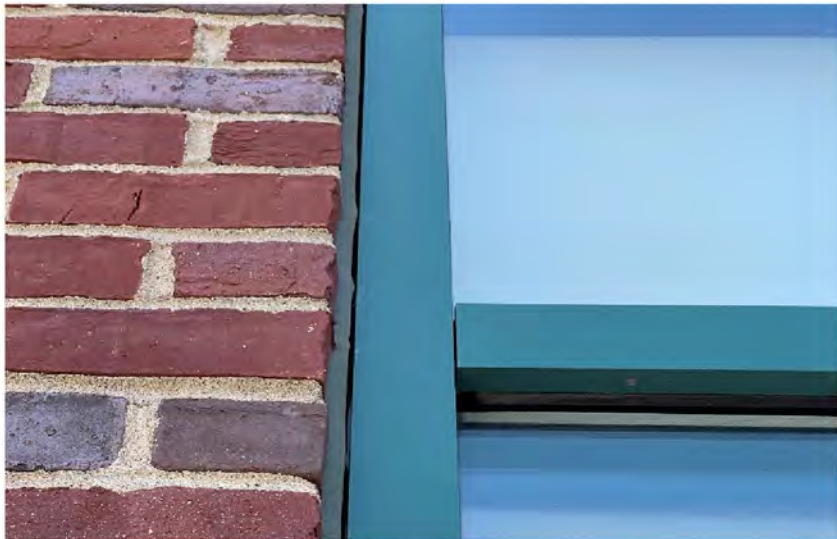
The fenestrations comprise thermally broken aluminum window, storefront and curtain wall assemblies, with isolated locations of hollow metal window and door units. Some aluminum framed hung and awning windows were observed at the older portions of the building. The fenestrations appear to be in good condition overall, with isolated areas in need of repair. Perimeter sealants around most of these assemblies have reached the end of their service life. (Ref: Photos AE-39)

AE-39: Typical failed sealant at perimeter of fenestration

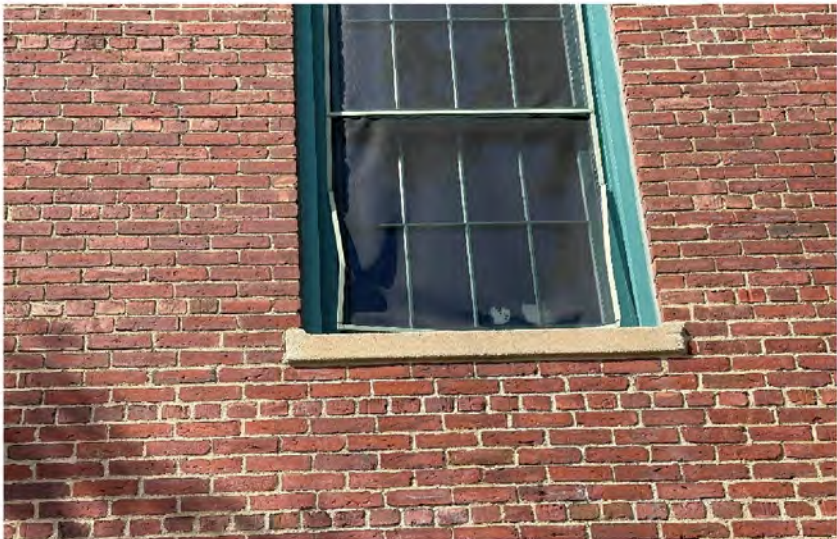
AE-40: Representative damaged insect screen

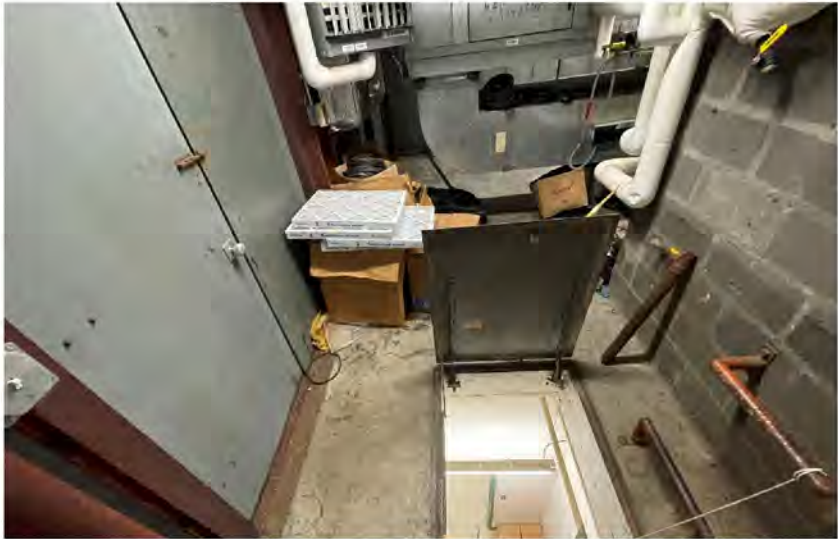
AE-41: Roof access within penthouse. Penthouse door is very close to hole in floor from access hatch. Very awkward and not safe.

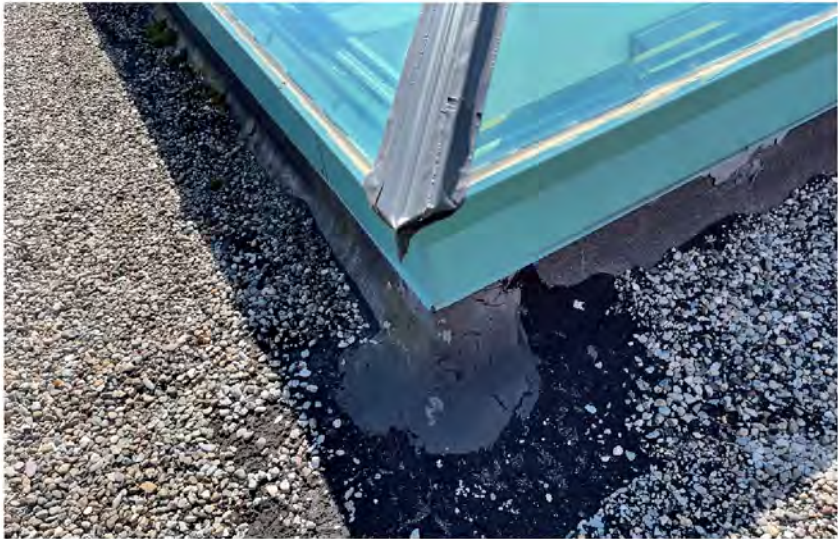
AE-49: Typical metal framed skylight with evidence of interior leakage. Note black tape applied over framing, sealants applied around glass.

Roofing:  
The existing metal-framed skylights should be reglazed. Unit skylights are 20 years old, are reaching the end of their expected service life and should be replaced.

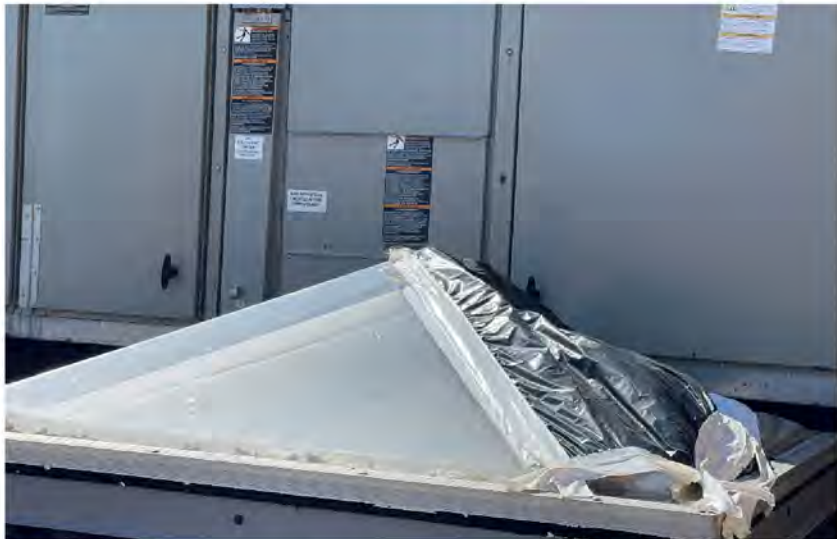
AE-47: Typical damaged unit skylight, covered with black plastic and duct tape

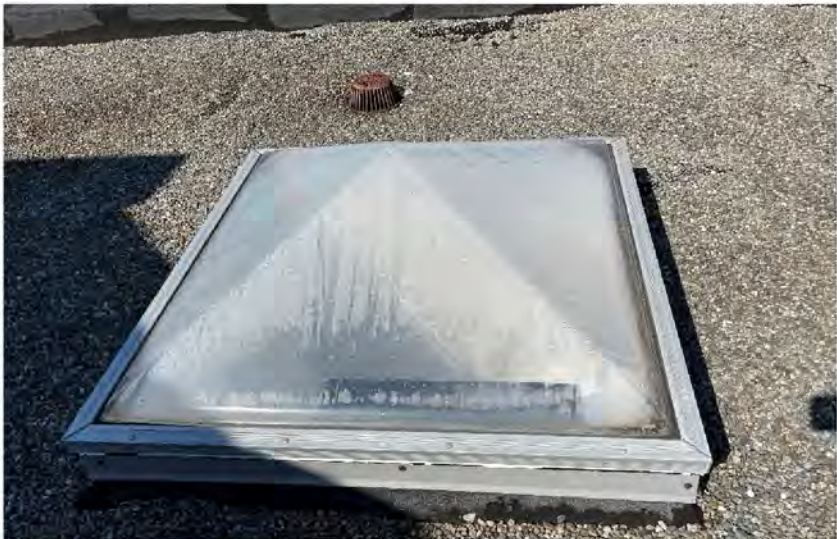
AE-48: Typical unit skylight where thermal seal has failed, allowing condensation between panes of skylight

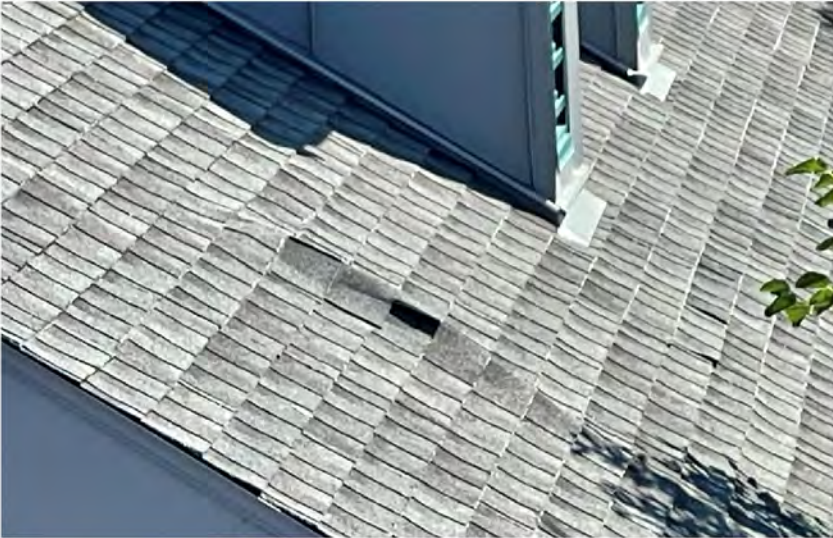
Roof drainage occurs via internal roof drains throughout most of the roof, with aluminum gutters and downspouts installed at the shingled roofs. Multiple metal-framed and unit skylights exist on the roof, with reported water leakage below one of the skylights at the Cafeteria. The skylights are in need of repair or replacement, with Tape and layers of sealants visible over most of the unit skylights and plastic sheeting applied over some unit skylights. Condensation was observed between the panes of the unit skylight, indicative of a failed thermal seal. (Ref: Photos AE-47-49) At the shingled roof, some buckled shingles were noted at a few locations. (Ref: Photo AE-53)

AE-53: Typical asphalt shingles buckling, noted in a few locations. Source of buckling is unknown.

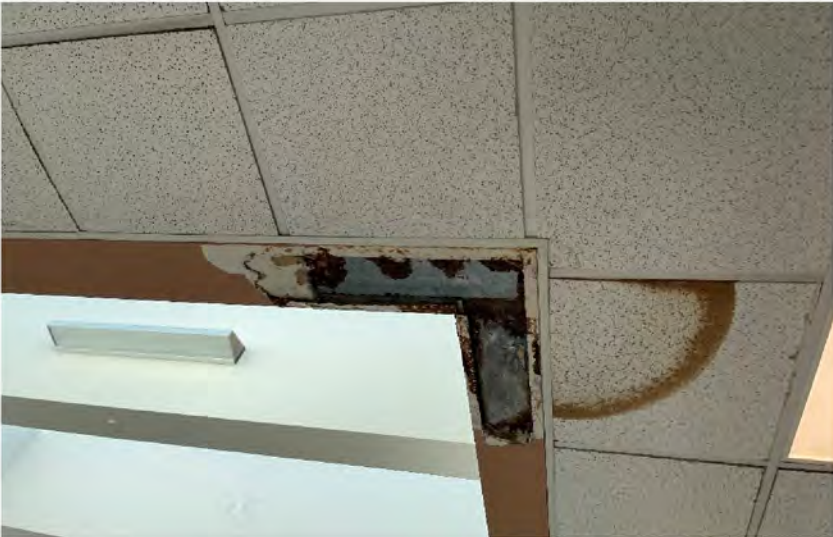
AE-55: Interior damage at leak below metal framed skylight in Cafeteria.
