# PEABODY SCHOOL

## Facilities Condition Assessment : October 14, 2022

Facilities Condition Assessment, Capacity Analysis and Master Plan for CPS

## 7.10 | PEABODY SCHOOL BUILDING APPENDIX

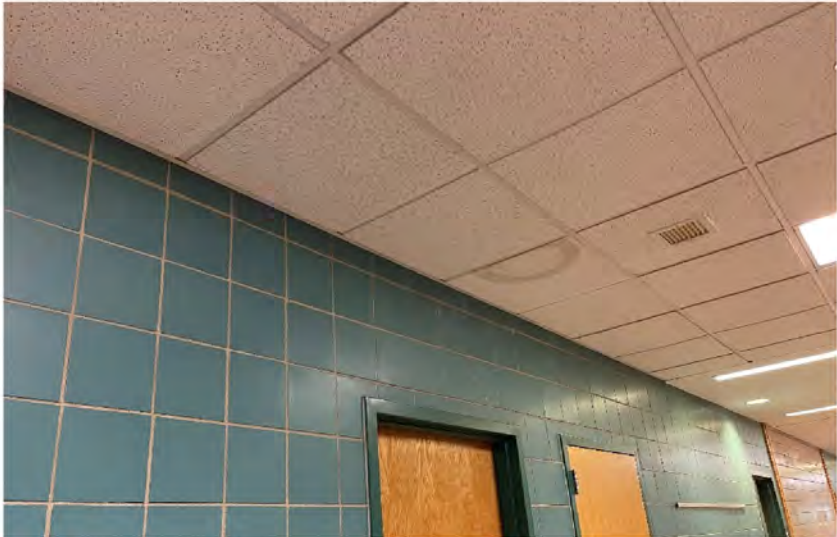
AE-56: Water damaged ceiling tile at leak location outside of Girl's Bathroom.
