Lead Clearance Examination Report

3360 North
Sherman
Boulevard,
Milwaukee, WI
53216

08/26/2025 at
8:00AM

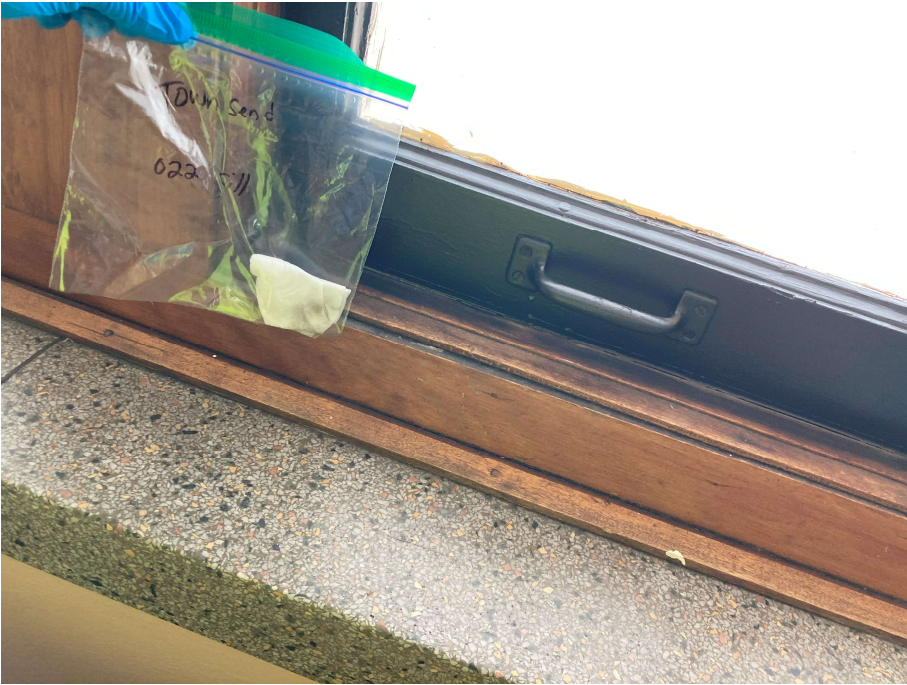
Figure 1: Example of a sill sample within one of the classrooms.

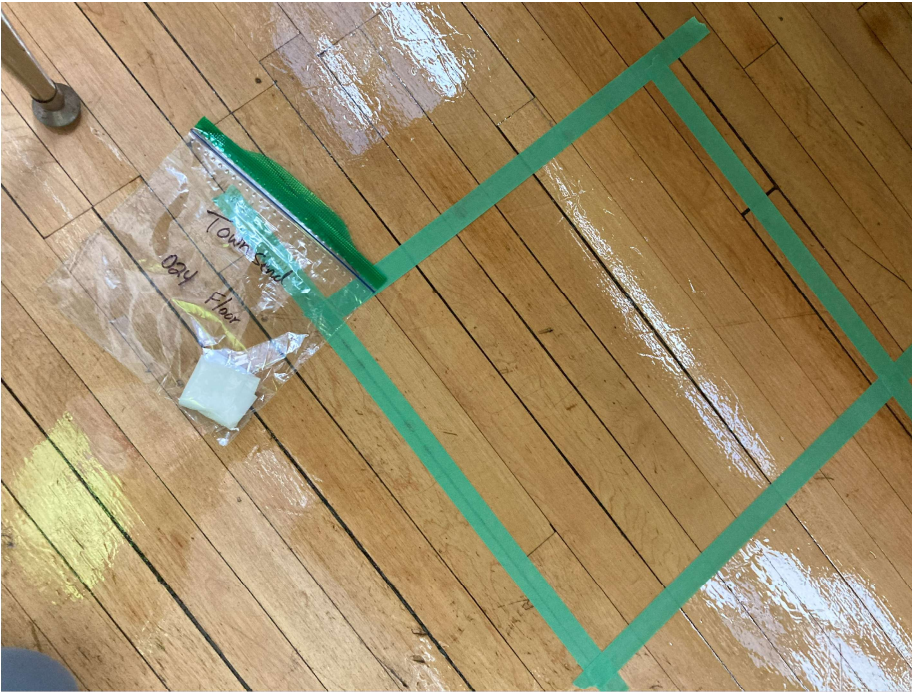
Figure 2: Example of a floor sample within one of the classrooms.
