Lead Clearance Examination Report

For the property at:
1601 N. Hawley
Road, Milwaukee,
WI 53208

Conducted on:
08/28/2025 at
9:00AM

SITE NO. 283 - NEESKARA ELEMENTARY SCHOOL
 1601 N. HAWLEY RD., MILW., WI., 53208
 DATE: 9/15/08

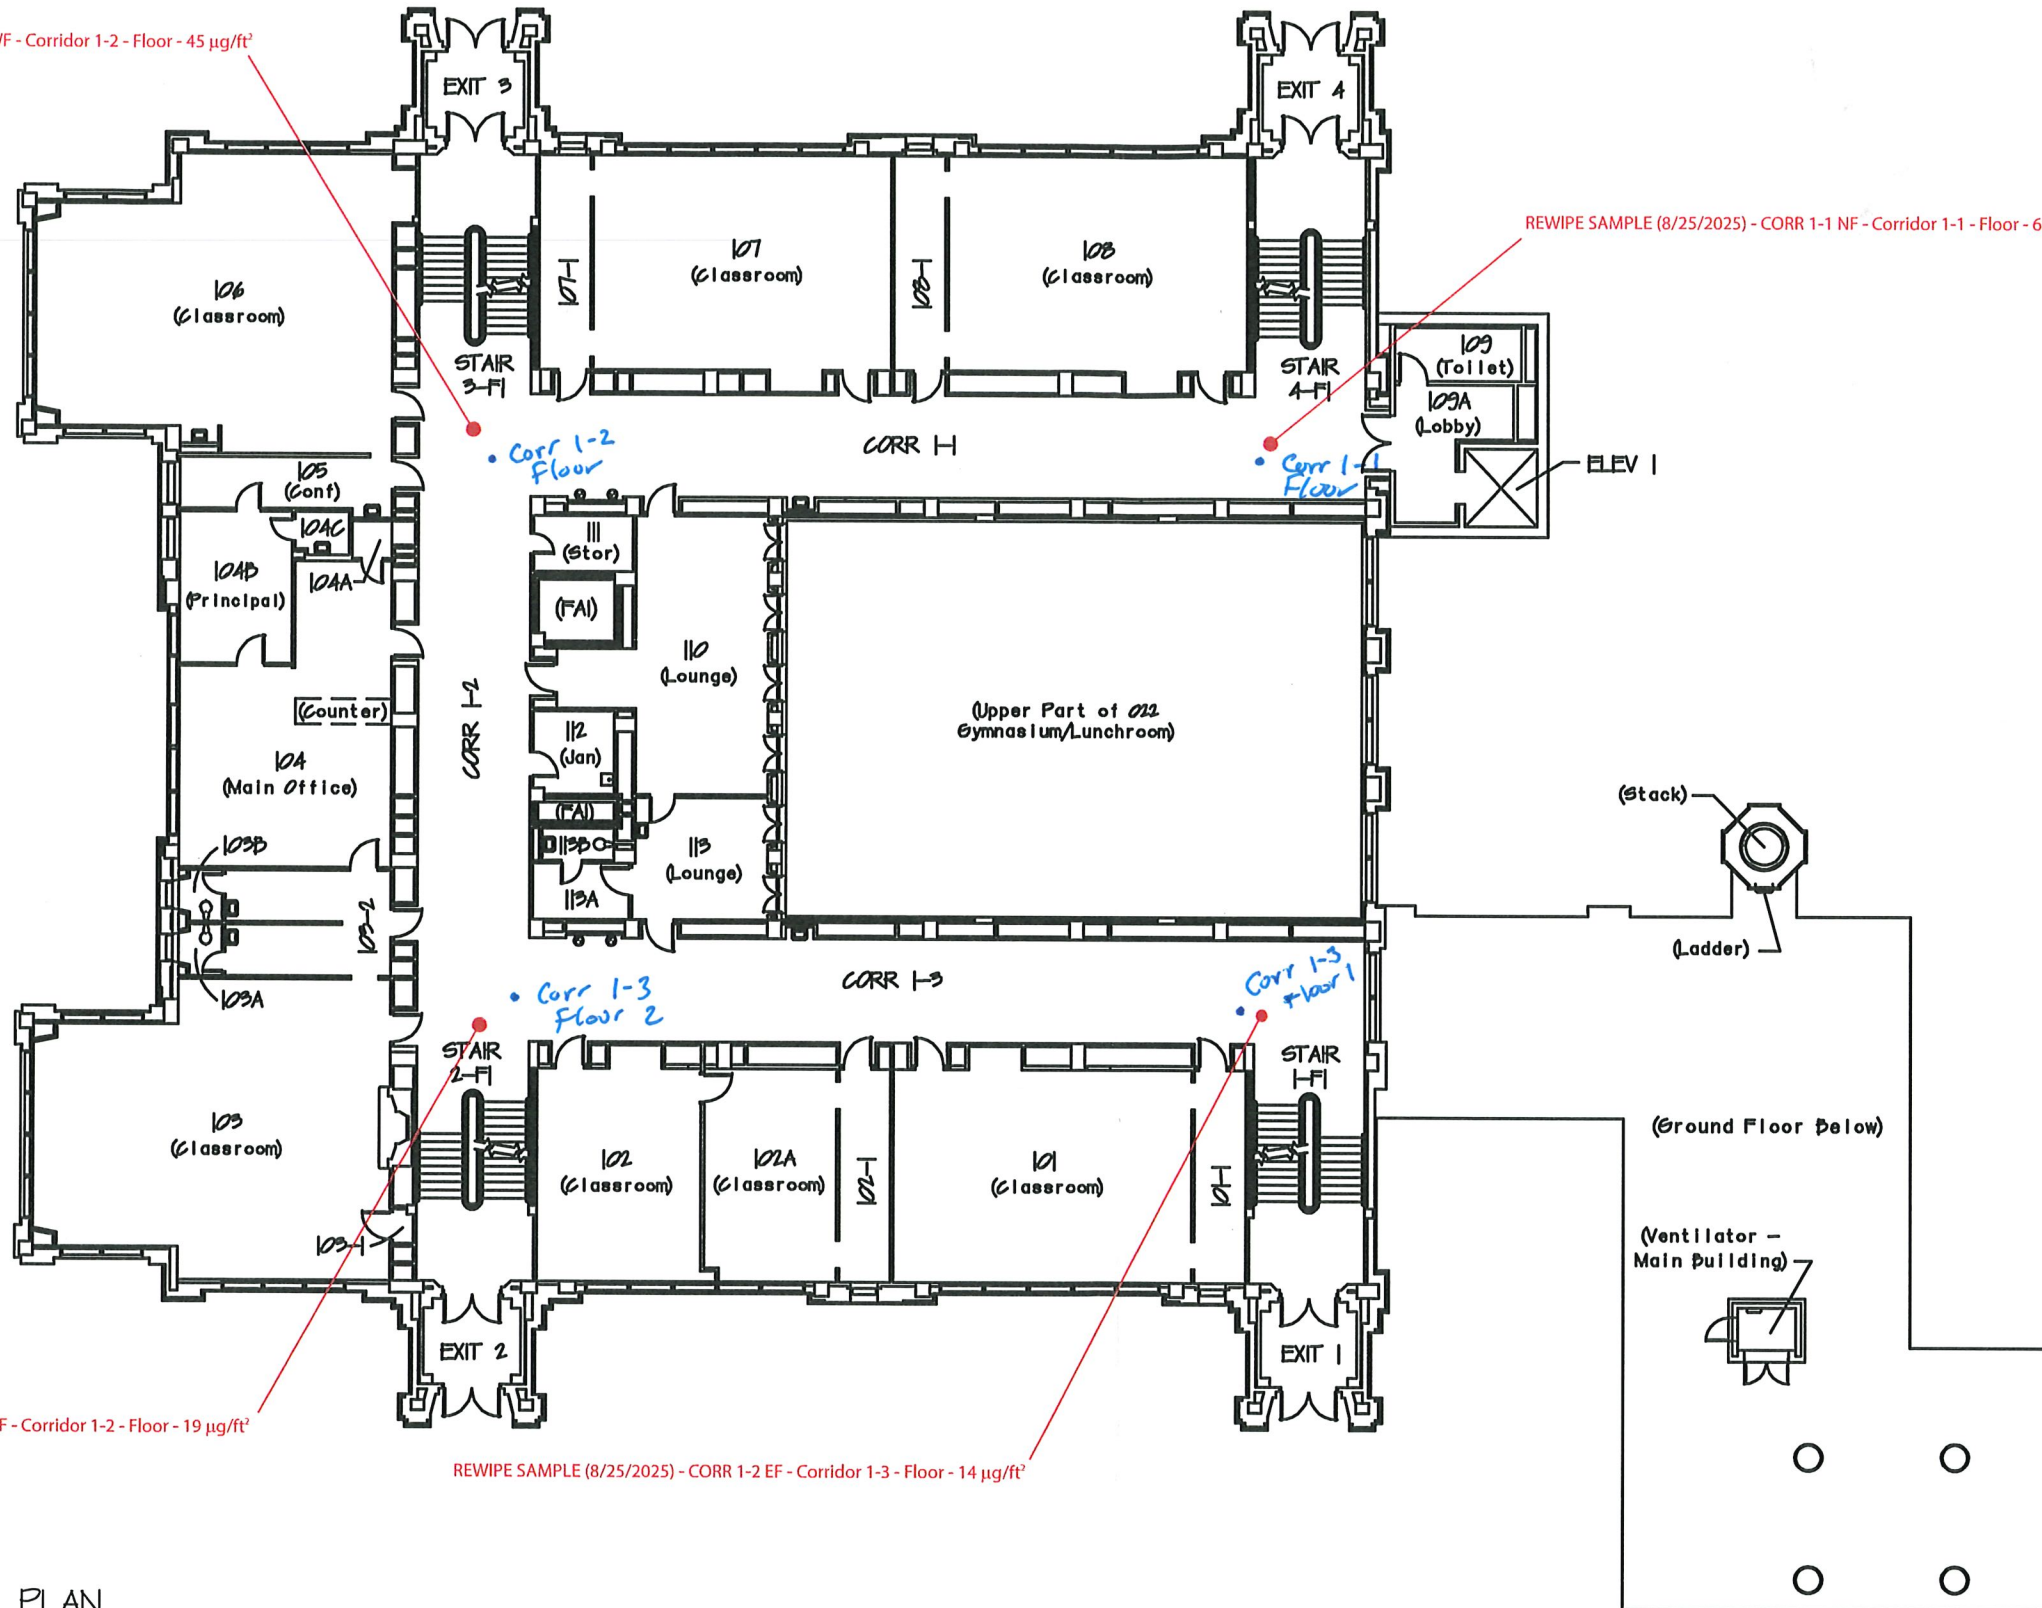
FIRST FLOOR PLAN

REWIPE SAMPLE (8/25/2025) - CORR 1-2 WF - Corridor 1-2 - Floor - 45 µg/ft²

REWIPE SAMPLE (8/25/2025) - CORR 1-1 NF - Corridor 1-1 - Floor - 67 µg/ft²

REWIPE SAMPLE (8/25/2025) - CORR 1-2 EF - Corridor 1-2 - Floor - 19 µg/ft²

REWIPE SAMPLE (8/25/2025) - CORR 1-2 EF - Corridor 1-3 - Floor - 14 µg/ft²

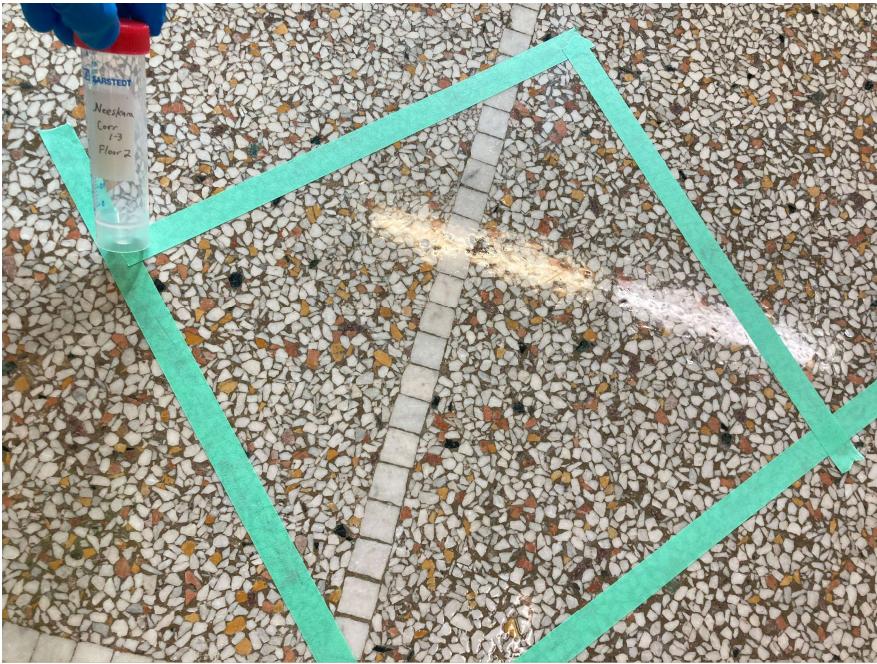
Figure 1: Example of a floor sample within one of the corridors.
