# Lead Clearance Examination Report

3815 W. Kilbourn  
Avenue,  
Milwaukee, WI  
53208

08/28/2025 at  
7:00AM

Cedar Corporation, DHS No. DHS-11770  
1695 Bellevue Street,  
Green Bay, Wisconsin 54311  
920-497-9081

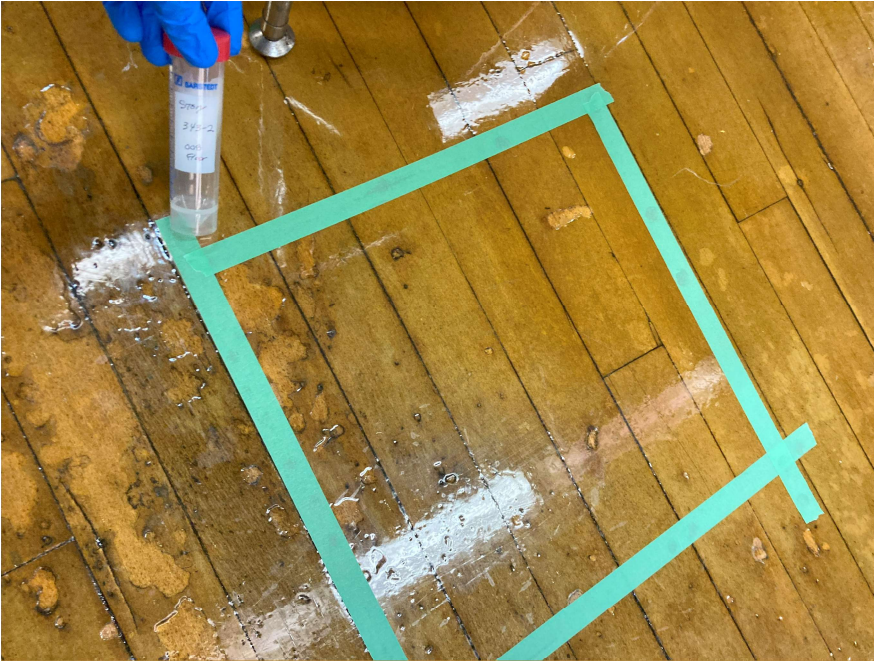
*Figure 1: Example of a floor sample within one of the classrooms.*
