Lead Clearance Examination Report

For the property at:
2227 E. Hartford Avenue,
Milwaukee, WI 53211

Conducted on:
08/26/2025 at
7:00AM

Cedar Corporation, DHS No. DHS-11770
1695 Bellevue Street,
Green Bay, Wisconsin 54311
920-497-9081

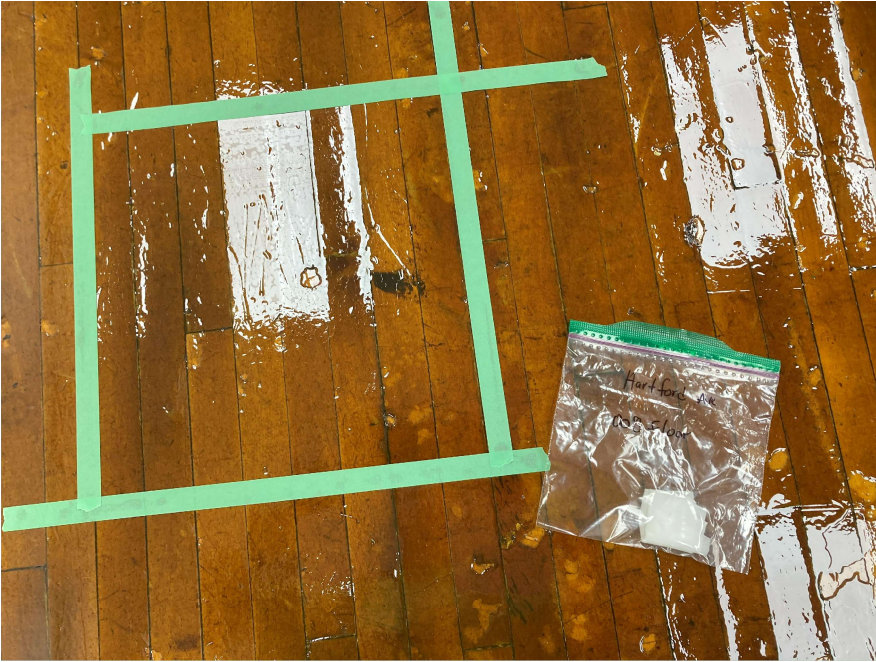
Figure 1: Example of a floor sample within one of the classrooms.
