LEAD CLEARANCE INSPECTION REPORT

For Site Located at: Hartford Avenue K-8 School, 2227 E. Hartford Ave. Milwaukee, WI 53211

Project #40638

Subject: Lead Clearance Inspection Report for Milwaukee Public Schools, Hartford Avenue K-8 School, 2227 E. Hartford Ave, Milwaukee WI 53211

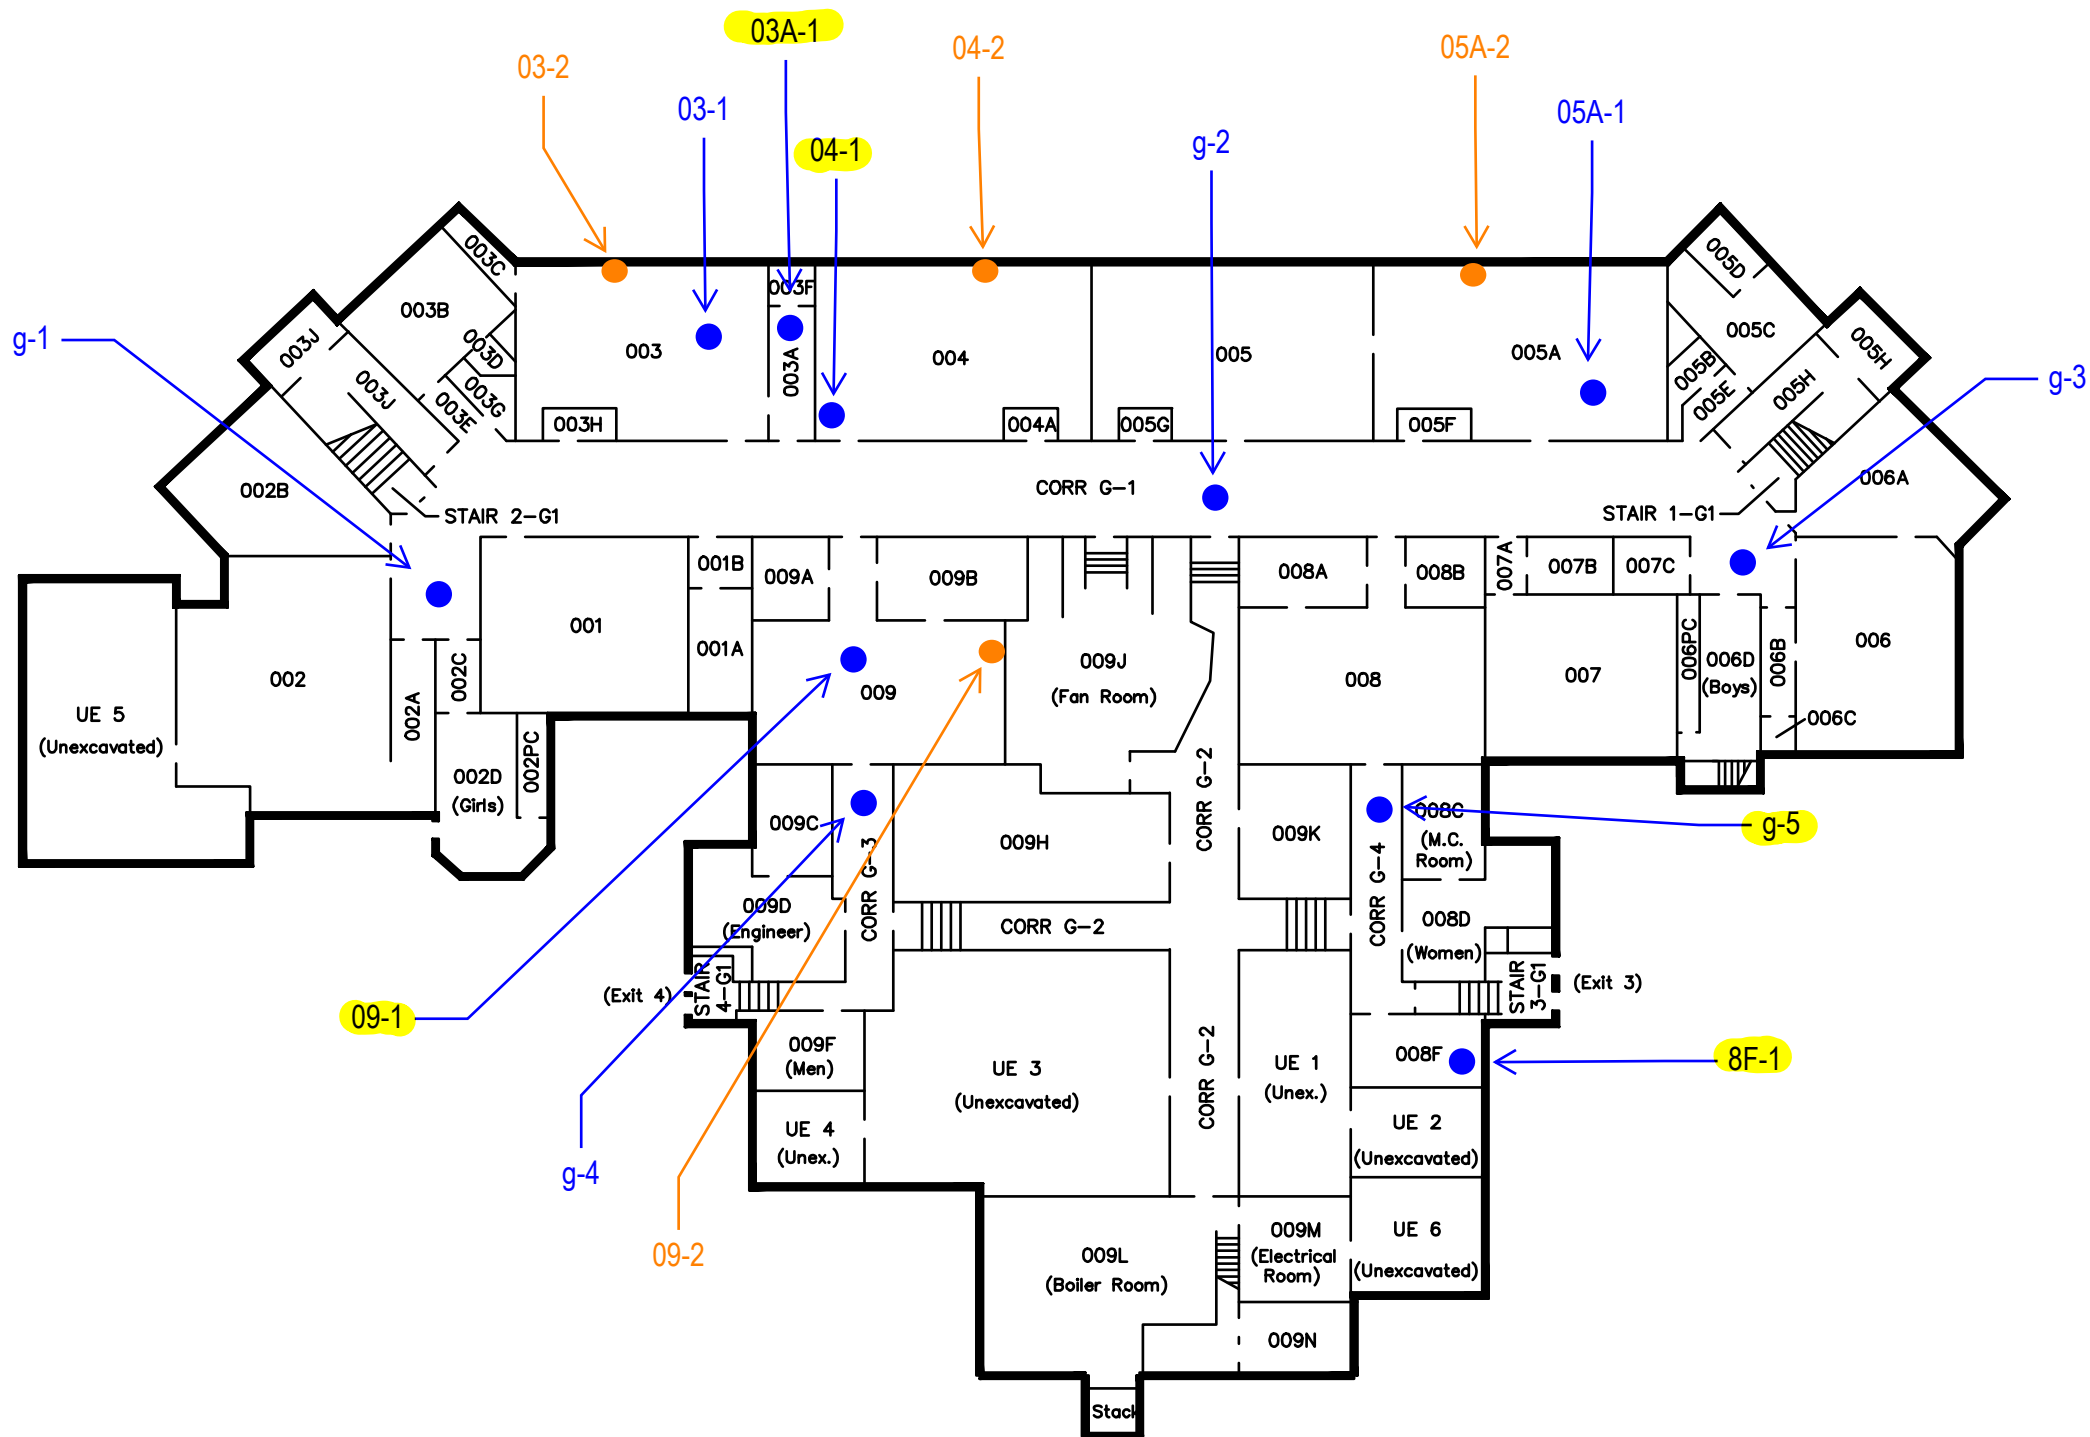
Figure 2: Ground Floor Sample Locations

- All 7 of these samples were floor samples, results greater than or equal to the threshold of 10.0 $\mu\text{g}/\text{ft}^2$.
- Of the 7 samples, 5 were on the ground floor, 1 was on the first floor, and 1 was on the second floor.

Based on the results of laboratory analysis, seven lead hazards were identified throughout the building, and the property has failed the clearance testing. Three floor samples were in regular classrooms, three floor samples were in bathrooms, and one floor sample was found in a hallway corridor. The contractor was notified of their responsibility to re-clean all failed components and all like components in all unsampled rooms.
