# Third-Party Lead Clearance Testing Report

**Performed On:** August 21, 2025, 2:28 PM

Burdick School (098)  
4348 South Griffin Avenue,  
Milwaukee, WI 53207

Milwaukee Public Schools

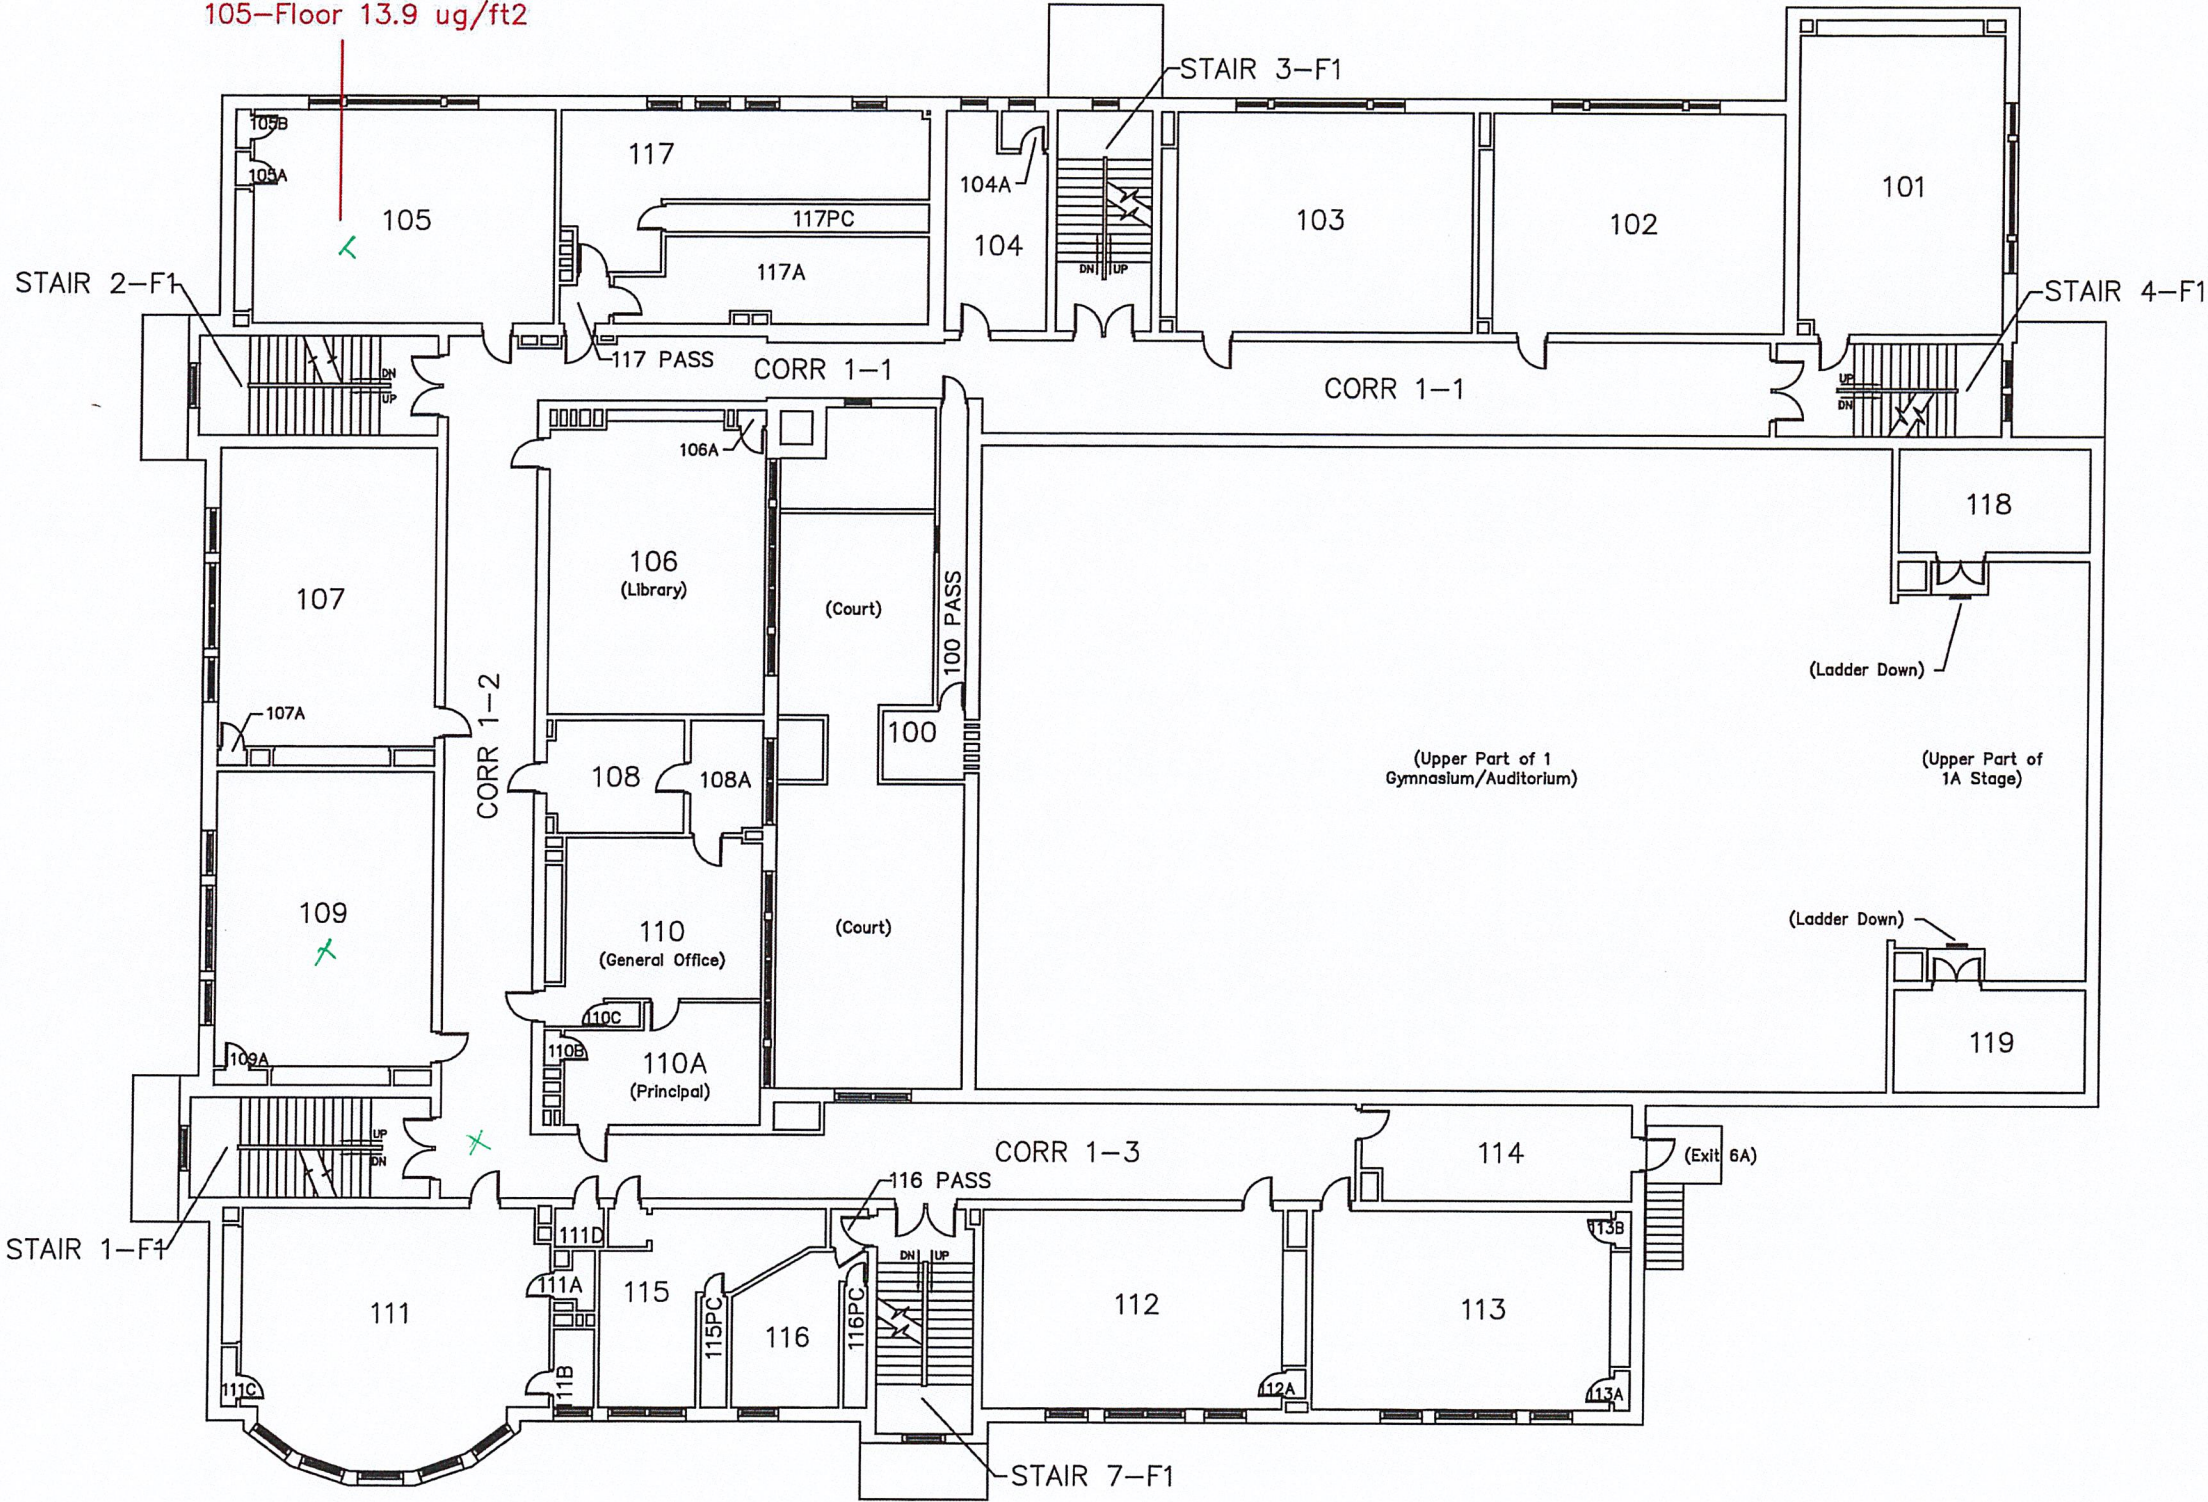
FIRST FLOOR PLAN

| Sample No. | Description | Surface Type | | Wipe Sample Detected Lead Concentration (ug/ft <sup>2</sup> ) | | DHS Regulatory Clearance Level (ug/ft <sup>2</sup> ) <sup>a,b,c</sup> |
|---|---|---|---|---|---|---|
| 105 F | Room 105 Floor | X | | <5 | Pass | 10 |
| 109 F | Room 109 Floor | X | | <5 | Pass | 10 |
| 112 F | Room 112 Floor | X | | <5 | Pass | 10 |
| Corr 1-2 S | Corridor 1-2 South | X | | <5 | Pass | 10 |
