# Lead Clearance Examination Report

2964 N 81st  
Street,  
Milwaukee, WI  
53222

08/18/2025 at  
8:00AM

Cedar Corporation, DHS No. DHS-11770  
1695 Bellevue Street,  
Green Bay, Wisconsin 54311  
920-497-9081

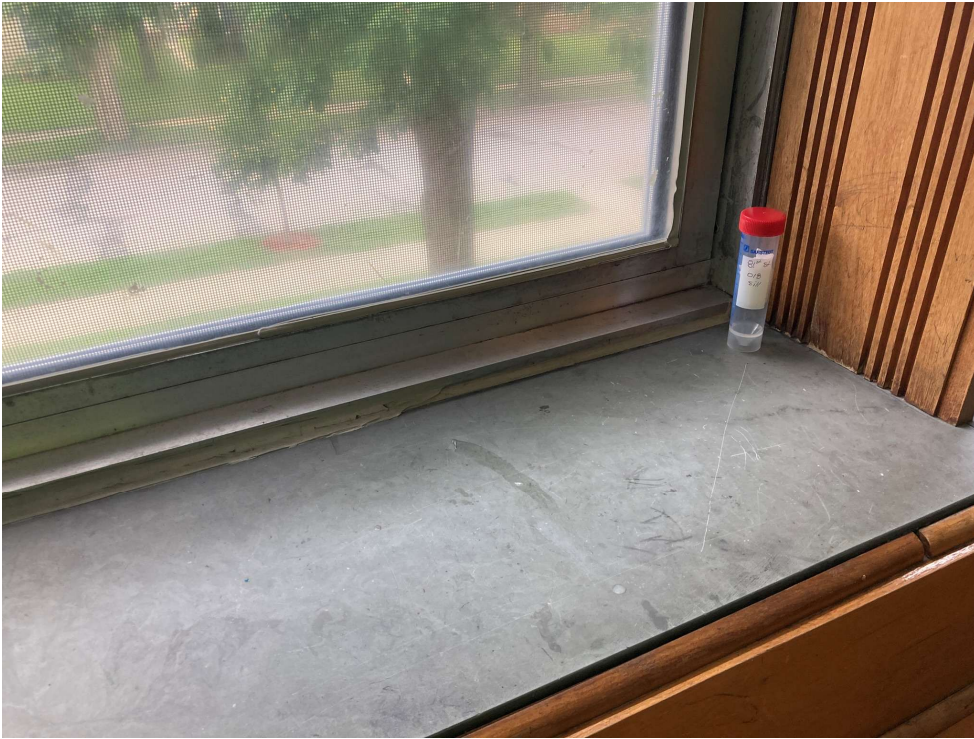
*Figure 1: Example of a sill within one of the classrooms*

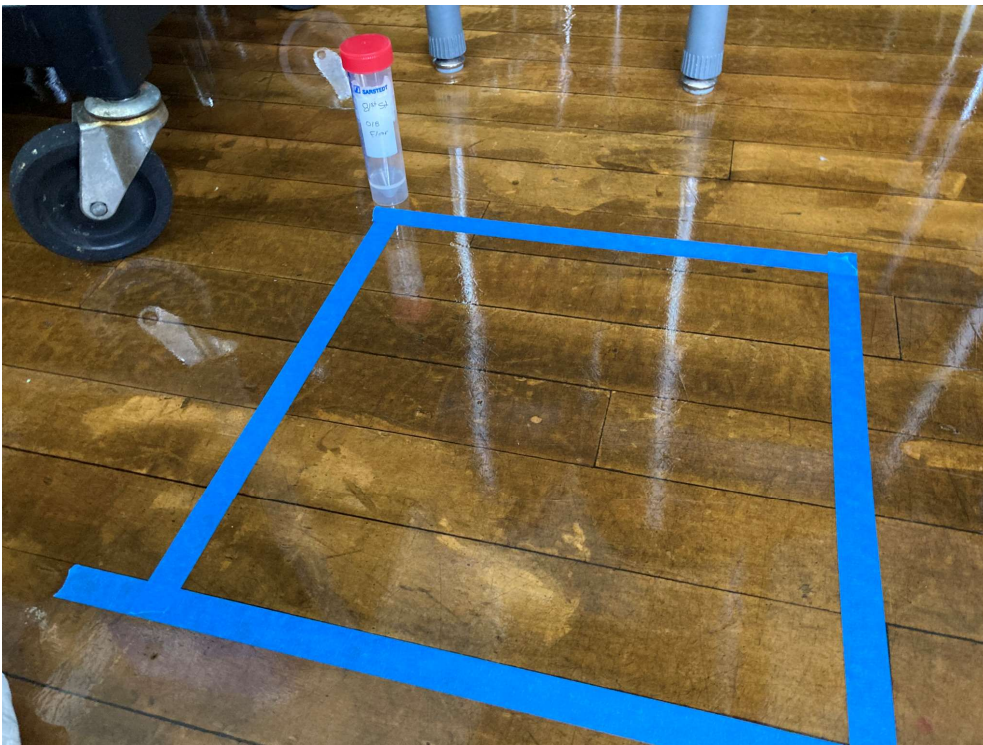
*Figure 2: Example of a floor sample within one of the classrooms*
