# Lead Clearance Examination Report

1647 N. Cass  
Street,  
Milwaukee, WI  
53202

08/26/2025 at  
7:00AM and  
8/28/2025 at  
10:00AM

Cedar Corporation, DHS No. DHS-11770  
1695 Bellevue Street,  
Green Bay, Wisconsin 54311  
920-497-9081

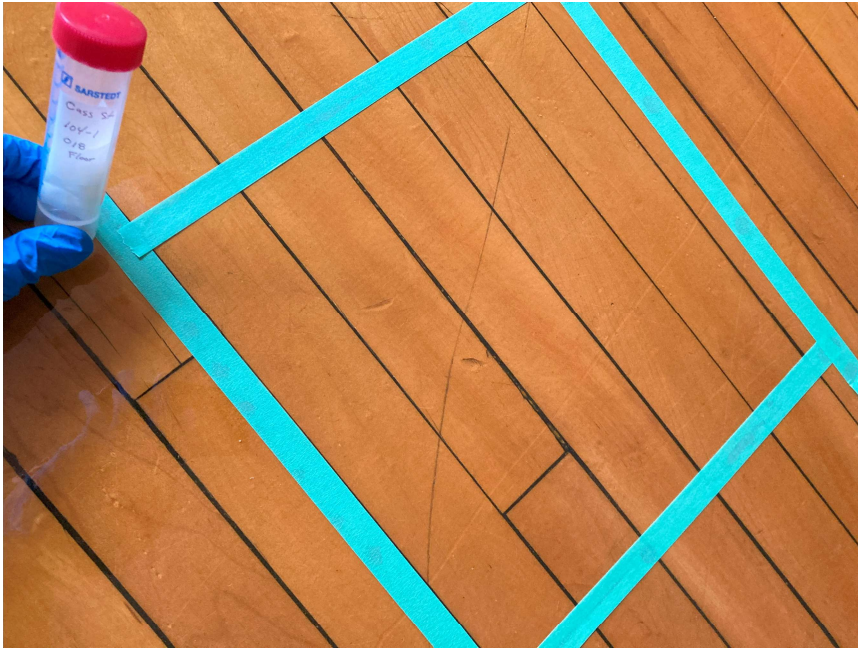
*Figure 1: Example of a floor sample within one of the classrooms.*
