# Lead Clearance Examination Report

1516 W. Forest  
Home Avenue,  
Milwaukee, WI  
53204

08/19/2025 at  
8:00AM

Cedar Corporation, DHS No. DHS-11770  
1695 Bellevue Street,  
Green Bay, Wisconsin 54311  
920-497-9081

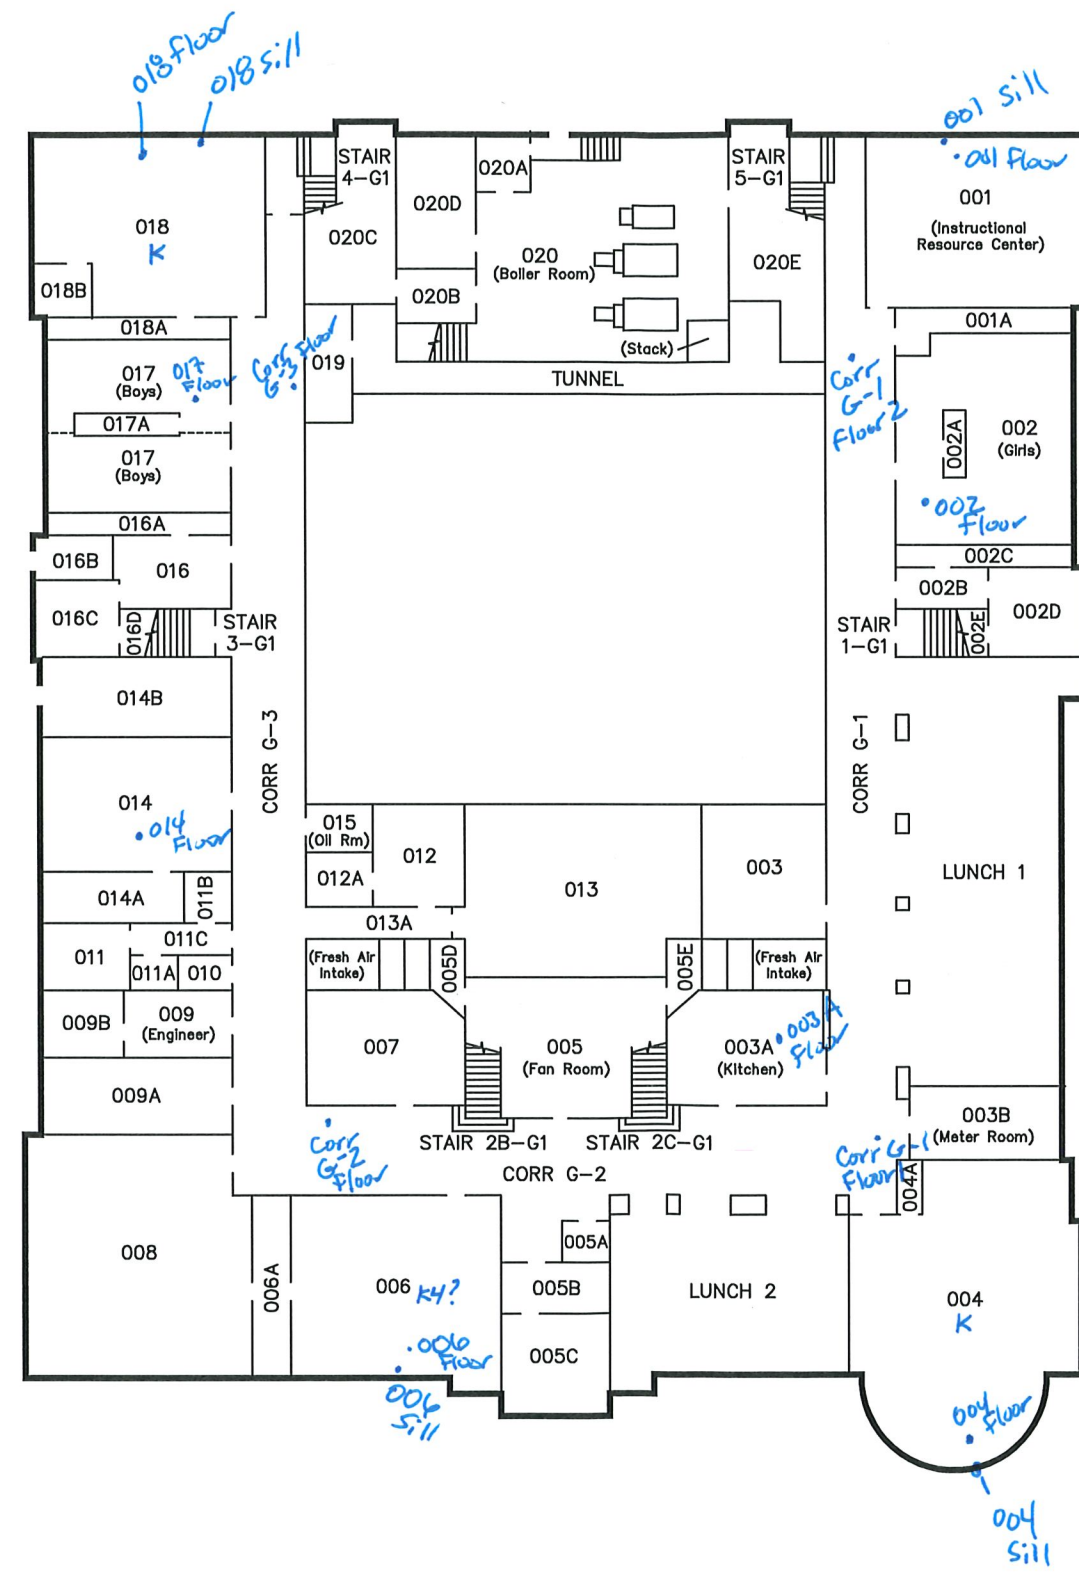
**GROUND FLOOR PLAN**

8/19/2025—Based on the results of laboratory analysis of dust samples, lead dust hazards were identified on the floor in rooms 002, 114, 200, Corr 2-1 and on the window sill in room 004. **This project has failed clearance.** The contractor was notified of their responsibility to re-clean all failed components and all like components in all un-sampled rooms.

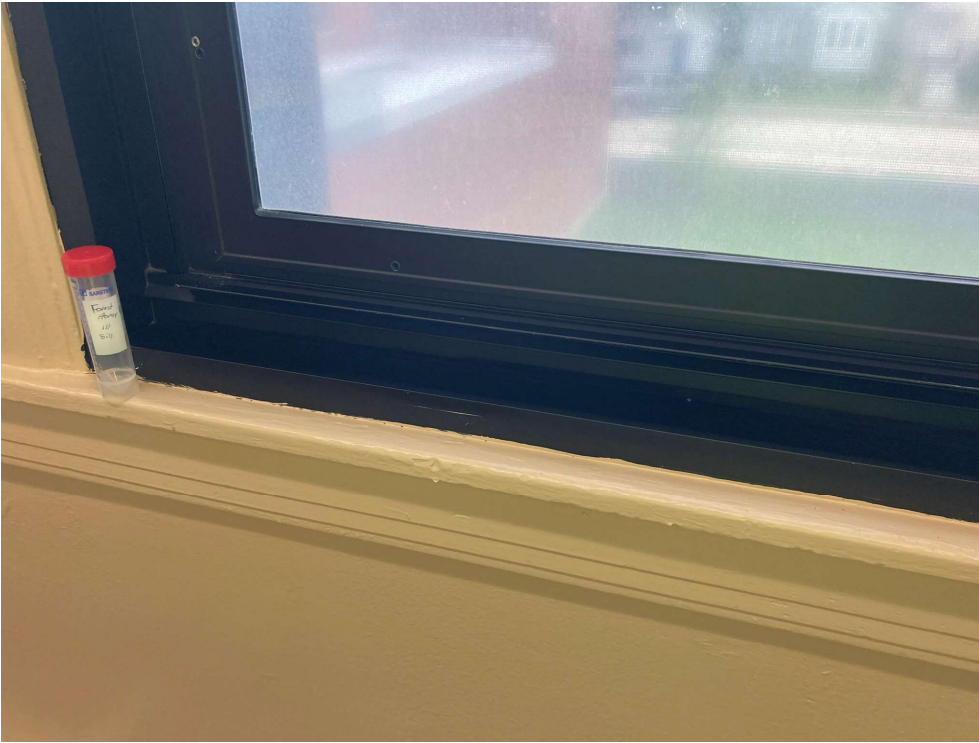
Figure 1: Example of a sill within one of the classrooms.

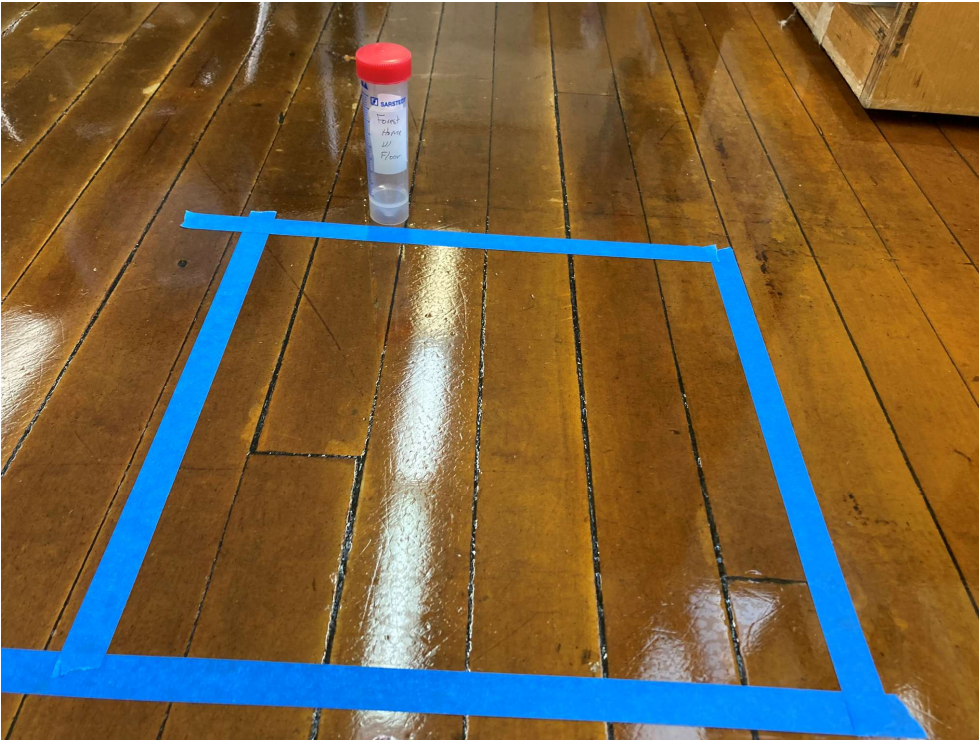
Figure 2: Example of a floor sample within one of the classrooms.
