Crivitz School District

District-wide Facilities Study

STUDY DOCUMENT

November, 2023

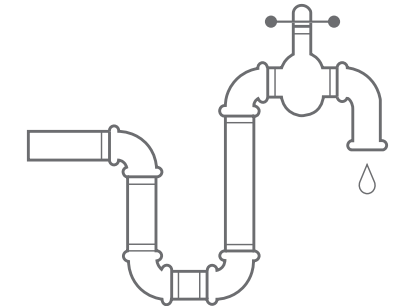
Replace Galvanized Piping

Domestic Water System	■	
Water Service	●	Upgrade if sprinkler added.
Water Distribution Piping	●	Many leaks were noted. Galvanized piping was present.
Water Softening System	○	
Fire Sprinkler System	○	
Sanitary System	■	
Sanitary Waste System	●	Piping is old and vintage to the facility,
Sanitary Drain, Waste + Vent Piping	●	Piping is old and vintage to the facility.
Acid Waste Piping + Basin	○	
Interceptors	○	
Storm System	■	
Storm System	●	Some leaks were noticed.
Storm Waste Piping	○	
Sump Pump	○	
Natural Gas System	■

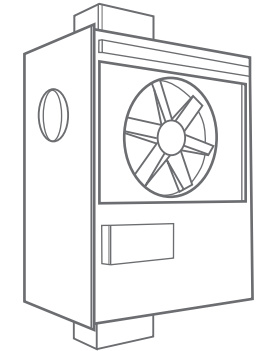
Replace Ventilation + A/C Systems

Heating		
Boiler Plant		Two boilers installed in 2006. A 20- year service life should be expected for this system.
Pumps		Two sets of pumps; one serves the original building and one serves the 1970 addition.
Ventilation + A/C Systems		
Air Handling Units		Units are constant volume, except for the multi-zone unit serving the center classrooms. Units have well exceeded their expected 30-year life span.
Air Conditioning Systems		Only the unit serving the office contains air conditioning.
Control Systems		
		The original pneumatic controls were replaced with a DDC system around 2005.

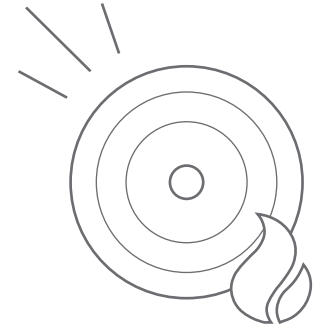
Replace Existing Fire Alarm System

Emergency Generator	□	
Emergency Egress Lighting	■	Add interior and exterior egress lighting to emergency generator or provide additional battery backup egress lighting to comply with current codes.
Fire Alarm System	■	Fire alarm system is more than 20 years old in majority of facility and has reached the end of its life expectancy.
Public Address System	■	Replace this system in its entirety. Provide new analog speakers, wiring and an IP based head end system.
Access Control	■	A new access control system should be considered.
Security System	■	Add additional IP cameras to the existing system as required.

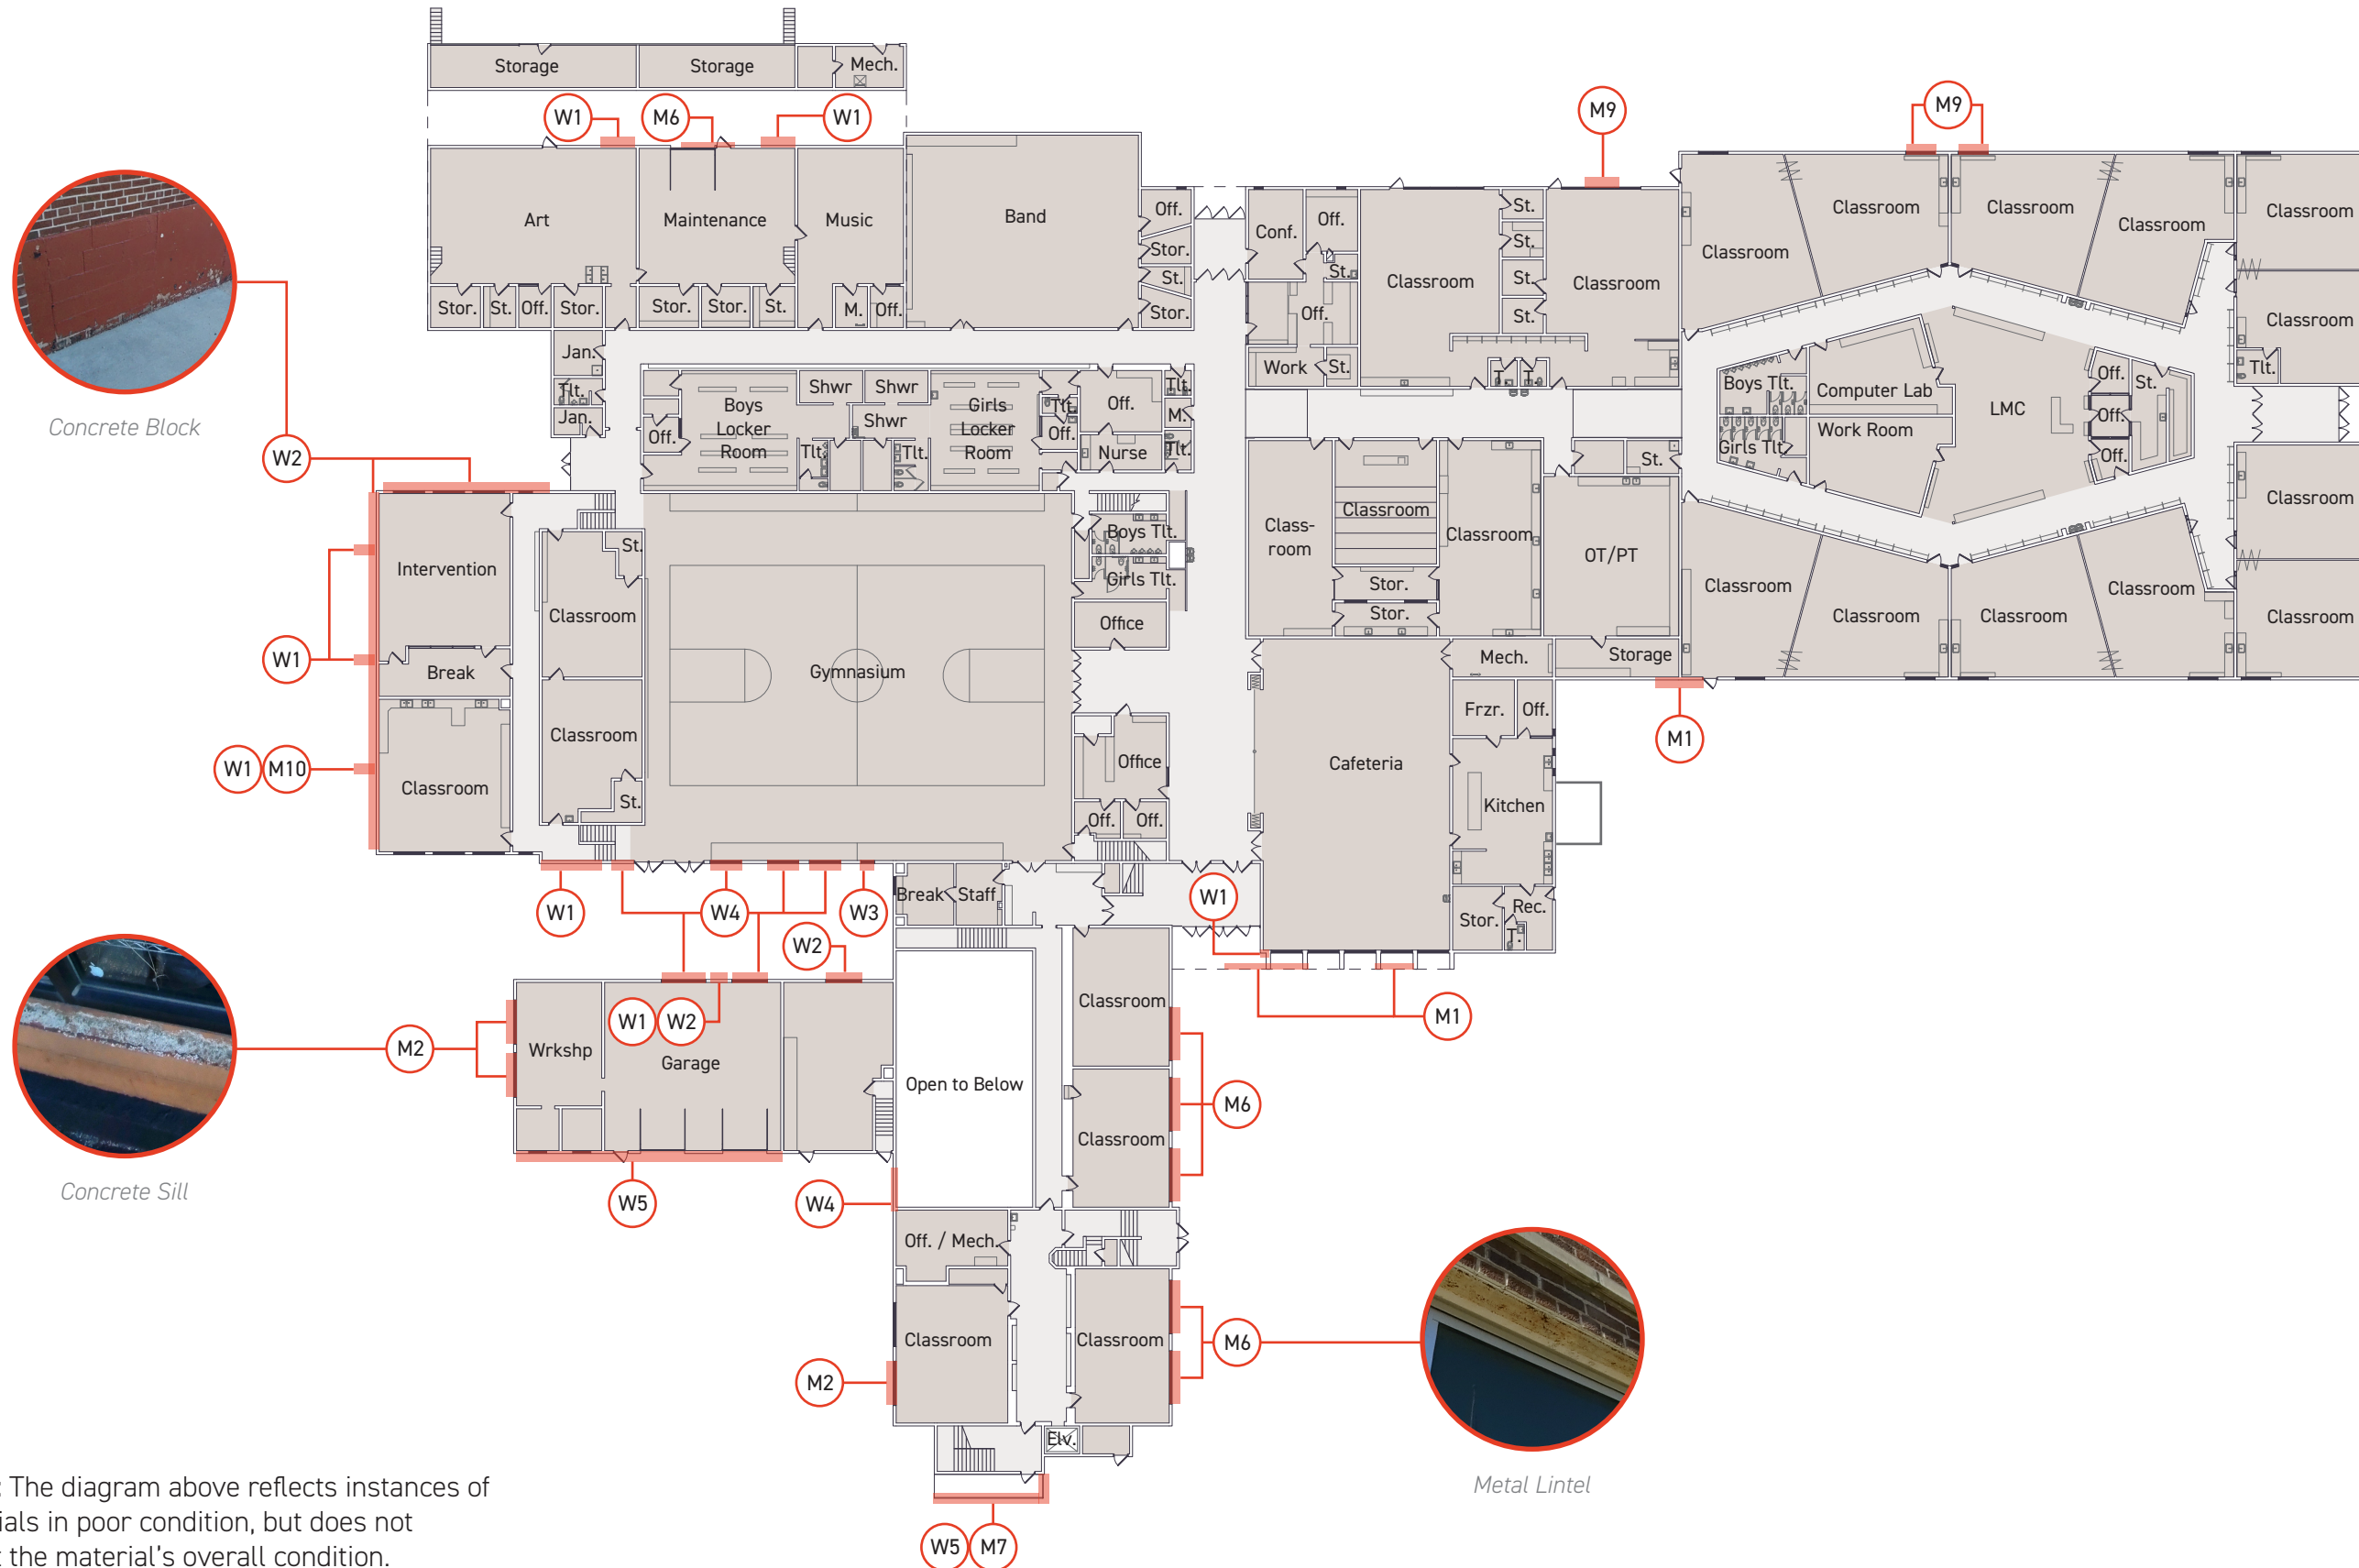
- Concrete wall is in poor condition due to instances of cracking, chipping, and crumbling.
- Majority of metal lintels located above windows on the original portion of the building are in poor condition due to rusting.
- Wood panel wall used to infill existing window openings is in poor condition due to peeling and chipping paint.
- Concrete sills located under windows are in fair condition due to staining.

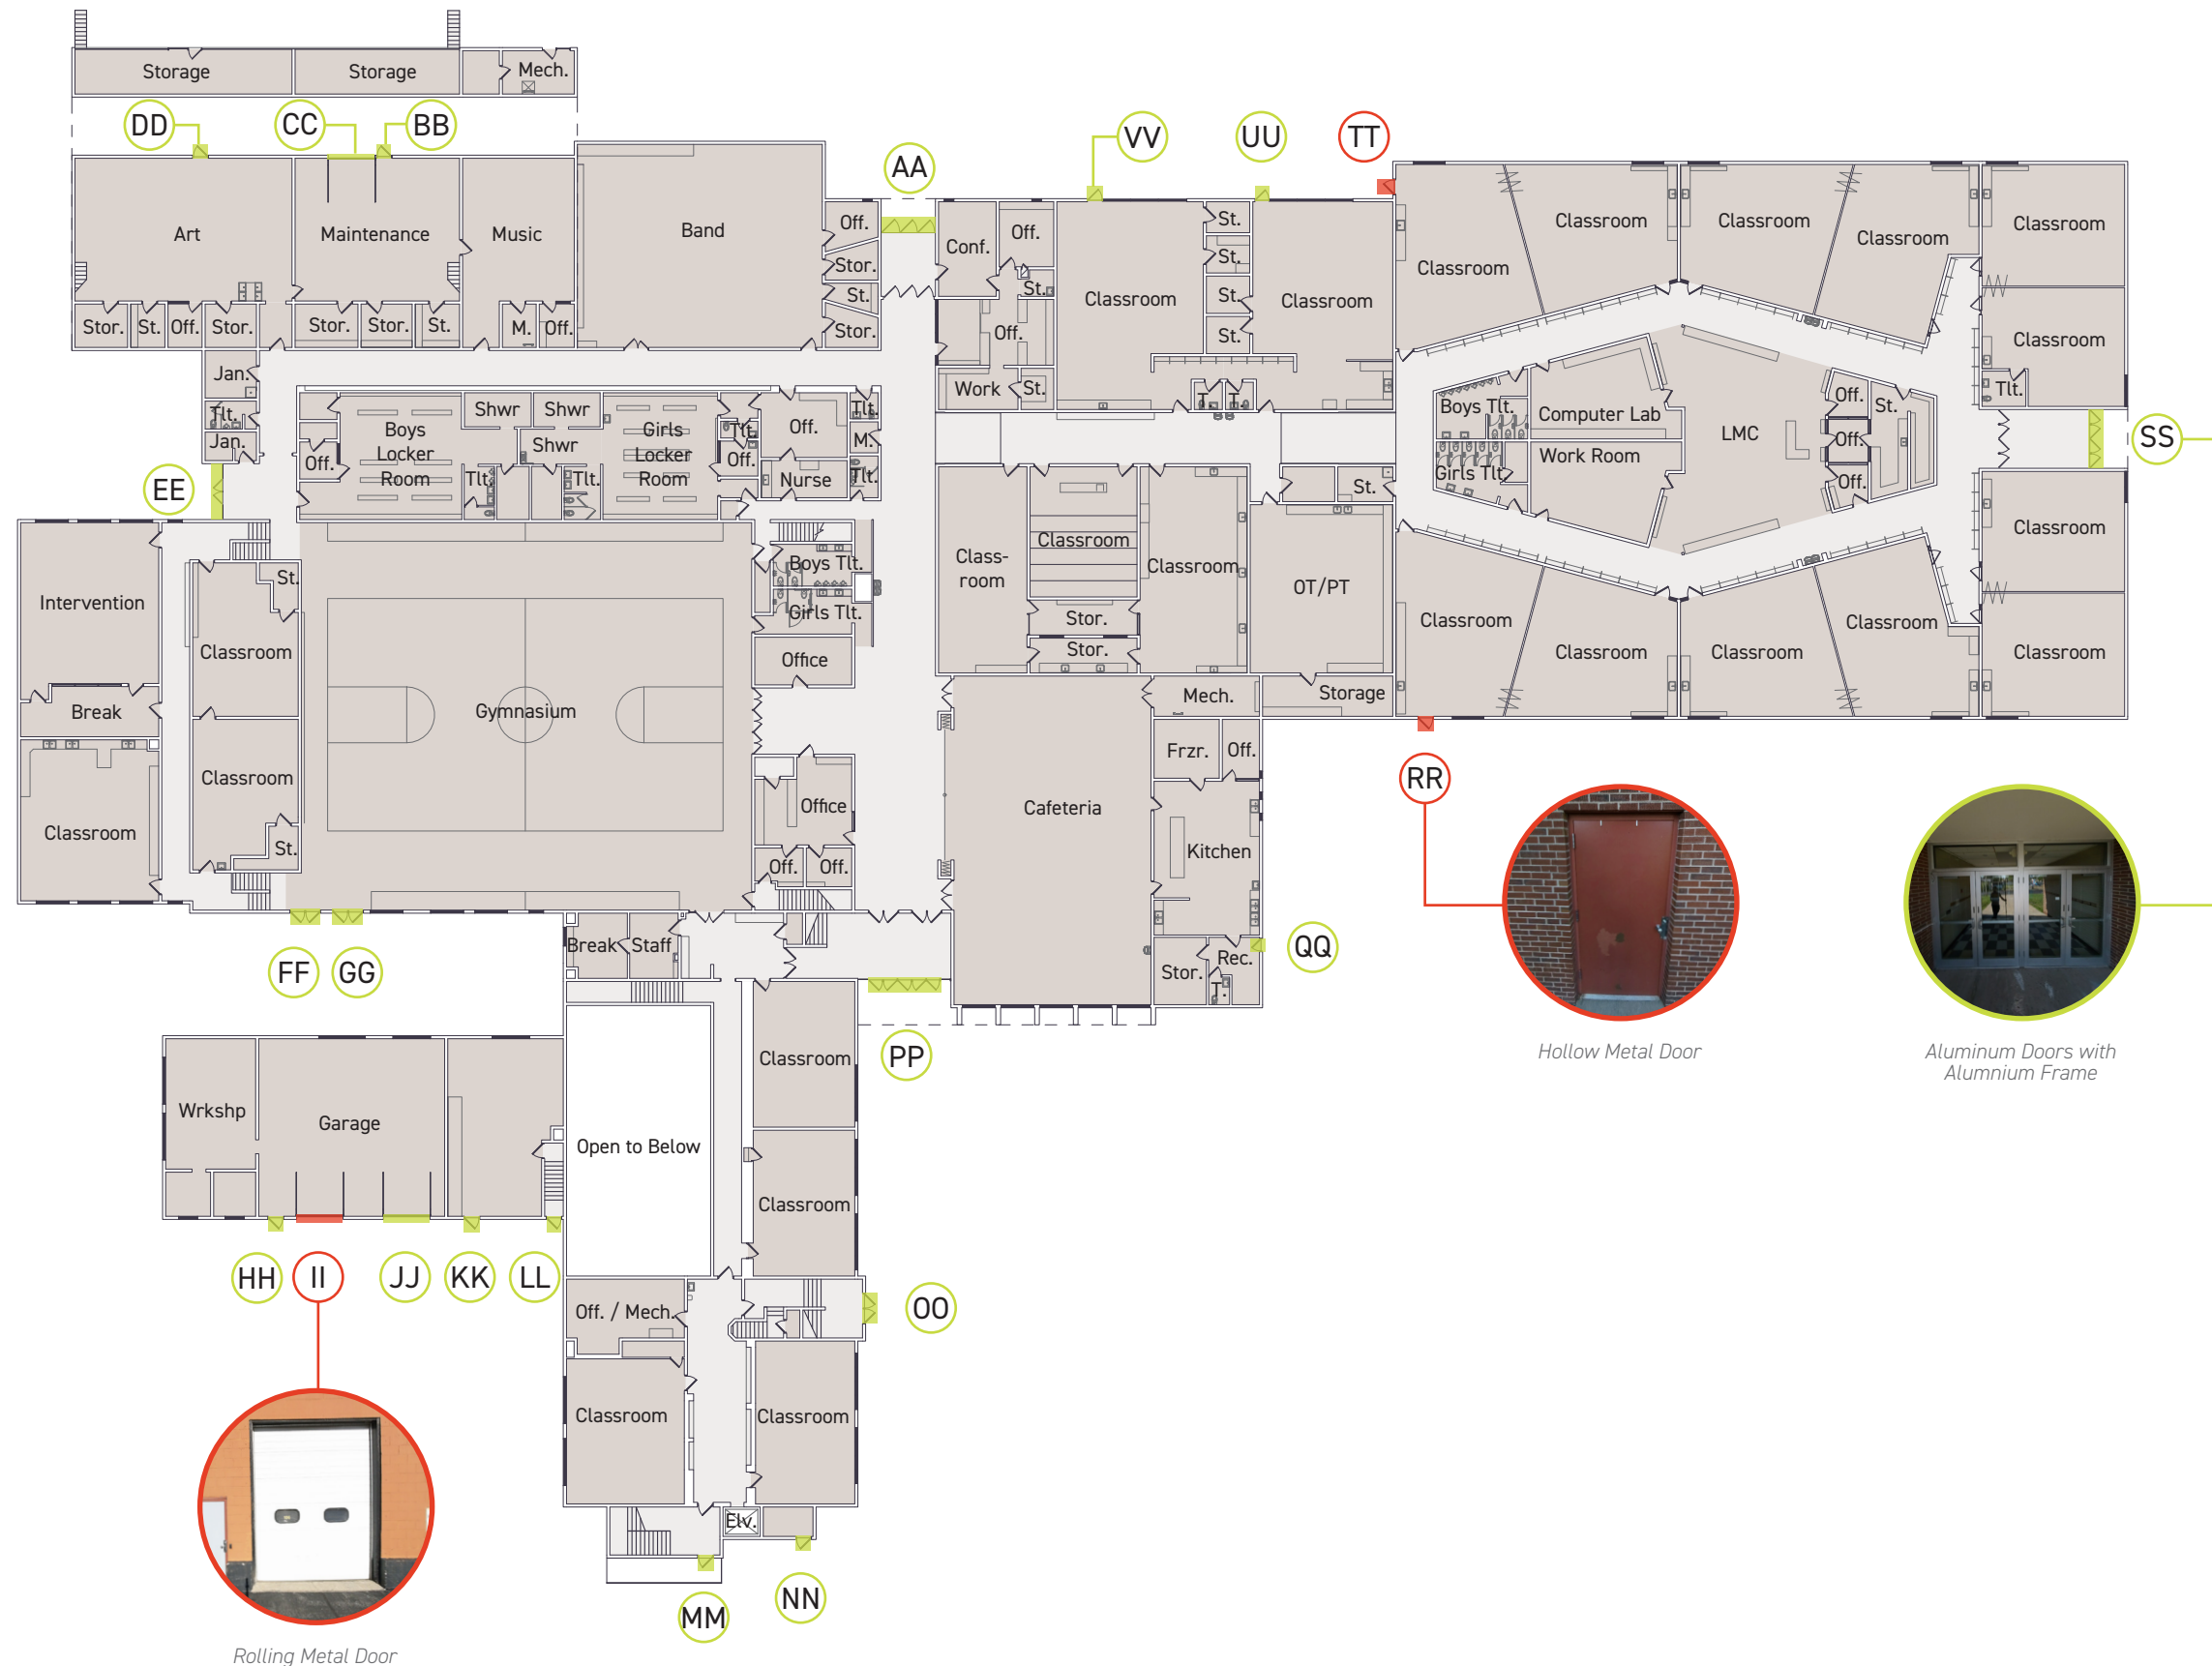
- Majority of the hollow metal doors are in fair condition due to rusting and paint peeling.
- Door EE has both hollow metal and aluminum frame types.
- Door II is in poor condition due to scratching and peeling at the opening.

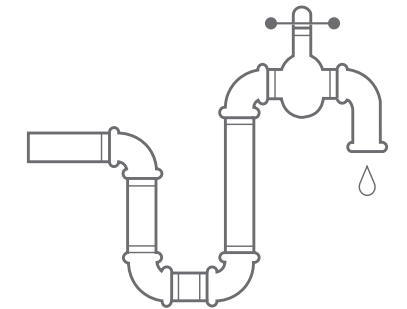
Replace Water Service

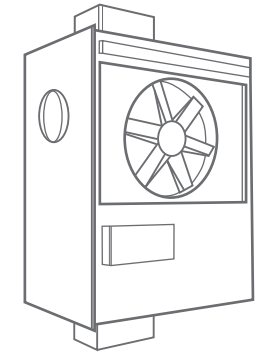
Replace Air Conditioning System

Heating	■
Boiler Plant	● Boiler installed in 2023.
Pumps	● Pumps installed in 2023.
Ventilation + A/C Systems	■
Air Handling Units	● Systems are at mid-life of their expected 35 year service life.
Air Conditioning Systems	● The air cooled condensing units serve the two office area air handling units and are at the end of their expected 20 year service life.
Control Systems	■ The BAS system is in good condition. The original controls have been almost completely replaced.

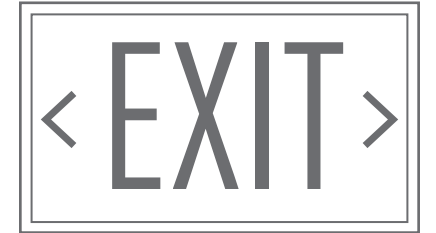
Add LED Egress Lighting

Emergency Generator	■	Currently one transfer switch and panel service life and non-life safety loads. Current codes require non-safety loads to be seperated.
Emergency Egress Lighting	■	Replace as needed.
Fire Alarm System	■	Existing system 20 years old
Public Address System	■	
Access Control	■	
Security System	□
