# HAZARDOUS MATERIALS SURVEY REPORT

## FORMER MARSHALL ELEMENTARY SCHOOL LIVONIA, MICHIGAN

December 16, 2025  
NTH Project No. 25002747-01

**RE: Report on Hazardous Materials Survey  
Former Marshall Elementary School  
33901 Curtis Road  
Livonia, Michigan**

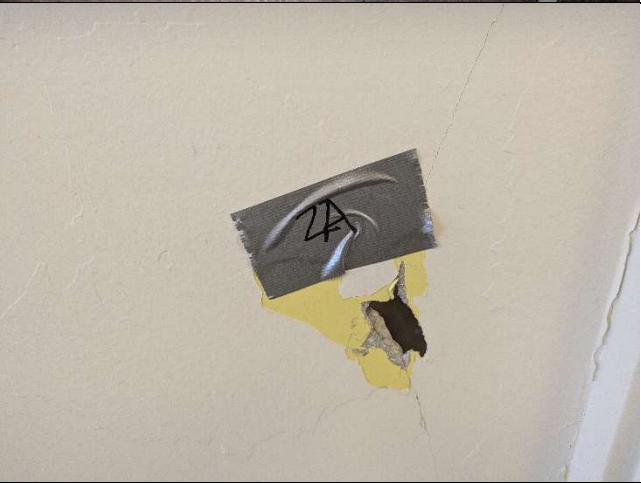
| Asbestos Samples | | | | | |
|---|---|---|---|---|---|
| 2A | Transite Panel | Room 9, at office | 10% Chrysotile | | |

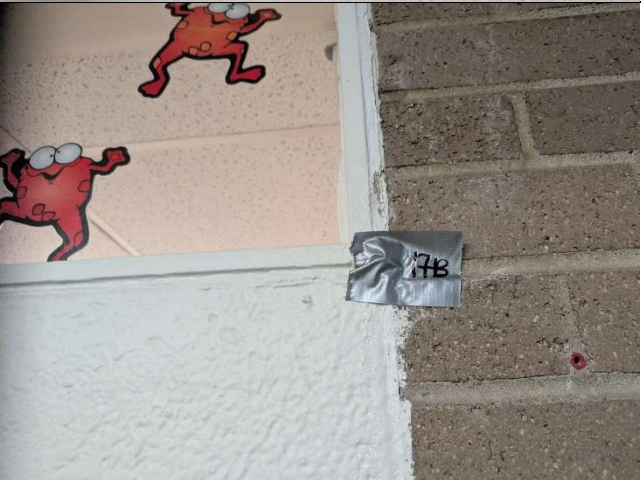
| Asbestos Samples | | | | |
|---|---|---|---|---|
| 17A | Window caulk around interior windows – hallway side | Hallway at Room 9, south end | 1.25% Chrysotile<br>(Point Count Result) | |
| 17B | | N-S corridor at kitchen, north end | Not Analyzed | |

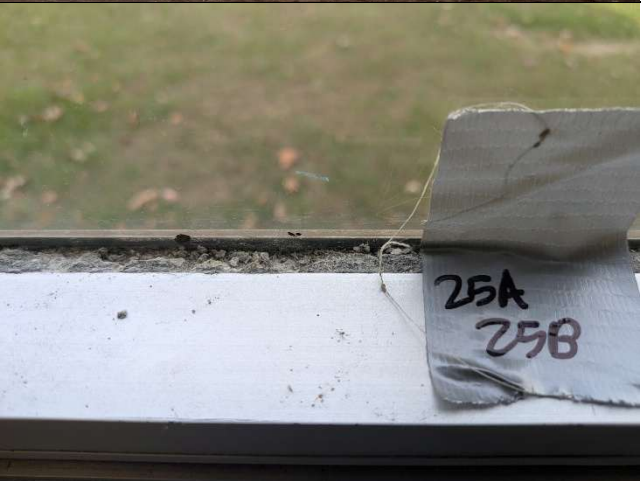
| Asbestos Samples | | | | |
|---|---|---|---|---|
| 25A | Window glazing, hard (under HA 8) | Room 7, east side | 1.5% Chrysotile<br>(Point Count Result) | |

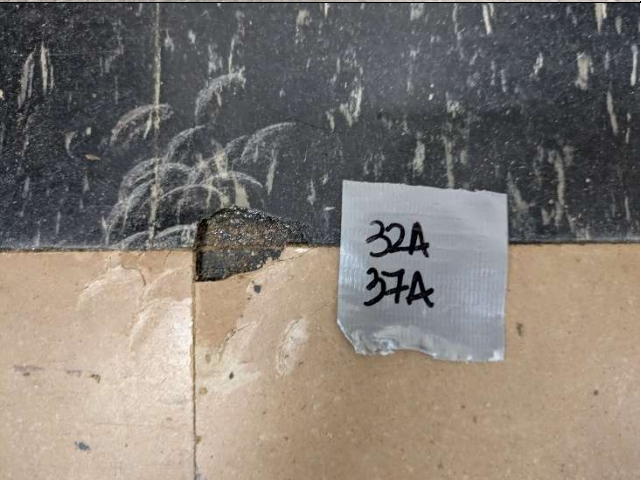
| Asbestos Samples | | | | |
|---|---|---|---|---|
| 32A | 9"x9" tan floor tile | Gym, north side, middle | Tile:<br>1.5% (Point Count Result)<br>Mastic:<br>None Detected | |

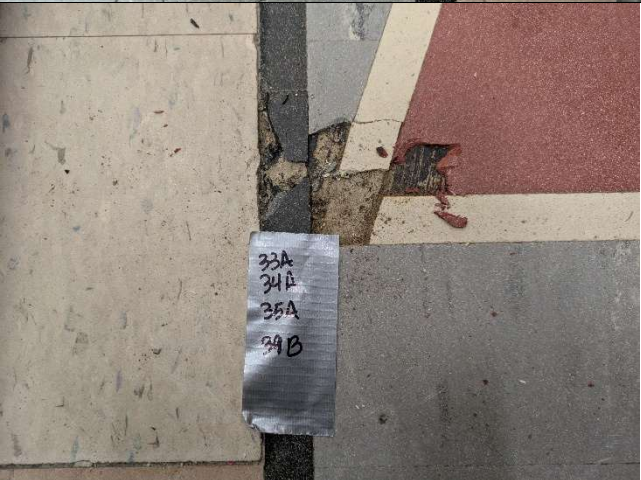
| Asbestos Samples | | | | |
|---|---|---|---|---|
| 35A | | Gym, NE at shuffleboard | Tile:<br>10% Chrysotile<br>Mastic:<br>None Detected | |

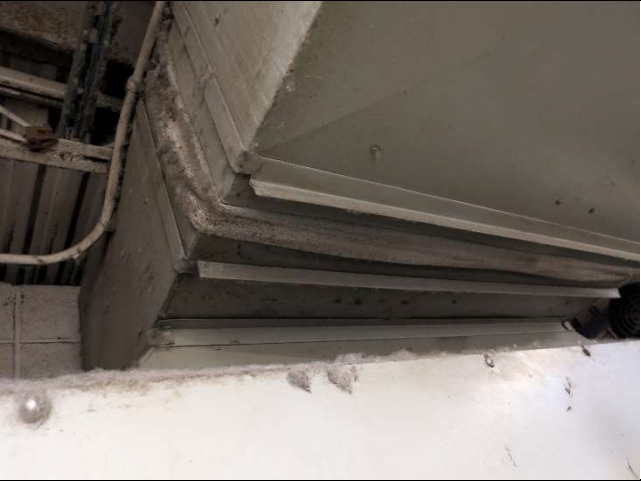
| Asbestos Samples | | | | |
|---|---|---|---|---|
| NA (HA-41) | White canvas vibration dampener | Fan Room | Assumed ACM | |

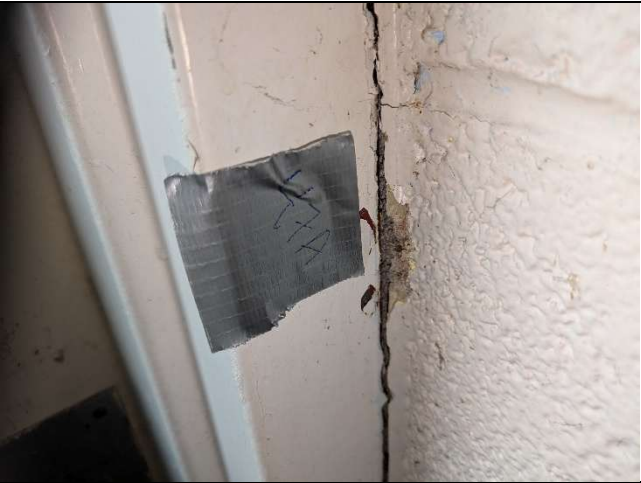
| Asbestos Samples | | | | |
|---|---|---|---|---|
| 47A | Door caulk | Room 2, east exterior door | 1.5% Chrysotile (Point Count Result) | |

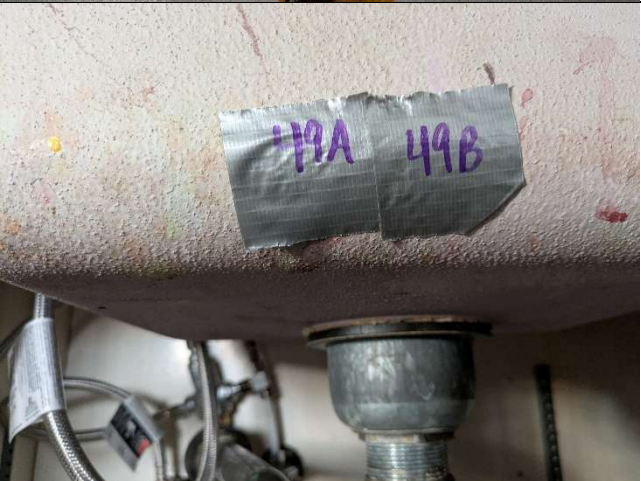
| Asbestos Samples | | | | | |
|---|---|---|---|---|---|
| 49A | White sink undercoating | Room 2, north side | 1.5% Chrysotile (Point Count Result) | | |

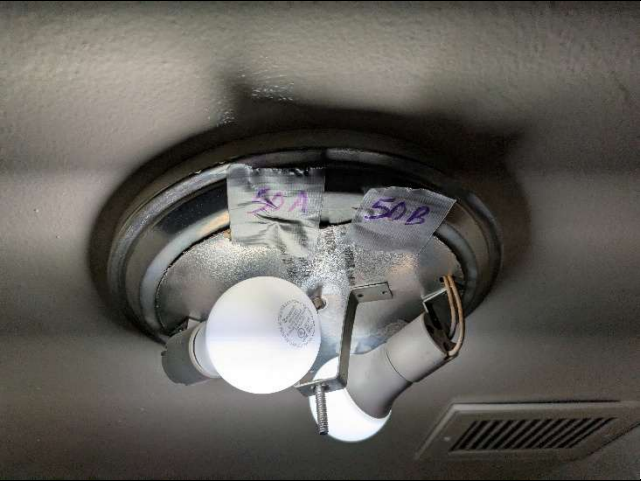
| Asbestos Samples | | | | |
|---|---|---|---|---|
| 50A | Circular light heat shield | Room 4, boys' bathroom | 60% Chrysotile | |

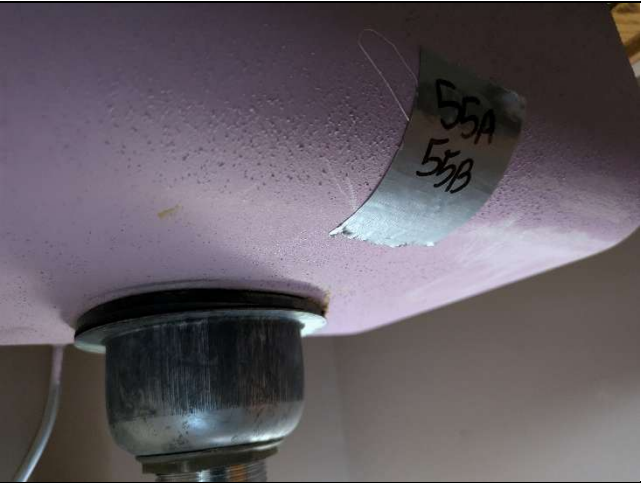
| Asbestos Samples | | | | |
|---|---|---|---|---|
| 55A | Light pink sink undercoating | Office Clinic | 1.75% Chrysotile (Point Count Result) | |
