# Capital Planning Review

Monona Grove SD

# Facility Assessment Issue Log

Monona Grove School District

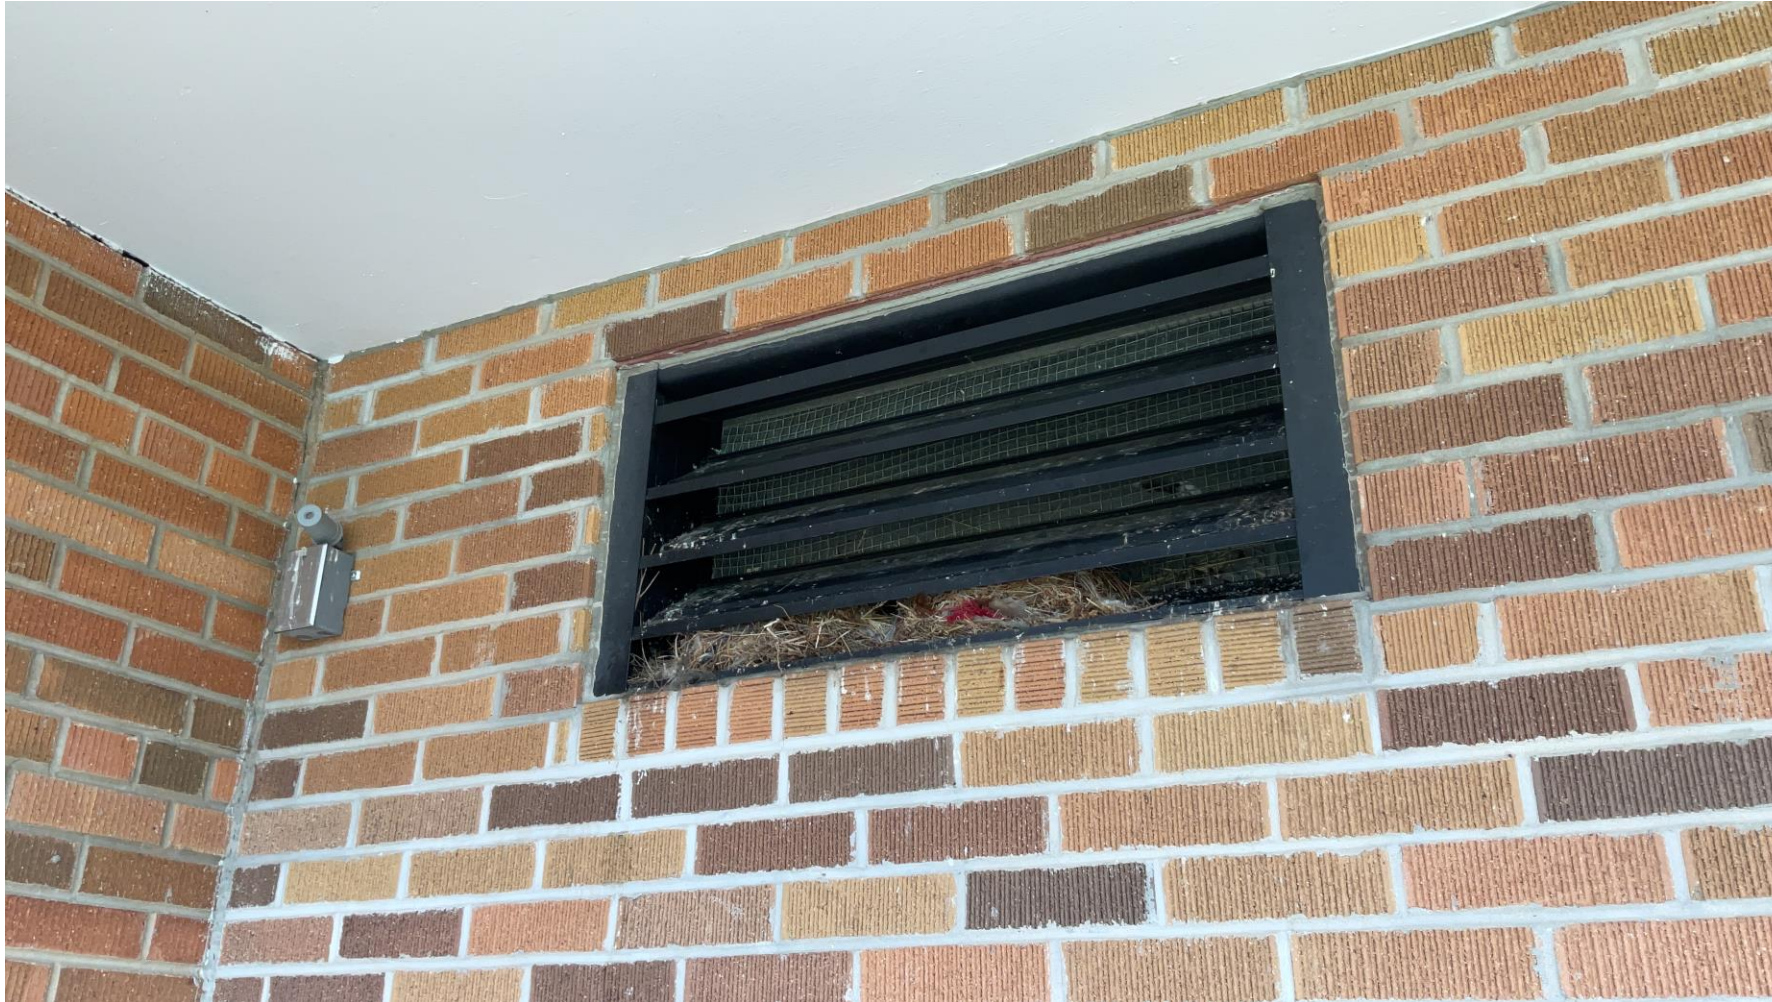
# CGS Issue #1

There is a bird's nest inside of the louver on the exterior. East-facing wall outside of room 58.

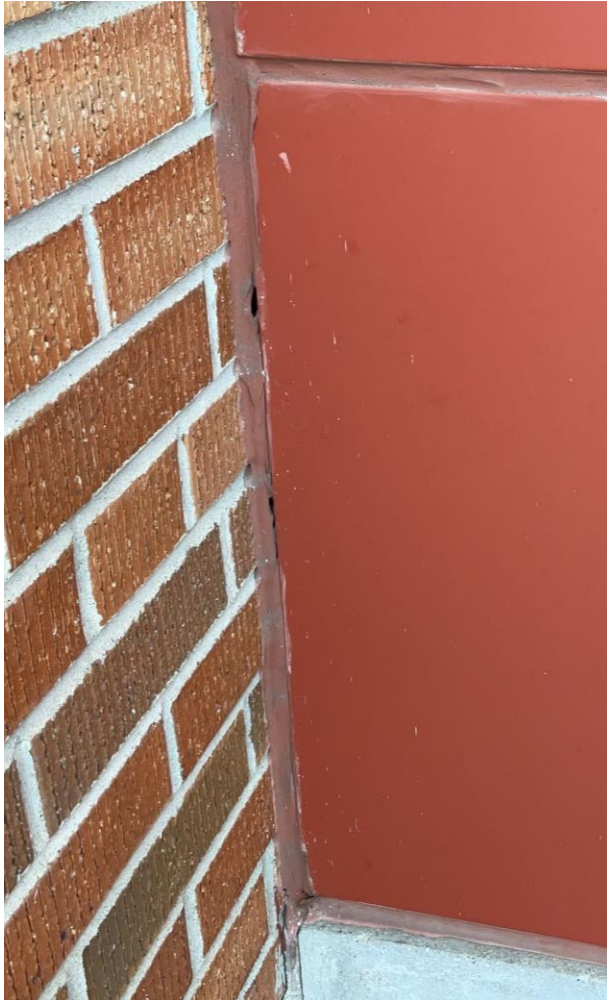
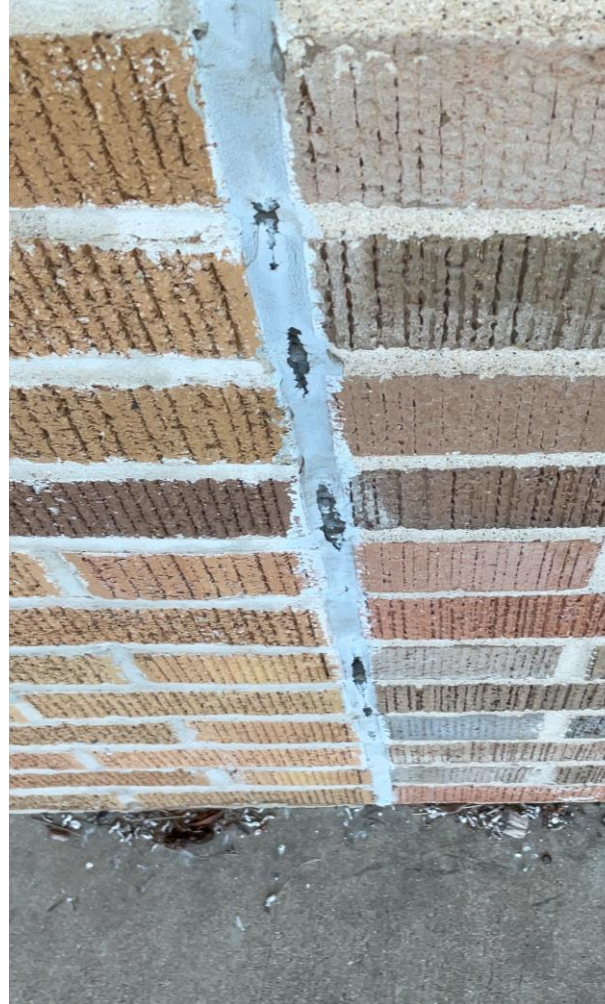
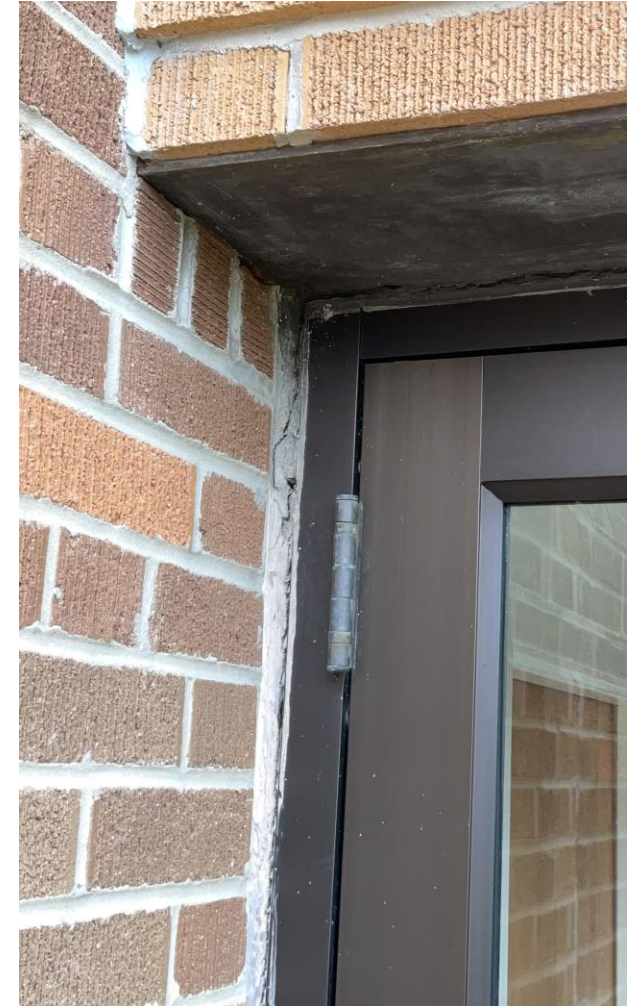
# CGS Issue #2

There are several joint sealant failures visible on the East-facing wall outside of rooms 58, 63 and 66

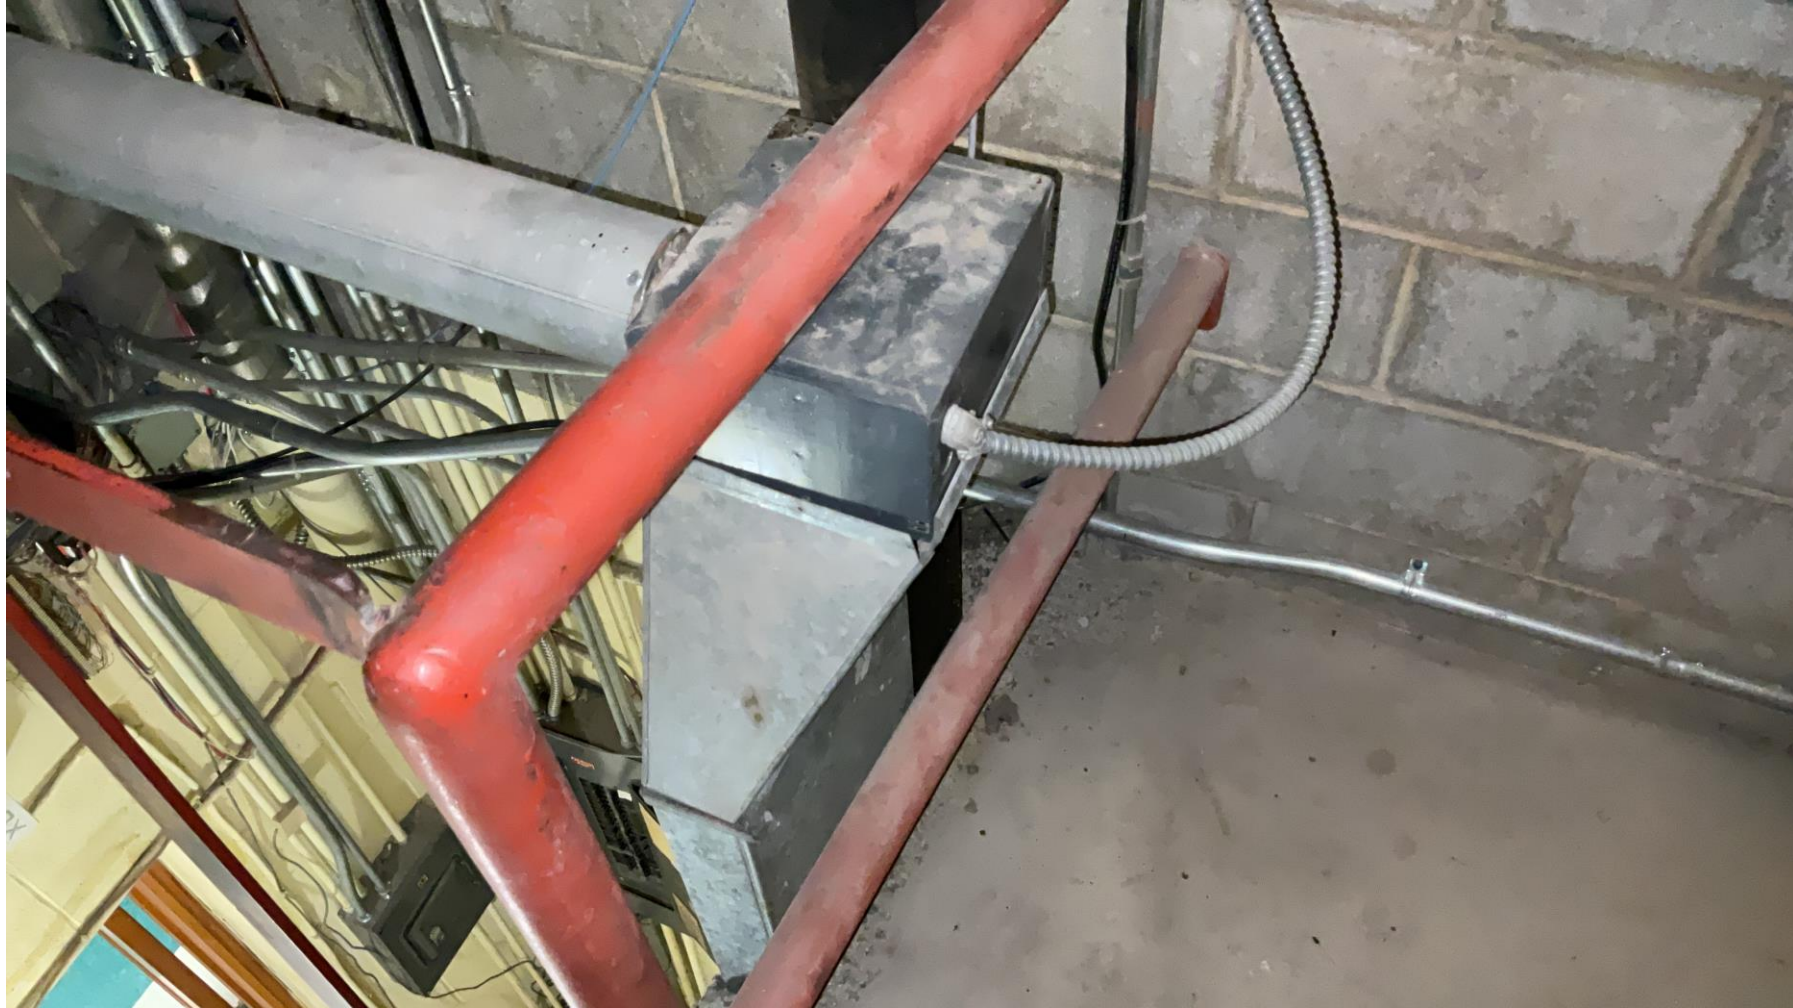
# CGS Issue #3

Exhaust fan serving custodial room 55 is making excess noise and needs repair.

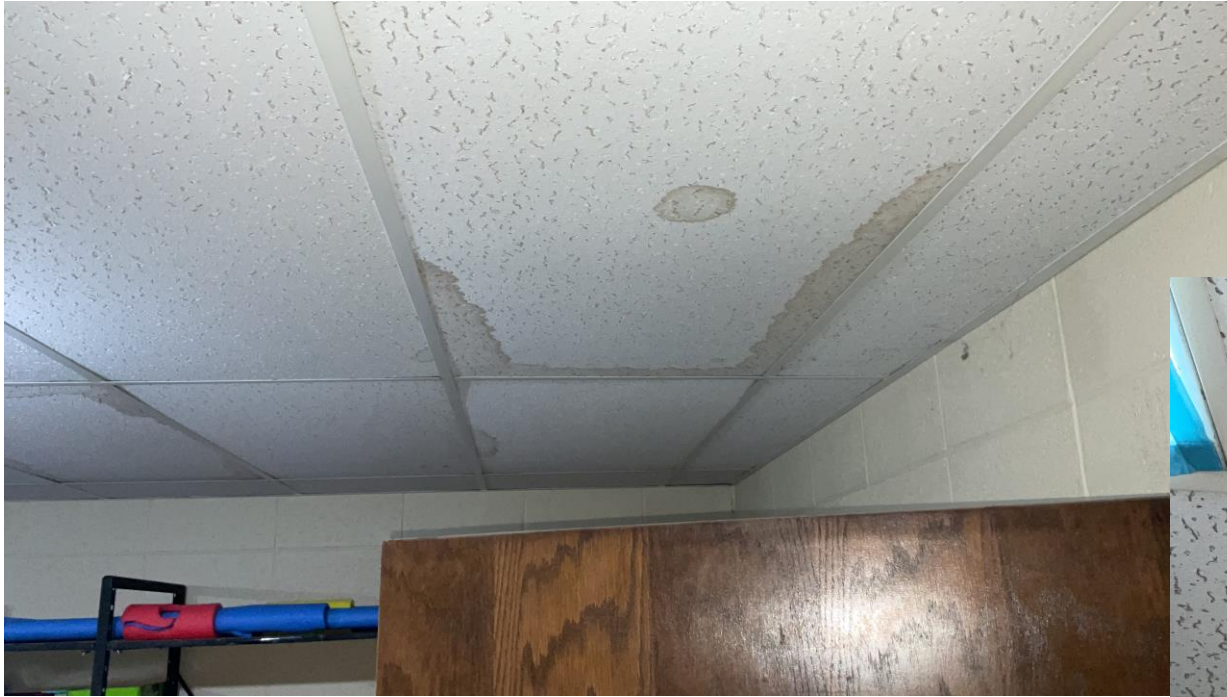
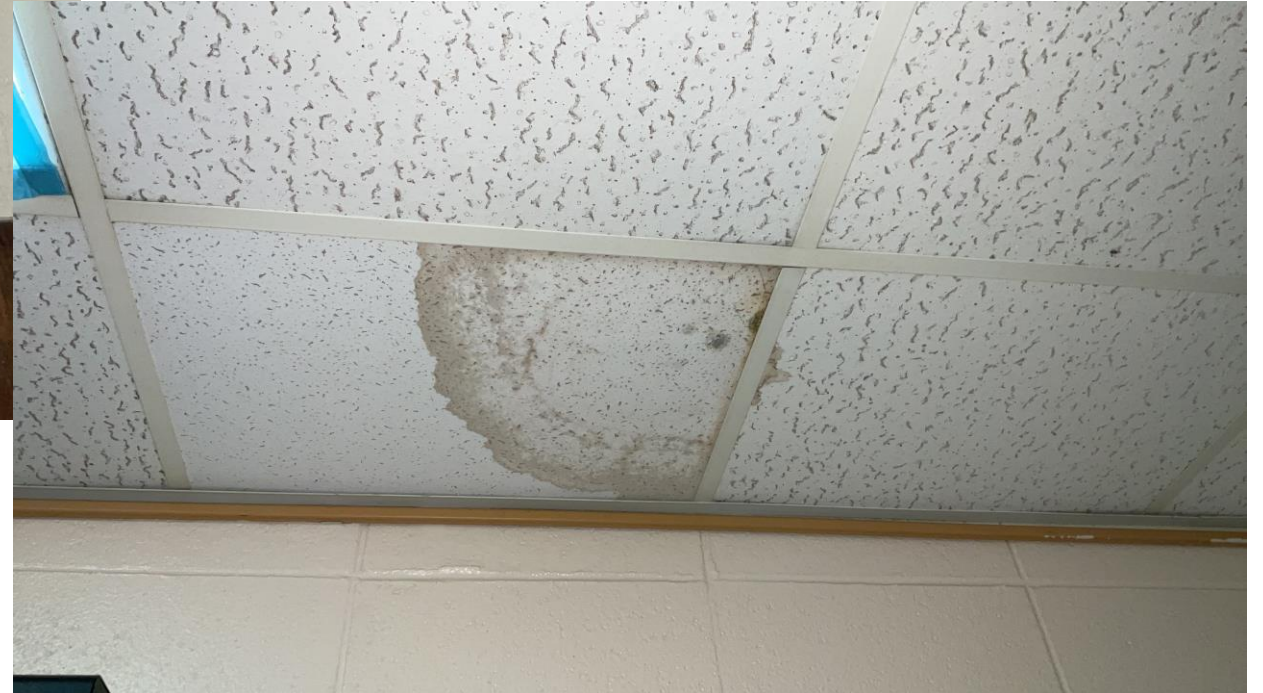
# CGS Issue #4

In classroom 20, 77 and the storage room attached to room 75 there are stained and water damaged ceiling tiles.

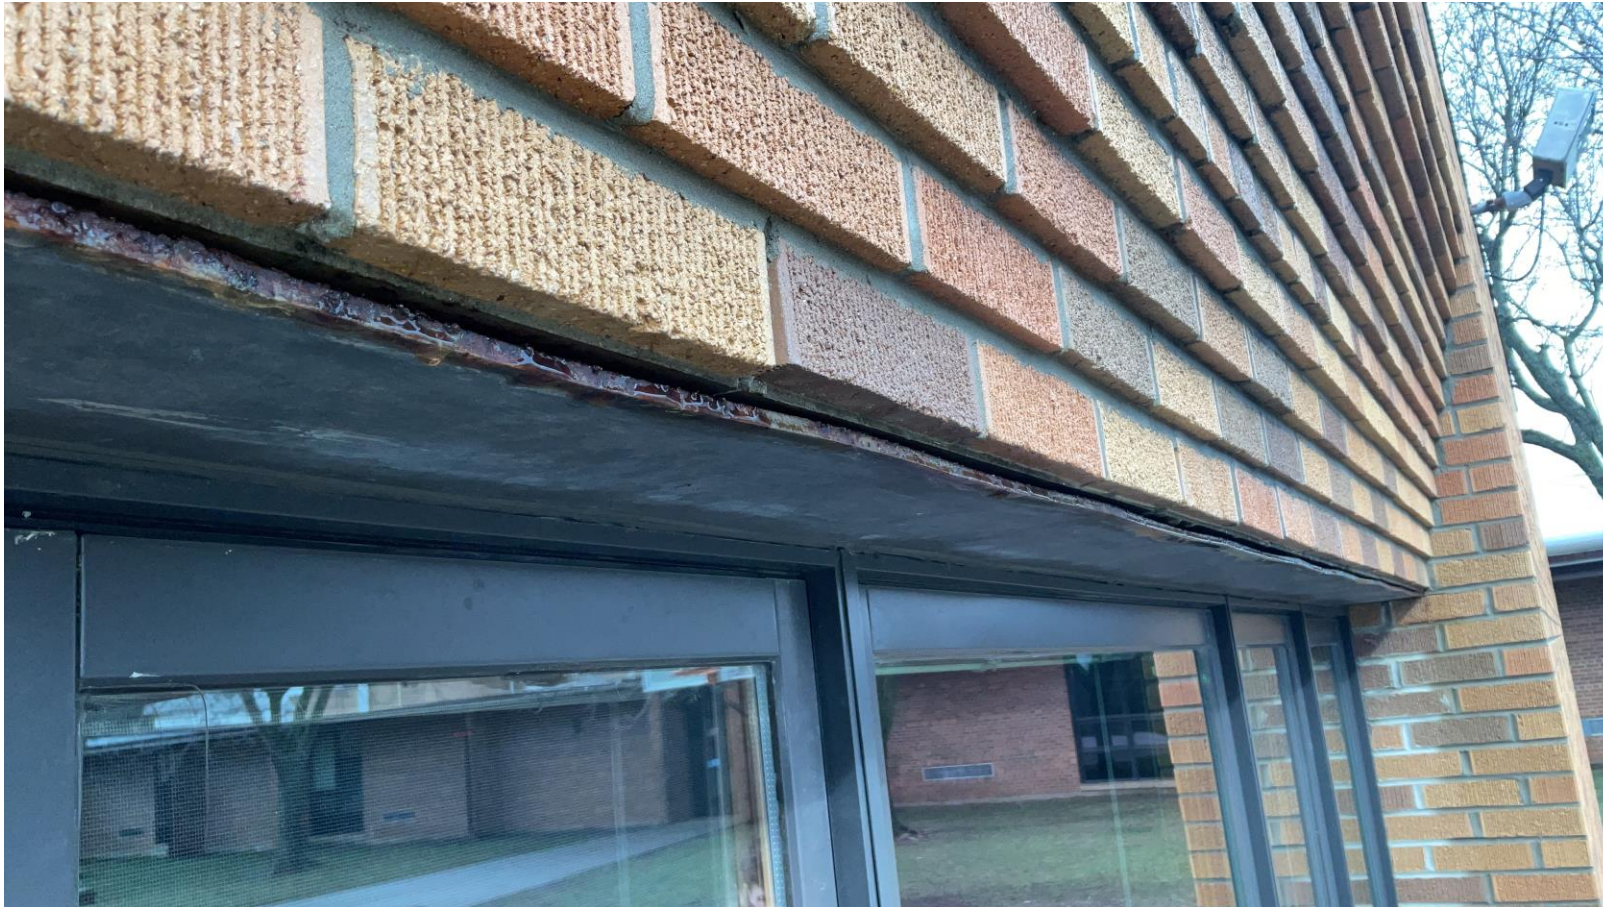
# CGS Issue #5

Window lintel outside of classroom 78 is rusting. This is causing staining on the glass.

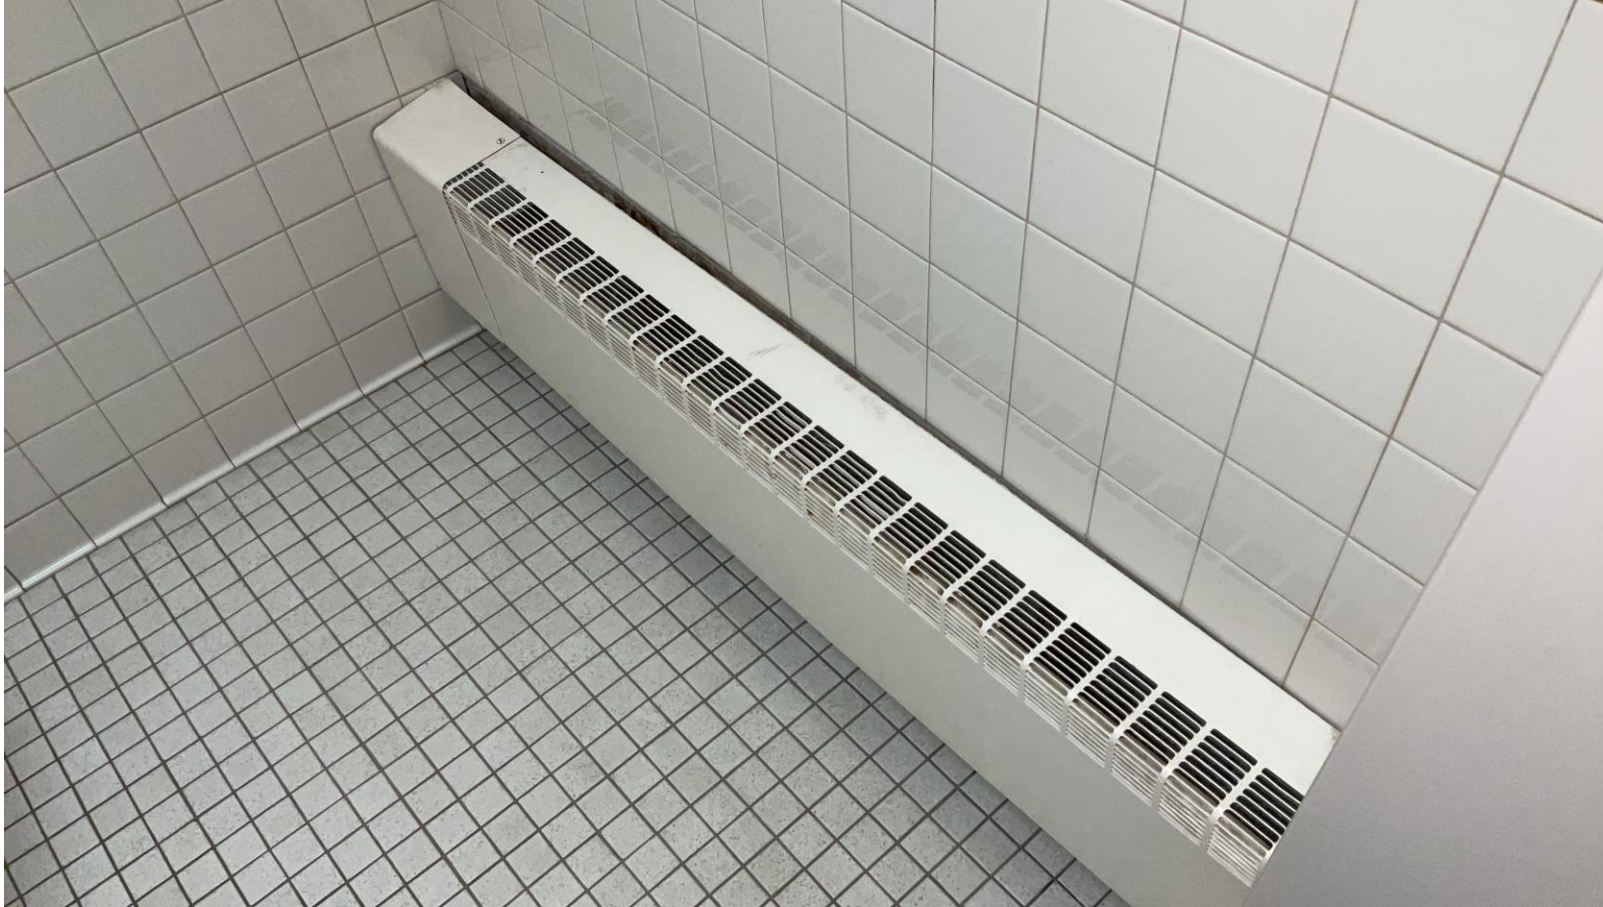
# CGS Issue #6

The radiator enclosure in the restroom neighboring classroom 37 is coming loose and needs to be reattached.

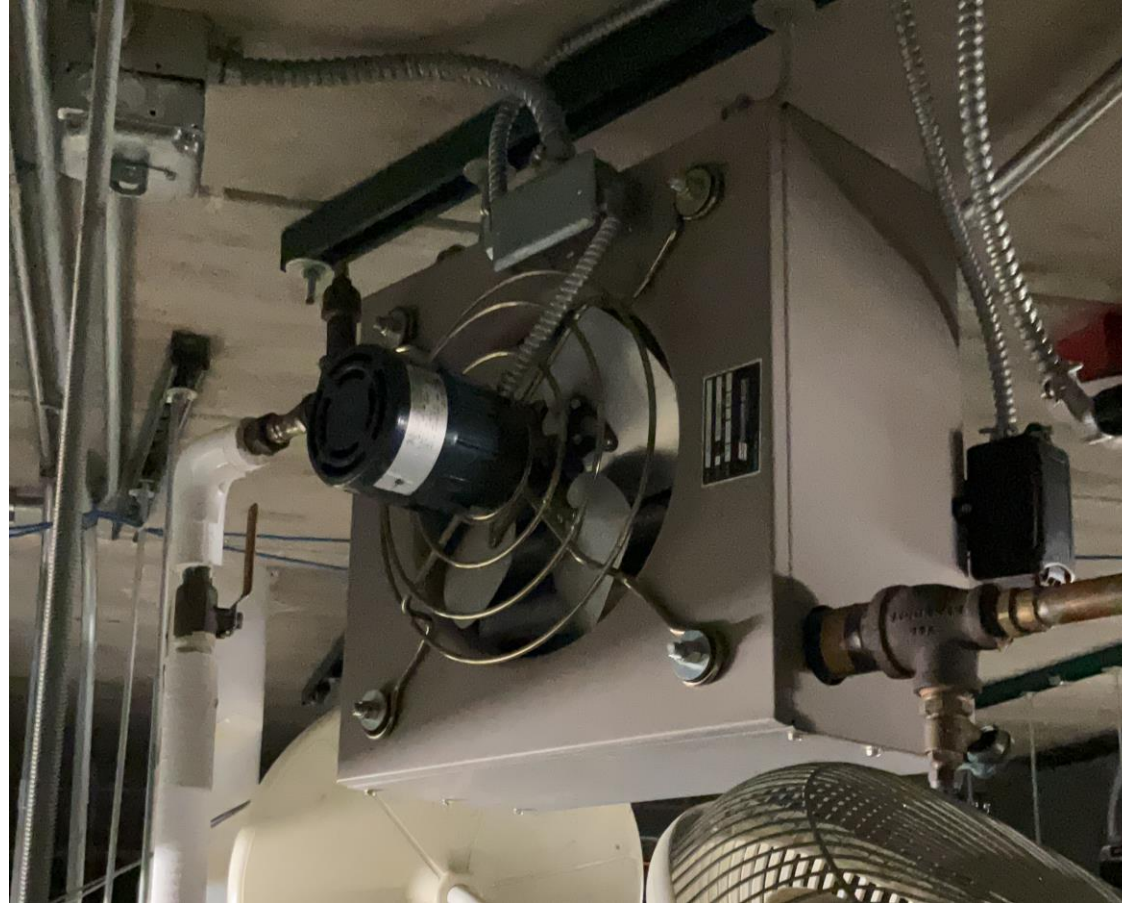
# CGS Issue #7

The fan on the unit heater in the upper mechanical room is off balance and loud.

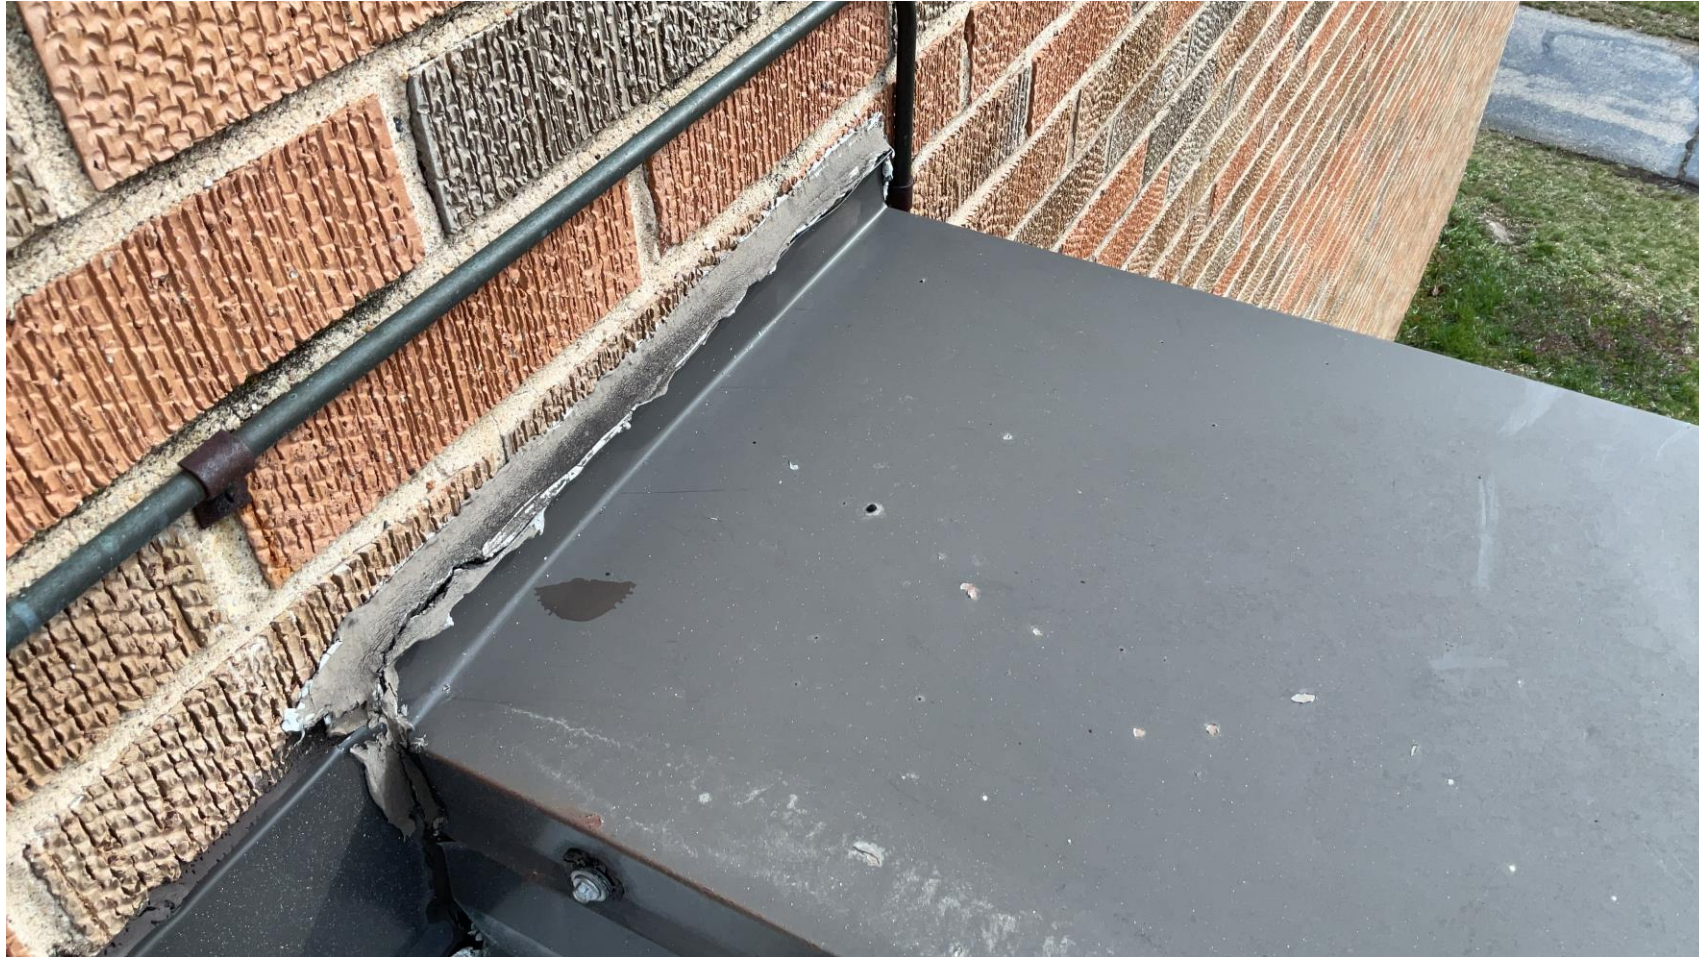
# CGS Issue #8

There is a sealant failure on the roof transition on the gym entrance roof.

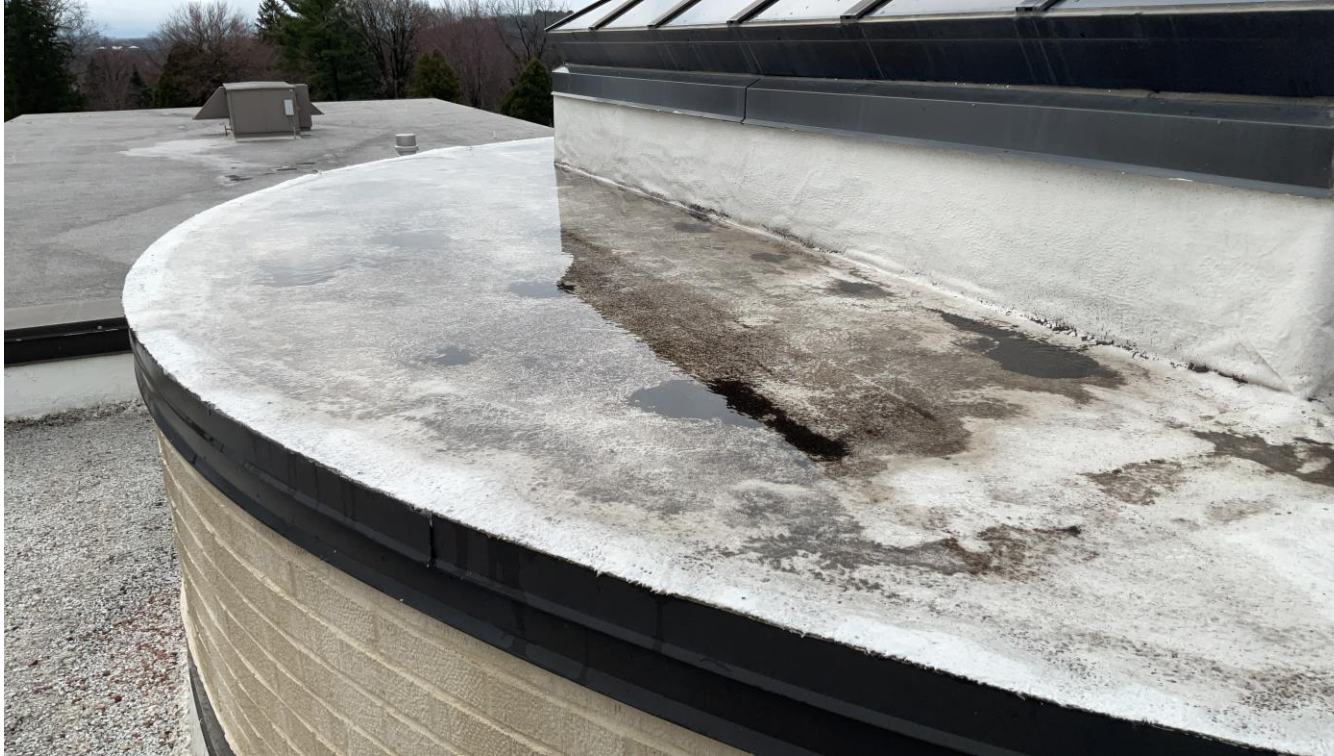
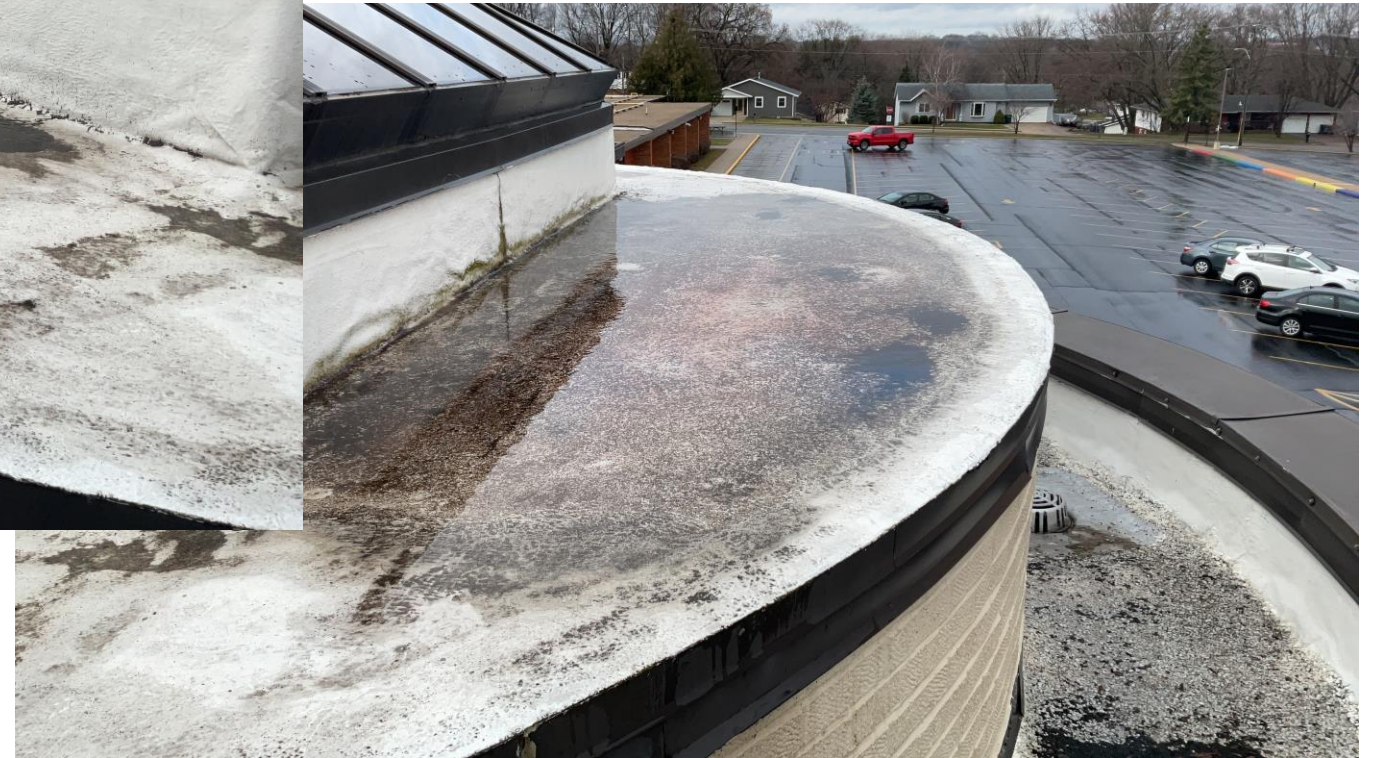
# CGS Issue #9

The turret roof above the gym entrance is not properly pitched for drainage.

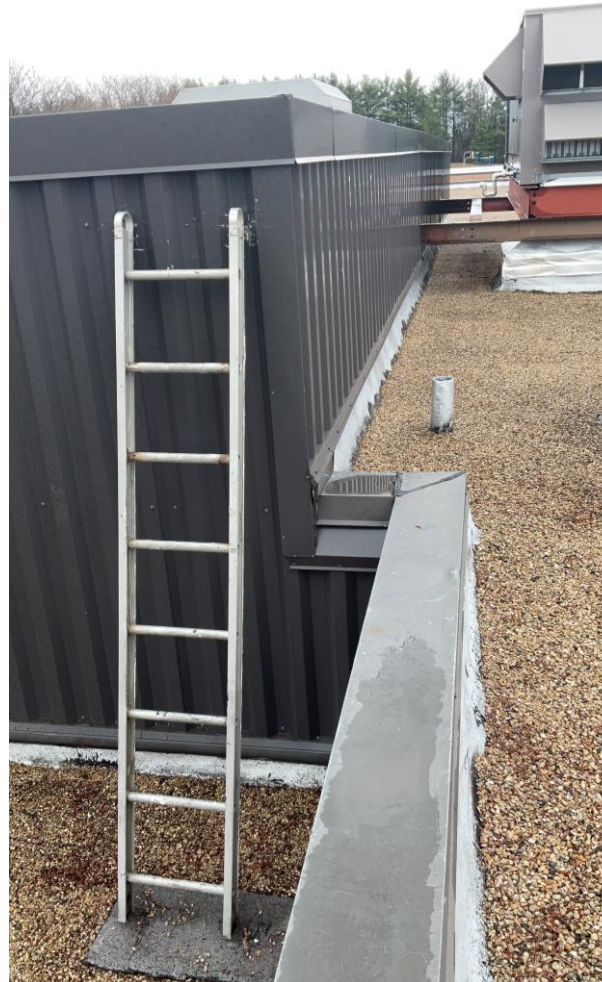
# CGS Issue #10

The ladder access to the high roof is unsafe due to the ladder not being large enough or secured properly. There is also a large transition to the right to access the south roof.

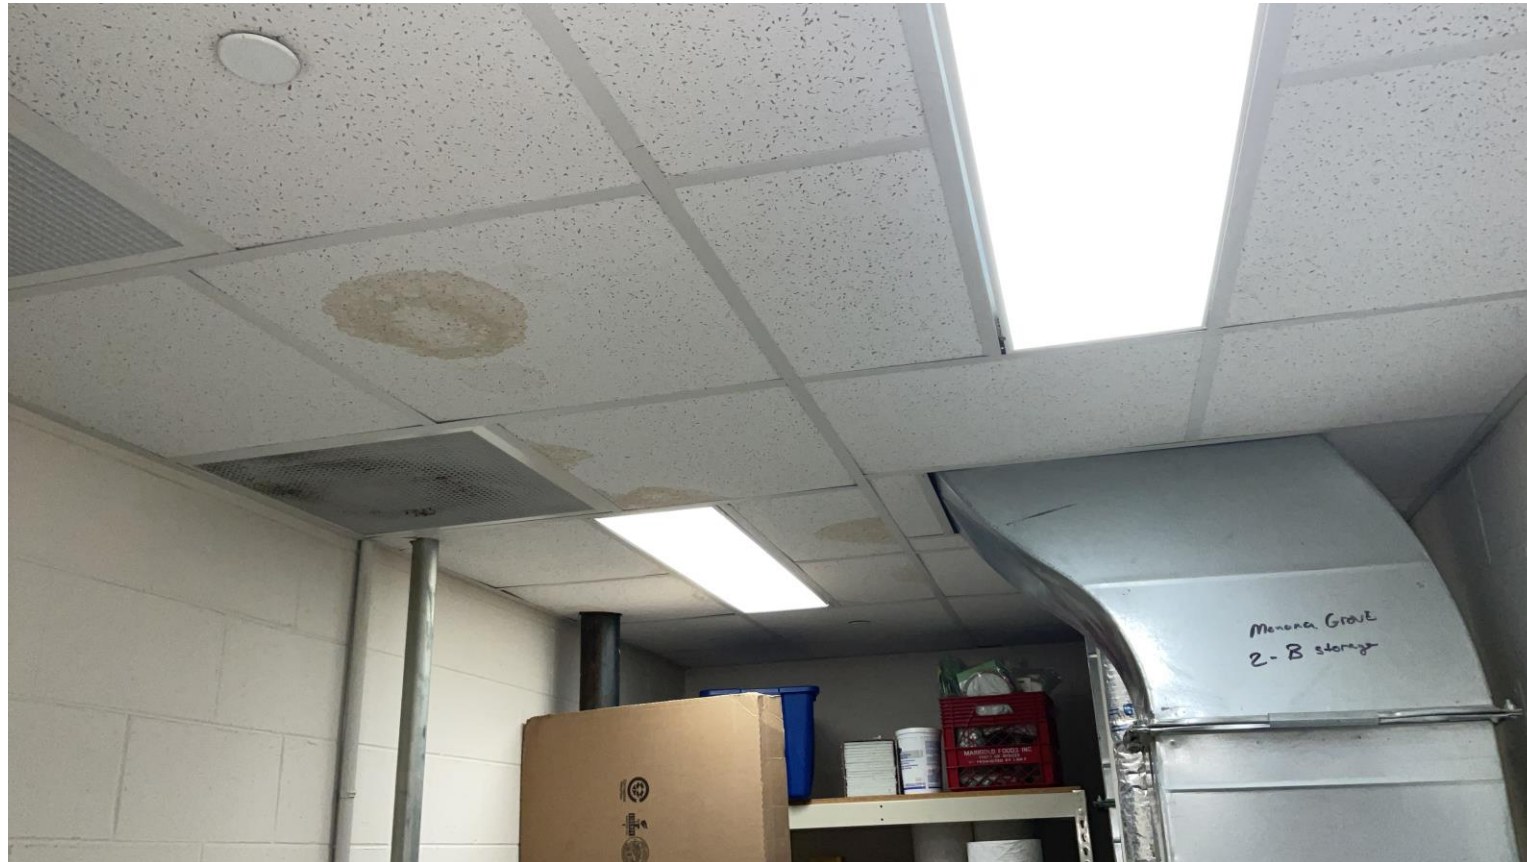
# GDS Issue #1

There is water damage to the ceiling tiles of the mechanical room next to B204.

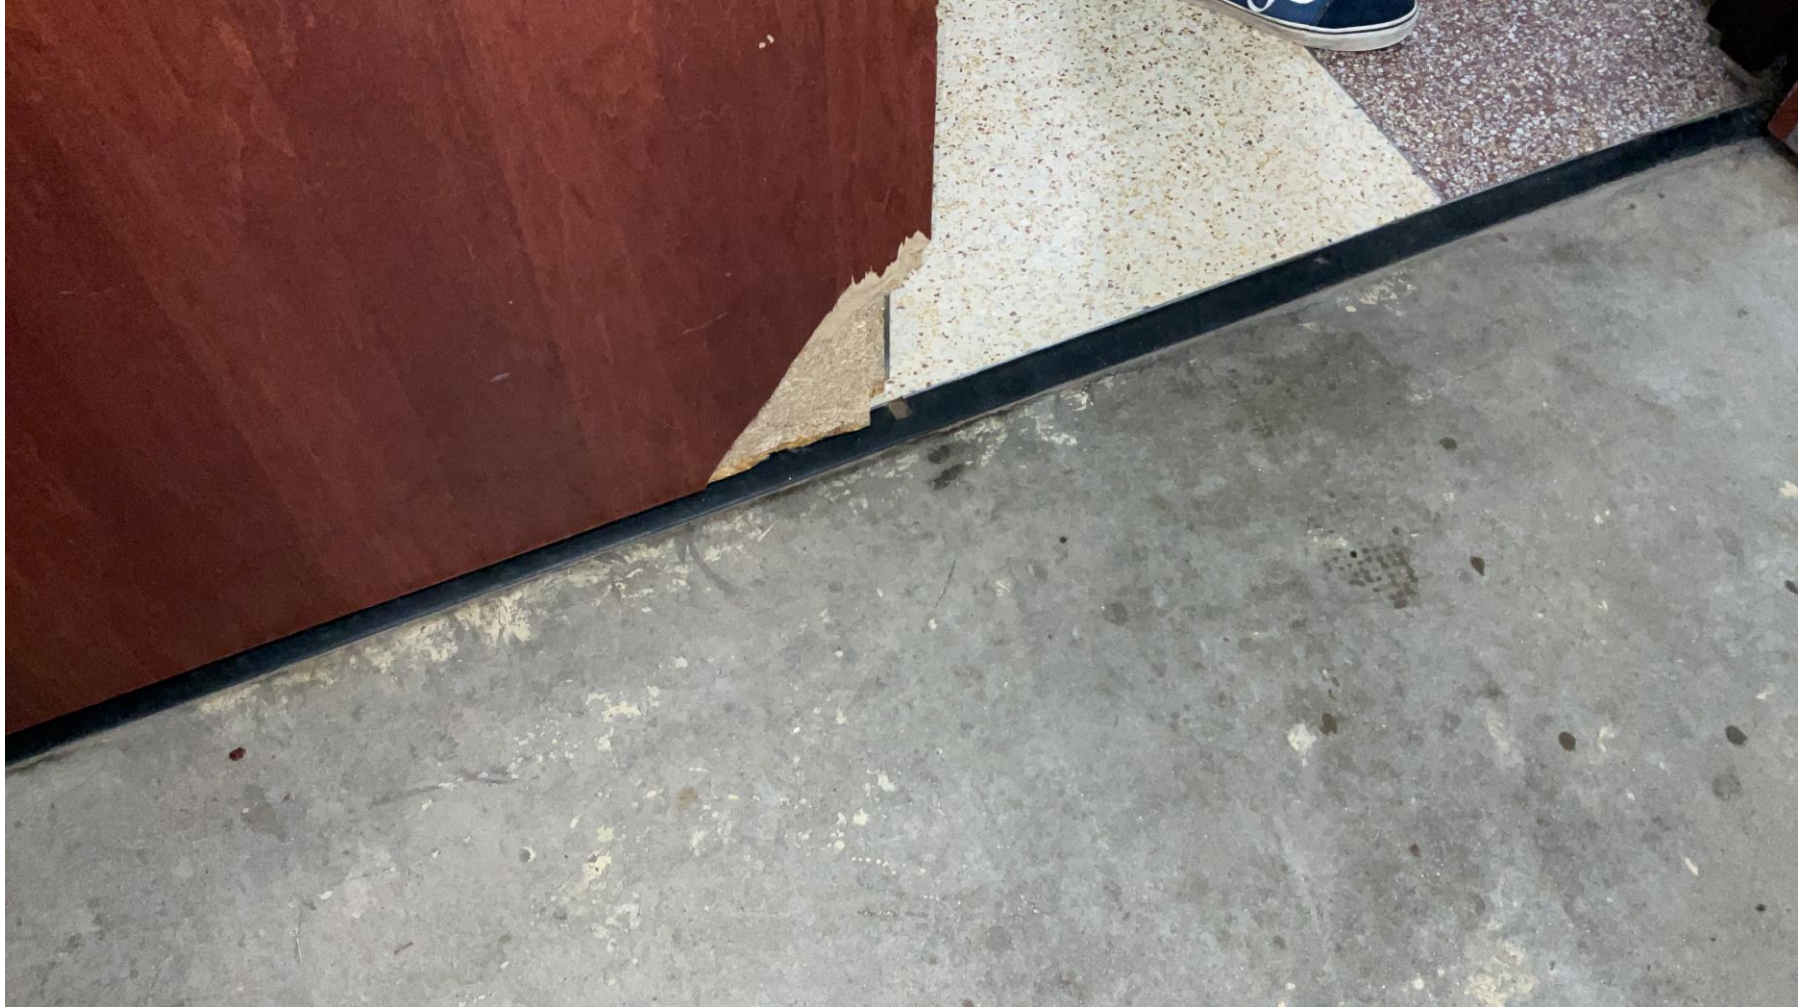
# GDS Issue #2

There is damage to the receiving door in D242.

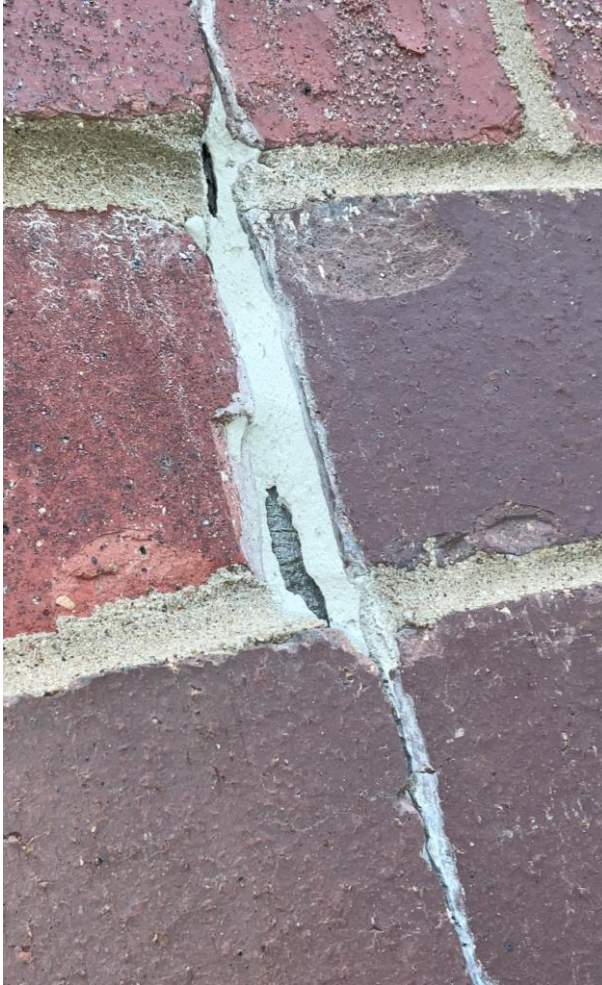
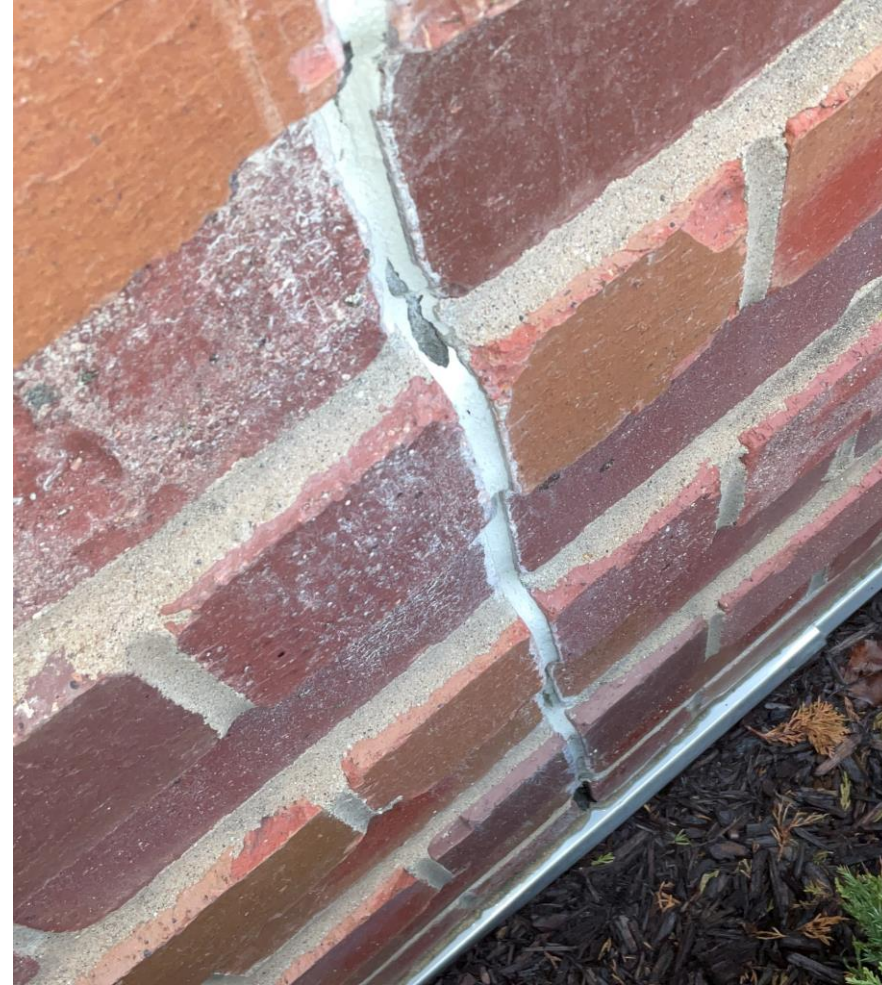
# GDS Issue #3

There is a sealant failure on the south facing wall outside of A125.

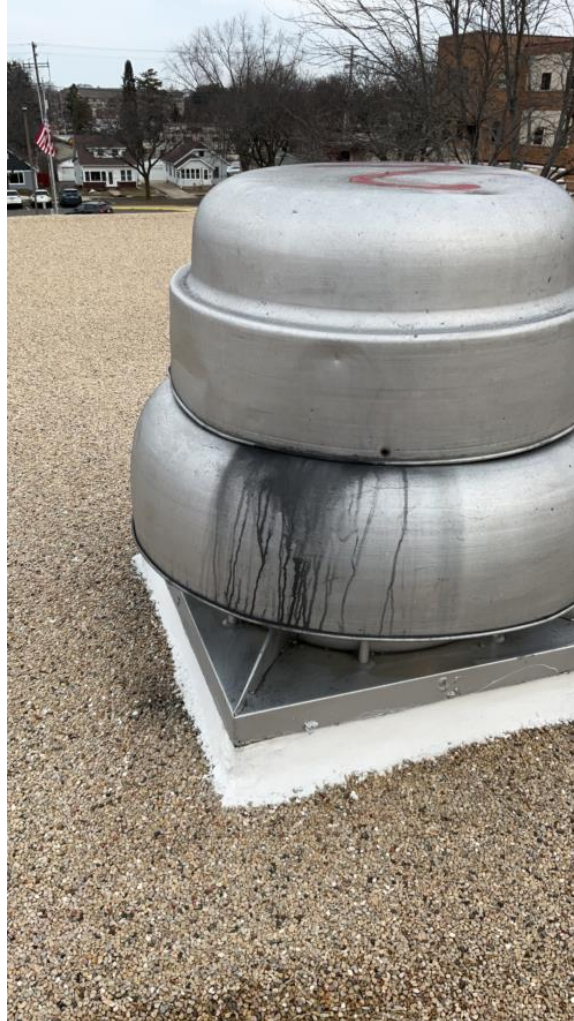
# DO/MG21 Issue #1

MG21 Exhaust fan #2 is unbalanced and loud and requires repair.

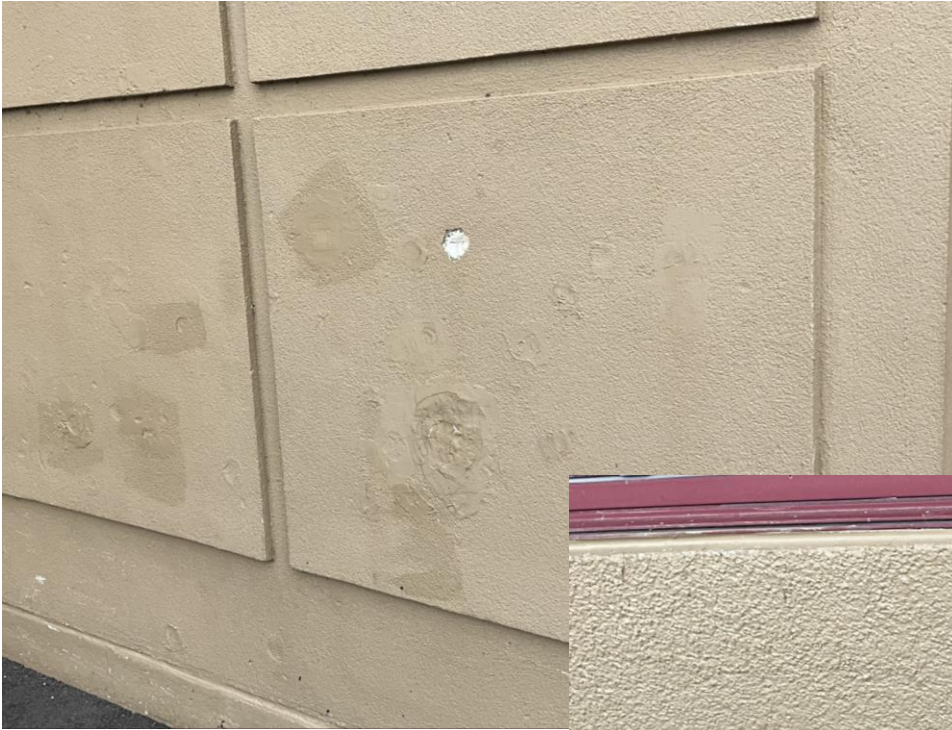
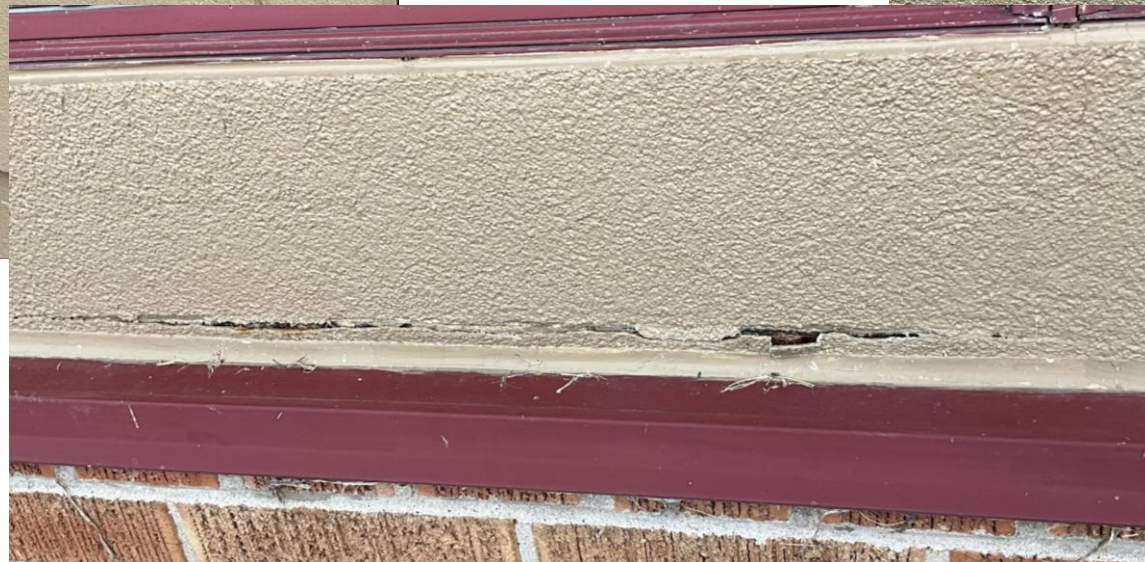
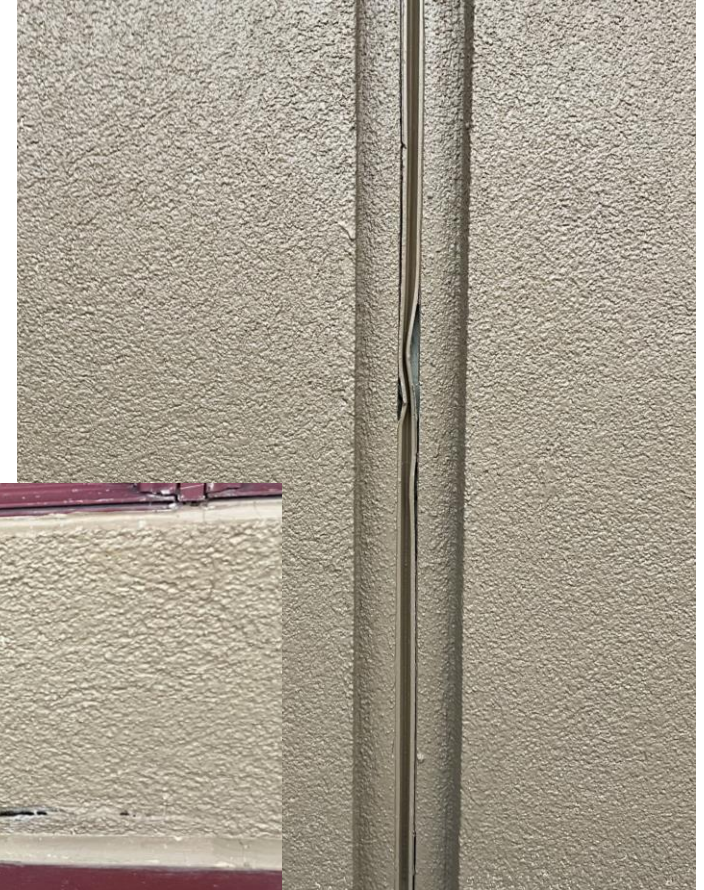
# DO/MG21 Issue #2

Façade on exterior of MG21 has many holes and cracks. There are also sealant failures seen around the exterior.
