# Capital Planning Review

Monona Grove SD

# Facility Assessment Issue Log

Monona Grove School District

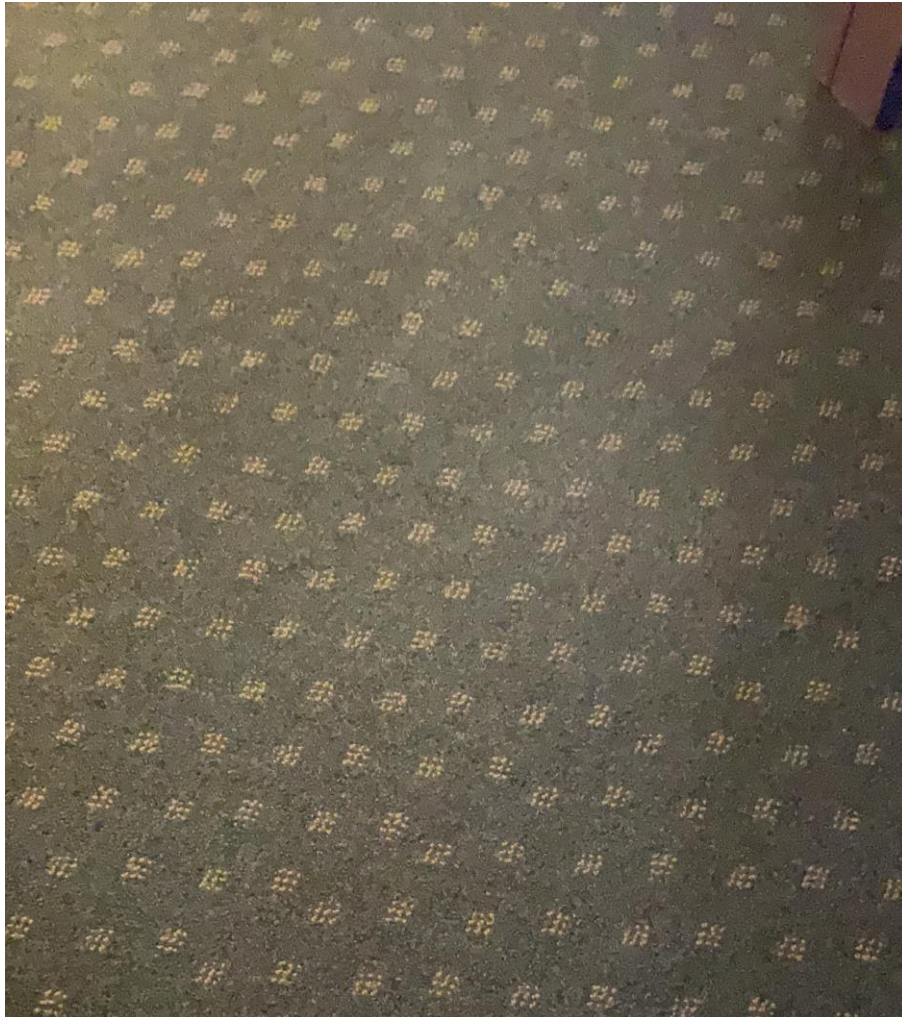
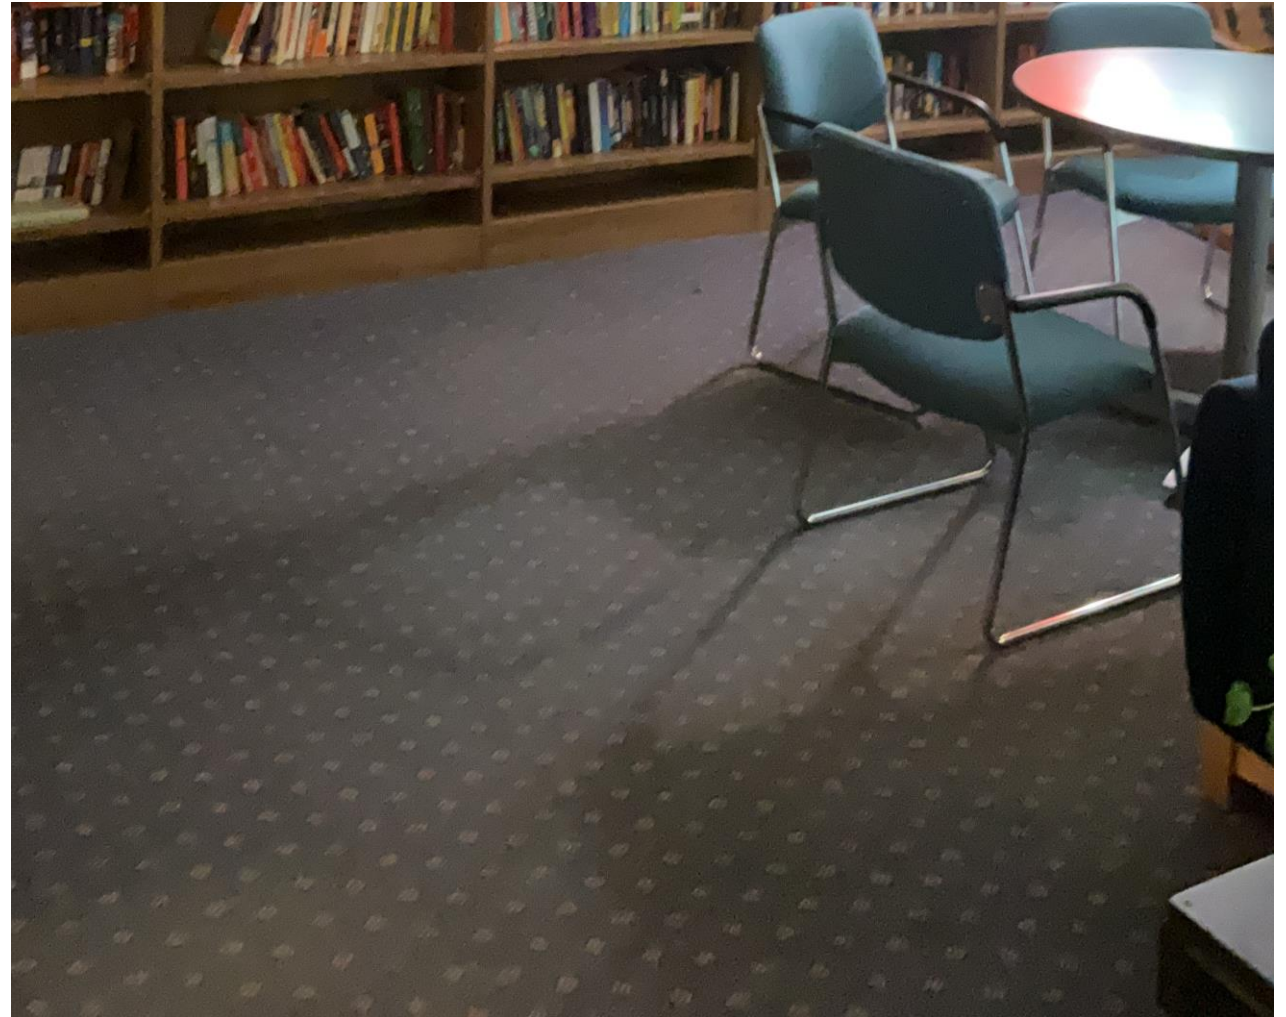
# DO/MG21 Issue #3

The carpet in the MG21 library shows staining, wear and pilling.

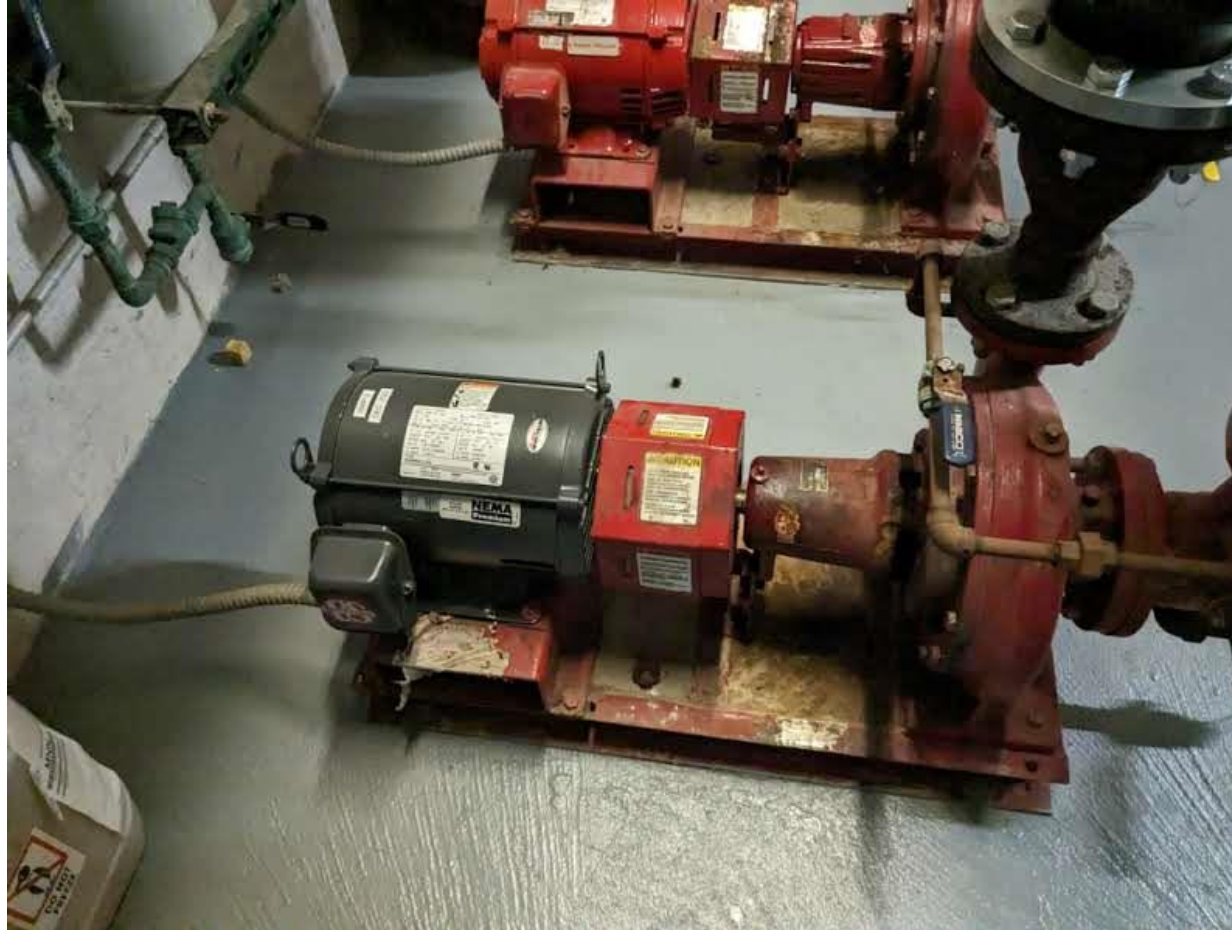
# DO/MG21 Issue #4

Both MG21 heating water pumps show extensive wear and corrosion. There appears to have been leaks in the past.

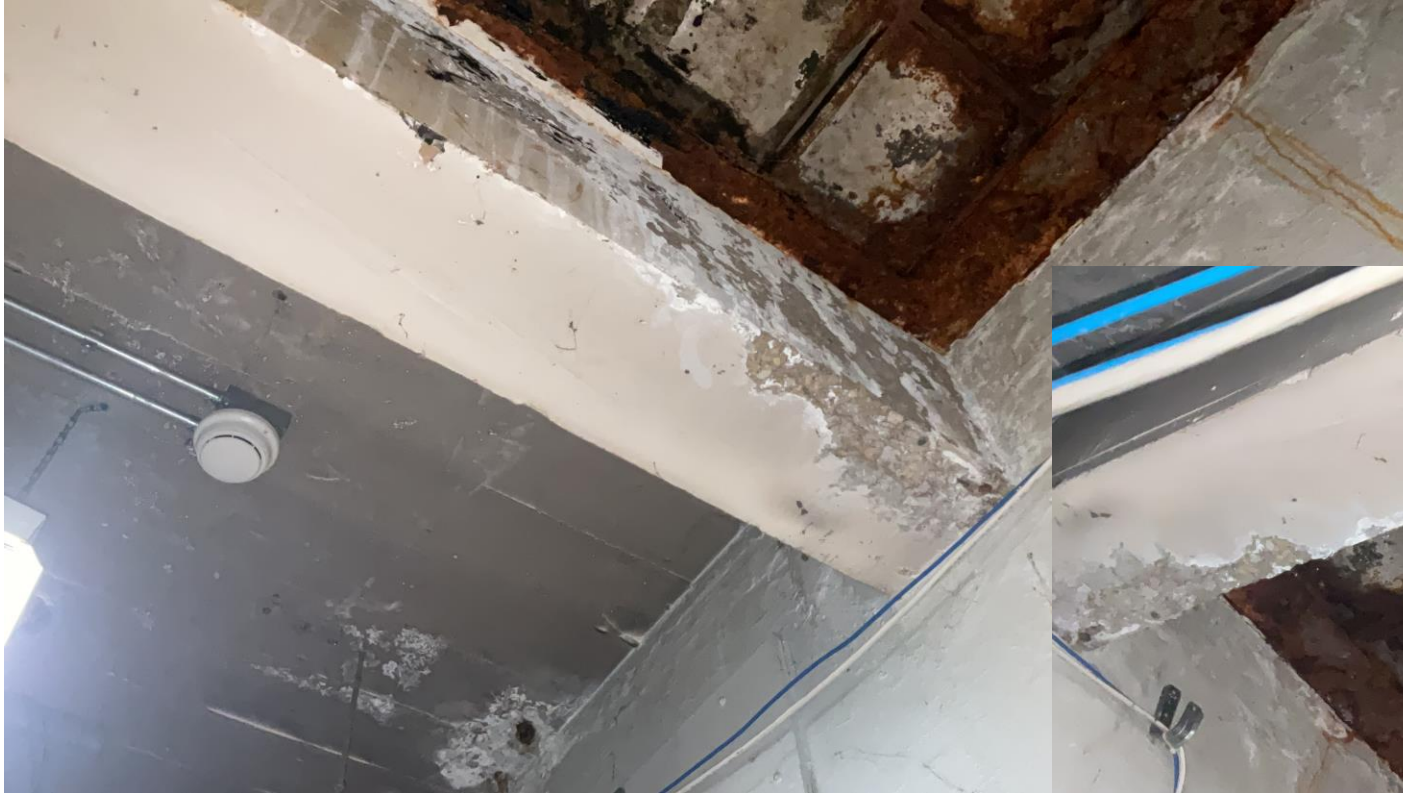
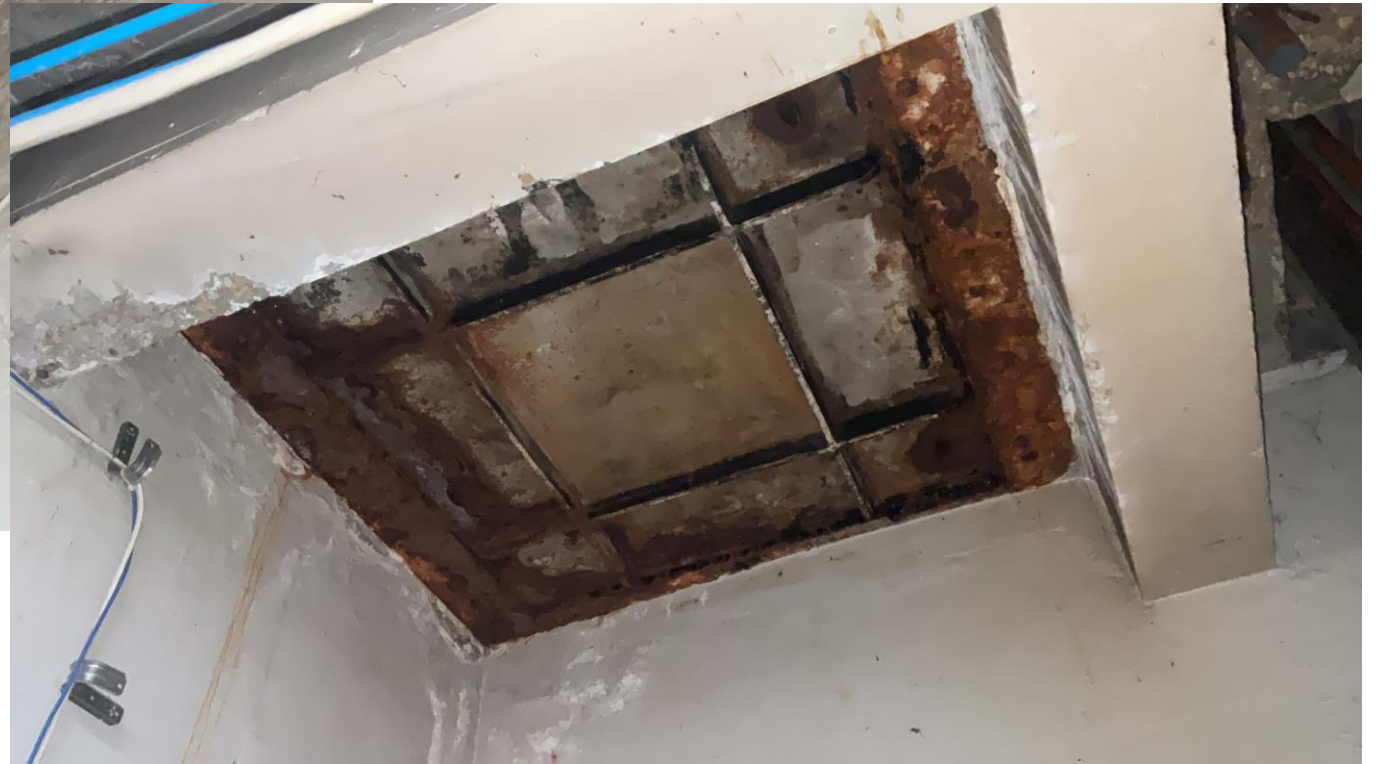
# DO/MG21 Issue #5

There is spalling and exposed rebar under the floor of MG21 near the kitchen area in the boiler room.

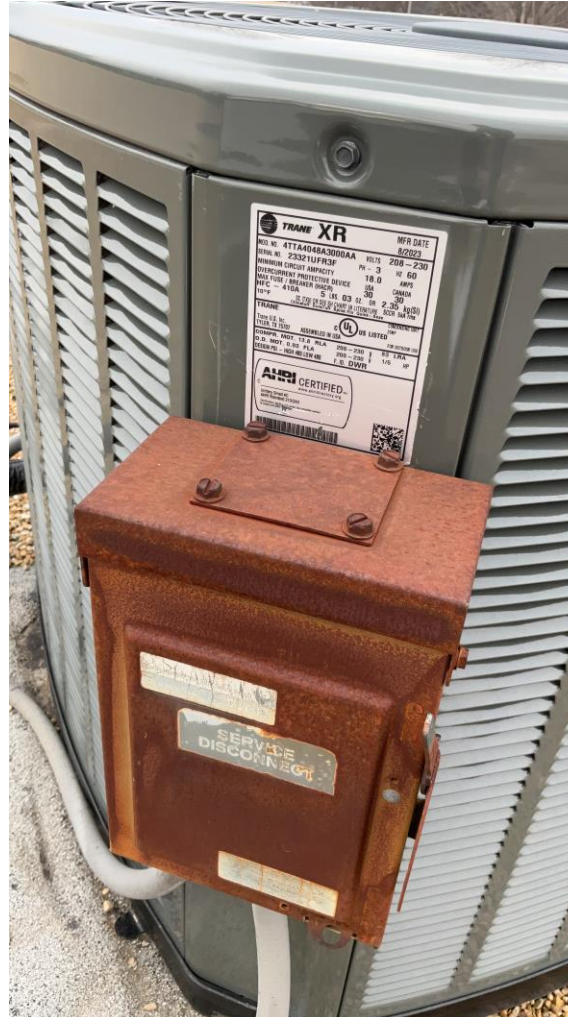
# DO/MG21 Issue #6

New condensing unit installed 2021 at MG21 has extremely rusty disconnect.

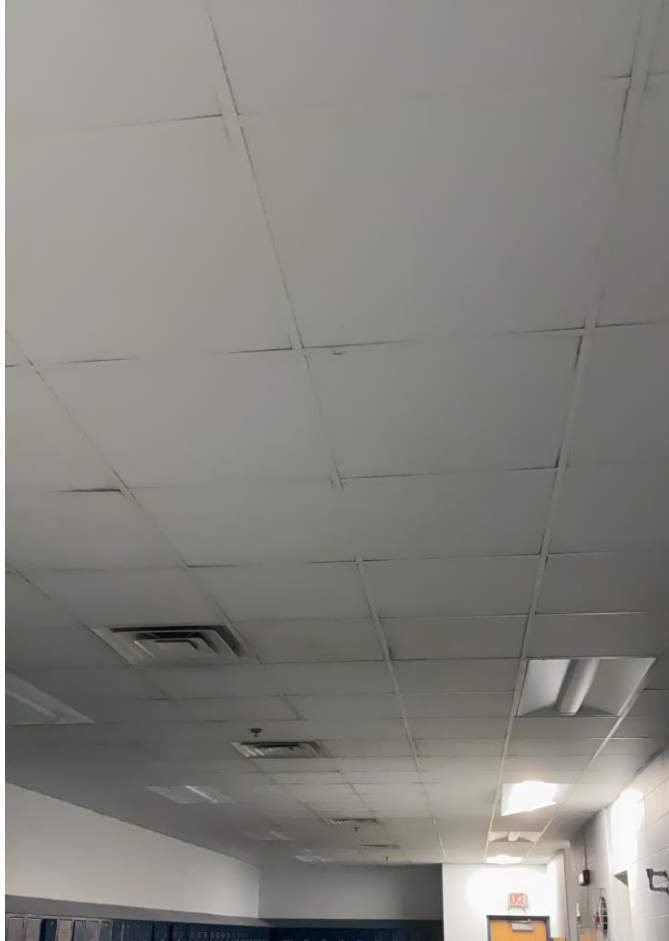
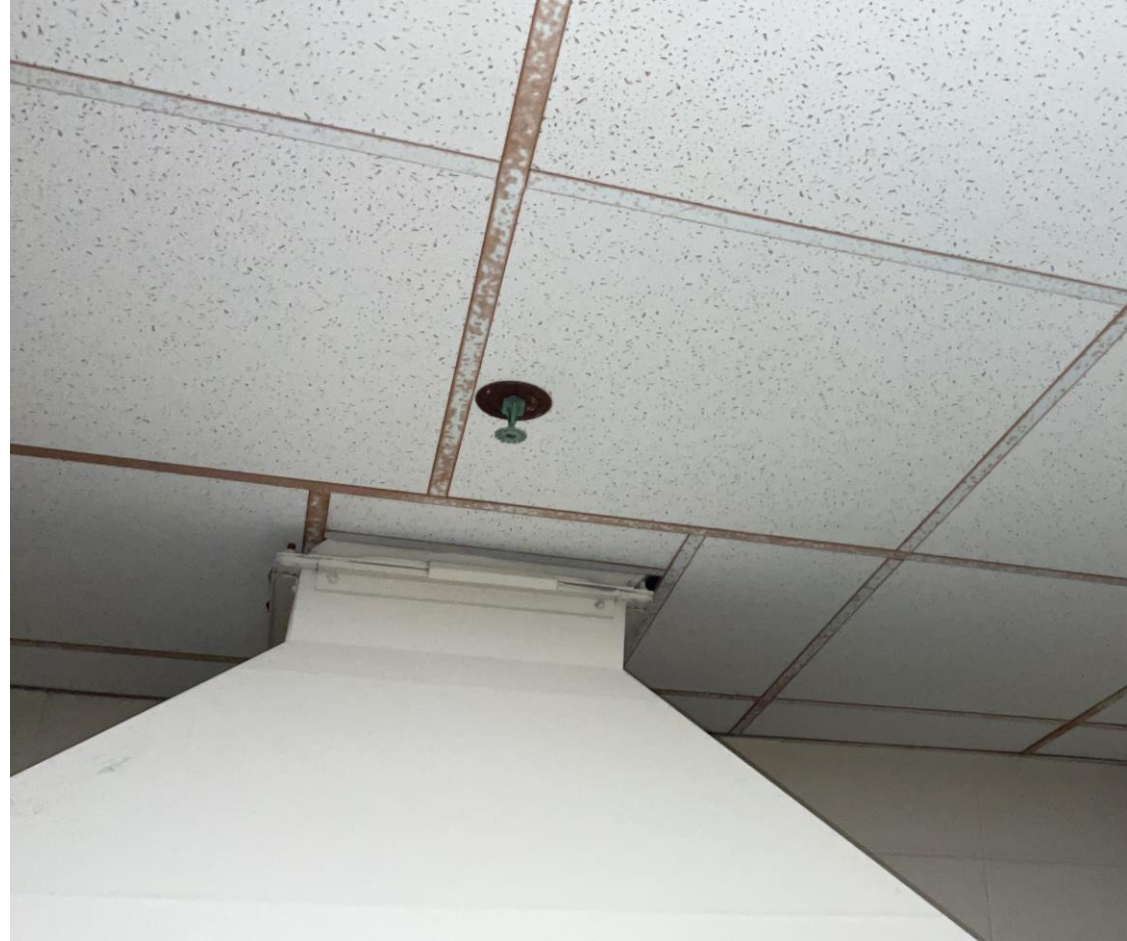
# MGHS Issue #1

Ceiling tiles are warping and stained in the gym locker rooms, the kiln room and the corridor near exit 6.

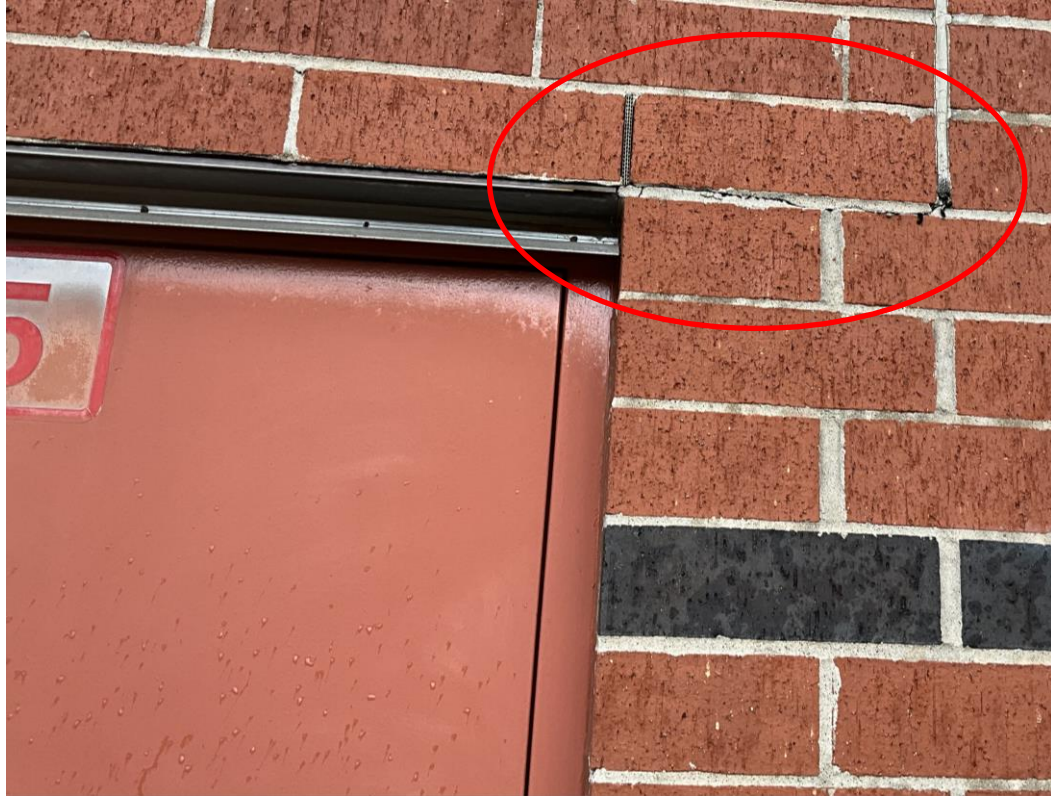
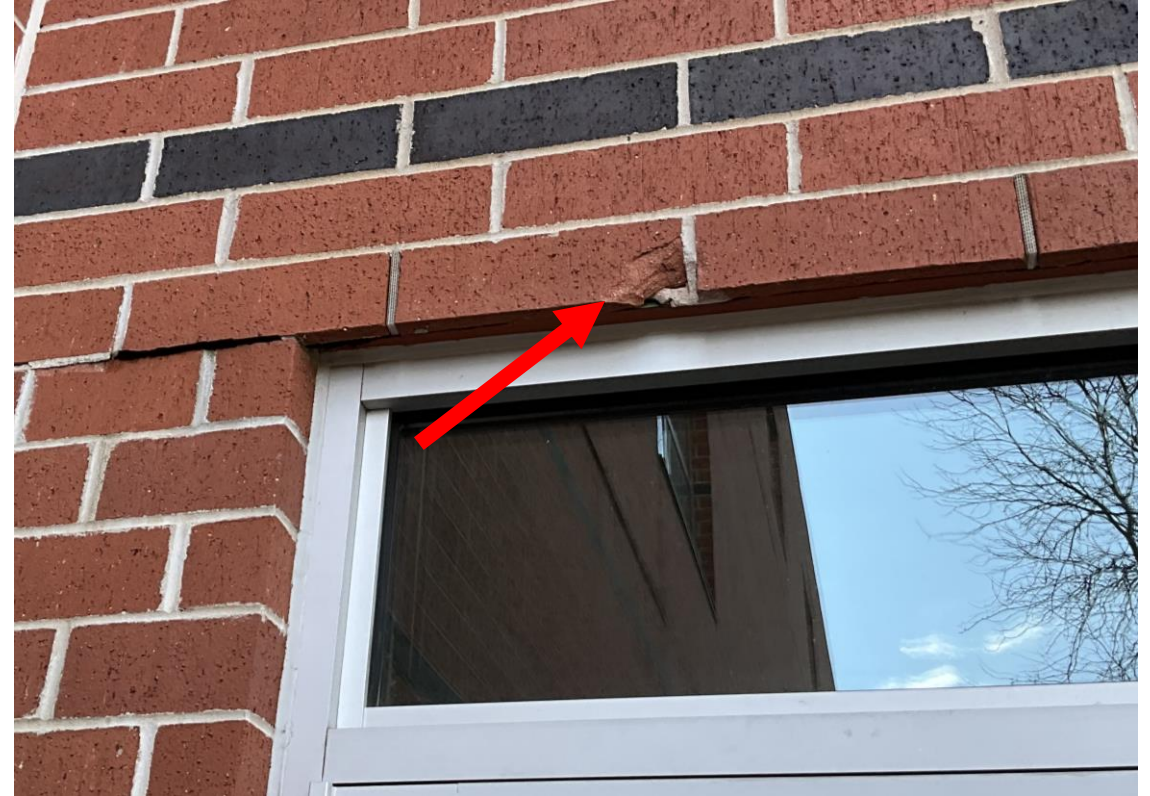
# MGHS Issue #2

Several mortar and brick cracks and failures at or above exterior doorways.

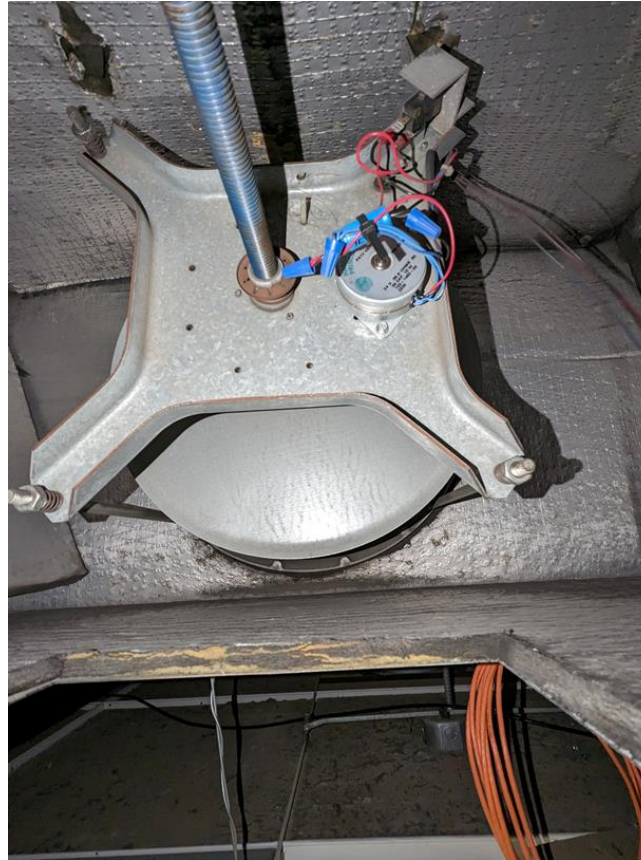
# MGHS Issue #3

MGHS VAV Boxes, \$900k

VAV boxes are aging and failing. They use an unserviceable damper mechanism and need to be replaced with butterfly damper style units.

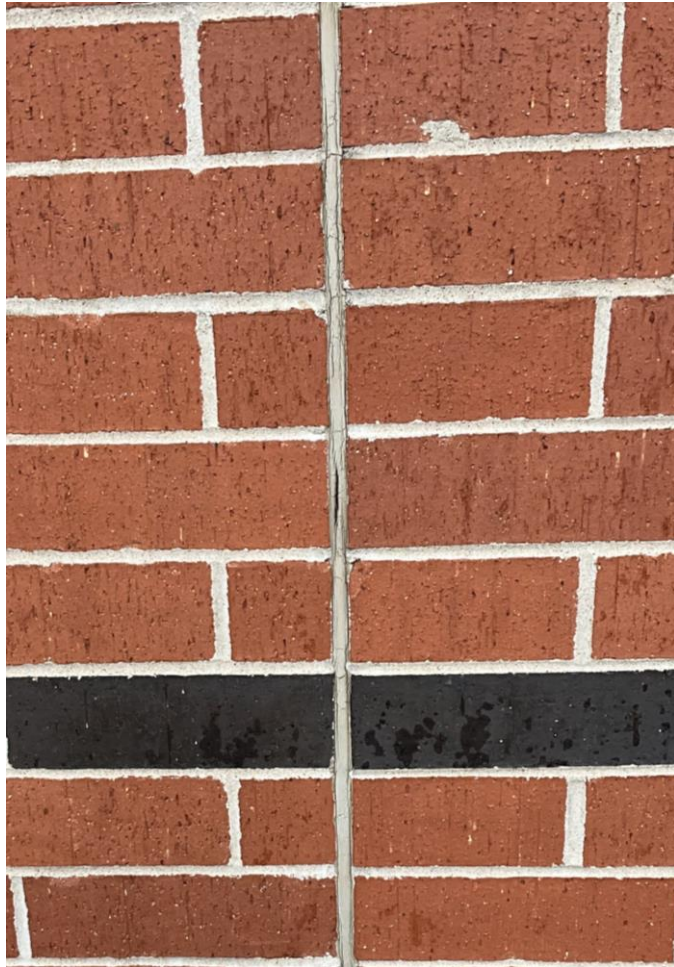
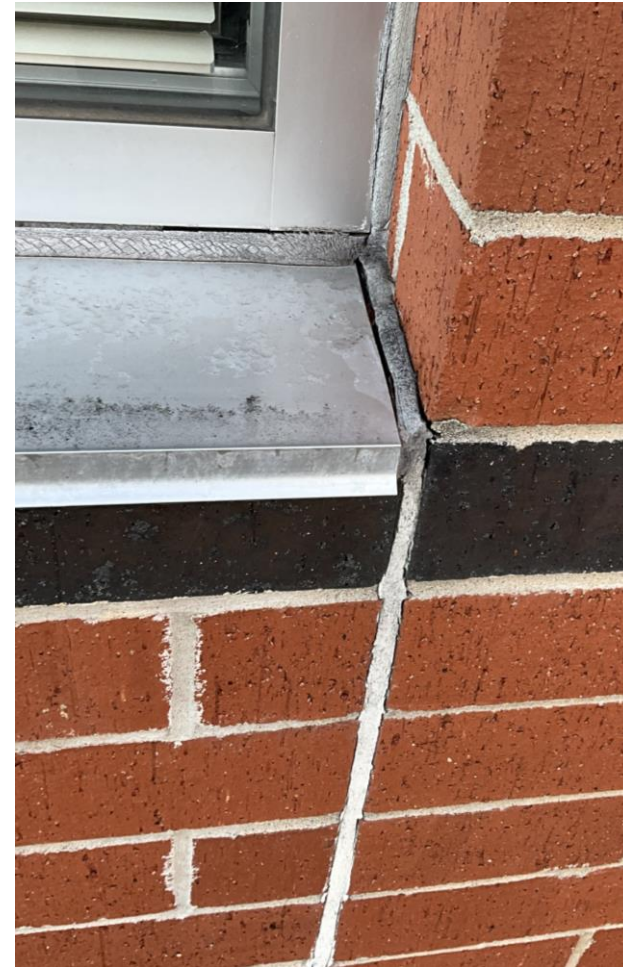
# MGHS Issue #4

Multiple joint sealant failures around exterior of building.

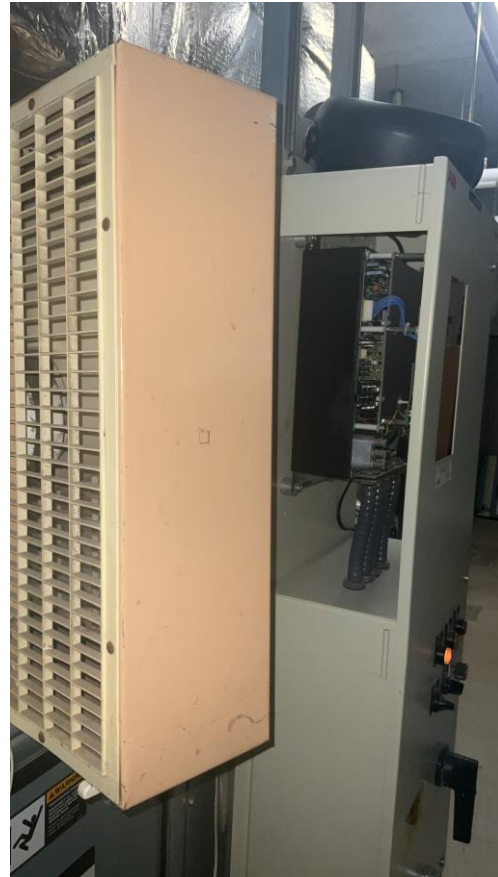
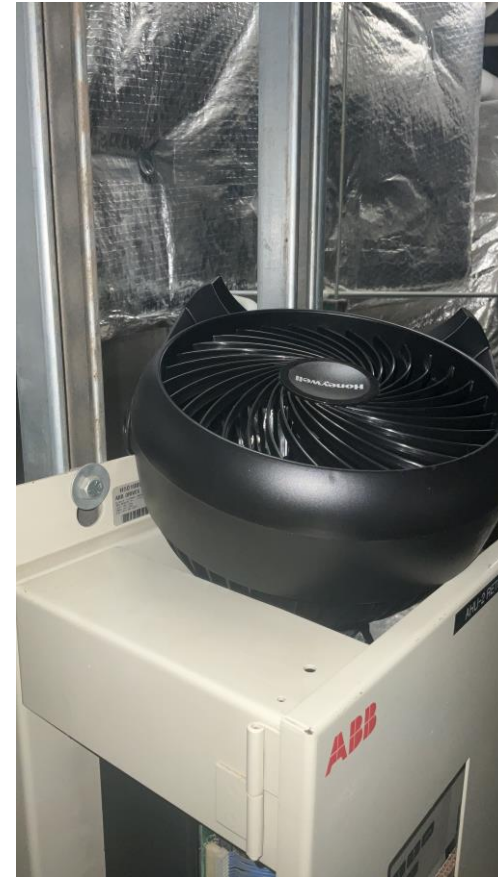
# MGHS Issue #5

The VFD serving AHU-2's return fan is overheating and needs to be cooled with additional fans to avoid failure. It should be repaired/replaced.

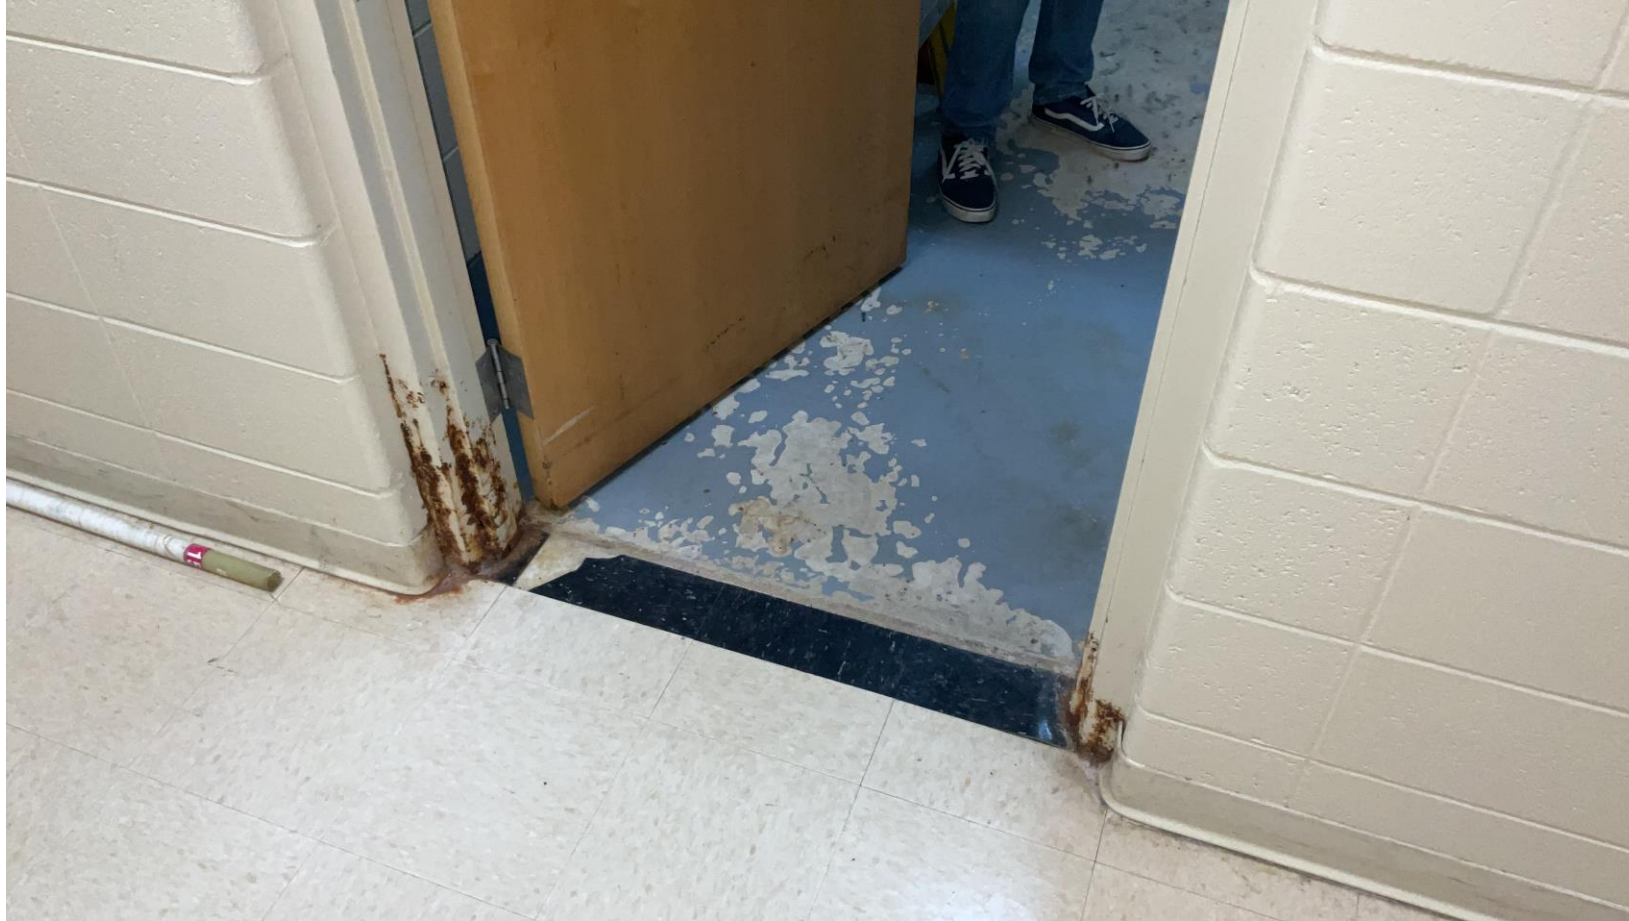
# MGHS Issue #6

Door frame to water service room is very corroded.

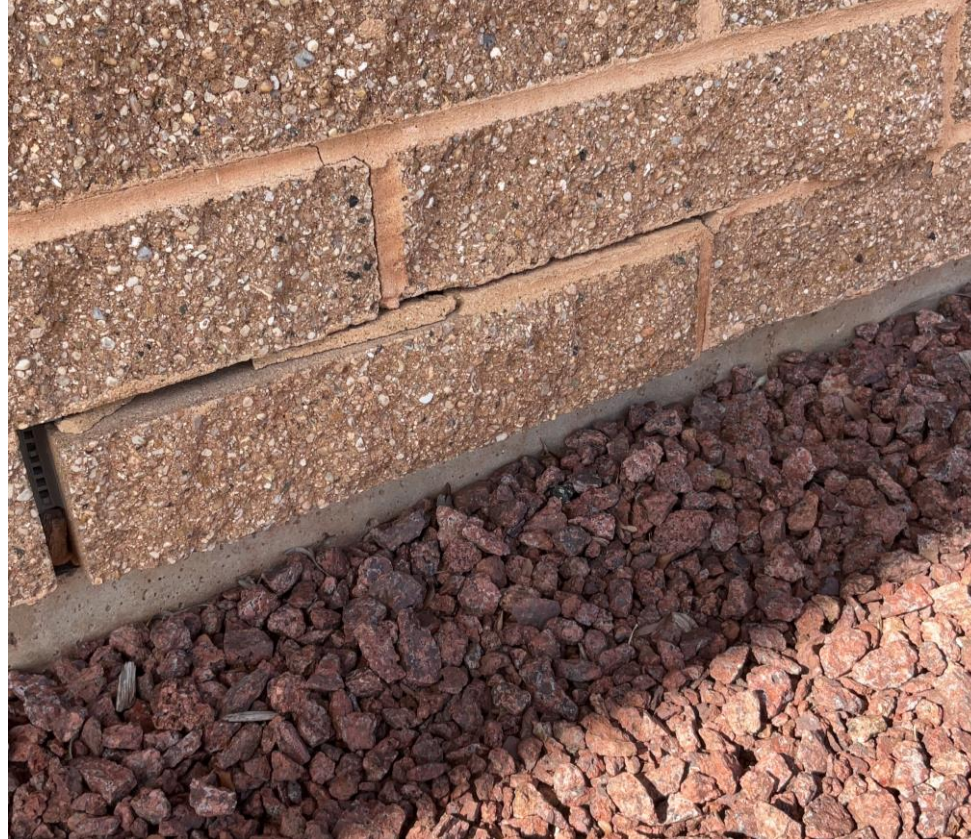
# TPS Issue #1

There is failing mortar on the exterior of classrooms 41 and 42.

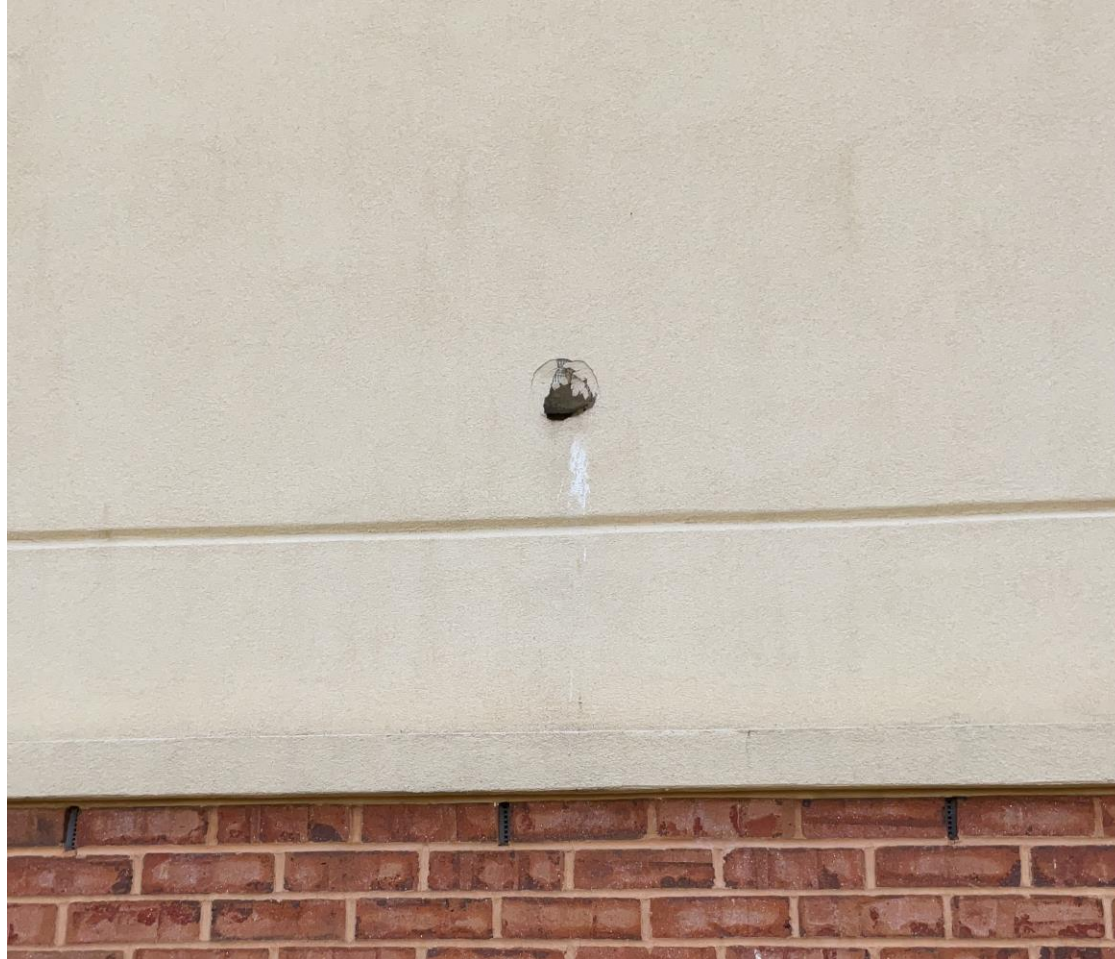
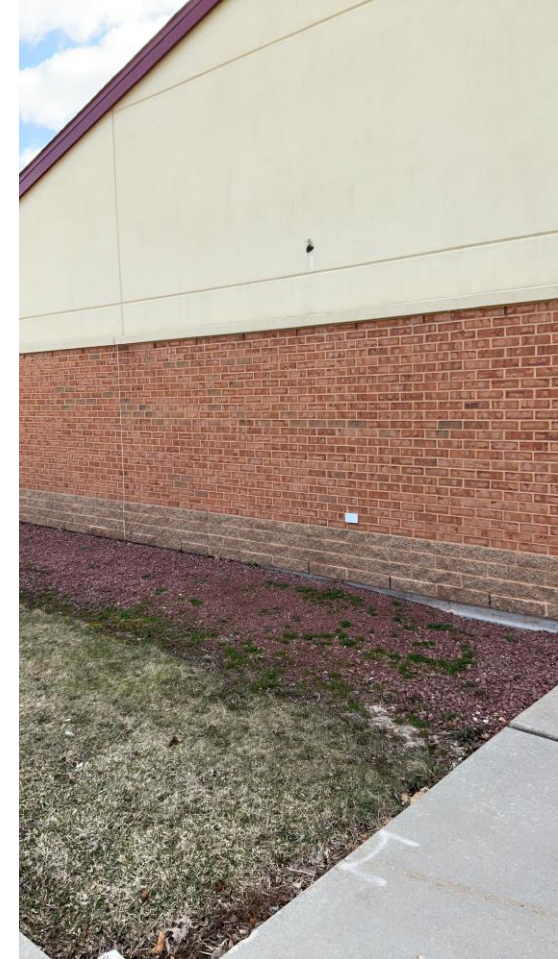
# TPS Issue #2

There is a hole in the façade outside of room 54. There are several smaller holes around the building.

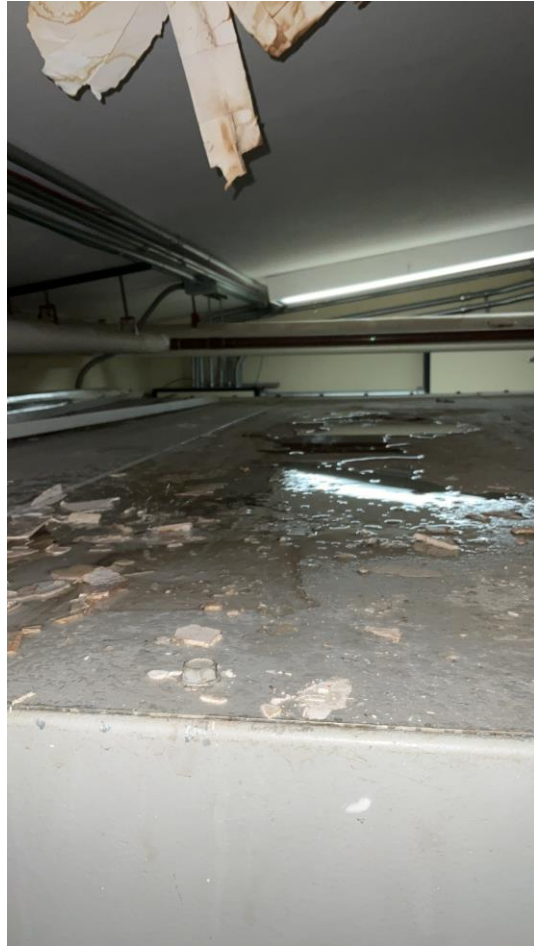
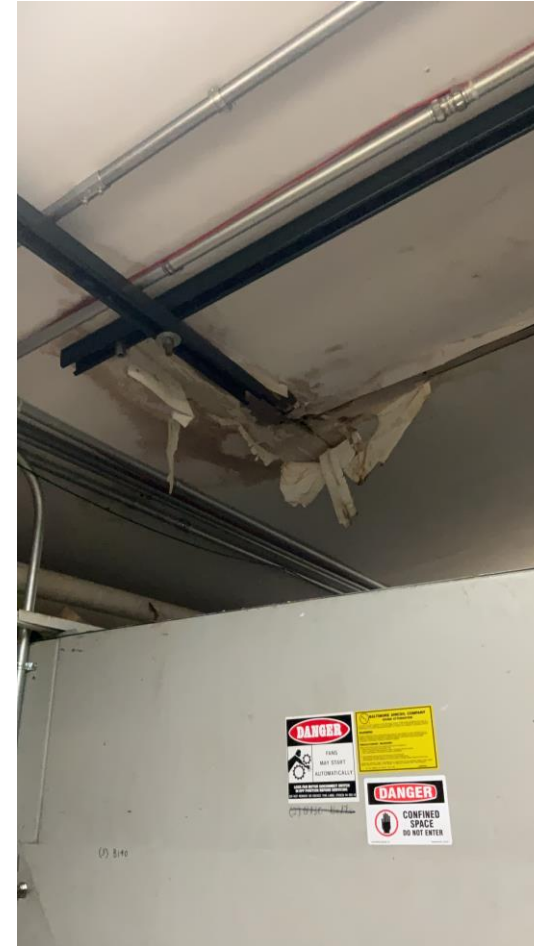
# TPS Issue #3

There is an active roof leak above the chiller.

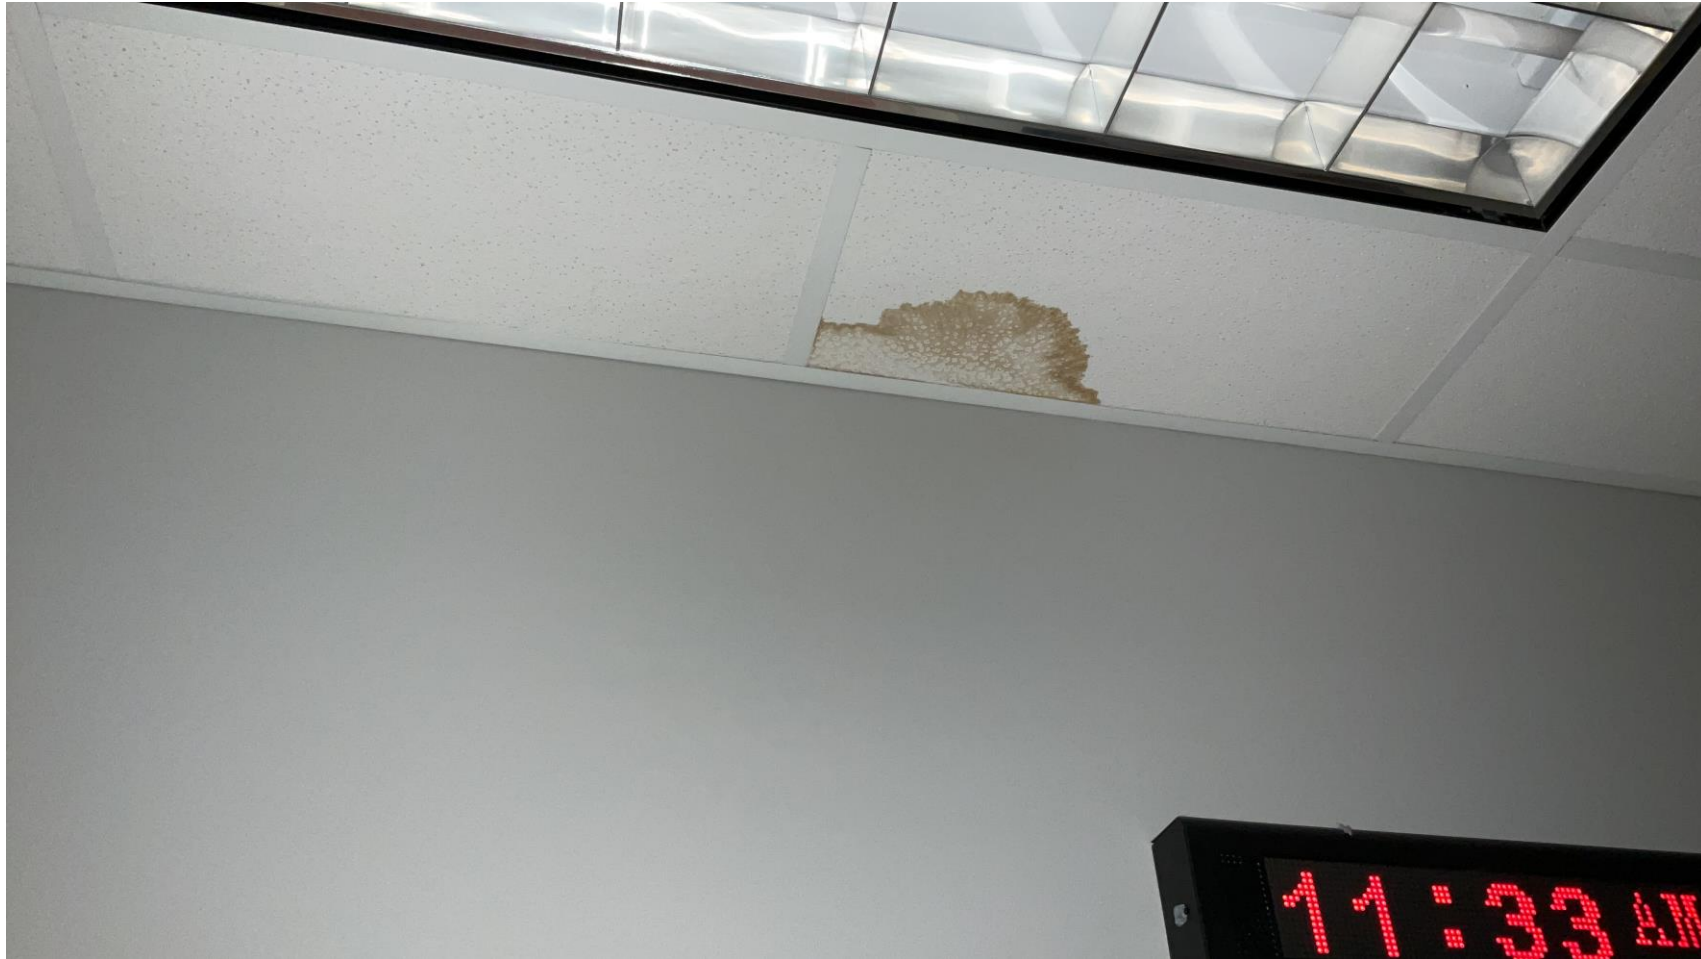
# TPS Issue #4

There are water damaged ceiling tiles in room 8.

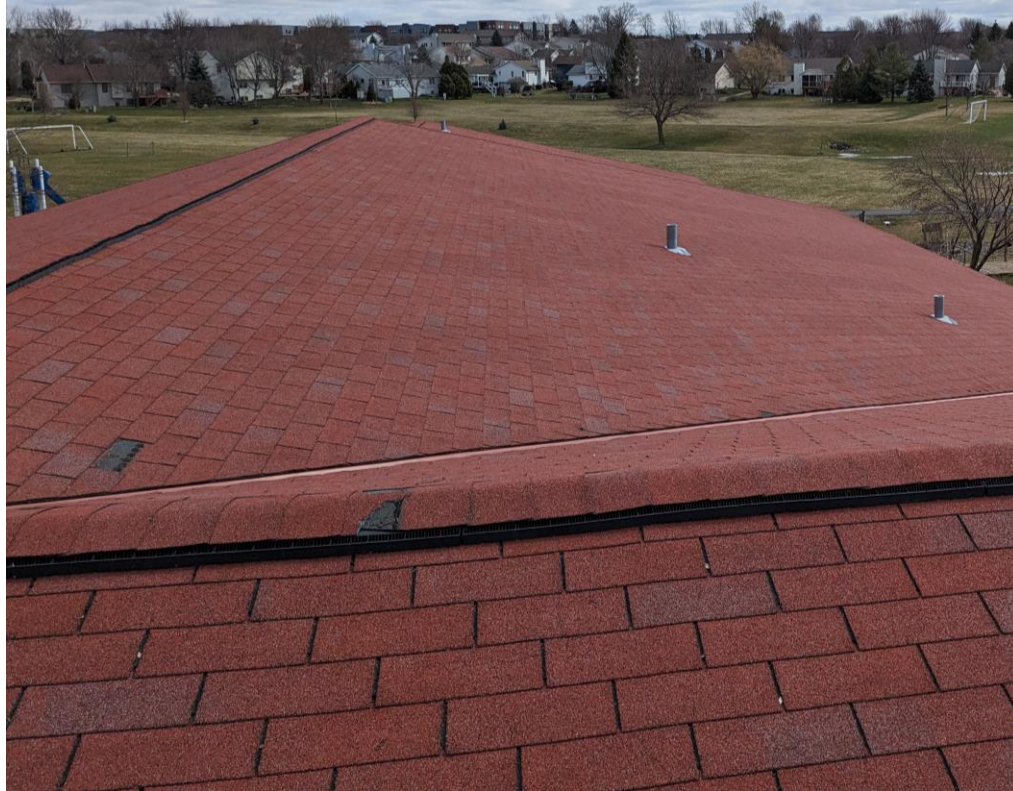
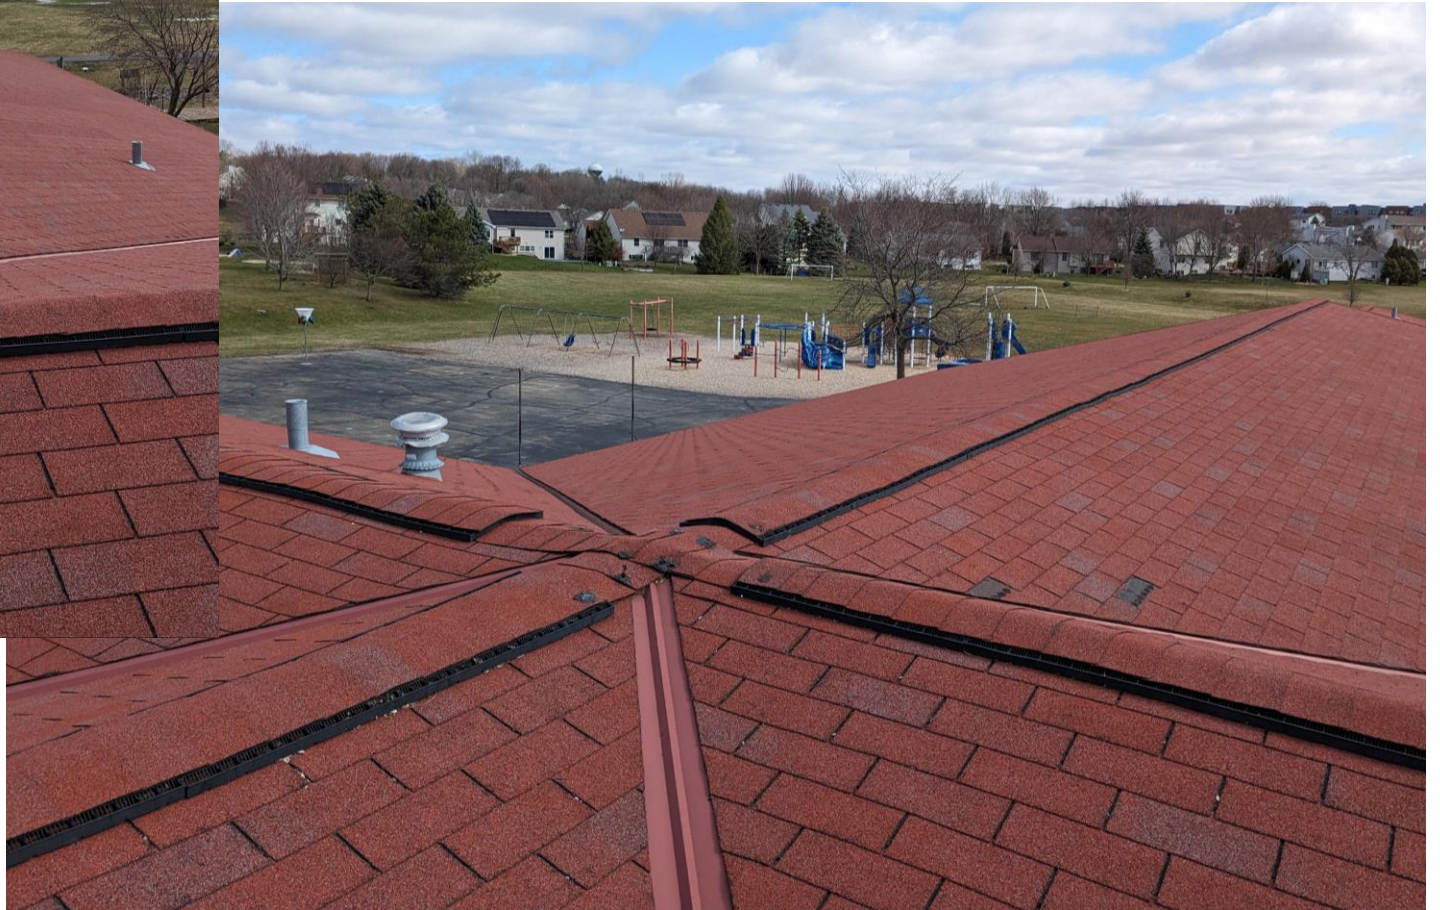
# TPS Issue #5

There are several shingles missing from the roof on the northern portion.

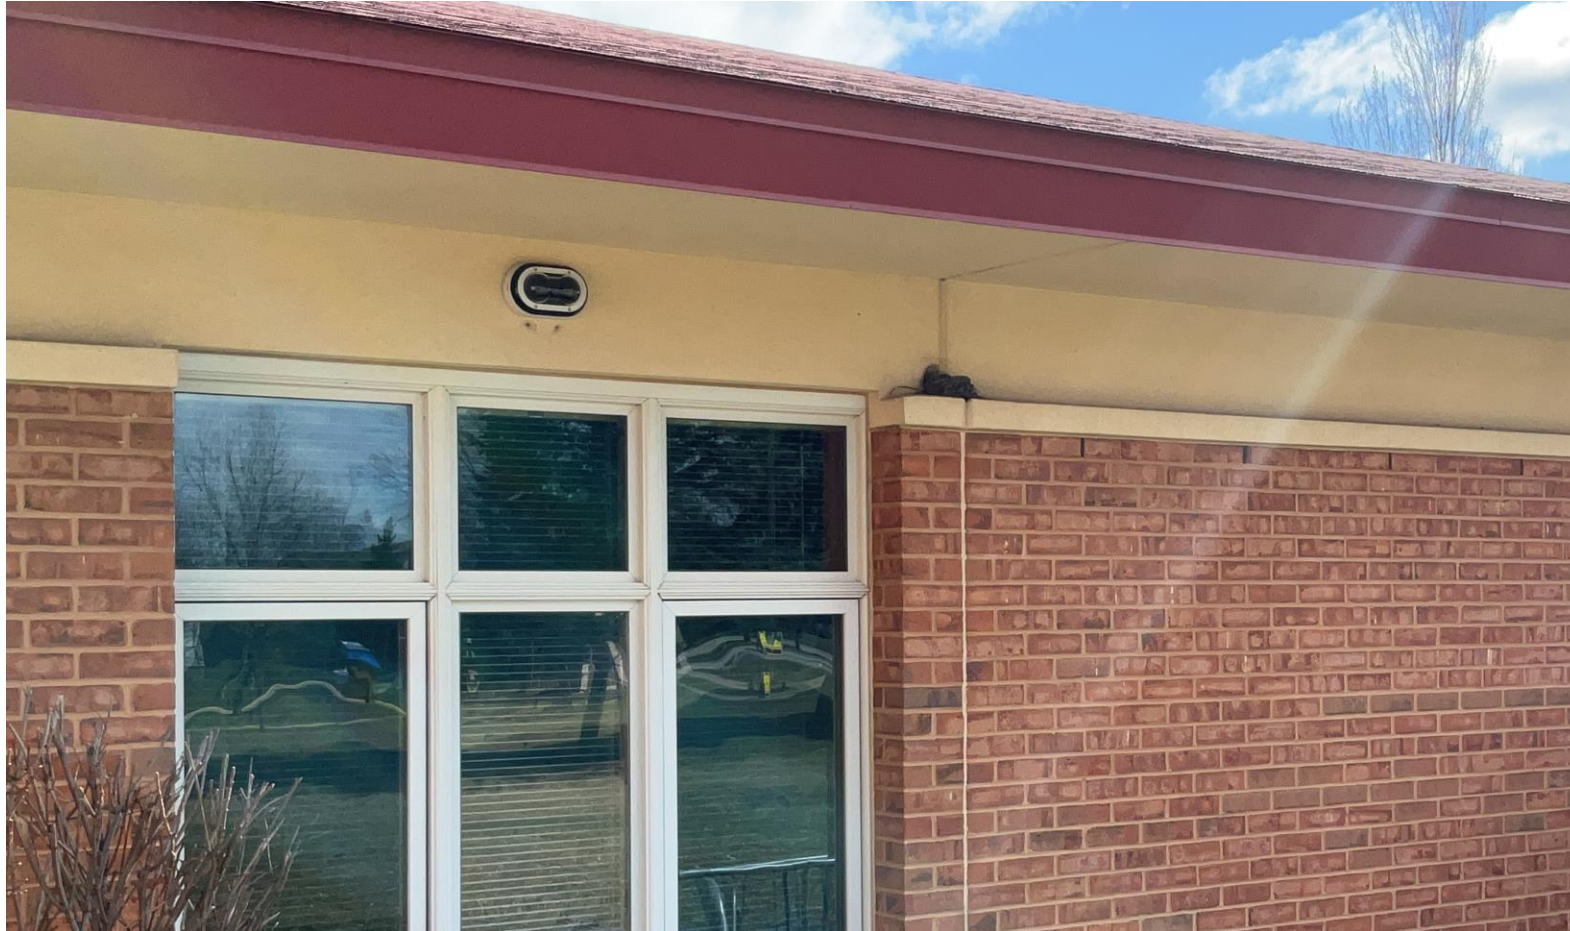
# TPS Issue #6

There are many bird's nests on the exterior of the building with some appearing to be inside the façade.
