# Capital Planning Review

Monona Grove SD

# Facility Assessment Issue Log

Monona Grove School District

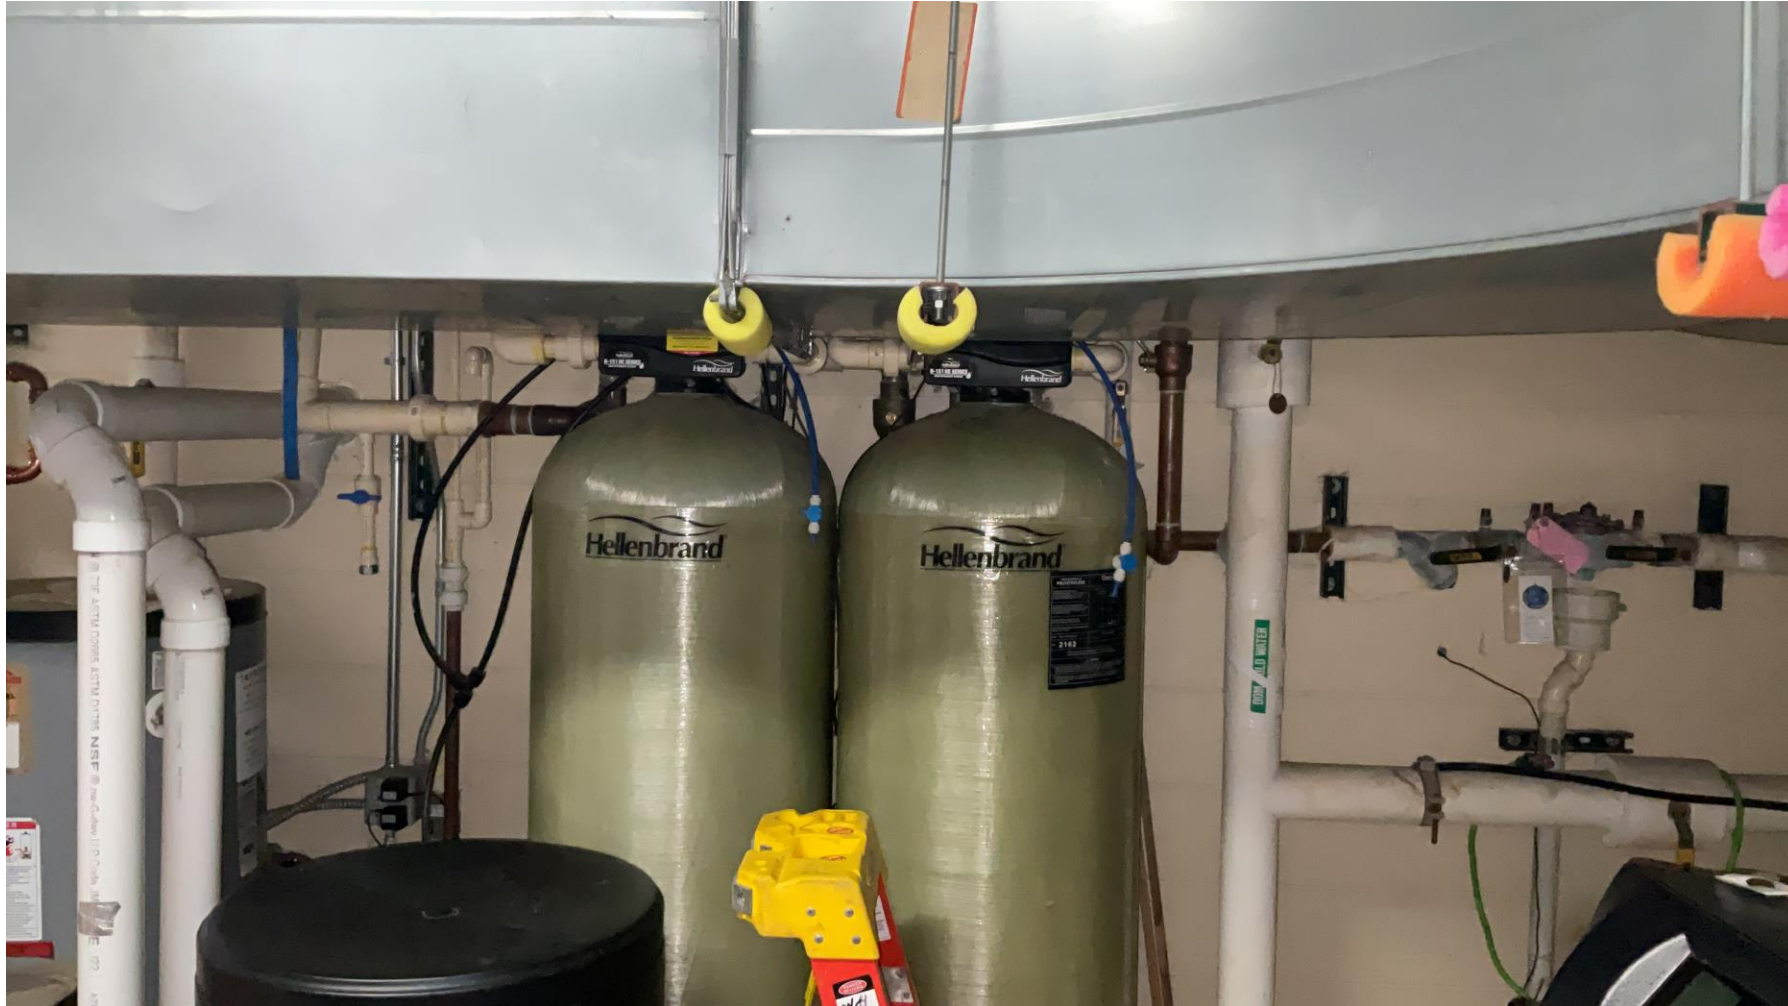
# TPS Issue #7

The water softeners are nearing end of life and cannot be repaired due to hard to reach location under ductwork.

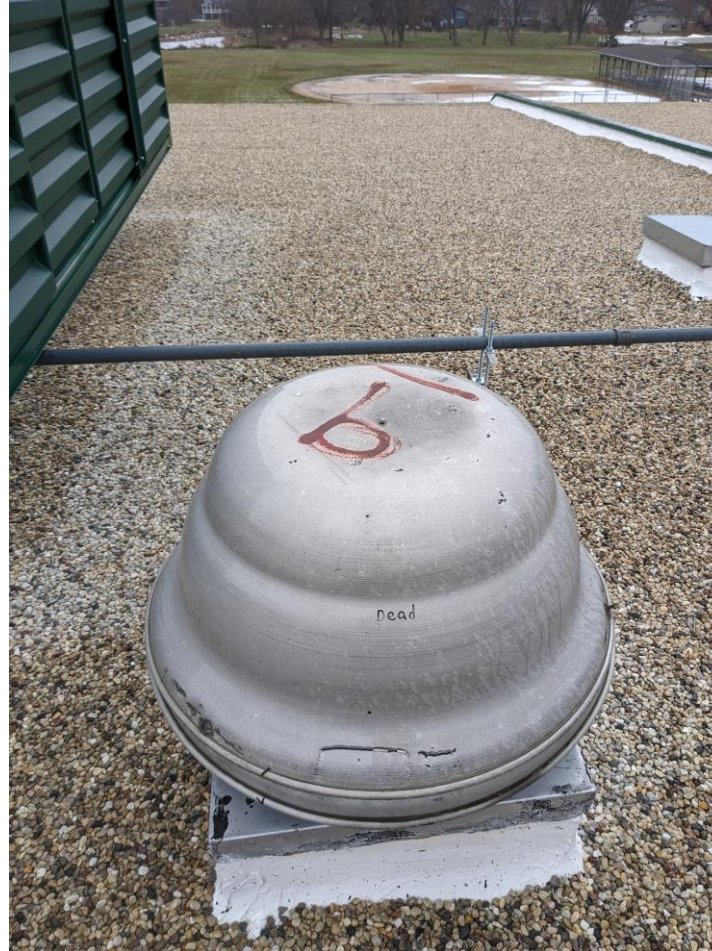
# WS Issue #1

Exhaust fan EF-9 is not functioning.

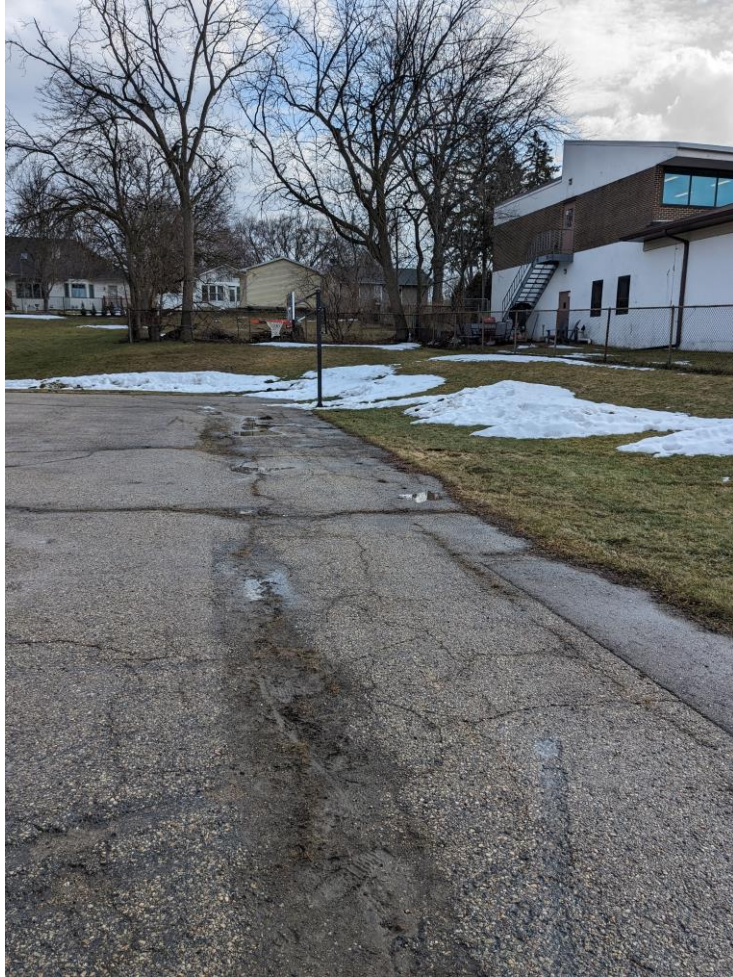
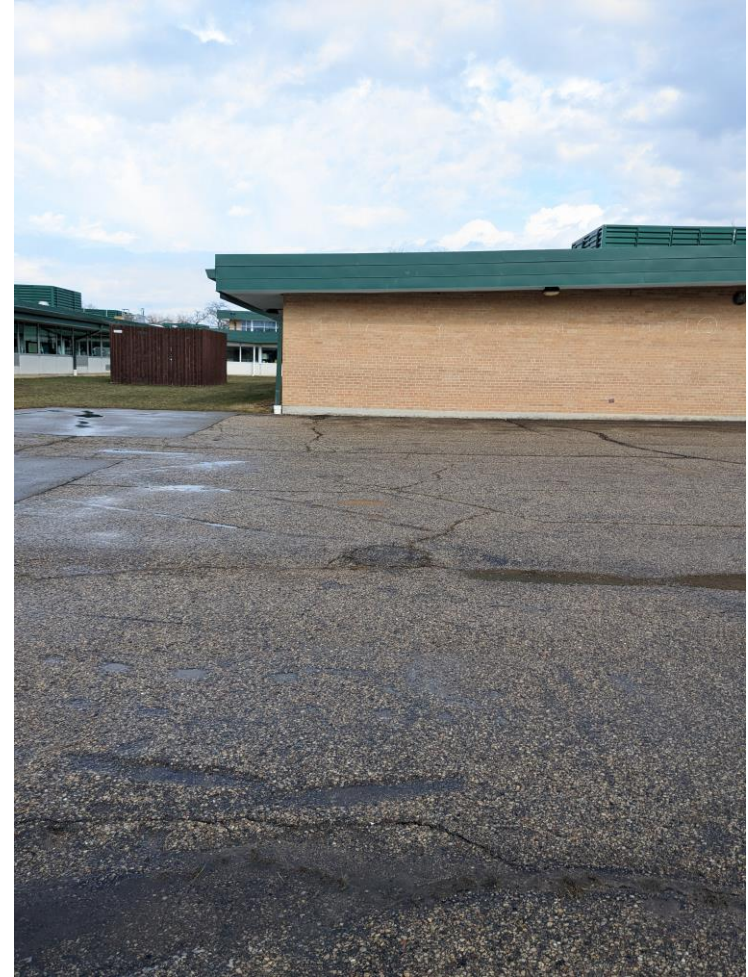
# WS Issue #2

The west play surface shows cracking, spalling and minor elevation changes.

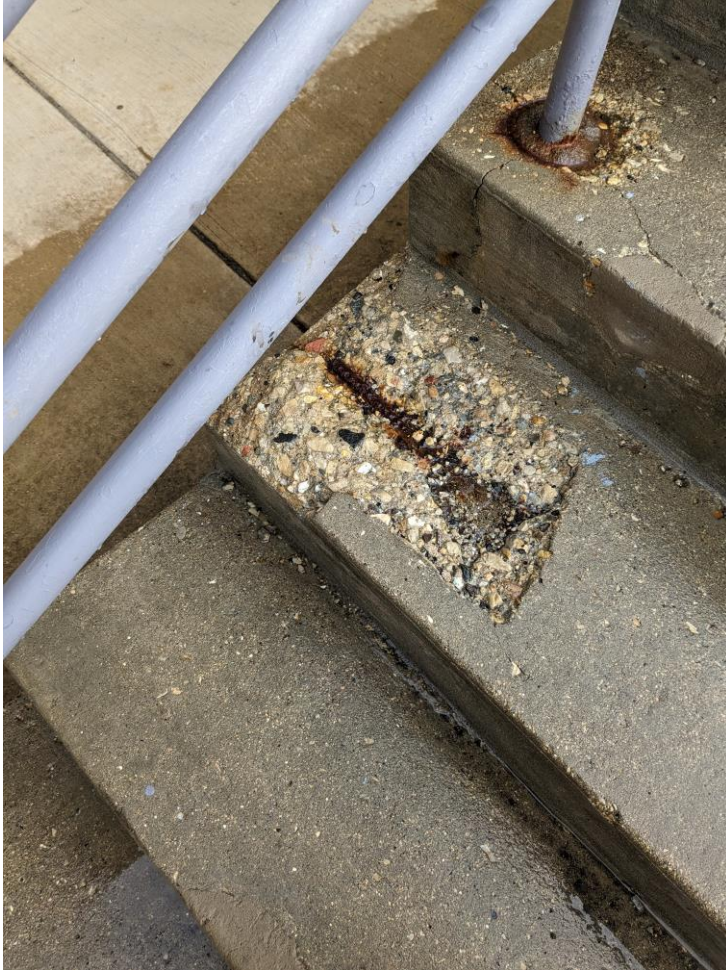
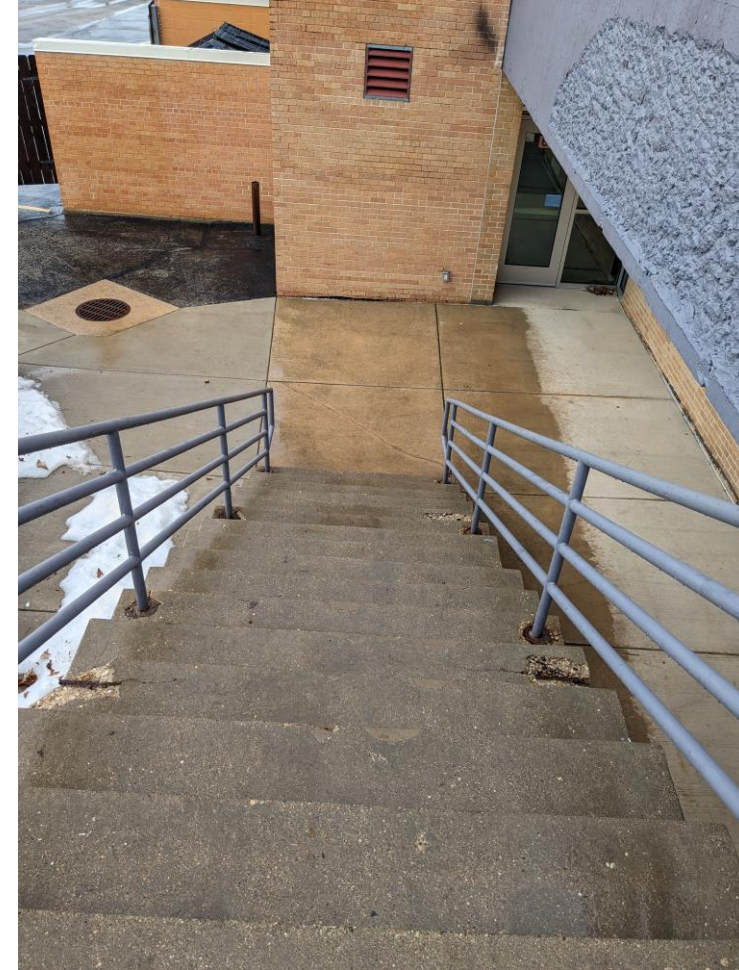
# WS Issue #3

Areas of paving near south side of building are in especially poor condition and crumbling.

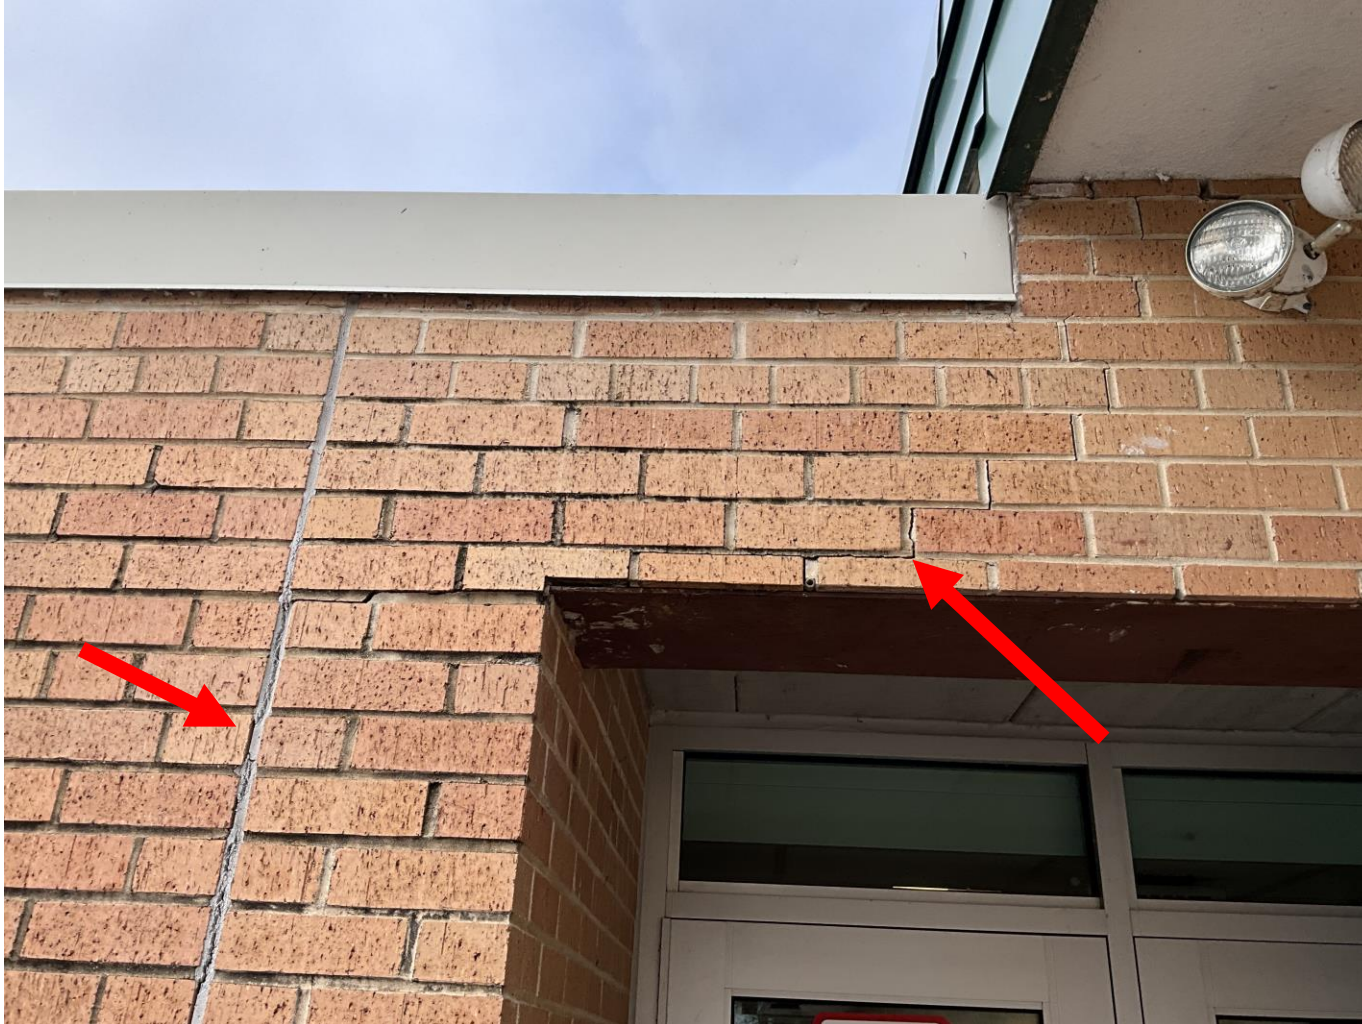
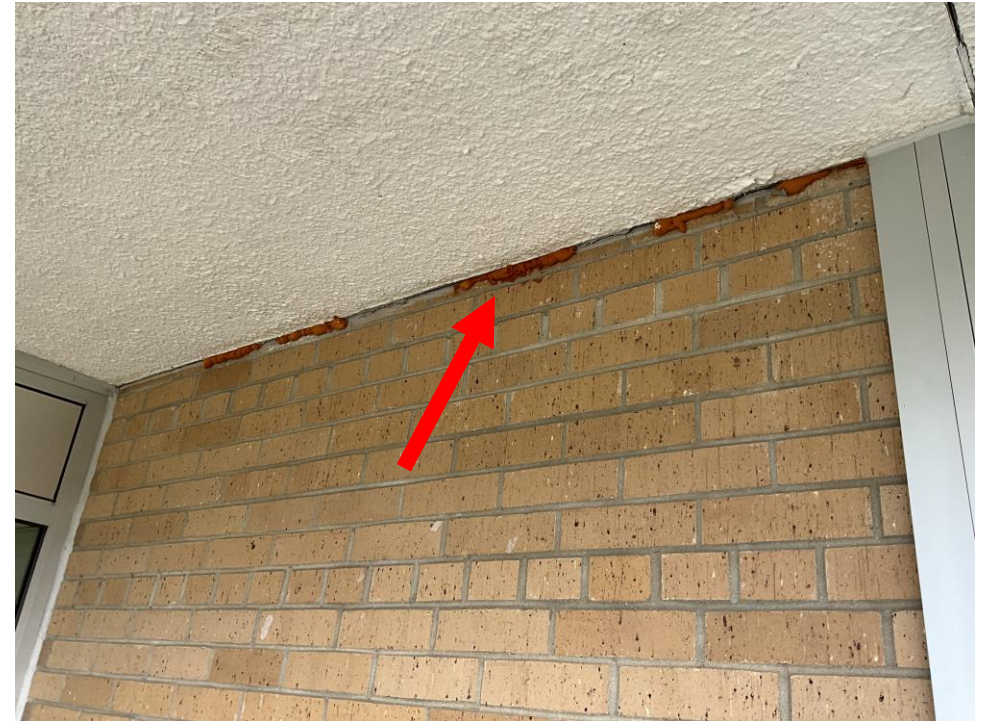
# WS Issue #4

Exterior masonry has failing/cracking mortar and failing sealant joints.
