**RE-ROOFING FOR  
CHUALAR UNION ELEMENTARY SCHOOL  
CHUALAR, CA  
(CUSD)  
BID #2026-0001**

**ADDENDUM #1**

## Limited Asbestos Survey Report

Site: Chualar Union Elementary School, 24285 Lincoln Street, Chualar, California

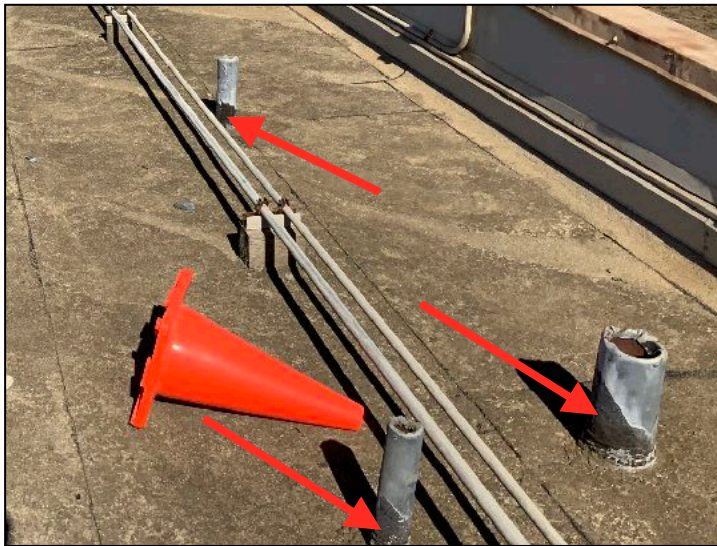
- \* **The roofing mastic on the roof of building B contains 3% Chrysotile asbestos. The mastic is classified as a Category I, Non-Friable Asbestos Containing Material (ACM). There is approximately 10 square feet of roofing mastic.**

| Asbestos Summary Table | | | | | |
|---|---|---|---|---|---|
| B | Roofing Mastic | Roof | 3% Chrysotile | Category I<br>Non-Friable, ACM | 10 SF |

*Building B - ACM Roofing Mastic*

When conducting renovation or demolition, A State of California [C-22](#) Licensed Asbestos Abatement Contractor who is Division of Occupational Safety & Health (DOSH) registered, must be retained when disturbing materials containing greater than 0.1% asbestos (Asbestos Containing Construction Material). All work must be conducted in strict accordance with Cal-OSHA's asbestos standard, [8 CCR 1529](#) and the requirements of the Monterey Bay Air Resources District's (MBARD) [Rule 424](#). Waste must be disposed of in the correct landfill for the classification of asbestos being removed.
