WESTPORT PUBLIC SCHOOLS  
COLEYTOWN ELEMENTARY SCHOOL  
65 Easton Road, Westport, Connecticut

Preliminary Assessment  
January 2023

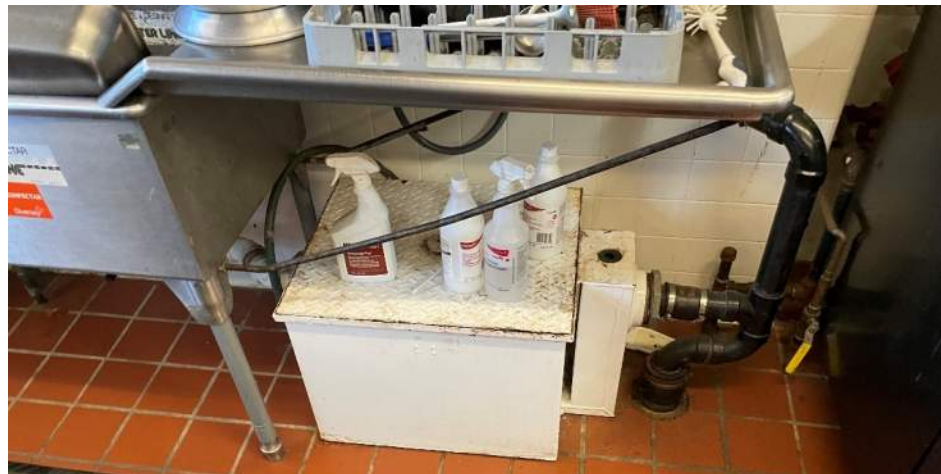
Current Department of Public Health requirements mandate the need for in-ground grease waste interceptors in new construction. The under-sink grease waste interceptor is permitted under prior code, but should be replaced as part of the renovation of the facility.

*Undercounter grease waste interceptor.*

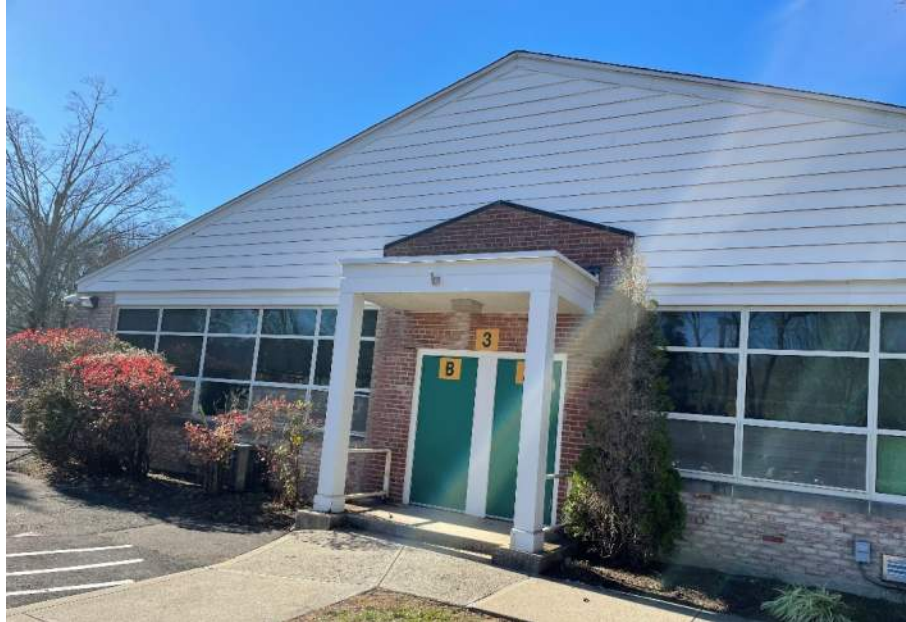
Some secondary building exits are inaccessible due to the presence of a step at the exit's exterior landing.

*An example of a non-accessible building exit.*

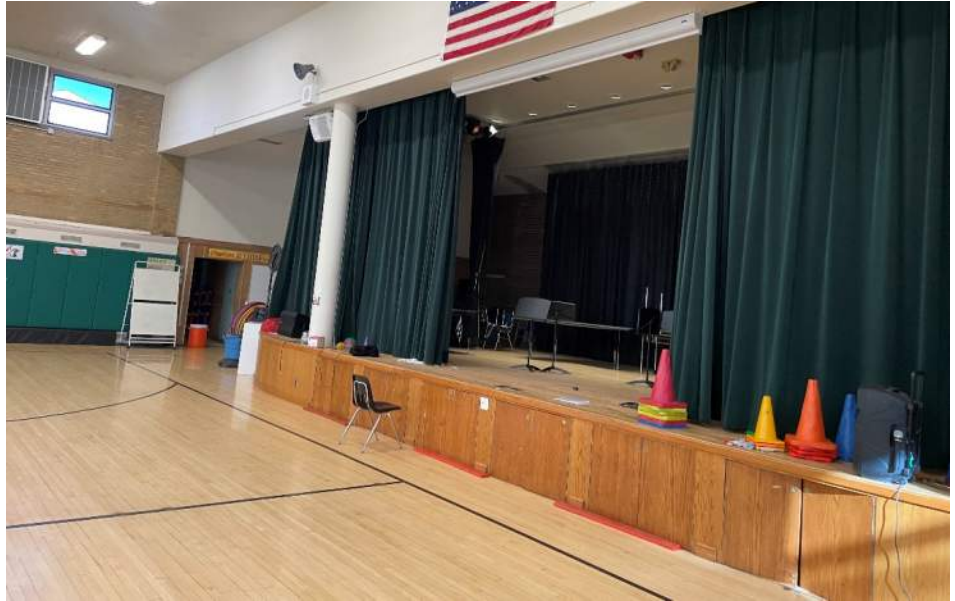
A common accessibility concern is the provision of barrier free access to elevated stages. Access needs to be "equal and adequate". A path to the stage from an adjacent corridor, for example, does not meet the intent of equal access. A renovation of the school should address access to the stage level for individuals with physical impairments. Because existing facilities rarely have sufficient surplus space to accommodate a compliance accessible ramp, a platform lift is most commonly the form of access provided. Newly constructed schools typically achieve access to the stage without the incorporation of platform lifts which operate slowly and are notorious for being prone to maintenance issues.

*A view of the existing stage located in the Gymnasium.*

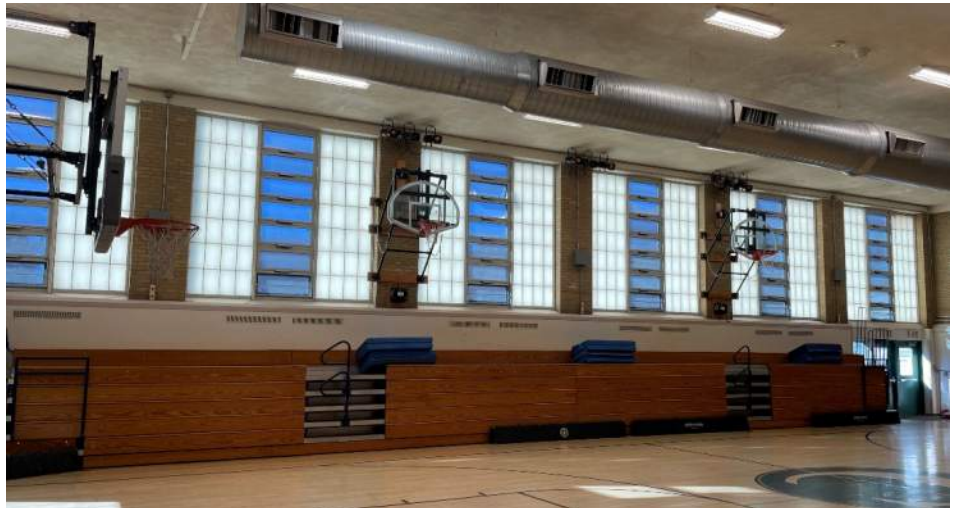
*Existing retractable seating lacking provisions for accessible seating.*

A portion of retractable bleacher seating in assembly spaces is also required to be accessible. A renovation of the school would require partial replacement of existing retractable bleachers to accommodate accessible seating.

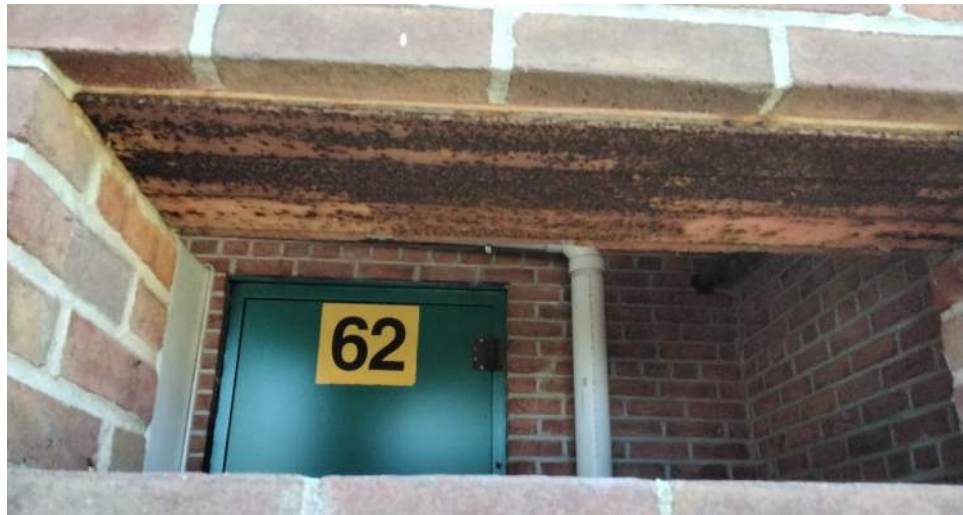
In general, the structure of the building was observed to be in fair condition and appears to have been well maintained. There are structural issues throughout, including cracks in concrete masonry unit and brick masonry walls, cracked concrete window sills, failing wall finishes, cracked, and failing mortar joints, cracked concrete slabs on grade, and significant cracking observed in the cast-in-place concrete foundation walls. Surface corrosion of exposed steel and lintels, as well as damage to an exterior steel column was also observed. Evidence of water infiltration existed at multiple locations throughout the building's interior. Remedial action should be taken to address any of these issues that are to be retained in the renovation project.

*Typical corroded steel lintel.*

A *Renovation Status* application that contemplates the retention the existing structure, in part or in whole, would require selective repairs to certify its serviceability for the next 50-years.

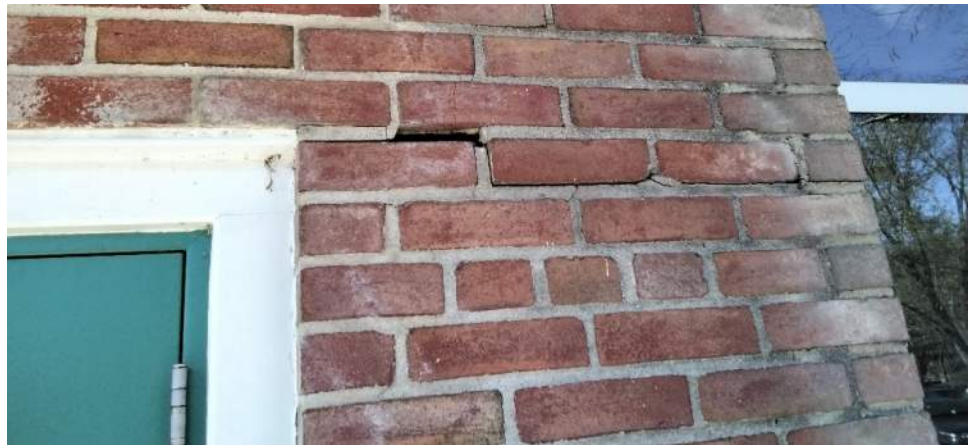
*Cracked brick and failed mortar joints.*

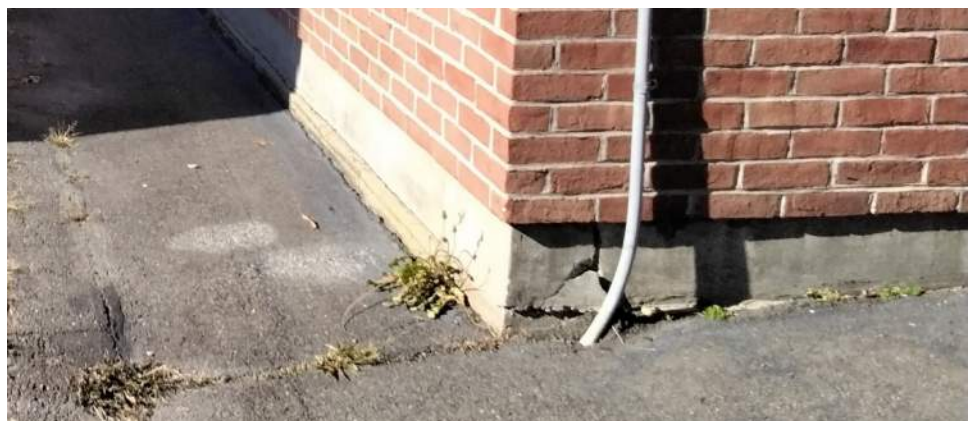
*An example of a cracked foundation wall.*

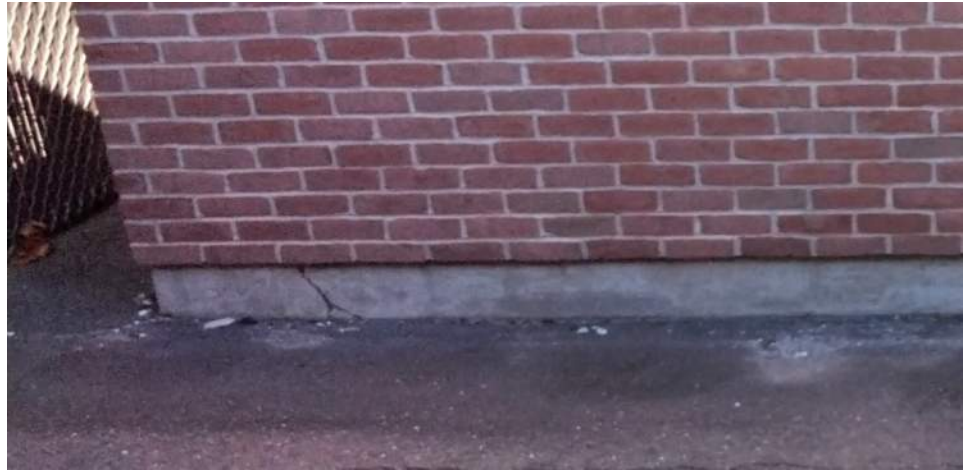
*Cracked cast-in-place concrete foundation typical.*

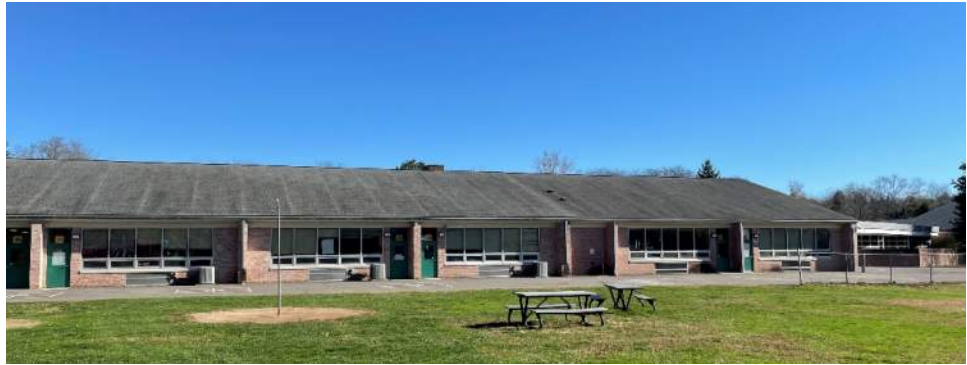
The existing roofs of Coleytown Elementary comprise both low-sloped membrane roof systems and pitched roofs finished in asphalt shingles. Based exclusively upon visual observations, the roofs appear to vary in age judging from the staining and the apparent telegraphing of roof structure for some portions of the pitched roofs.

*Staining of roof shingles and evidence of roof truss locations telegraphing through the roof finish.*

Unless a roof has been recently replaced, or has an extended warranty period, it is common to anticipate the full roof replacement when applying for *Renovation Status*. Roof replacements are common non-priority list State grant funded projects. Determining whether any open State funded roof replacement projects will aid the district in forecasting a prorated funding penalty that might exist under a *Renovation Status* roof replacement.

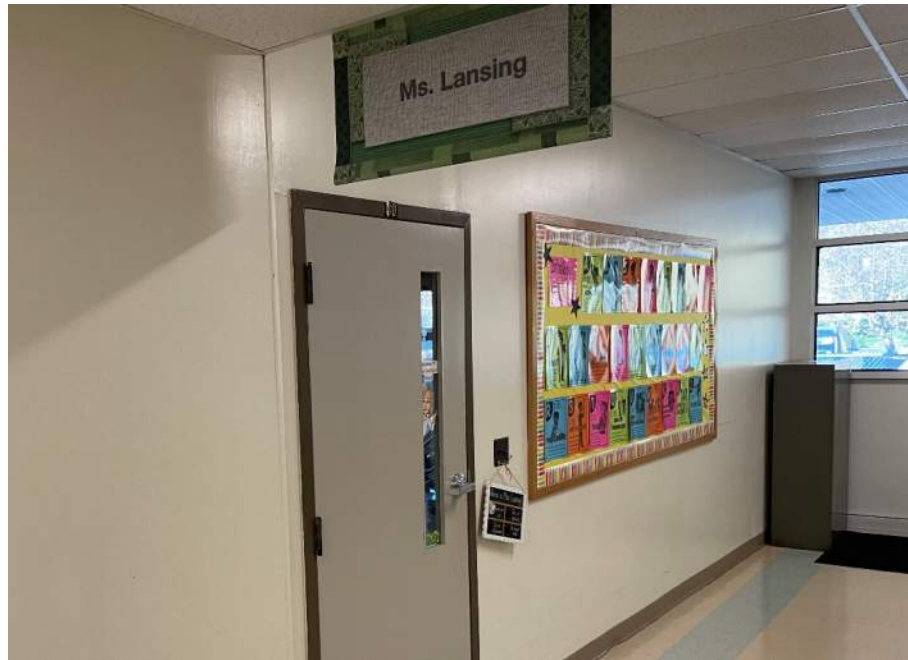
*A typical suspended corridor ceiling demonstrating a slight deflection of the 2 feet by 4 feet ceiling panel.*

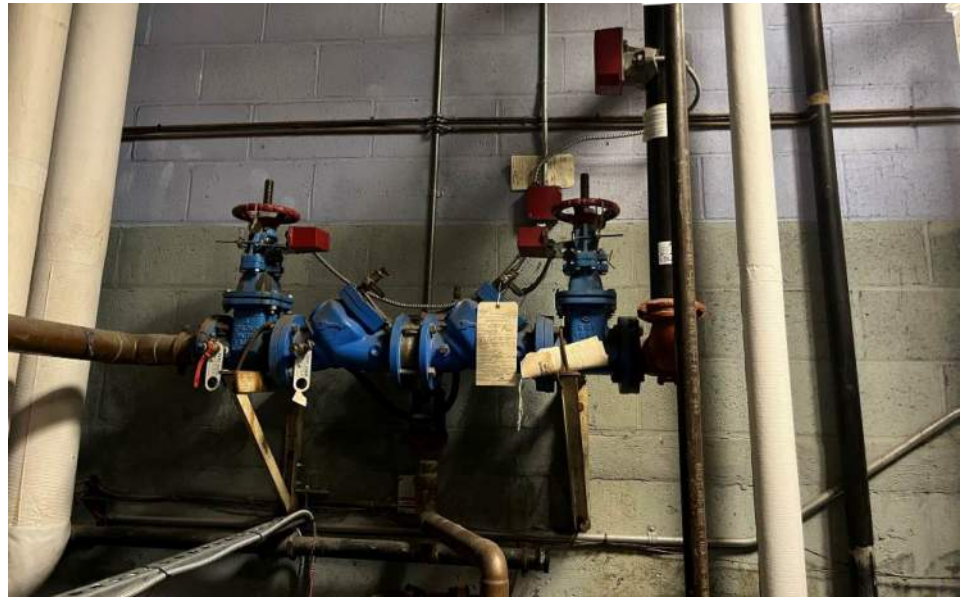
The building is served by a dedicated 4" fire service that the increases to 6" piping after the double check backflow preventer.

The fire service serves only limited portions of the building, such as under the stage, the boiler room, and janitor's storage room. The balance of the building is not sprinklered. The incoming 4" fire service pipe is not large enough to accommodate a fully sprinklered building. A new service would need to be brought into the building, like 8" in size, for the building to be fully sprinklered.

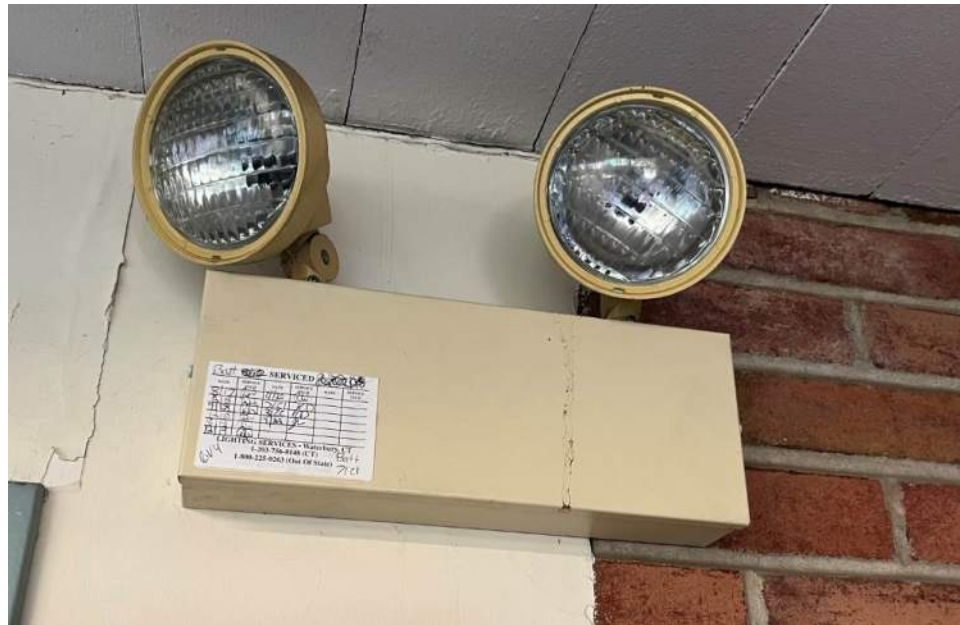
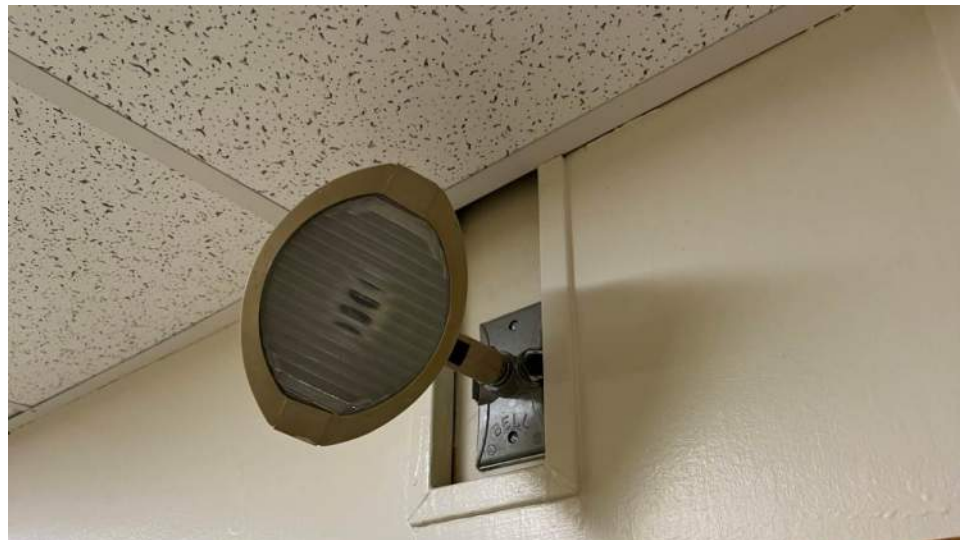
Emergency lighting is achieved through dedicated “bug-eye” lights with local battery packs. Most of these units appear to be at or past their useful life.

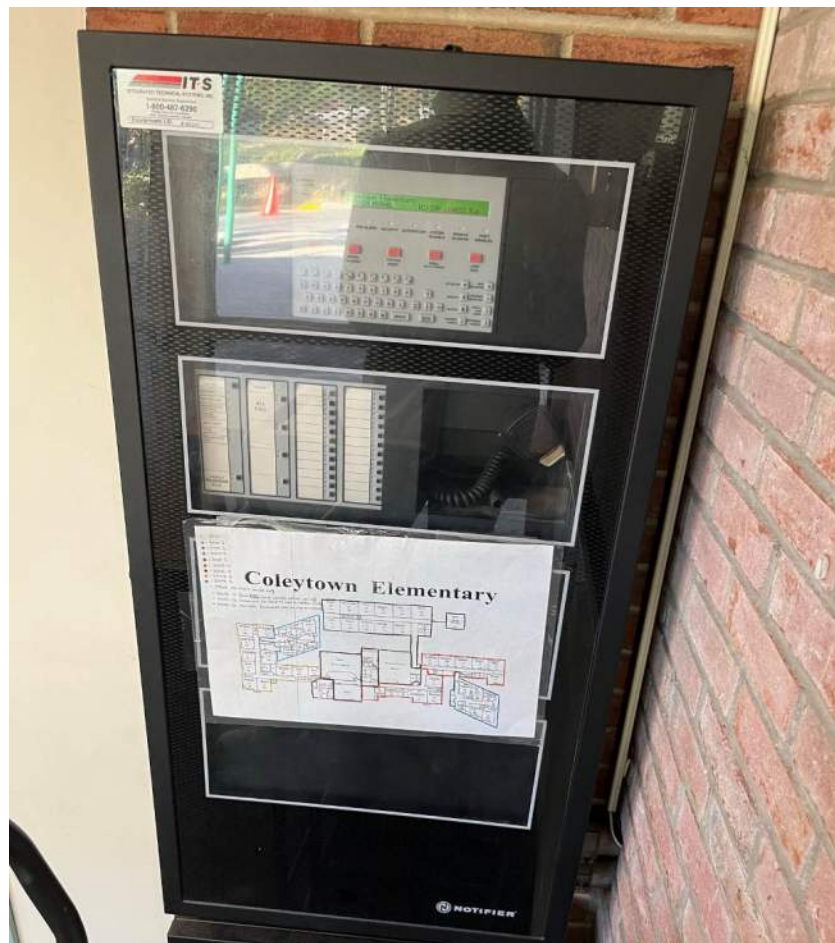
The building is equipped with a Notifier addressable fire alarm system. Pull stations and horn strobes throughout appear newer, however the quantity and placement may not be adequate per current code. Full replacement of this system is recommended as part of any major renovation.
