# New Elementary School on Greendale Road

Week Ending February 6, 2026

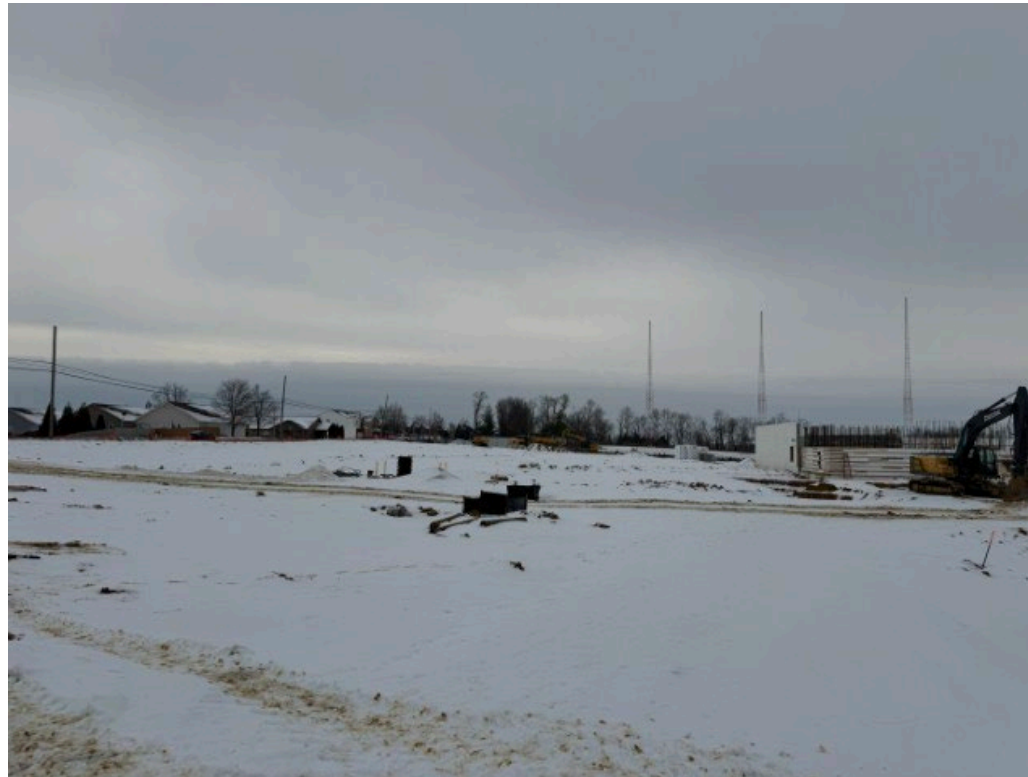
Snow Covered Site at the Geothermal

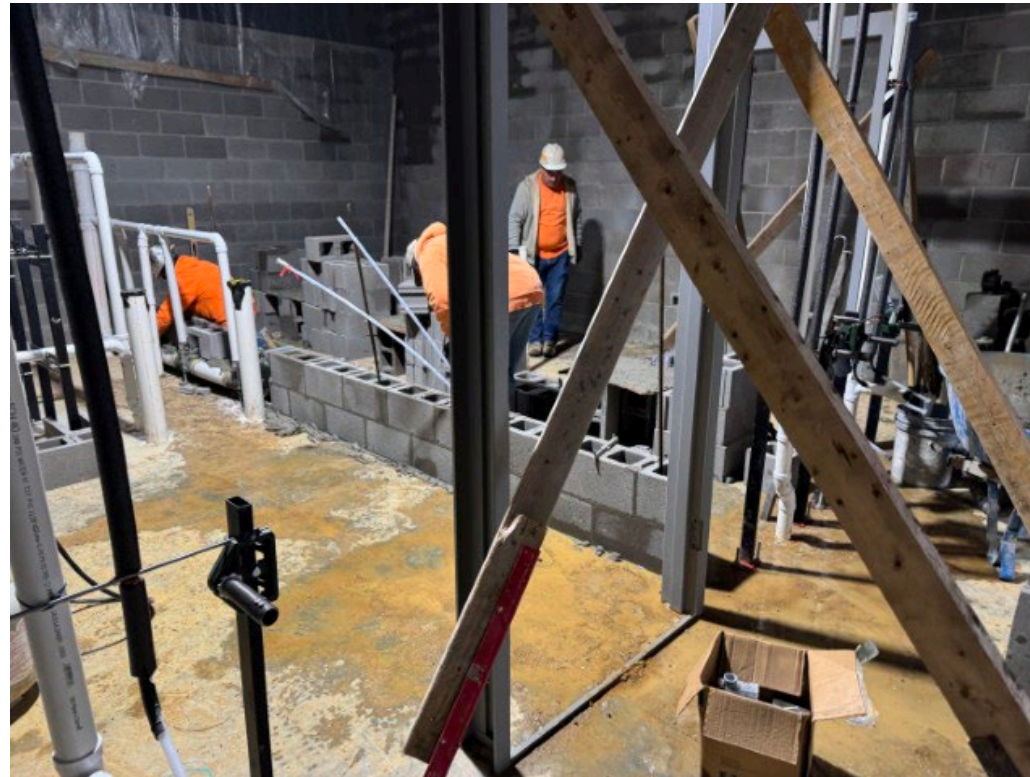
Laying of Interior CMU at Womens 169

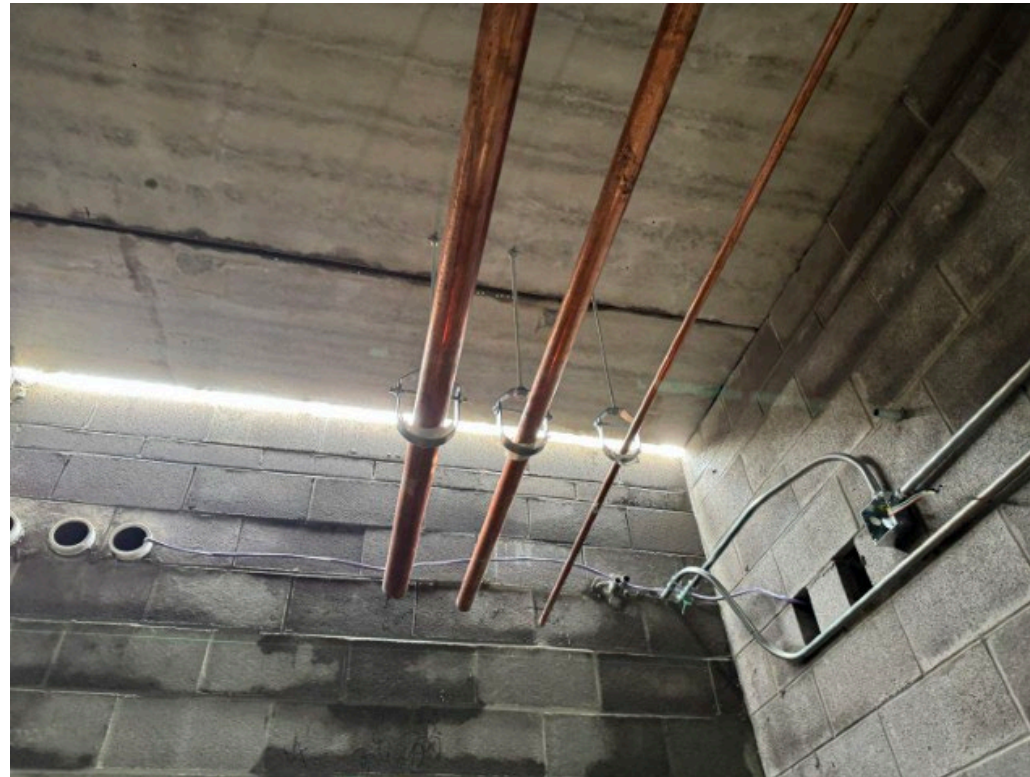
## Copper Piping Installation at Corridor C02

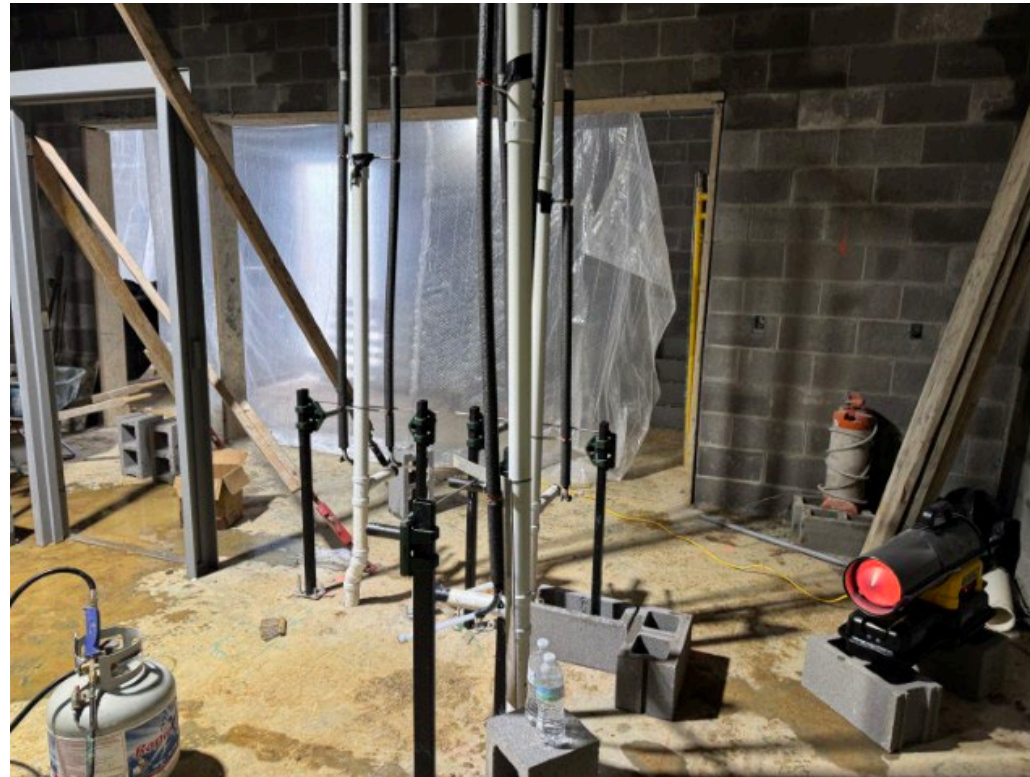
## Plumbing Stub Ups in Restroom 170A

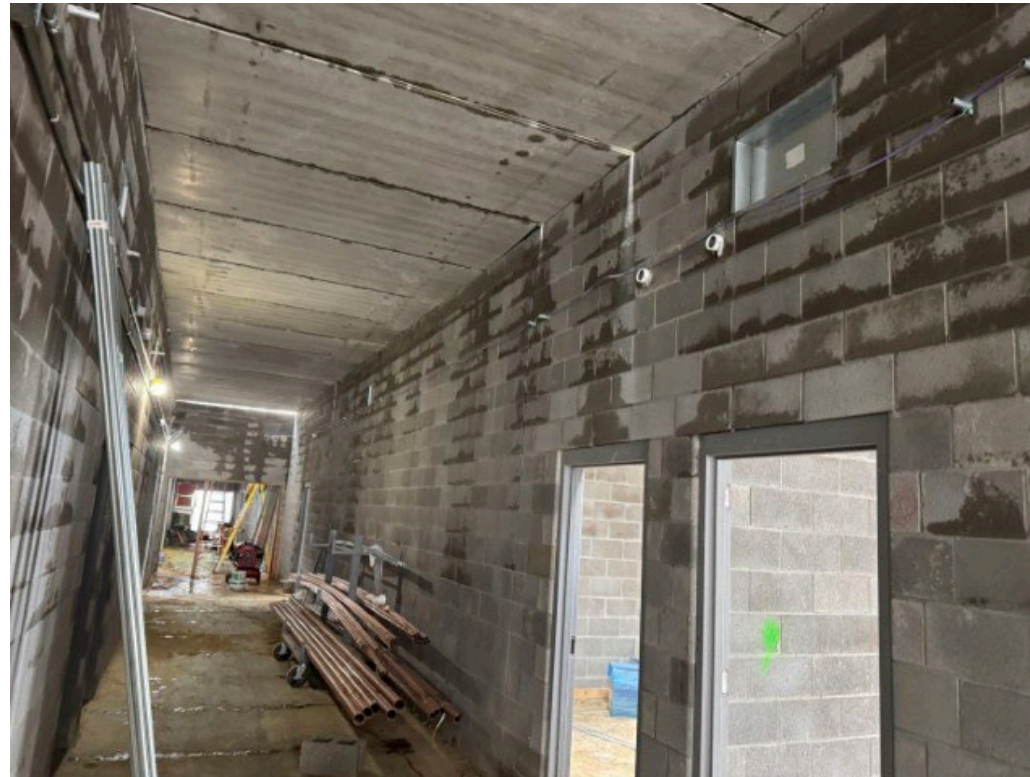
Duct Openings are installed in the CMU Corridor Wall (C02)

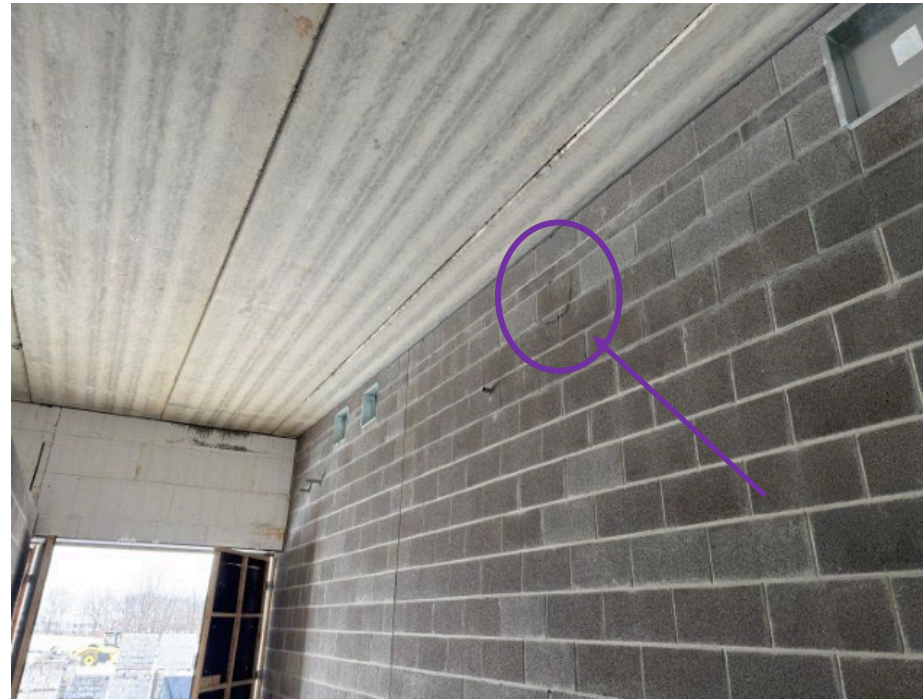
- The site was covered in snow and ice. Not all site items could be observed.
- Laying of interior CMU masonry is in progress in Womens 169 and Mens 170. The area has been tented to keep heat.
- A few locations of CMU appear to have been damaged from the cold temperature. The CM was advised for replacement of the damage CMU.
- Installation of above grade MEP is in progress.
- The retention pond is frozen over but appears to be operating properly. Water was not observed in the lower pond.
- Temporary electric is connected to the building.

Apparent CMU Damage from the Cold Weather
