# **ENGINEERING INSPECTION & RECOMMENDATION REPORT**

## **TOWN OF SUFFIELD UNDER 20 FEET SPAN BRIDGES**

**PREPARED FOR  
TOWN OF SUFFIELD  
83 MOUNTAIN ROAD WEST  
SUFFIELD, CT 06078**

**JANUARY 2026**

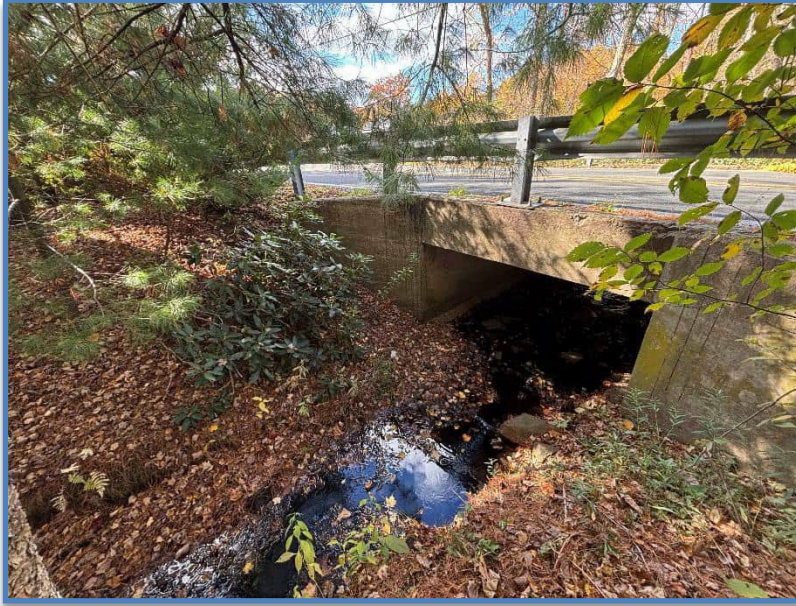
## 2. Bridge 139001 – North Stone St. over Stony Brook

- Top Deck: The condition of the deck's top surface is currently unknown due to the bituminous concrete overlay. The overlay exhibits longitudinal and transverse cracking and isolated potholes. **Fair**

- Bottom Underside: The underside of the concrete slab is in fair condition with isolated areas of concrete spalling with exposed reinforcing steel observed near the inlet side of the bridge. **Fair**

- West Abutment: Cast-in-place concrete abutment exhibiting moderate spalling, early-stage disintegration with section loss, and evidence of minor scour. The abutment is in overall sound. **Fair**
- East Abutment: Cast-in-place concrete with footing exhibiting moderate delamination and early-stage disintegration. **Fair**
- Northwest Wingwall: Fair condition with small hairline cracks. The bottom of the wingwall is protected by riprap and is covered in heavy vegetation that obstructs the waterway. Some concrete spall areas on top of the wall. **Fair**
- Northeast Wingwall: Bottom of wingwall is protected by riprap and shows heavy vegetation that obstructs the waterway. **Fair**
- Southwest Wingwall: Small hairline cracks. **Fair**
- Southeast Wingwall: The top of the wall shows concrete deterioration with concrete spalling at the corner end of the wall. **Fair**

- Repair concrete spalling at the toes of the abutment footings.
- Repair concrete spalling and deterioration at the toes of the wingwall footings.

- Perform partial-depth concrete repairs to address deteriorated concrete and exposed reinforcing steel on the underside of the deck.
- Repair spalled and deteriorated concrete at the tops of wingwalls and headwalls.
- Remove debris and excessive vegetation from within the bridge channel to improve hydraulic performance.
- Clean, reposition, or remove riprap and loose rocks within the bridge channel, as appropriate, to restore proper channel flow and footing protection.

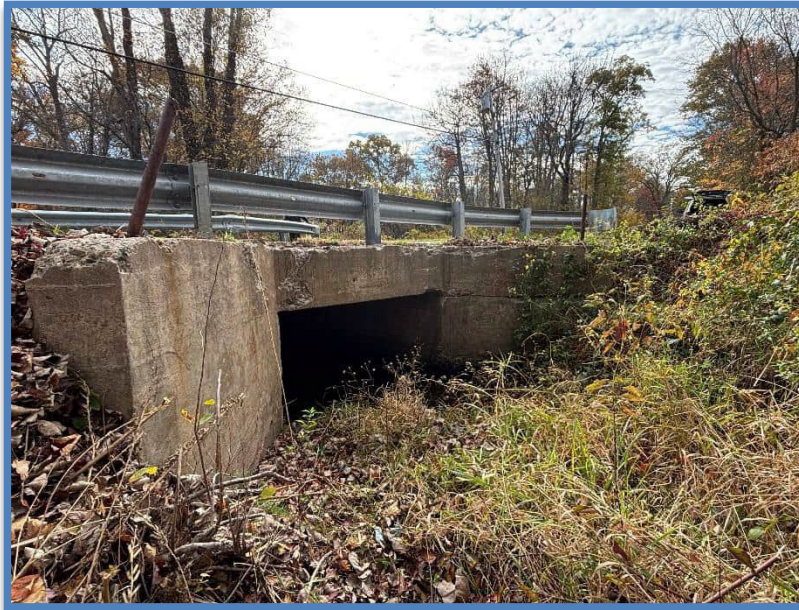
### 3. Bridge 139002 – North Stone St. over Unnamed Brook

- Top Deck: The condition of the top deck is unknown due to the bituminous concrete overlay. The overlay exhibits minor transverse and longitudinal cracking. **Fair**
- Deck Underside: The underside of the concrete slab is in fair condition with minor, light concrete spalling observed. **Fair**

- West Abutment: Cast-in-place concrete abutment exhibiting minor delamination and cracking at the abutment stem. The footing shows minor concrete spalling and evidence of minor scour. **Fair**

- East Abutment: Cast-in-place concrete abutment with stem wall exhibiting moderate delamination and vertical and horizontal cracks. The footing shows early-stage disintegration, advanced concrete spalls, and evidence of moderate scour. **Fair**

- Northwest Wingwall: Wingwall exhibits moderate scour at the base of the wall next to the abutment footing, concrete spalling, concrete section loss, and a horizontal crack (or construction joint). Additional concrete spalling is present at the corner closest to the abutment and along the top of the wall. Wingwall base is protected by riprap and has moderate vegetation present. **Poor**

- Northeast Wingwall: Wingwalls exhibit concrete spalling at the corner closest to the bridge abutment, and some spalled concrete areas on top of the wingwall. Wingwall base is protected by riprap and shows minor vegetation. **Poor**

- Southwest Wingwall: Wingwall exhibits concrete spalling at the top corner adjacent to the bridge abutment. Wingwall base is protected by modified riprap and shows moderate vegetation. **Fair**

- Southeast Wingwall: Wingwall exhibits concrete deterioration, spalling, and localized concrete section loss at the bottom corner adjacent to the east abutment, as well as spalling at top of the wall. Wingwall base is protected by some riprap and shows minor vegetation. **Poor**

- Headwalls: Both headwalls exhibit concrete spalling and section loss that may compromise the stability of the metal beam railing posts mounted on the headwalls. **Poor**

- Repair all concrete spill areas at wingwalls and abutments.
- Repair concrete spill areas at headwalls.

- Repair deteriorated concrete at abutment foundations.
- Repair vertical and horizontal cracks at abutment stems.
- Provide scour protection at inlet and outlet areas.
- Clean vegetation on both sides of the bridge.

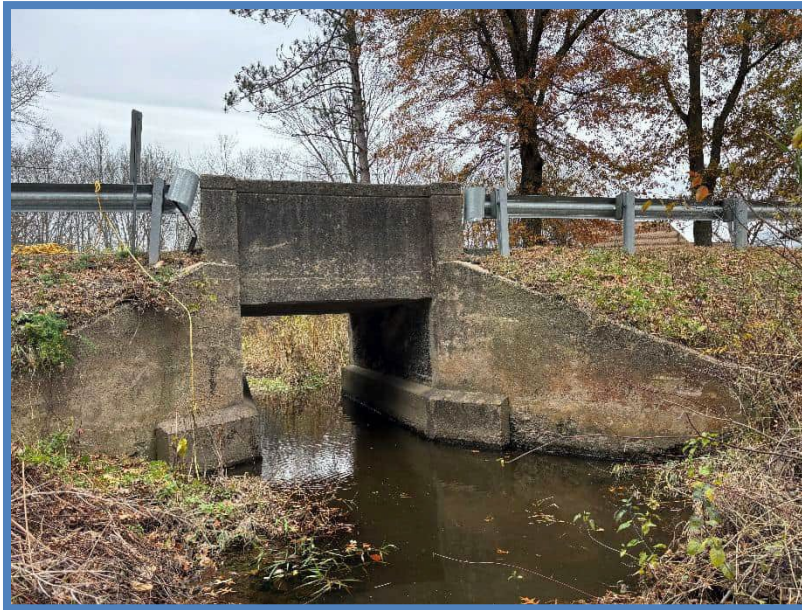
## 4. Bridge 139003 – Russel Avenue over Clay Brook

- Top Deck: The condition of the deck's top surface is unknown due to the presence of a bituminous concrete overlay. The overlay exhibits minor transverse and longitudinal cracks. **Fair**
- Deck Underside: The underside of the deck exhibits minor isolated spalling and one localized area of more advanced spalling with exposed reinforcing steel. **Fair**

- West Abutment: Cast-in-place concrete abutment exhibiting moderate to advanced surface scaling with exposed aggregate. No exposed reinforcing steel was observed at the time of inspection; however continued deterioration may result in deeper section loss if left unaddressed. The footing appears to have been previously rehabilitated by constructing an approximately 7-inch-thick concrete toe extension that extends approximately 3.5 feet vertically and runs longitudinally along the full length of the abutment and wingwalls. Steel plates are installed at all four corners between the abutments and wingwalls. The rehabilitated concrete is in good condition; however, one wingwall location was not included in the rehabilitation and shows spalling and scouring of the original bridge footing. **Fair / Poor**

- East Abutment: Same condition as the west abutment. **Fair / Poor**
- Northwest Wingwall: Wingwall exhibits moderate scour and concrete deterioration at the base beyond the rehabilitated concrete limits. Moderate vegetation present. **Poor**

- Repair all concrete spalls at wingwalls and abutments stem.
- Perform partial-depth concrete repairs to address deteriorated concrete and exposed reinforcing steel on the underside of the deck.
- Repair wingwalls footing not reached by the previously rehabilitated footing.
- Repair vertical and horizontal cracks at abutments stems.
- Protect inlet and outlets areas from scouring.
- Remove vegetation around bridge abutments and its banks.
- Remove vegetation and protect outlet drainage pipe.

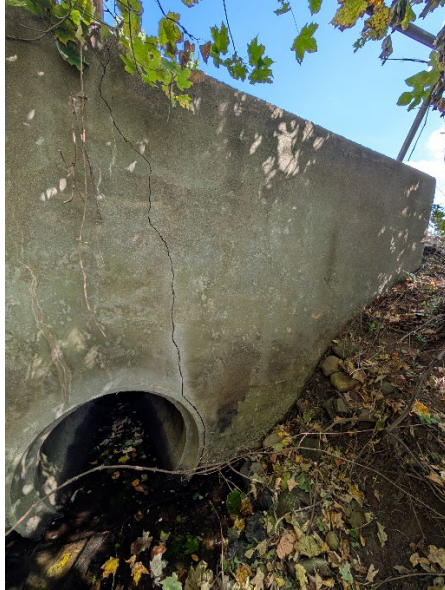
## 21. Suffield St. over unnamed stream

The headwalls at the Suffield Street culvert appear to be rotating away from the roadway. The reinforced concrete pipe (RCP) beneath Suffield Street shows separation between pipe sections, with backfill material visible between the joints. We believe this is occurring because the RCP is connected to the headwalls—so as the headwalls shift, the end pipe sections move with them, worsening the separation between the interior sections.
