**LIMITED LEAD-
BASED PAINT
INSPECTION
REPORT**

**CENTRAL KITCHEN
HVAC UPGRADE PROJECT
4110 WEST 154TH STREET
LAWNDALE, CALIFORNIA 90260**

NOVEMBER 26, 2024
Y&T PROJECT NO. 24-067 (LESD)

LIMITED LEAD-BASED PAINT INSPECTION REPORT

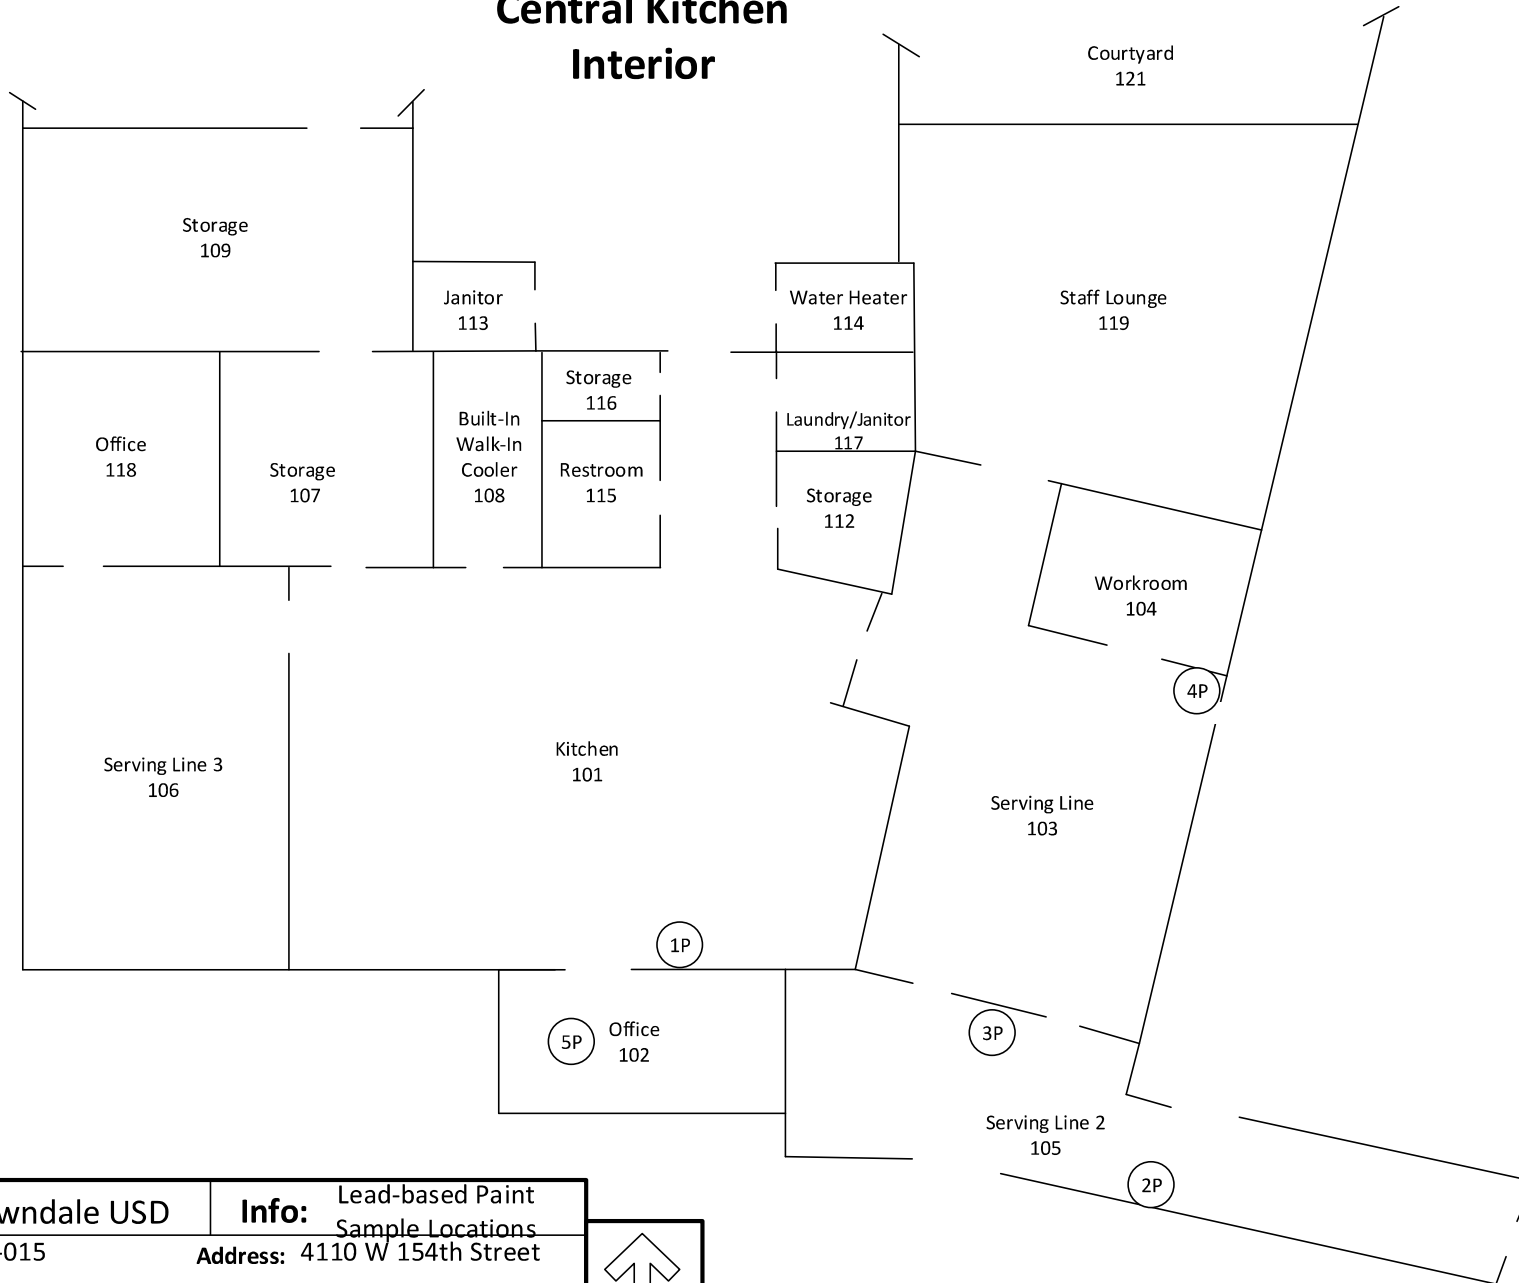
Central Kitchen Interior

Info: Lead-based Paint
Sample Locations
